To: City of Toronto
 From: MMM Group
 Subject: Glen Road Pedestrian Bridge
 Existing Conditions and
 Recommendations

Date: October 31, 2016
 Job No.: 3216026
 CC:

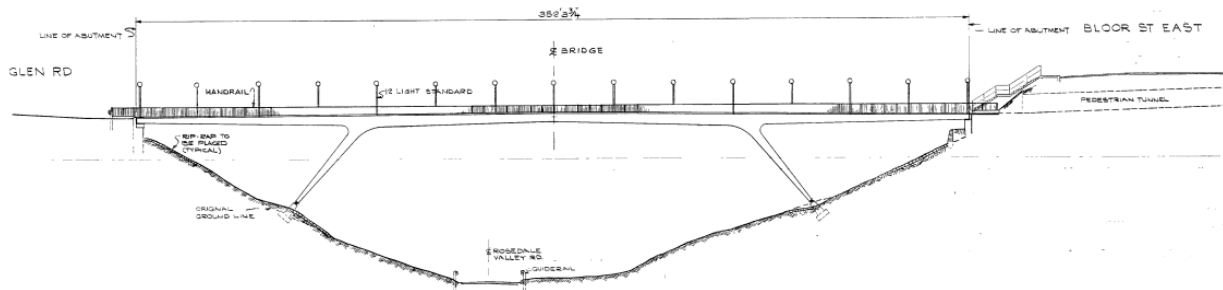
Figure 1: West Elevation

See Figure 1 below for a general view of the existing bridge’s elevation looking east.
