ARBORIST REPORT

**Passmore Avenue,
(Markham Road to East of State
Crown Boulevard) Toronto,
Ontario**

Matthew Hooker, B.LA, OALA, CSLA, ISA
Landscape Architect & ISA Certified Arborist
Morrison Hershfield Limited

Report No. 1160509

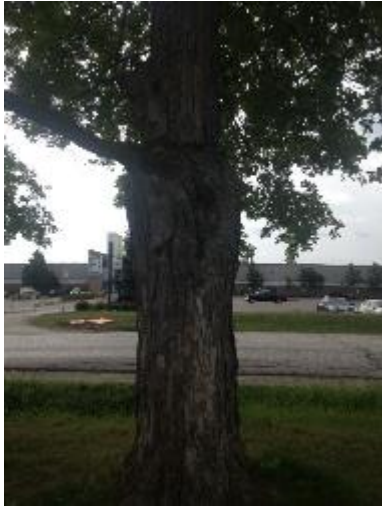
North Side of Passmore Avenue	12	5	Acer saccharum	Sugar Maple	G-F	67	
North Side of Passmore Avenue	13	5	Ulmus americana	American Elm	G	30	
North Side of Passmore Avenue	14	5	Crataegus sp.	Hawthorn	G	30	Heavy Suckering
North Side of Passmore Avenue	15	5	Gleditsia triacanthos var. inermis	Thornless Honeylocust	G	5.5	
North Side of Passmore Avenue	16	5	Gymnocladus dioicus	Kentucky Coffee Tree	G	5.5	
North Side of Passmore Avenue	17	5	Aesculus Flava	Ohio Buckeye	G-F	6.5	Trunk Split
North Side of Passmore Avenue	18	5	Robinia pseudoacacia	Black Locust	G	7	Small Clump of Stems all <7cm
North Side of Passmore Avenue	19	5	Gleditsia triacanthos var. inermis	Thornless Honeylocust	F-P	9.5	2 Large Wounds on Trunk
North Side of Passmore Avenue	20		Acer plataniodes 'Crimson King'	Crimson King Maple	G	23	
North Side of Passmore Avenue	21		Gleditsia triacanthos var. inermis	Thornless Honeylocust	G	19	
North Side of Passmore Avenue	22		Gleditsia triacanthos var. inermis	Thornless Honeylocust	G	12.5

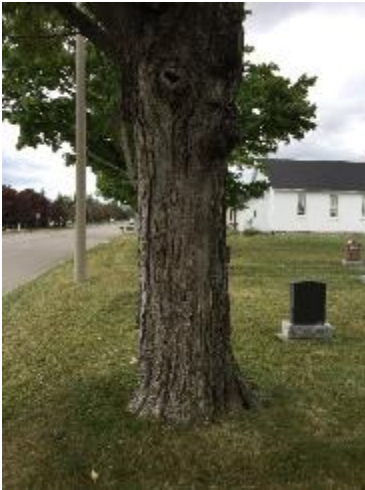
North Side of Passmore Avenue	52	2	Acer plataniodes 'Crimson King'	Crimson King Maple	G	41	
North Side of Passmore Avenue	53	5	Amelanchier laevis	Serviceberry	G-F	8	3 Stems
North Side of Passmore Avenue	54	2	Acer plataniodes 'Crimson King'	Crimson King Maple	G	40	
North Side of Passmore Avenue	55	2	Pinus nigra	Austrian Pine	G	31	
North Side of Passmore Avenue	56	2	Pinus resinosa	Red Pine	G	35	
North Side of Passmore Avenue	57	2	Acer negundo	Manitoba Maple	G	44	
North Side of Passmore Avenue	58	2	Thuja occidentalis	White Cedar	G-F	50	2 Stems
North Side of Passmore Avenue	59	5	Acer saccharum	Sugar Maple			Dead Stump
North Side of Passmore Avenue	60	5	Amelanchier laevis	Serviceberry	G	9	
North Side of Passmore Avenue	61	5	Acer saccharum	Sugar Maple	G-F	55	10% Die-Back
North Side of Passmore Avenue	62	5	Acer saccharum	Sugar Maple	F	69	Main Leader is Dead
North Side of Passmore Avenue	63	5	Acer saccharum	Sugar Maple	G-F	78	Main Leader is Dead

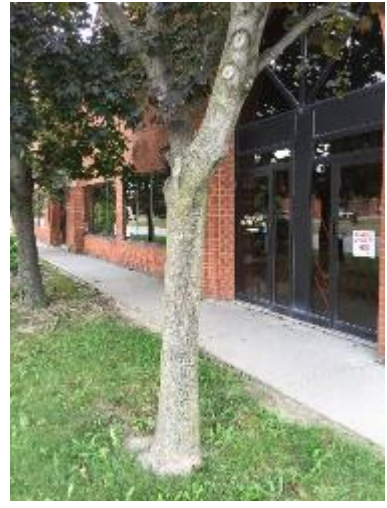
Tree #79

General Location	Tree #	Category	Botanical Name	Common Name	Rating	DBH (cm)	Notes
South Side of Passmore Avenue	79	5	Acer plataniodes 'Crimson King'	Crimson King Maple	F-P	27	60% Die-Back
South Side of Passmore Avenue	80	5	Acer plataniodes 'Crimson King'	Crimson King Maple	G	29	
South Side of Passmore Avenue	81	5	Acer plataniodes 'Crimson King'	Crimson King Maple	G	20	
South Side of Passmore Avenue	82	5	Acer plataniodes	Norway Maple	G-F	26	10% Die-Back
South Side of Passmore Avenue	83	5	Acer plataniodes 'Crimson King'	Crimson King Maple	G-F	27	10% Die-Back
South Side of Passmore Avenue	84	5	Acer plataniodes	Norway Maple	G-F	25	
South Side of Passmore Avenue	85	5	Gymnocladus dioicus	Kentucky Coffee Tree	G	5.5	
South Side of Passmore Avenue	86	5	Gymnocladus dioicus	Kentucky Coffee Tree	G	4.8	
South Side of Passmore Avenue	87	5	Gymnocladus dioicus	Kentucky Coffee Tree	G	4.6	
South Side of Passmore Avenue	88	5	Aesculus Flava	Ohio Buckeye	P	5	Main Leader is Dead, Suckering at Base

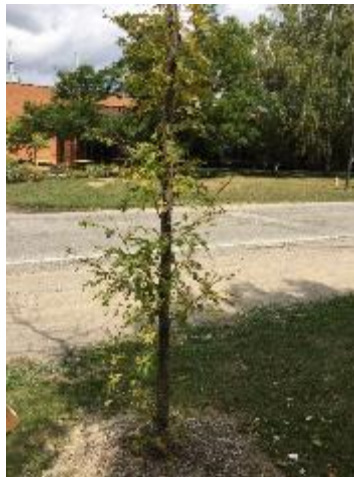
Tree #89

South Side of Passmore Avenue	89	5	Gleditsia triacanthos var. inermis	Thornless Honeylocust	F-P	5	Main Leader is Dead, Suckering at Base
South Side of Passmore Avenue	90	5	Gleditsia triacanthos var. inermis	Thornless Honeylocust	G-F	5	
South Side of Passmore Avenue	91	5	Acer plataniodes	Norway Maple	G	20	
South Side of Passmore Avenue	92		Acer plataniodes	Norway Maple	G-F	29	
South Side of Passmore Avenue	93		Acer plataniodes	Norway Maple	G-F	24	
South Side of Passmore Avenue	94		Acer plataniodes	Norway Maple	G-F	25	
South Side of Passmore Avenue	95		Acer plataniodes	Norway Maple	F-P	21	50% Die-Back
South Side of Passmore Avenue	96		Acer plataniodes	Norway Maple	F	18	40% Die-Back
South Side of Passmore Avenue	97		Acer plataniodes	Norway Maple	G-F	20	
South Side of Passmore Avenue	98		Acer plataniodes	Norway Maple	G-F	18	
South Side of Passmore Avenue	99		Acer plataniodes	Norway Maple	G	16	Birds Nest
