Taylor Massy Creek Sub-Watershed Master Plan Development

Flood and Stream Restoration

Area 1 & 2

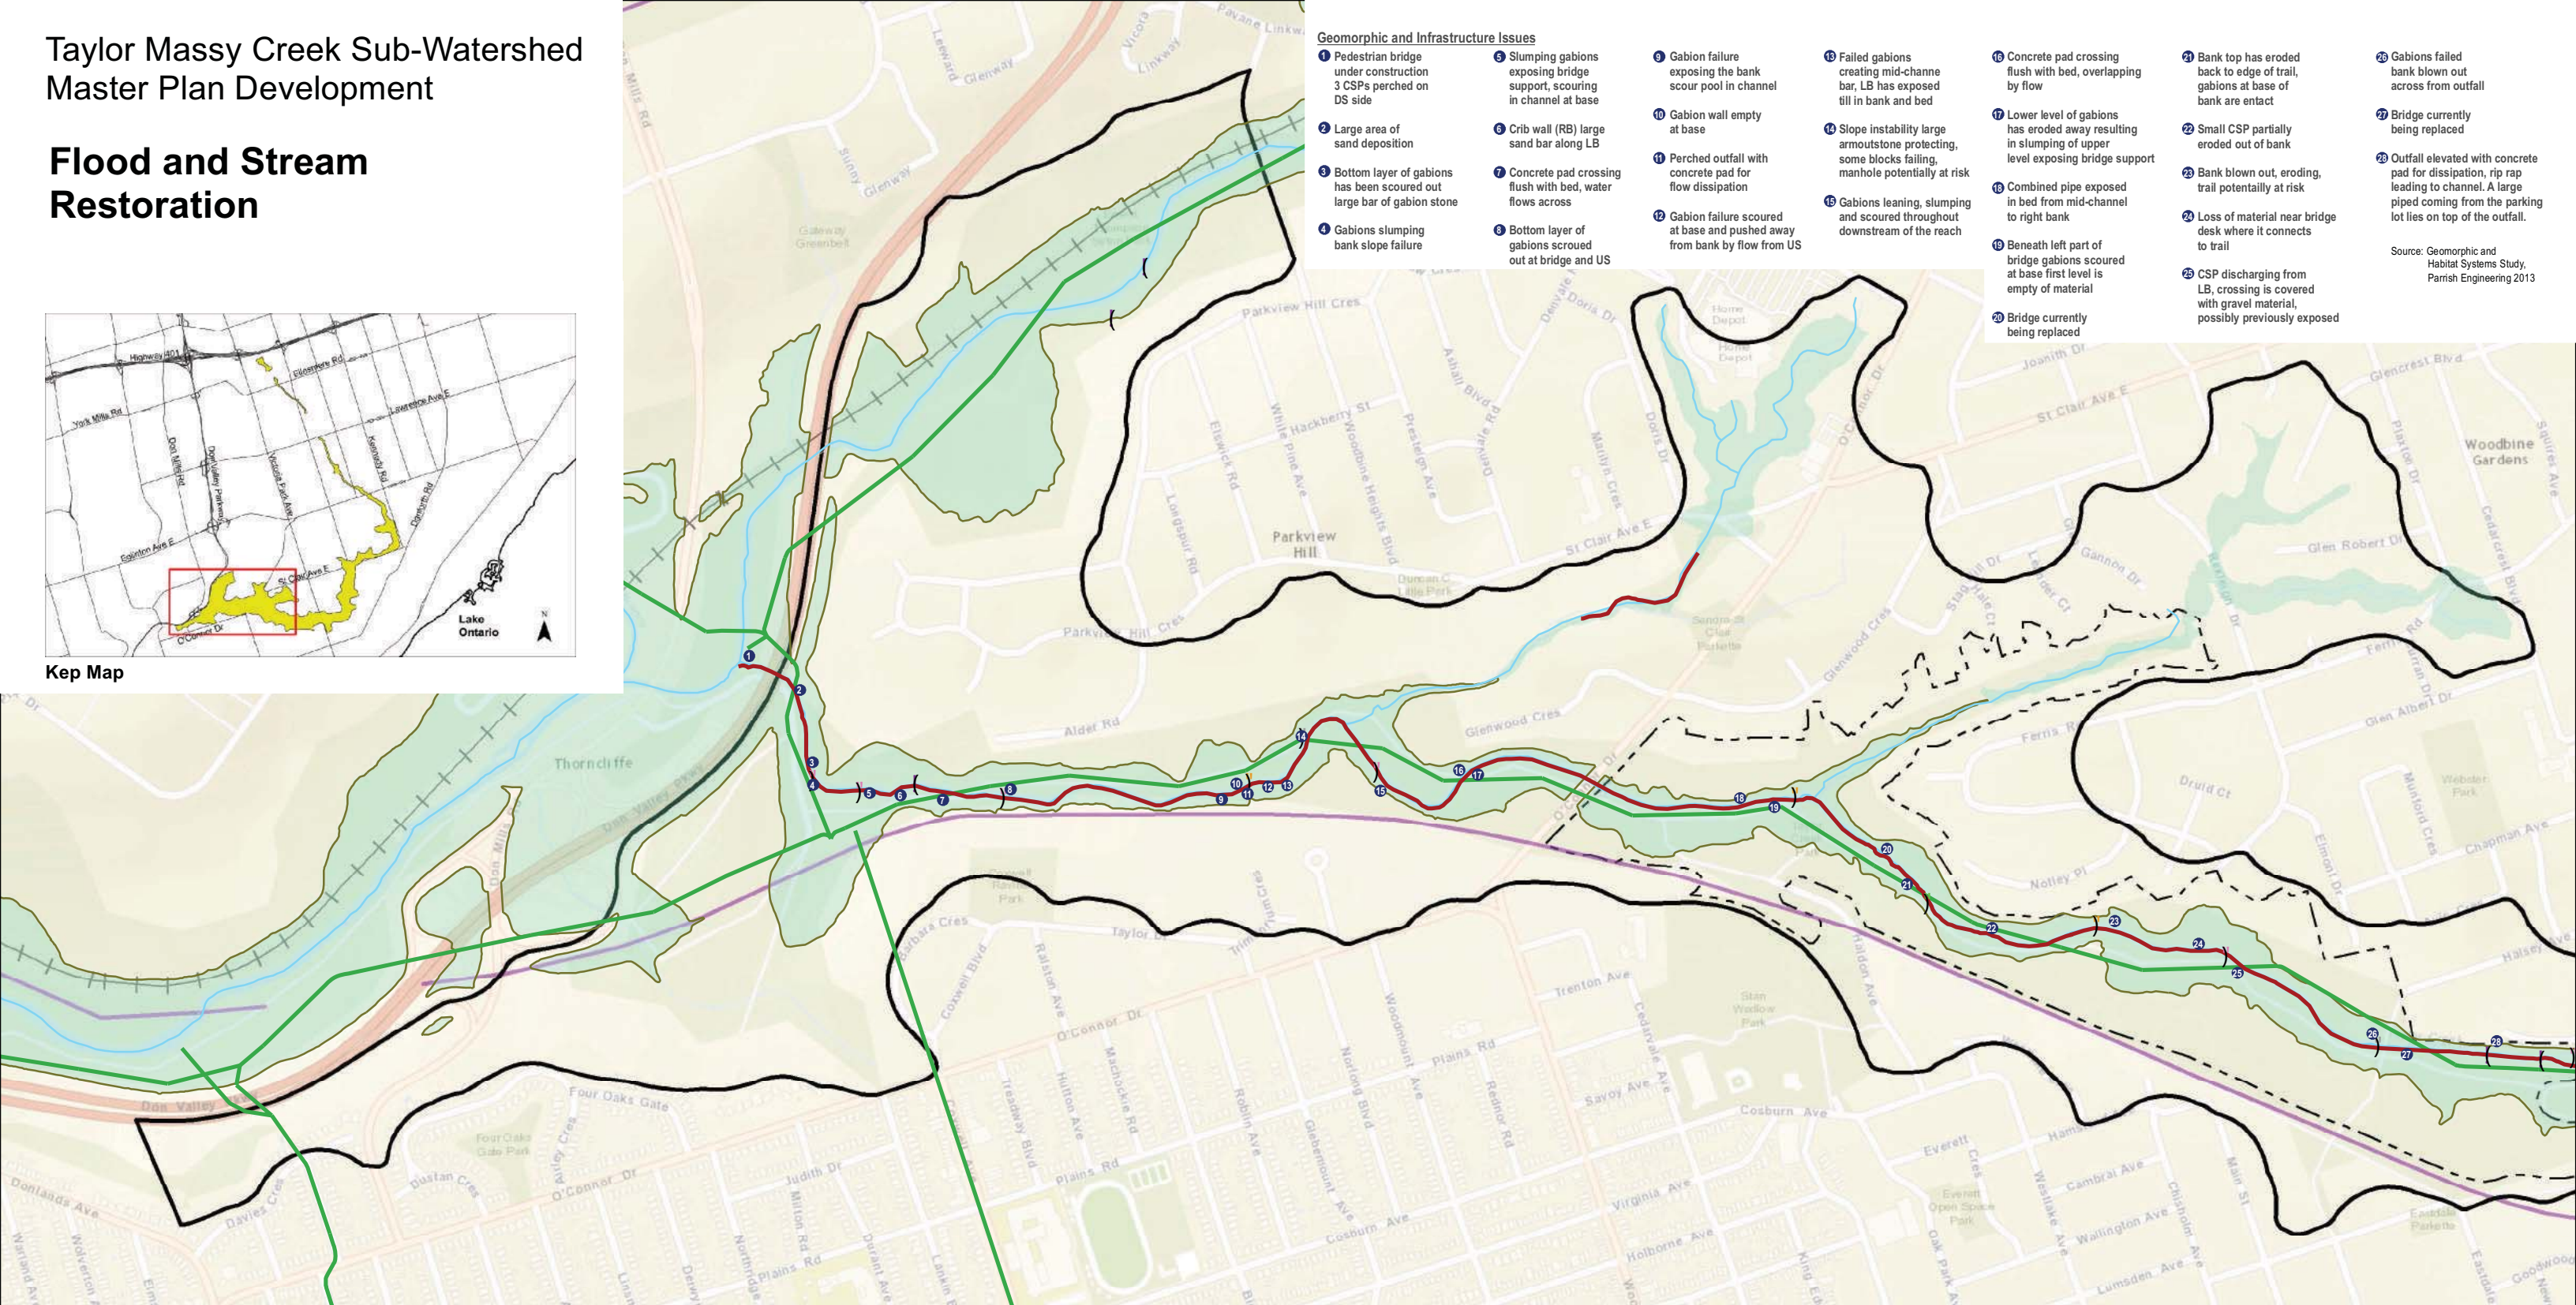
- Geomorphic and Infrastructure Issues**
- 1 Pedestrian bridge under construction 3 CSPs perched on DS side
 - 2 Large area of sand deposition
 - 3 Bottom layer of gabions has been scoured out large bar of gabion stone

- 4 Gabions slumping bank slope failure
 - 5 Slumping gabions exposing bridge support, scouring in channel at base
 - 6 Crib wall (RB) large sand bar along LB

- 7 Concrete pad crossing flush with bed, water flows across
 - 8 Bottom layer of gabions scroued out at bridge and US
 - 9 Gabion failure exposing the bank scour pool in channel

- 10 Gabion wall empty at base
 - 11 Perched outfall with concrete pad for flow dissipation
 - 12 Gabion failure scoured at base and pushed away from bank by flow from US

- 13 Failed gabions creating mid-channel bar, LB has exposed till in bank and bed
 - 14 Slope instability large armoutstone protecting, some blocks failing, manhole potentially at risk

- 15 Gabions leaning, slumping and scoured throughout downstream of the reach
 - 16 Concrete pad crossing flush with bed, overlapping by flow
 - 17 Lower level of gabions has eroded away resulting in slumping of upper level exposing bridge support

- 18 Combined pipe exposed in bed from mid-channel to right bank
 - 19 Beneath left part of bridge gabions scoured at base first level is empty of material

- 20 Bridge currently being replaced
 - 21 Bank top has eroded back to edge of trail, gabions at base of bank are entact
 - 22 Small CSP partially eroded out of bank

- 23 Bank blown out, eroding, trail potentially at risk
 - 24 Loss of material near bridge desk where it connects to trail
 - 25 CSP discharging from LB, crossing is covered with gravel material, possibly previously exposed

- 26 Gabions failed bank blown out across from outfall
 - 27 Bridge currently being replaced
 - 28 Outfall elevated with concrete pad for dissipation, rip rap leading to channel. A large piped coming from the parking lot lies on top of the outfall.

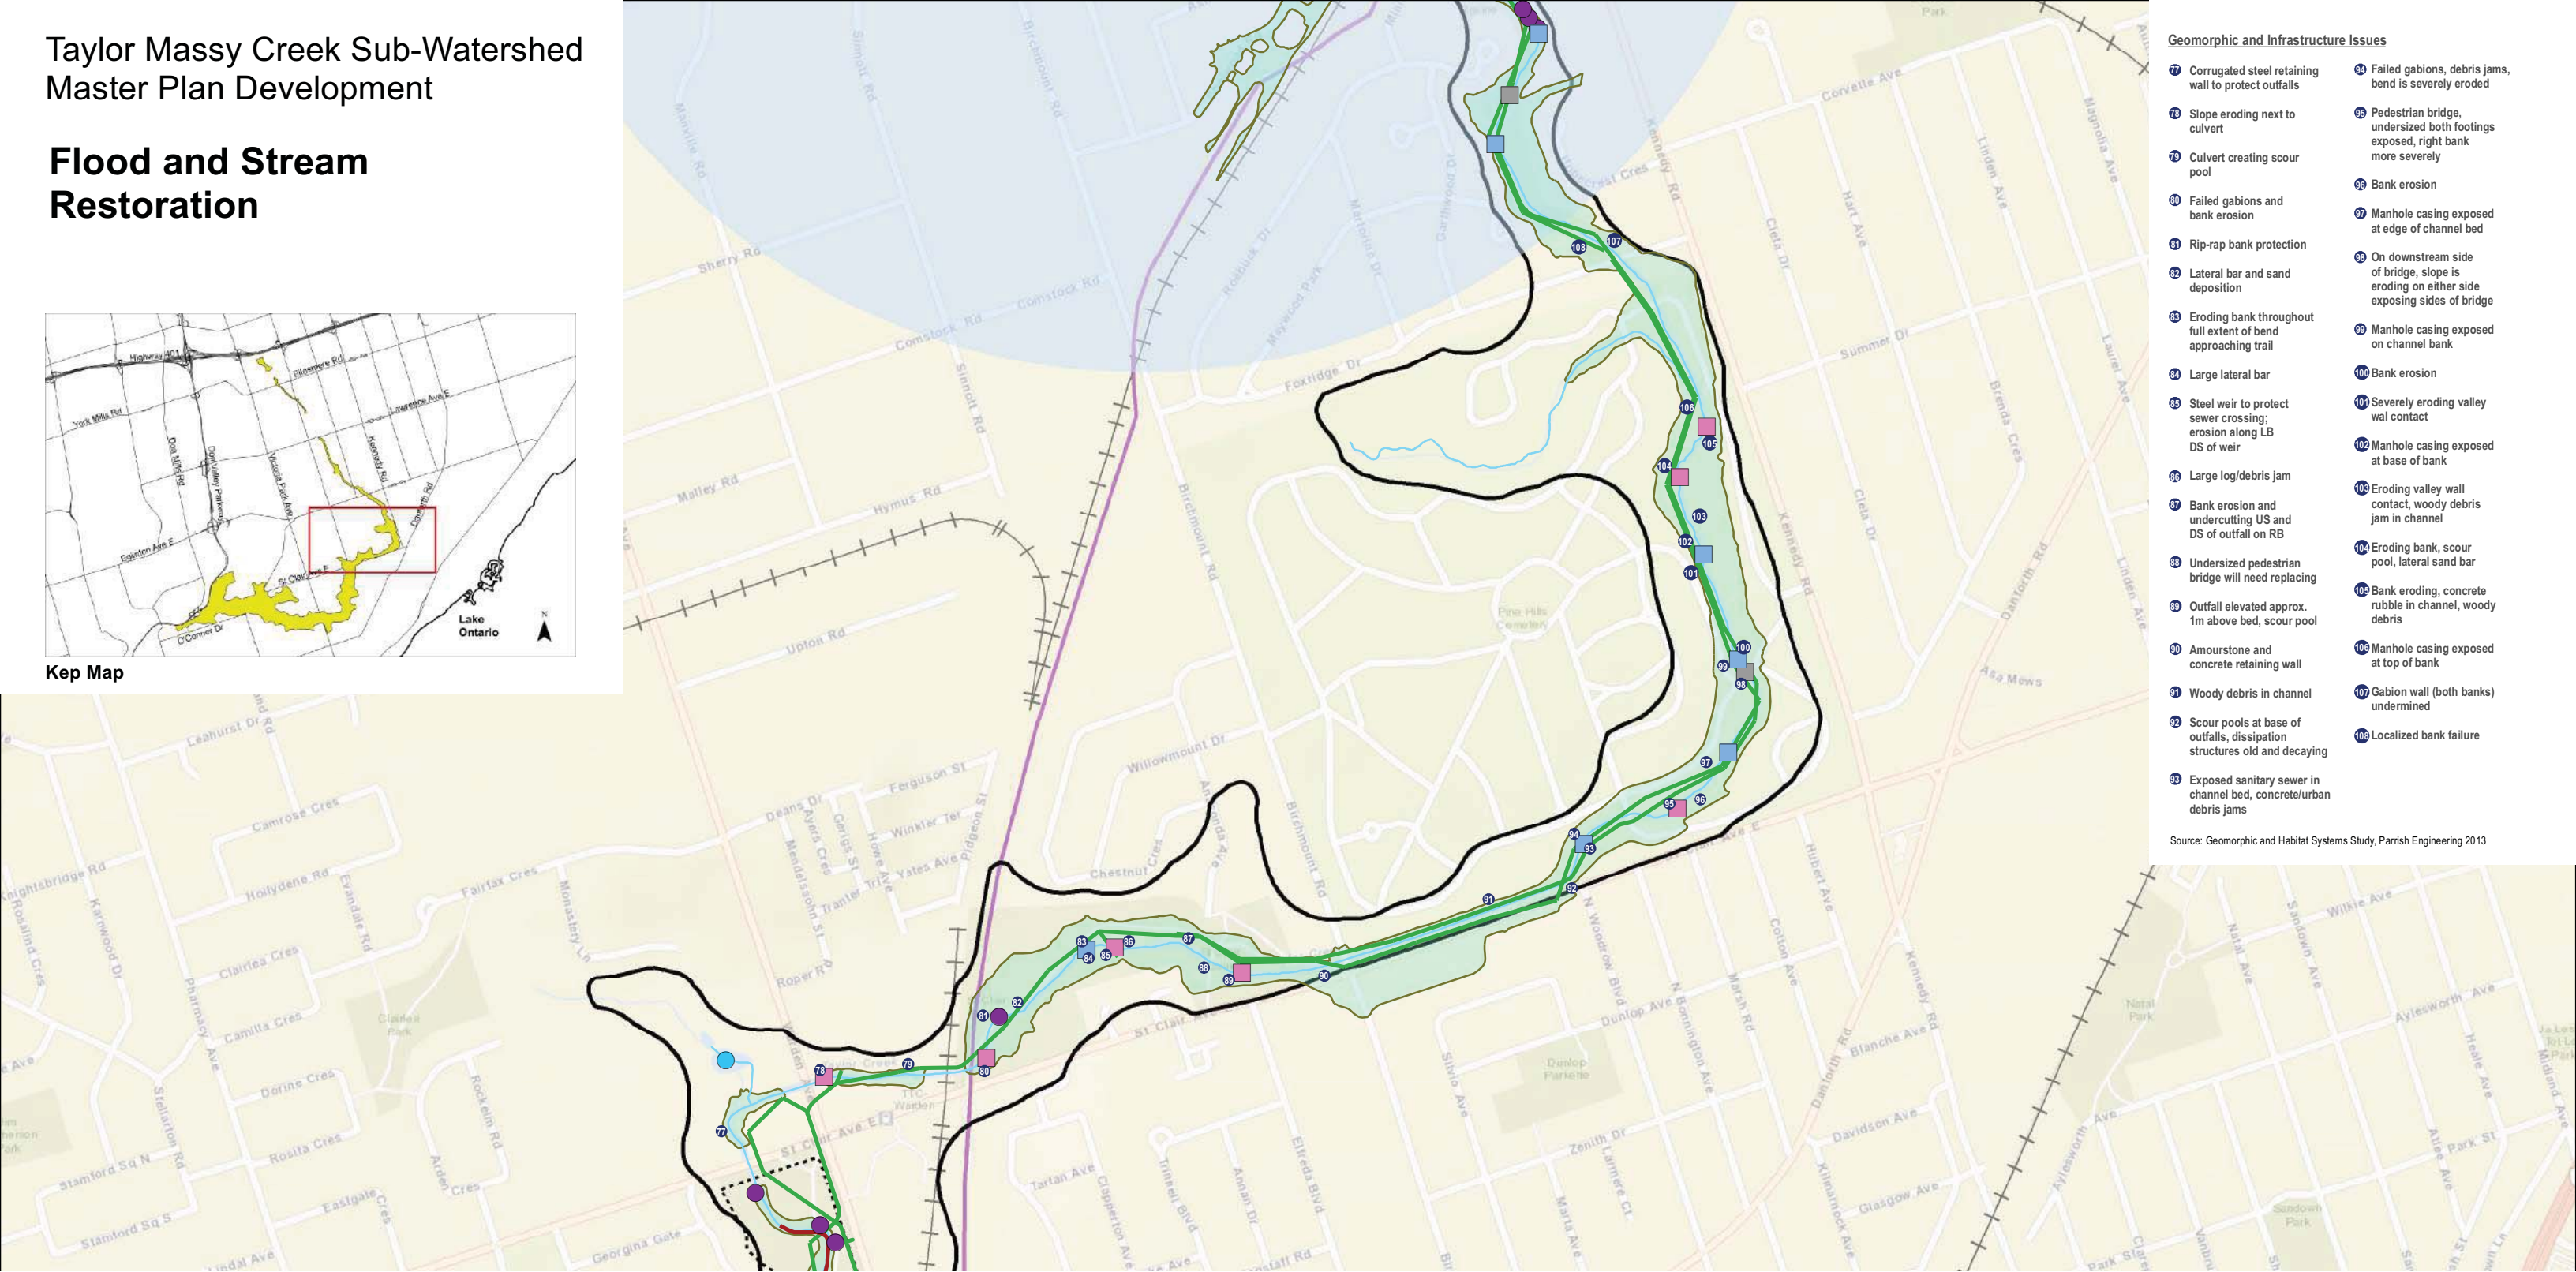
Area 5 & 6

- 71 Corrugated steel retaining wall to protect outfalls
- 72 Slope eroding next to culvert
- 73 Culvert creating scour pool
- 80 Failed gabions and bank erosion

- 81 Rip-rap bank protection
- 82 Lateral bar and sand deposition
- 83 Eroding bank throughout full extent of bend approaching trail
- 84 Large lateral bar

- 85 Steel weir to protect sewer crossing; erosion along LB DS of weir
- 86 Large log/debris jam
- 87 Bank erosion and undercutting US and DS of outfall on RB

- 88 Undersized pedestrian bridge will need replacing
- 89 Outfall elevated approx. 1m above bed, scour pool
- 90 Amourstone and concrete retaining wall
- 91 Woody debris in channel

- 92 Scour pools at base of outfalls, dissipation structures old and decaying
- 93 Exposed sanitary sewer in channel bed, concrete/urban debris jams
- 94 Failed gabions, debris jams, bend is severely eroded

- 95 Pedestrian bridge, undersized both footings exposed, right bank more severely
- 96 Bank erosion
- 97 Manhole casing exposed at edge of channel bed
- 98 On downstream side of bridge, slope is eroding on either side exposing sides of bridge

- 99 Manhole casing exposed on channel bank
- 100 Bank erosion
- 101 Severely eroding valley wal contact
- 102 Manhole casing exposed at base of bank
- 103 Eroding valley wall contact, woody debris jam in channel

- 104 Eroding bank, scour pool, lateral sand bar
- 105 Bank eroding, concrete rubble in channel, woody debris
- 106 Manhole casing exposed at top of bank

- 107 Gabion wall (both banks) undermined
- 108 Localized bank failure

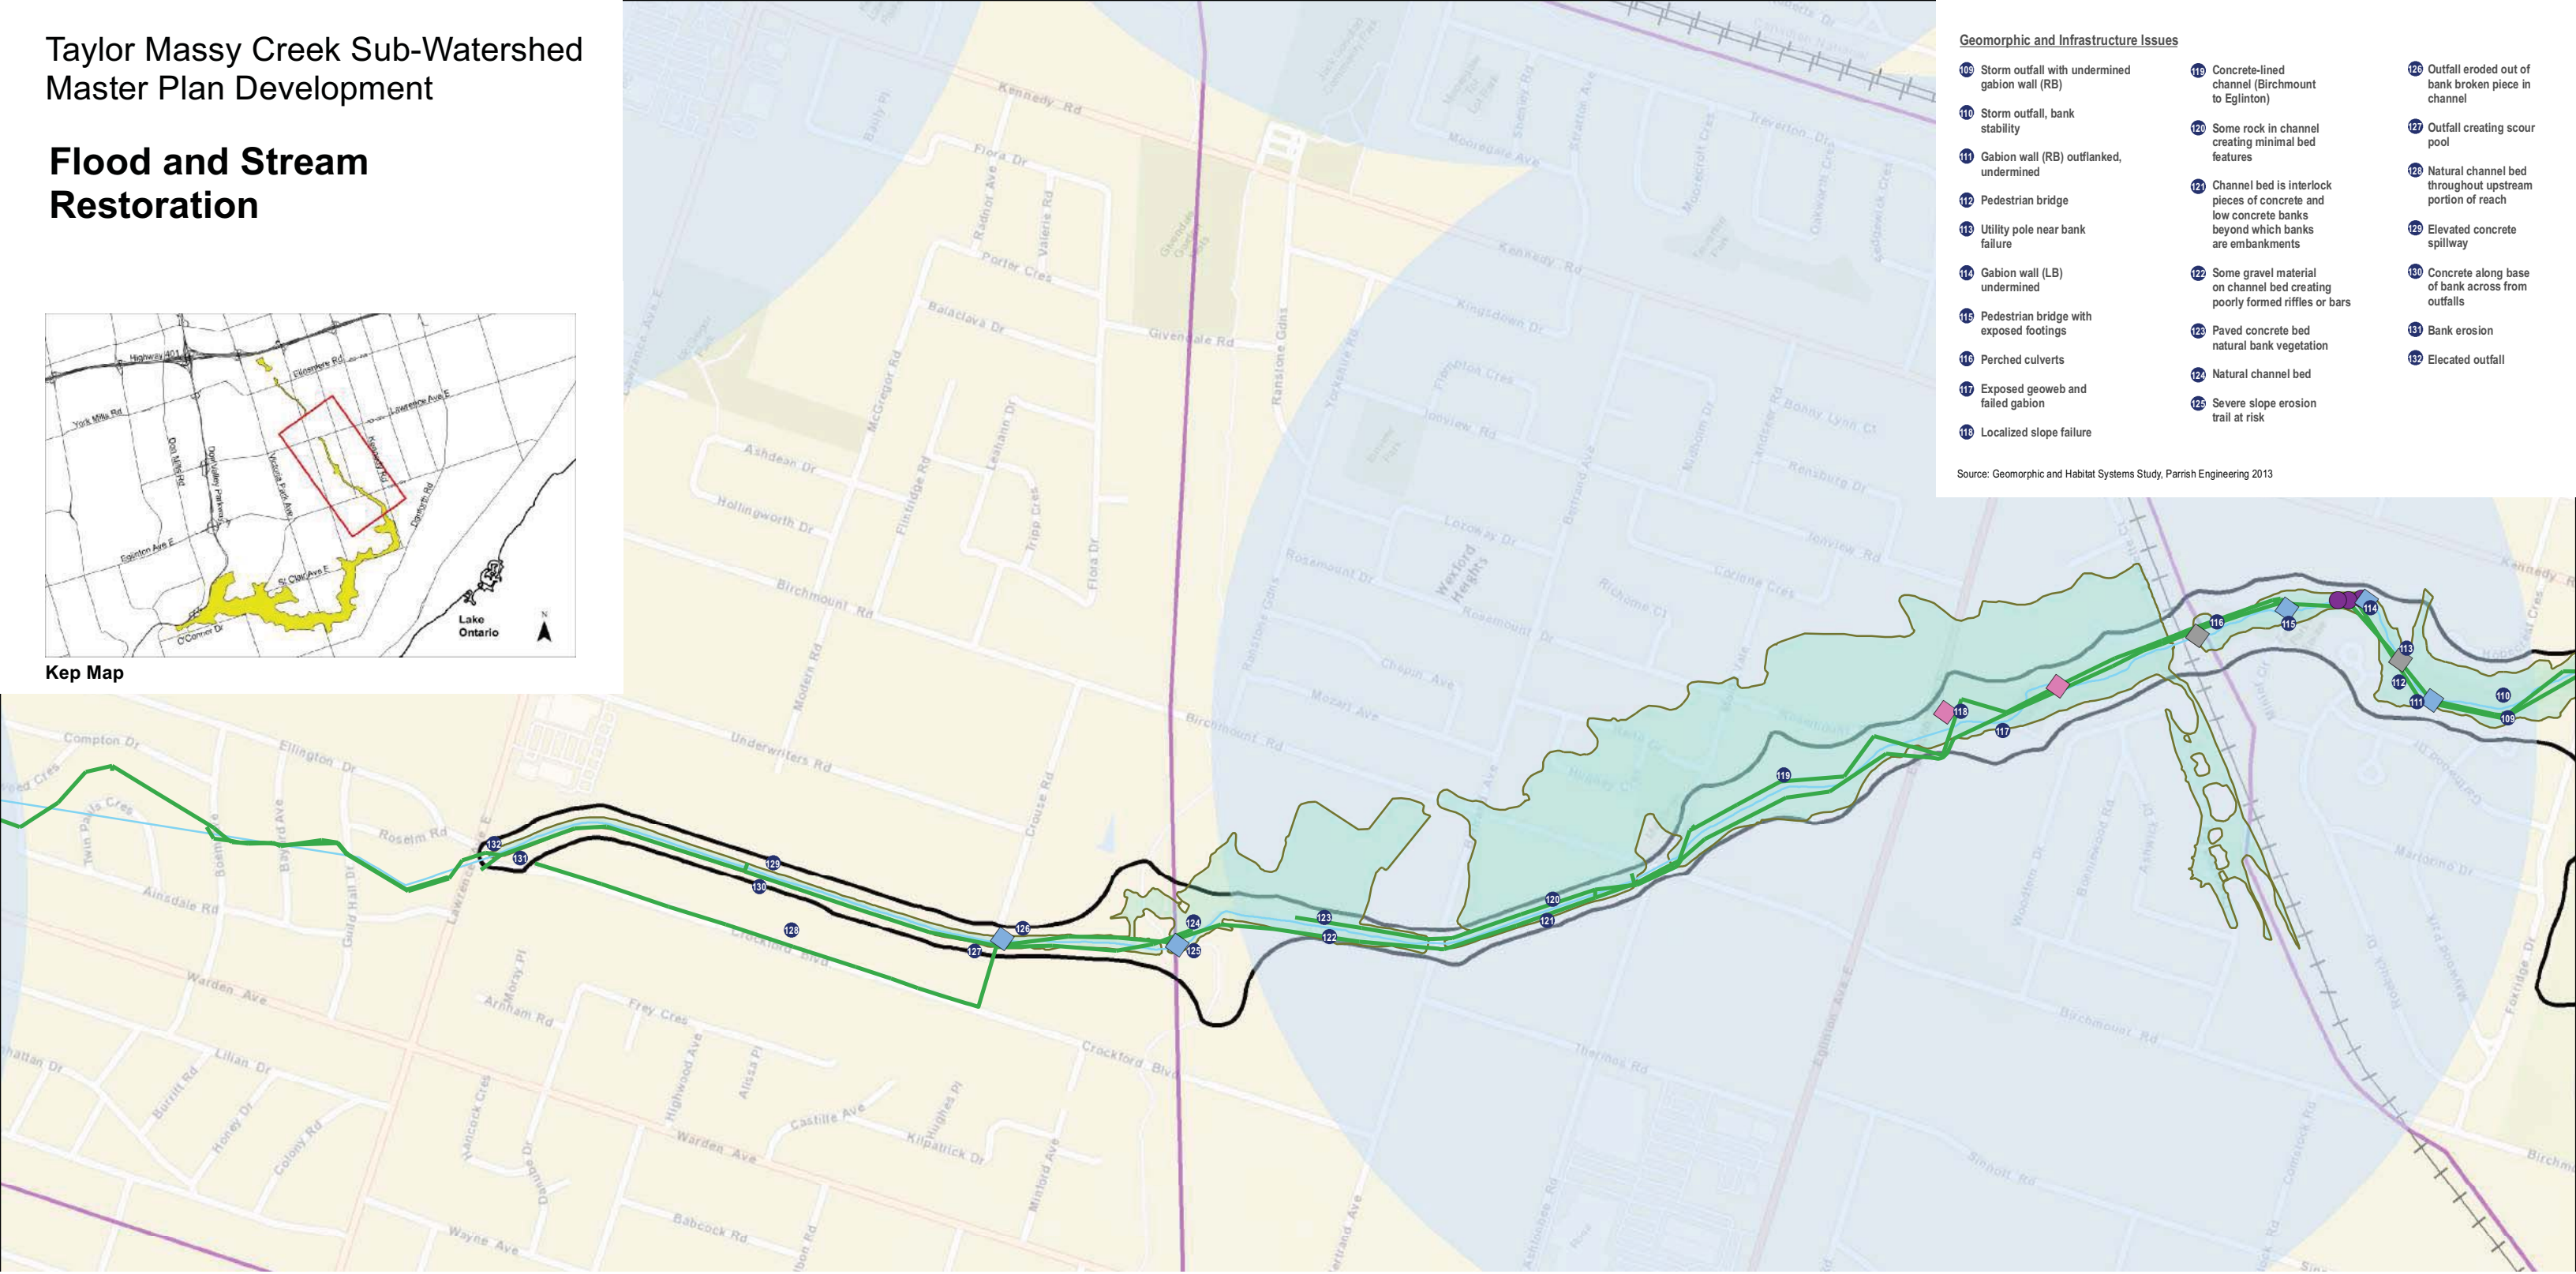
Area 7

Storm outfall with undermined gabion wall (RB)

Storm outfall, bank stability

Gabion wall (RB) outflanked, undermined

Concrete-lined channel (Birchmount to Eglinton)

Outfall eroded out of bank broken piece in channel

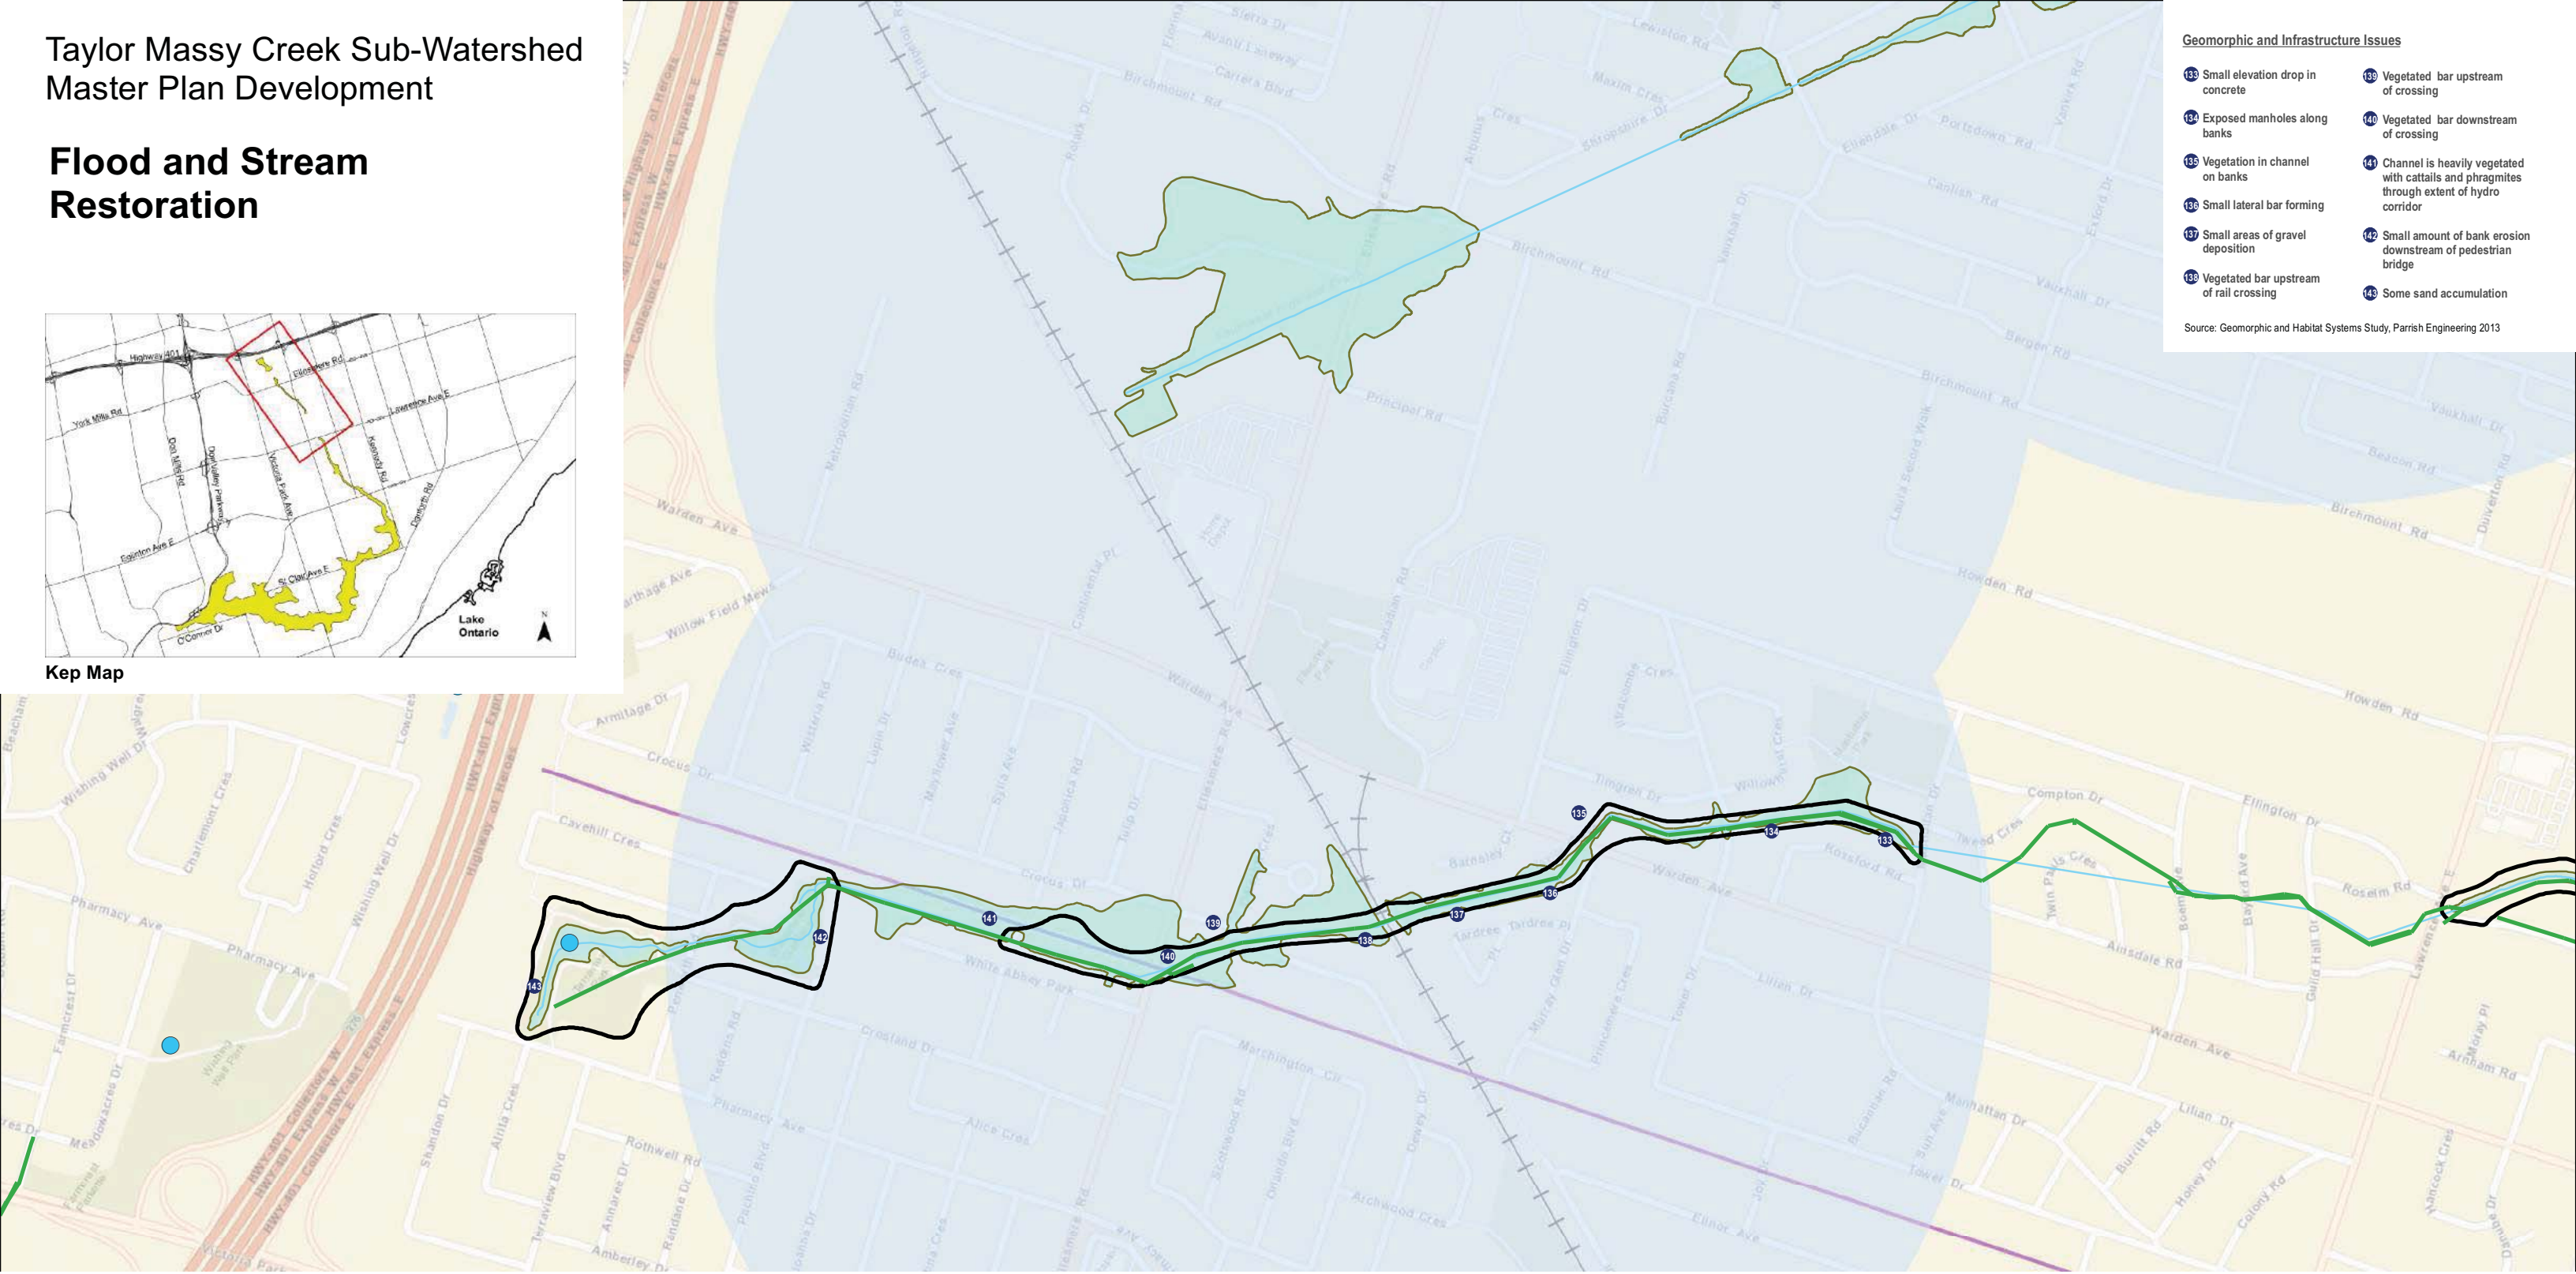
Area 8

| 133 Small elevation drop in concrete | 139 Vegetated bar upstream of crossing |
| 134 Exposed manholes along banks | 140 Vegetated bar downstream of crossing |
| 135 Vegetation in channel on banks | 141 Channel is heavily vegetated with cattails and phragmites through extent of hydro corridor |
| 136 Small lateral bar forming | 142 Small amount of bank erosion downstream of pedestrian bridge |
| 137 Small areas of gravel deposition | 143 Some sand accumulation |
| 138 Vegetated bar upstream of rail crossing | |
