## Appendix C: Detailed Inventory of Toronto Water Infrastructure and Erosion Control Measures

## Inventory 1: Areas of Erosion Concern, Existing Erosion Control Measures, and City of Toronto Infrastructure for Reach BB1

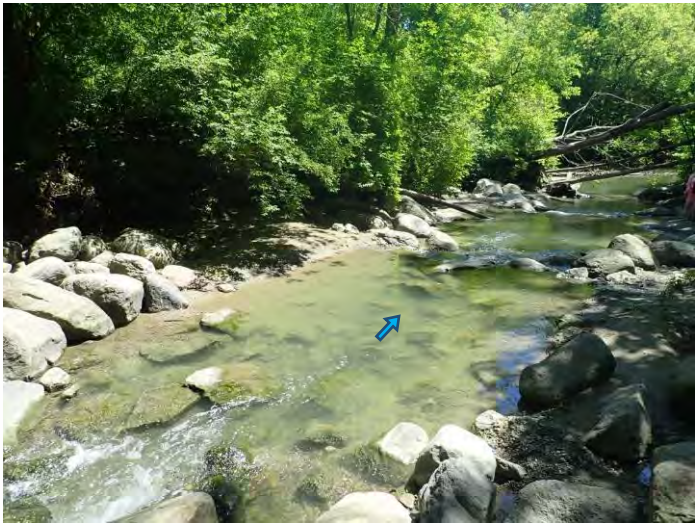
Feature ID	Feature Type	State of Feature	Description	Photograph	Risk Classification and Recommended Action
VRW1-1	<p>Vortex rock weirs</p> <p>Length of channel with weirs: 40 m</p> <p>Constructed in 2005</p>	<p>Condition: Moderately Stable</p> <p>Impact: Moderate (bridge is an item of heritage)</p>	<p>The channel downstream from RC1-1 was reinforced with a series of vortex rock weirs. The weirs enhance the potential for fish passage upstream through Burke Brook.</p> <p>There was minor outflanking at the edges of the weirs due to anthropogenic activities (e.g., park user access to channel).</p>

<p>Recommended Action: Do Nothing / Monitor condition of VRW1-1</p> <p>Rehabilitation Timing: 10 to 15 years</p> <p>Risk Classification: Low</p>
BT1-1	<p>Boulder treatment (left and right bank)</p> <p>Length: 50 m</p> <p>Constructed in 2005</p>	<p>Condition: Moderately stable</p> <p>Impact: Moderate (bridge is an item of heritage)</p>	<p>Both channel banks were reinforced with a boulder treatment.</p> <p>There was minor erosion along the top of bank due to anthropogenic activities (e.g., park user access to channel)</p>

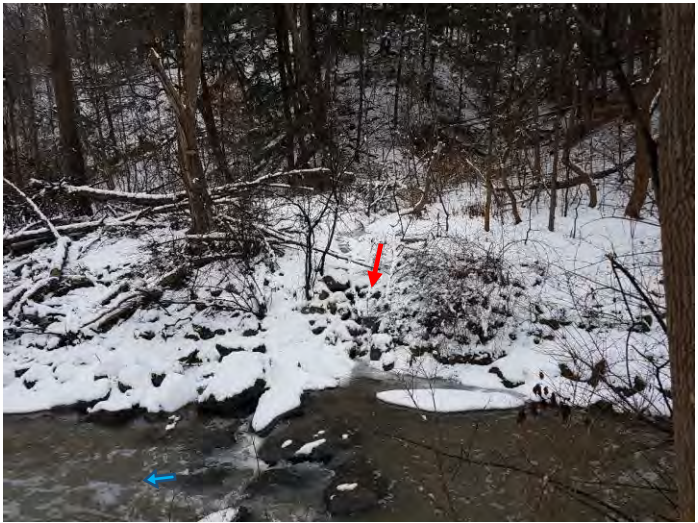
Feature ID	Feature Type	State of Feature	Description	Photograph	Risk Classification and Recommended Action
C1-1	Confluence with Burke Brook	Condition: Stable Impact: N/A	<p>A steep gully feature transects the valley slope and discharges into the main branch of Burke Brook, over a boulder revetment.</p> <p>There is limited flow stemming from the feature. There are no stability concerns at the confluence.</p>

<p>Recommended Action: Do Nothing / Monitor condition of C1-1</p> <p>Rehabilitation Timing: 15+ years</p> <p>Risk Classification: Very Low</p>
GF1-1	Gully feature Length: 110 m	Condition: Unstable Impact: Very Low	<p>The gully feature is entrenched within the south valley wall. The feature was characterized by indicators of degradation (e.g., knickpoint formation, basal scouring) and widening (e.g., fallen trees, exposed roots).</p> <p>There is no City infrastructure at risk within the feature.</p>

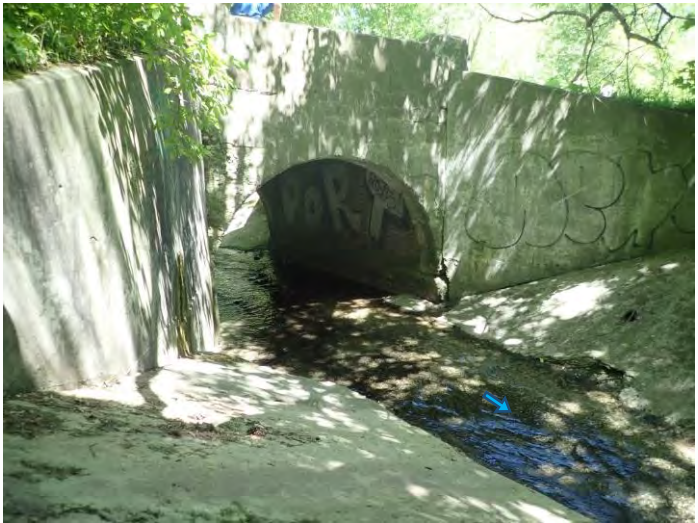
Feature ID	Feature Type	State of Feature	Description	Photograph	Risk Classification and Recommended Action
RC1-1 (DS)	Roadway / Service crossing (downstream end)  Constructed prior to 1950	Condition: Moderately Stable  Impact: Moderate	<p>The channel passed through a concrete arch structure. The structure was undersized relative to the channel and exhibited minor signs of structural degradation.</p> <p>The structure was supported on either side with concrete aprons, which delivered flows into a scour pool.</p> <p>The structure was intact</p>

<p>Recommended Action: Do Nothing / Monitor condition of RC1-1</p> <p>Rehabilitation Timing: 10 to 15 years</p> <p>Risk Classification: Low</p>
RC1-1 (US)	Roadway / Service crossing (upstream end)  Constructed prior to 1950	Condition: Moderately Unstable  Impact: Moderate	<p>The upstream end of the crossing was supported with a boulder treatment. Constriction of the channel in the vicinity of the crossing has led to the general displacement of the materials from the bank.</p>

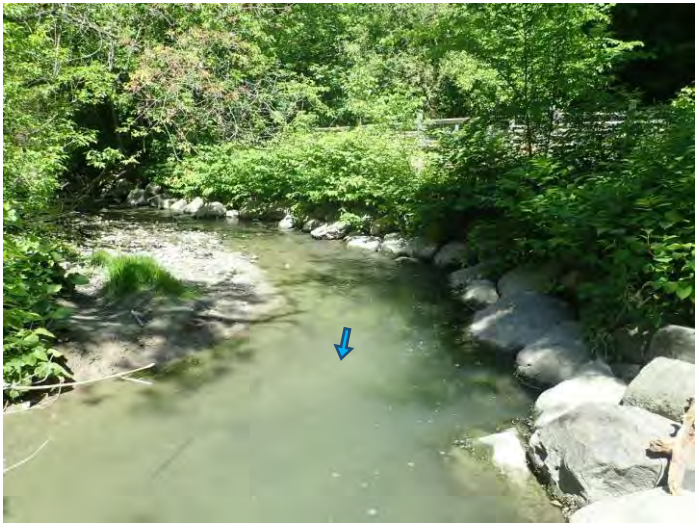
Feature ID	Feature Type	State of Feature	Description	Photograph	Risk Classification and Recommended Action
BT2-1	Boulder treatment (left bank)  Length: 60 m  Constructed by 2007	Condition: Stable  Impact: High (see SSC2-1 and SSP2-1)  Risk is reduced due to good condition of protective treatment	The outer left bank of a channel meander is reinforced with a vegetated boulder treatment. The treatment is in generally good condition.  The treatment protects the adjacent park path and SSP2-1, which extends to within 7.6 m of the top of channel bank.

Recommended Action: Do Nothing / Monitor condition of BT2-1  Rehabilitation Timing: 10 to 15 years  Risk Classification: Low
SSC2-1 *	Sanitary sewer crossing  Asset I.D.: SL4164186  Encased  Maintenance: Toronto Water  Constructed in 1963	Condition: Stable  1.12 m of cover (gravels, cobbles) based on measure-down survey  Cover re-established with BT2-1 in 2004  Impact: High	A sanitary sewer crosses the channel at a riffle feature which consists of gravels and cobbles.  The channel is partially constricted by BT2-1. Widening is anticipated along the unprotected right inner bank over the long term.  The dotted line demarcates approximate sewer alignment.

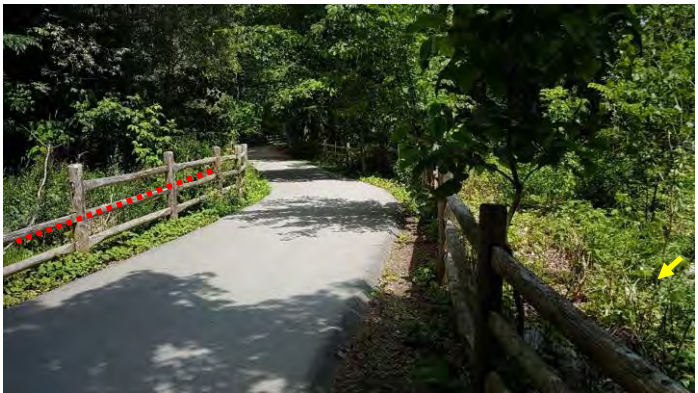
Feature ID	Feature Type	State of Feature	Description	Photograph	Risk Classification and Recommended Action
SSP2-1 *	<p>Sanitary sewer parallel to channel</p> <p>Asset I.D.: SL204051</p> <p>Not encased</p> <p>Maintenance: Toronto Water</p> <p>Constructed in 1963</p>	<p>Condition: Stable</p> <p>Impact: High</p> <p>Risk is reduced as bank treatment is in good condition</p>	<p>A sanitary sewer line runs parallel to the watercourse. The sewer and adjacent park trail is protected with BT2-1. The trail extends to within 3 m of the top of bank and is at greater risk of exposure than the sewer, which is set 7.6 m from the channel.</p> <p>The dotted line demarcates approximate sewer alignment. The yellow arrow indicates the top of channel bank.</p>

<p>Recommended Action: Do Nothing / Monitor condition of SSP2-1</p> <p>Rehabilitation Timing: 15+ years</p> <p>Risk Classification: Low</p>
SSP2-2 *	<p>Sanitary sewer parallel to channel</p> <p>Asset I.D.: SL4164186</p> <p>Not encased</p> <p>Maintenance: Toronto Water</p> <p>Constructed in 1963</p>	<p>Condition: Stable</p> <p>1.12 m of cover (gravels, cobbles) based on measure-down survey</p> <p>Impact: High</p> <p>Risk is reduced due to good condition of protective treatment (BT2-2)</p>	<p>A sanitary sewer line is close proximity to the watercourse. The adjoining manhole MH5512528306 is located at the top of bank, protected within BT2-2. There is adequate cover over the sewer.</p> <p>A private sewer from CAMH located upslope and an abandoned sewer line connect to the manhole. The connecting sewers are protected by BT2-2.</p>

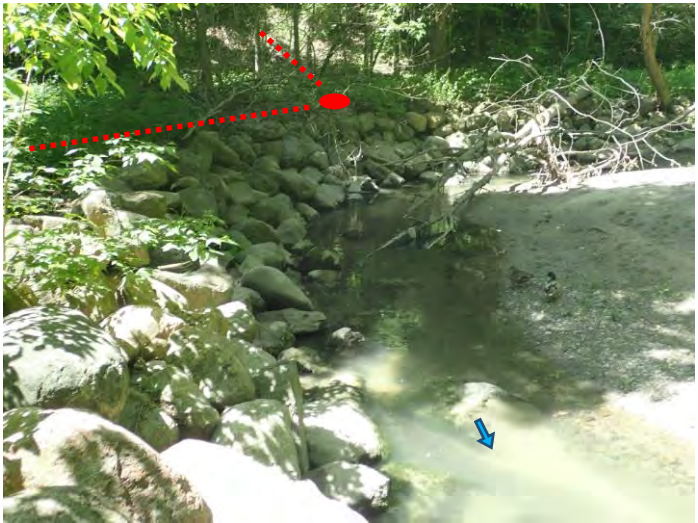
Feature ID	Feature Type	State of Feature	Description	Photograph	Risk Classification and Recommended Action
BT2-2	Boulder treatment (left bank)  Length: 40 m  Constructed by 2007	Condition: Stable  Impact: High  Risk is reduced due to good condition of protective treatment	The outer left bank of a channel meander is reinforced with a vegetated boulder treatment. The treatment is in generally good condition. The channel thalweg is aligned along the toe of the treatment.  The treatment protects the SSP2-2 and the adjoining manhole (MH5512528306) which is embedded in the top course of stone of the treatment at the bend apex.

A photograph showing a river channel with a boulder treatment on the left bank. A red dotted line and a red dot highlight a specific area on the treatment. A blue arrow points to the toe of the treatment where the channel thalweg is aligned.	Recommended Action: Do Nothing / Monitor condition of BT2-2  Rehabilitation Timing: 10 to 15 years  Risk Classification: Low

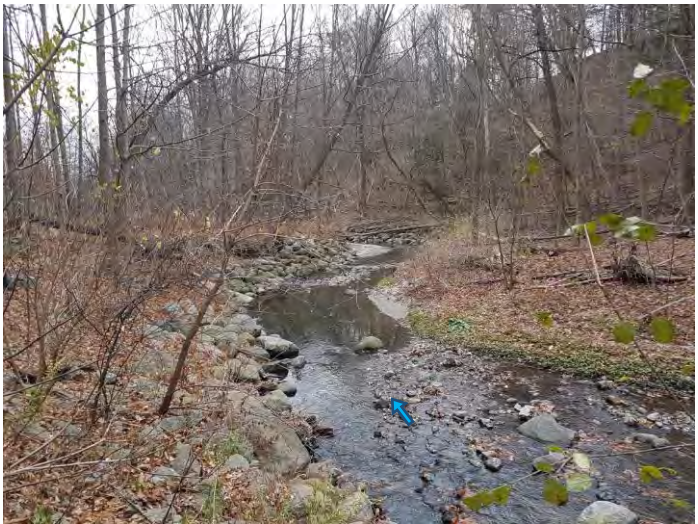
BT2-3	Boulder treatment (left bank)  Length: 50 m  Constructed in 2007	Condition: Moderately Stable  Impact: High  Risk is reduced due to good condition of protective treatment	The outer left bank of a channel meander is reinforced with a vegetated boulder treatment. The treatment is in generally good condition. There is minor scouring along top course of stone at the apex of the meander bend, potentially due to overtopping.  The treatment protects SSP2-3.

A photograph showing a river channel with a boulder treatment on the left bank. A blue arrow points to the apex of the meander bend where there is minor scouring.	Recommended Action: Do Nothing / Monitor condition of BT2-3  Rehabilitation Timing: 10 to 15 years  Risk Classification: Low

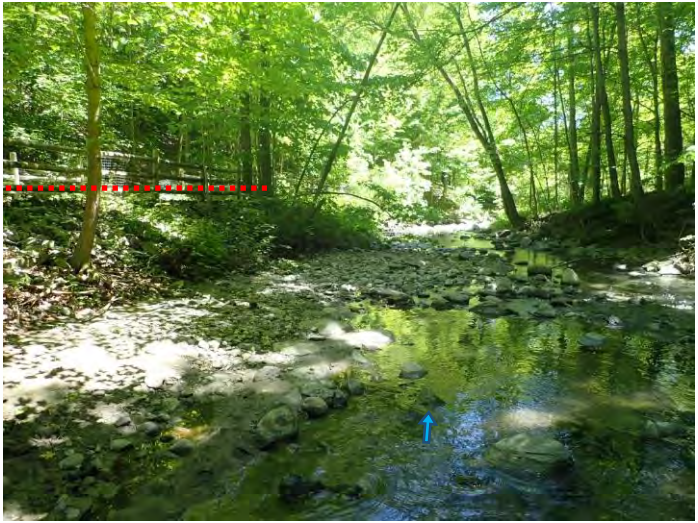
Feature ID	Feature Type	State of Feature	Description	Photograph	Risk Classification and Recommended Action
SSP2-3*	<p>Sanitary sewer parallel to channel</p> <p>Asset I.D.: SL204050</p> <p>Not encased</p> <p>Maintenance: Toronto Water</p> <p>Constructed in 1963</p>	<p>Condition: Moderately stable</p> <p>2.5 m offset from channel</p> <p>0.98 m of cover (cobble, sands) over adjacent sewer, based on measure-down survey</p> <p>Impact: High</p>	<p>A sanitary sewer runs parallel to the watercourse. The sewer extends to within 2.5 m of the left channel bank. The sewer line is 1.5 m below the channel bed at this location.</p> <p>The adjacent channel bank is only partially protected by BT2-3 at the downstream end and BT2-4 at the upstream end. This intermittent section of non-reinforced bank is generally vegetated and stable.</p>

<p>Recommended Action: Introduce erosion mitigation along left bank. Candidate for vegetated rock buttress. Tie in to existing treatment (BT2-3 and BT2-4).</p> <p>Rehabilitation Timing: 5 to 10 years</p> <p>Risk Classification: Moderate</p>

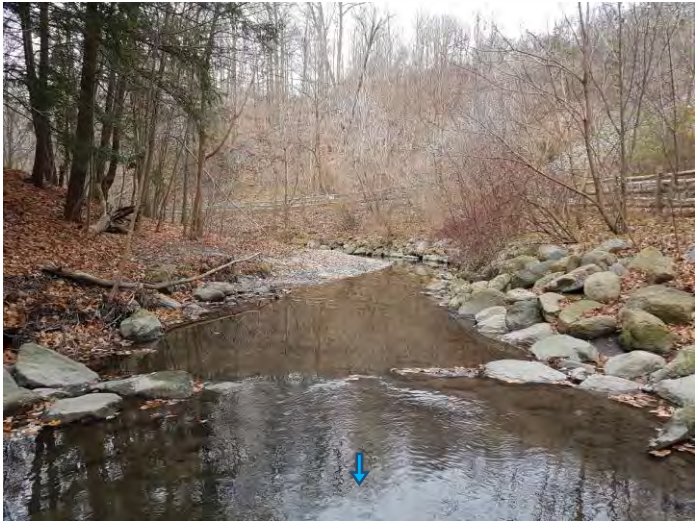
Feature ID	Feature Type	State of Feature	Description	Photograph	Risk Classification and Recommended Action
BT2-4	<p>Boulder treatment (left bank)</p> <p>Length: 50 m</p> <p>Constructed in 2006</p>	<p>Condition: Stable</p> <p>Impact: High</p> <p>Risk is reduced due to good condition of protective treatment</p>	<p>The outer left bank of a channel meander is reinforced with a vegetated boulder treatment. The treatment is in generally good condition.</p> <p>Channel grade is controlled by vortex rock weirs.</p> <p>SSC2-2 extends beneath the channel / point bar along the inside bank of the meander.</p>

<p>Recommended Action: Do Nothing / Monitor condition of BT2-4</p> <p>Rehabilitation Timing: 15+ years</p> <p>Risk Classification: Very Low</p>
SSC2-2*	<p>Sanitary sewer crossing</p> <p>Asset I.D.: SL204047</p> <p>Encased</p> <p>Maintenance: Toronto Water</p> <p>Constructed by 2008</p>	<p>Condition: Stable</p> <p>1.00 m of cover over encasement (gravels, cobbles)</p> <p>Impact: High</p> <p>Risk is reduced due to good condition of protective treatment</p>	<p>A sanitary sewer line transects the channel meander, beneath the point bar and adjacent boulder treatment (BT2-4). The sewer line was equipped with a relatively enlarged concrete encasement (0.95 m in thickness) for added protection.</p> <p>Channel degradation is limited by the presence of vortex rock weirs.</p> <p>The upstream Manhole (MH5512528304) was not located and should be uncovered.</p>

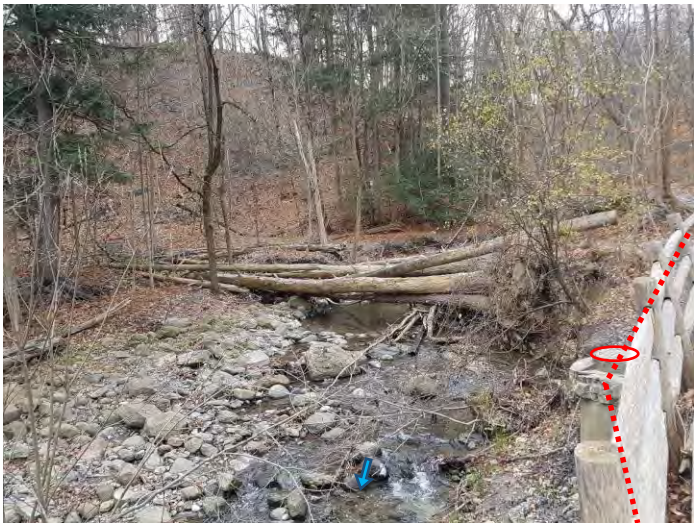
Feature ID	Feature Type	State of Feature	Description	Photograph	Risk Classification and Recommended Action
SSP3-1 *	Sanitary sewer parallel to channel  Asset I.D.: SL4164181  Not encased  Maintenance: Toronto Water  Constructed in 1963	Condition: Unstable  0.14 m of cover relative to the adjacent channel bed, based on measure-down survey  Impact: High	There is significant bank erosion around a sanitary sewer and adjoining manhole (MH5512528302). The manhole chimney is exposed to channel flows during storm events.  Large boulders present along the inside channel bank deflect flows towards the exposed manhole.

TRCA to restore the adjacent park trail in 2021. Coordinate channel works with TRCA.  Recommended Action: Reinforce left channel bank with erosion mitigation protection. Candidate for vegetated rock buttress.  Re-establish cover over sewer and introduce grade controls. Candidate for vortex rock weirs.  Rehabilitation Timing: 0 to 5 years  Risk Classification: Very High

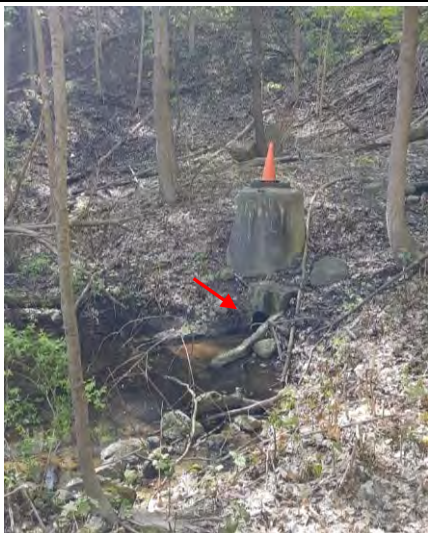
OF3-1	Outfall feature (right bank)  300 mm diameter CP  Maintenance: Unknown  Construction year unknown	Condition: Stable  Impact: Moderate	There is an unmapped concrete outfall that discharges to a vegetated drainage feature on the right channel bank. The outfall is set back 14 m from the channel.  An unmapped manhole is adjacent to the outfall. The feature is likely associated with SSP2-4 and is therefore abandoned.  Both features are intact. Limited erosion was observed around feature.

Recommended Action: Do Nothing / Monitor condition of OF3-1  Verify active / inactive status and ownership of manhole  Rehabilitation Timing: 15+ years  Risk Classification: Very Low

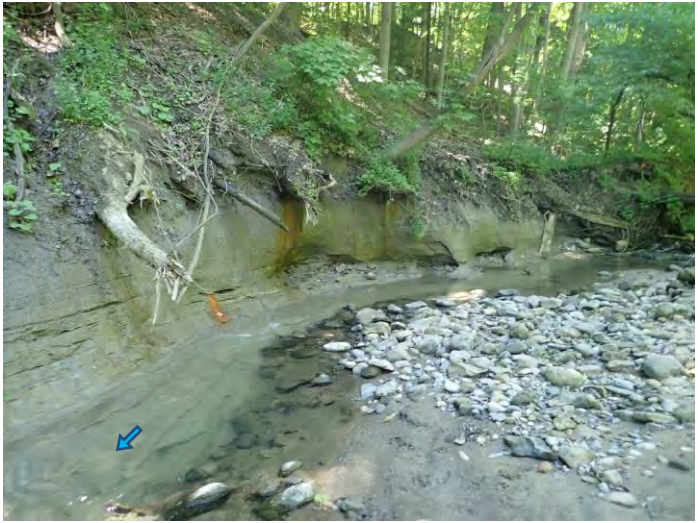
Feature ID	Feature Type	State of Feature	Description	Photograph	Risk Classification and Recommended Action
VWC3-1	Valley wall contact (right bank) Length: 40 m	Condition: Unstable  Impact: Low to moderate (deflects flows towards SSP4-1)	The channel has migrated into the adjacent valley wall, exposing a firm glaciolacustrine deposit along the toe of the slope.  Widening along this stretch of channel has resulted in the formation of multiple in-channel bars, consisting of sands and small cobbles.

Recommended Action: Do Nothing / Monitor condition of VWC3-1  Rehabilitation Timing: 5 to 10 years  Risk Classification: Moderate
SSC3-1 *	Sanitary sewer crossing  Asset I.D.: SL204042  Not encased (HDPE pipe)  Maintenance: Toronto Water  Constructed in 2007	Condition: Moderately unstable  0.42 m of cover (hard till with gravels, boulders), based on measure-down survey  1.1 m of cover reported in 2007  Impact: High	A sanitary sewer line crosses the channel in a diagonal manner. According to the as-built drawings, the channel has degraded 0.68 m since 2004.  The over-widened state of the channel and presence of till and coarse substrates may inhibit further downcutting.  SSC3-1 and SSP4-1 converge at MH5512528301 (not found). See dotted lines for reference.

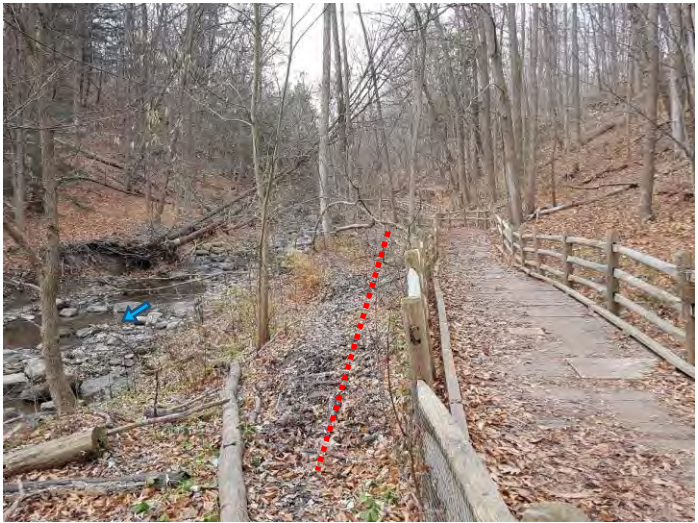
Feature ID	Feature Type	State of Feature	Description	Photograph	Risk Classification and Recommended Action
SSP4-1 *	Sanitary sewer parallel to channel  Asset I.D.: SL4164180  Not encased  Maintenance: Toronto Water  Constructed in 1963	Condition: Moderately unstable  3.0 m offset from channel  0.42 m of cover relative to the adjacent channel bed, based on measure-down survey  Impact: High	A sanitary sewer runs parallel to the watercourse. The sewer extends to within 3.0 m of the channel top of bank.  The adjacent channel bank is moderately unstable, with evidence of active widening (e.g., undercutting, fallen trees, root exposure, etc.).  The adjoining downstream manhole (MH5512528301) is buried

TRCA to restore the adjacent park trail in 2021. Coordinate channel works with TRCA.  Recommended Action: Uncover and verify location of manhole MH5512528301  Reinforce left channel bank with erosion mitigation protection. Candidate for vegetated rock buttress.  Rehabilitation Timing: 5 to 10 years  Risk Classification: Moderate

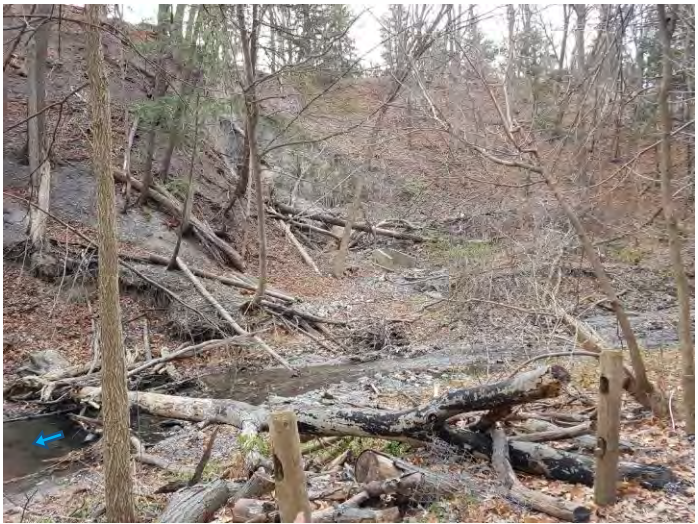
VWC4-1	Valley wall contact (right bank)  Length: 80 m	Condition: Unstable  Impact: High  (Risk to outfall, park trails, and buildings at top of slope)	There is significant slope instability on the right channel bank. This includes a major slump around a storm sewer pipe and outlet (OF4-1).  The channel is in contact with the toe of the slope, promoting instability along adjacent sections of valley wall.

Recommended Action: Slope restoration to be coordinated with OF4-1. It is understood this emergency work is not related to / being completed by Toronto Water  Rehabilitation Timing: 0 to 5 years  Risk Classification: Very High

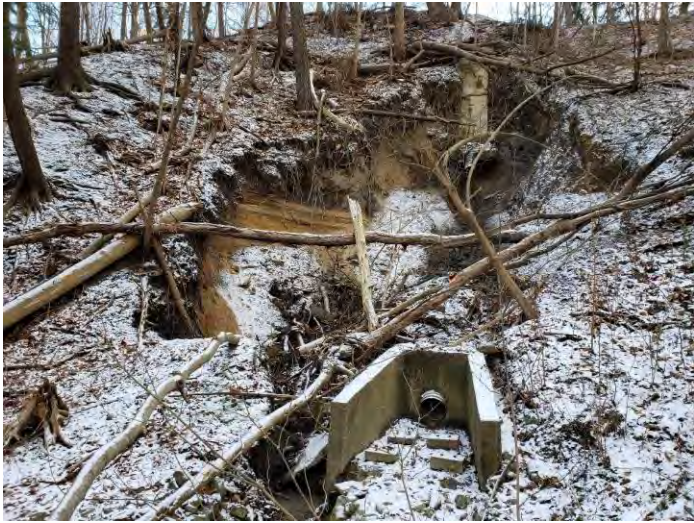
Feature ID	Feature Type	State of Feature	Description	Photograph	Risk Classification and Recommended Action
OF4-1	<p>Outfall feature (right bank)</p> <p>375 mm CSP</p> <p>Asset I.D.: OF800072</p> <p>Not Toronto Water infrastructure</p> <p>Constructed date unknown</p>	<p>Condition: Unstable</p> <p>Impact: High</p> <p>(Risk to outfall, park trails, and buildings at top of slope)</p>	<p>Significant slope failure on the right bank has resulted in the complete dislocation of an outfall pipe stemming from the top of slope.</p> <p>Continued slumping around the pipe chimney is anticipated as the pipe remains active and continues to saturate the newly exposed slope.</p>

<p>Recommended Action: Emergency slope and outfall restoration work is being undertaken by TRCA</p> <p>Rehabilitation Timing: 0 to 5 years</p> <p>Risk Classification: Very High</p>
SSP4-2*	<p>Sanitary sewer parallel to channel</p> <p>Asset I.D.: SL4164179</p> <p>Not encased</p> <p>Maintenance: Toronto Water</p> <p>Constructed in 1963</p>	<p>Condition: Unstable</p> <p>0.30 m offset from channel (see line)</p> <p>Sewer is elevated 0.65 m over the adjacent channel bed, based on measure-down assessment</p> <p>Impact: High</p>	<p>A sanitary sewer runs parallel to the watercourse. The sewer extends to within 0.30 m of the channel top of bank and is at risk of exposure. The top of pipe was visible at SSC4-1.</p> <p>The adjacent channel bank is unstable, with evidence of active widening (e.g., undercutting, fallen trees, root exposure, etc.).</p>

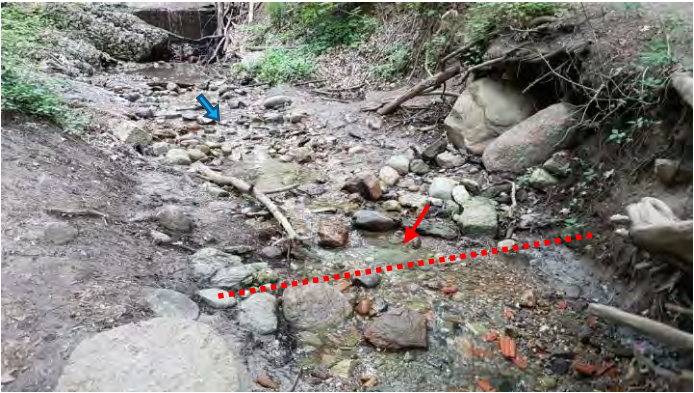
Feature ID	Feature Type	State of Feature	Description	Photograph	Risk Classification and Recommended Action
SSC4-1 *	<p>Sanitary sewer crossing</p> <p>Asset I.D.: SL4164179</p> <p>Not encased (Concrete pipe)</p> <p>Maintenance: Toronto Water</p> <p>Constructed in 1963</p>	<p>Condition: Unstable</p> <p>0.03 m of pipe exposure observed in Fall 2020 (see arrow)</p> <p>Impact: High</p>	<p>A sanitary sewer line crosses a drainage channel associated with OF4-2. According to a historical topographic survey, the channel has not degraded significantly since 2004.</p> <p>Prior to 2004, there was significant downcutting within the drainage feature, as evidenced by OF4-2 and the observed level of feature entrenchment.</p>

<p>TRCA to restore the adjacent park trail in 2021. Coordinate channel works with TRCA.</p> <p>Recommended Action: Re-establish cover over adjacent sewer and introduce grade controls. Candidate for vortex rock weirs.</p> <p>Reinforce drainage feature banks with erosion mitigation protection. Candidate for vegetated rock buttress.</p> <p>Rehabilitation Timing: 0 to 5 years</p> <p>Risk Classification: Very High</p>

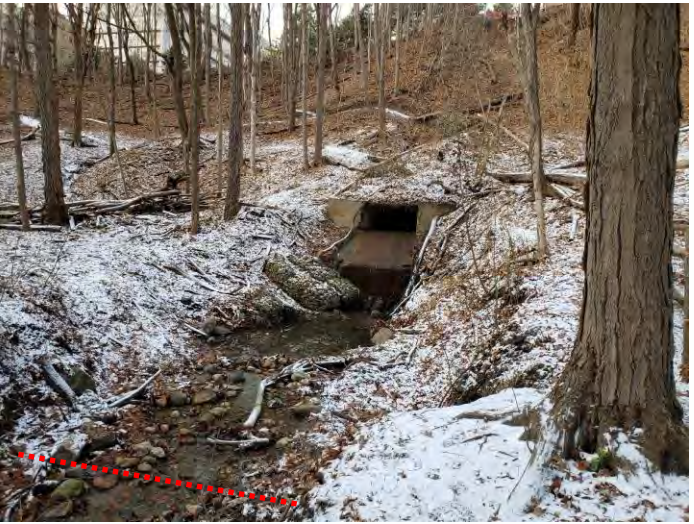
OF4-2	<p>Outfall feature (left bank)</p> <p>Concrete box</p> <p>Asset I.D.: Unknown</p> <p>Maintenance: SHSC (Hospital)</p> <p>Constructed date unknown</p>	<p>Condition: Unstable</p> <p>Impact: High (see SSC4-1)</p>	<p>A concrete box outfall discharges to a drainage feature from the left channel bank.</p> <p>Significant downcutting has occurred within the drainage feature, leading to the exposure of SSC4-1 and the failure of the adjacent gabion basket bank treatment.</p>

<p>TRCA to restore the adjacent park trail in 2021. Coordinate channel works with TRCA.</p> <p>Recommended Action: Re-establish cover over adjacent sewer and introduce grade controls. Candidate for vortex rock weirs.</p> <p>Reinforce drainage feature banks with erosion mitigation protection. Candidate for vegetated rock buttress.</p> <p>Rehabilitation Timing: 0 to 5 years</p> <p>Risk Classification: High</p>

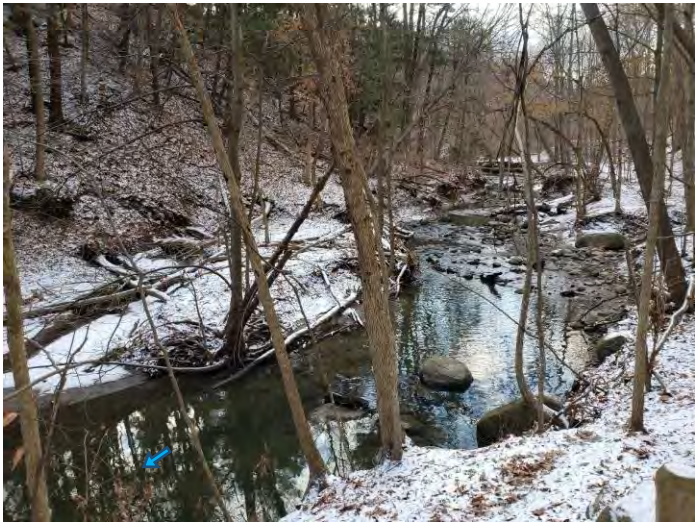
Feature ID	Feature Type	State of Feature	Description	Photograph	Risk Classification and Recommended Action
BE4-1	Bank erosion (right and left banks)  Length: 100 m	Condition: Unstable  Impact: High	<p>The left and right channel banks are undergoing active widening, in proximity to SSP4-3.</p> <p>The banks are characterized by undercutting, root exposure, and tree falls. There is a prominent scour along the left bank which extends through the adjacent sanitary sewer line.</p>

<p>Recommended Action: Re-establish cover over adjacent sewer and introduce grade controls. Candidate for vortex rock weirs.</p> <p>Reinforce drainage feature banks with erosion mitigation protection. Candidate for vegetated rock buttress.</p> <p>Rehabilitation Timing: 0 to 5 years</p> <p>Risk Classification: High</p>
SSP4-3*	<p>Sanitary sewer parallel to channel</p> <p>Asset I.D.: SL4164178</p> <p>Not encased</p> <p>Maintenance: Toronto Water</p> <p>Constructed in 1963</p>	<p>Condition: Unstable</p> <p>Sewer is elevated over 1 m above the adjacent channel bed based on measure-down assessment</p> <p>Impact: High</p>	<p>A sanitary sewer runs parallel to the watercourse. There is a prominent erosion scour along the bank, which the sewer transects (see line).</p> <p>The adjacent channel banks are unstable, with evidence of active widening (e.g., undercutting, fallen trees, root exposure, etc.).</p>

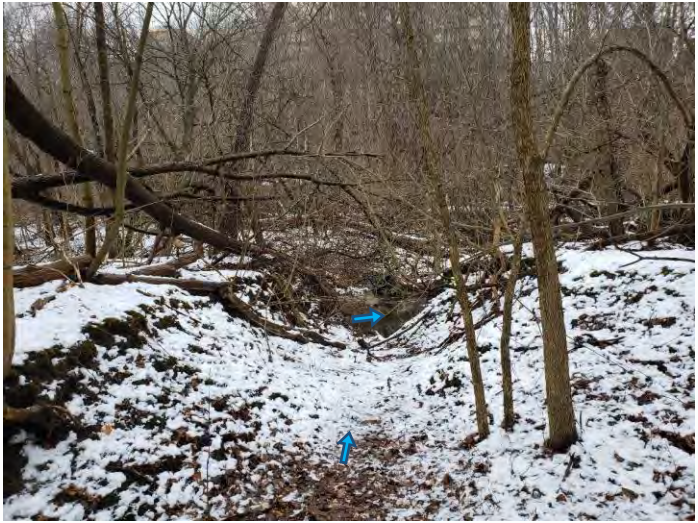
Feature ID	Feature Type	State of Feature	Description	Photograph	Risk Classification and Recommended Action
C4-1	Confluence with Burke Brook	Condition: Stable Impact: N/A	<p>A steep gully feature transects the valley slope and discharges into the main branch of Burke Brook.</p> <p>There is limited flow being conveyed within the feature.</p>

<p>Recommended Action: Do Nothing / Monitor condition of C4-1</p> <p>Rehabilitation Timing: 15+ years</p> <p>Risk Classification: Very Low</p>
GF4-1	Gully feature Length: 110 m	Condition: Unstable Impact: Low	<p>The gully feature is entrenched within the south valley wall. The feature was characterized by downcutting and widening. The feature stemmed from an abandoned concrete drainage structure associated with the building complex at the top of slope.</p> <p>There is no City infrastructure at risk along the feature extents.</p>

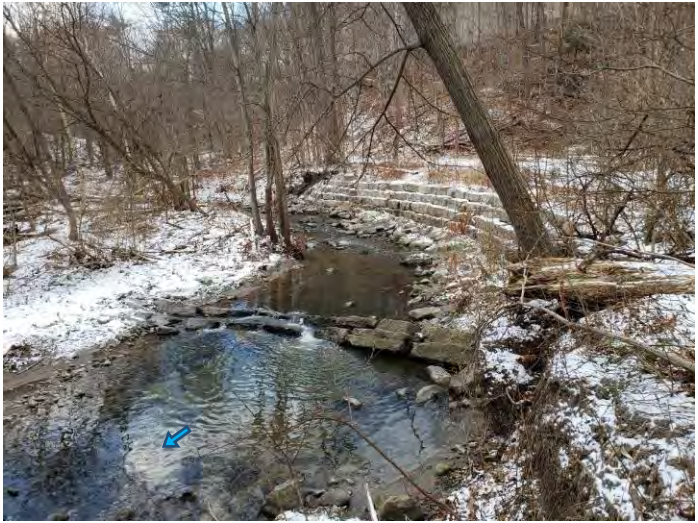
Feature ID	Feature Type	State of Feature	Description	Photograph	Risk Classification and Recommended Action
AW4-1	Armourstone wall and weirs (left bank)  Length: 45 m  Constructed by 2013	Condition: Stable  Impact: High  Risk is reduced given good condition of protective treatment	The left outer bank of a channel meander is reinforced with armourstone with riprap toe protection. Armourstone weirs are present along the channel bed for added grade control. The feature protects the adjacent sanitary sewer line SSP4-4.

Recommended Action: Do Nothing / Monitor condition of AW4-1  Rehabilitation Timing: 15+ years  Risk Classification: Very Low
SSP4-4 *	Sanitary sewer parallel to channel  Asset I.D.: SL4164177  Maintenance: Toronto Water  Constructed in 1963  Reinforced by 2013	Condition: Stable  Offset 3 m from channel bank  Protected by AW4-1  Risk is reduced given good condition of protective treatment	A sanitary sewer runs parallel to the watercourse near a channel meander. The adjacent channel bank and bed is reinforced with AW4-1, which is in good condition.

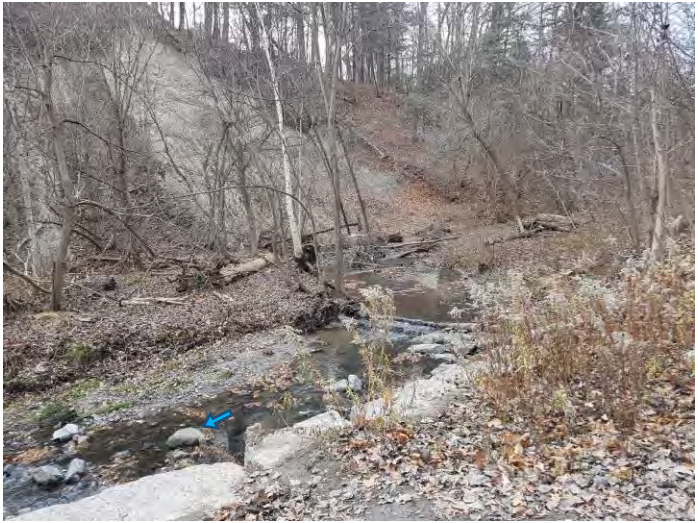
Feature ID	Feature Type	State of Feature	Description	Photograph	Risk Classification and Recommended Action
VWC4-2	Valley wall contact (right bank)  Length: 130 m	Condition: unstable  Impact: Low	A channel meander has migrated into the adjacent valley wall, leading to slope instability and failure.  There is no infrastructure at immediate risk.

Recommended Action: Do Nothing / Monitor condition of VWC4-2  Rehabilitation Timing: 10 to 15 years  Risk Classification: Low
RT4-1	Riprap treatment (left bank)  Length: 70 m  Constructed by 2013	Condition: Stable  Impact: High  Risk is reduced given good condition of protective treatment	The left outer bank of a channel meander is reinforced with vegetated riprap protection. Armourstone weirs are present along the channel bed for added grade control at the up- and downstream extents of the treatment.  The feature protects the adjacent sanitary sewer line SSP4-5.

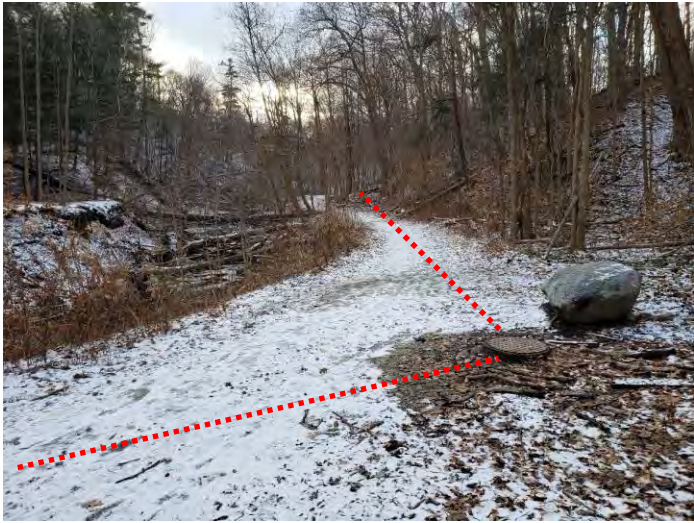
Feature ID	Feature Type	State of Feature	Description	Photograph	Risk Classification and Recommended Action
SSP4-5 *	<p>Sanitary sewer parallel to channel</p> <p>Asset I.D.: SL4164176</p> <p>Maintenance: Toronto Water</p> <p>Constructed in 1963</p> <p>Reinforced by 2013</p>	<p>Condition: Stable</p> <p>Impact: High</p> <p>Risk is reduced given good condition of protective treatment</p>	<p>A sanitary sewer runs parallel to the watercourse near a channel meander. The sewer extends to manhole MH5512528296. The adjacent channel bank and bed is reinforced with RT4-1, which is in good condition.</p>

<p>Recommended Action: Do Nothing / Monitor condition of SSP4-5</p> <p>Rehabilitation Timing: 10 to 15 years</p> <p>Risk Classification: Low</p>
SSP4-6 *	<p>Sanitary sewer parallel to channel</p> <p>Asset I.D.: SL4164175</p> <p>Maintenance: Toronto Water</p> <p>Constructed in 1963</p>	<p>Condition: Unstable</p> <p>Impact: High</p> <p>Risk is reduced as sewer is offset 9.9 m from channel</p>	<p>A sanitary sewer runs parallel to the watercourse. The left bank is actively widening towards the sewer (BE4-2).</p> <p>Channel flows are constricted by the adjacent valley wall, which exacerbates erosion within the channel reach (VWC4-3).</p>

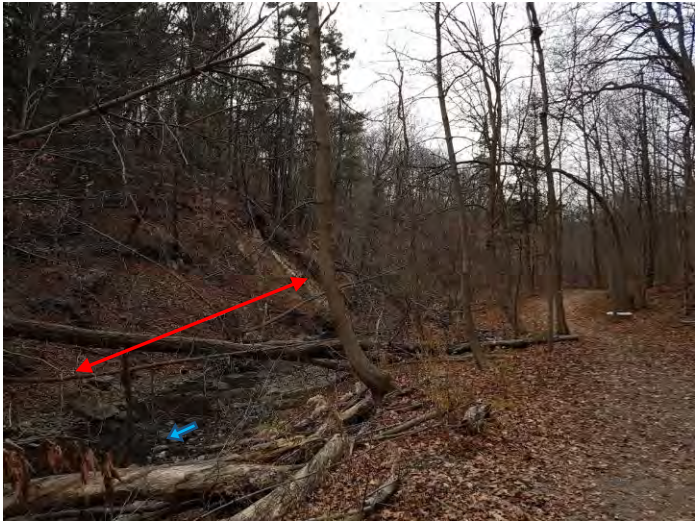
Feature ID	Feature Type	State of Feature	Description	Photograph	Risk Classification and Recommended Action
VWC4-3	Valley wall contact (right bank) Length: 65 m	Condition: Unstable Impact: Low (Deflects flows towards SSP4-6 and SSP4-7)	<p>A stretch of channel has widened into the adjacent valley wall, leading to slope instability. A hard till is present at the slope toe.</p> <p>While there is no infrastructure at immediate risk, flow contact with the valley wall may enhance the potential for erosion along the opposite bank (BE4-2) in proximity to SSP4-6.</p>

<p>Recommended Action: Do Nothing / Monitor condition of VWC4-3</p> <p>Rehabilitation Timing: 5 to 10 years</p> <p>Risk Classification: Moderate</p>
BE4-2	Bank erosion (left bank) Length: 70 m	<p>Condition: Unstable Impact: High</p> <p>Risk is reduced as SSP4-6 and SSP4-7 are offset 9.9 and 4.7 m from the channel</p>	<p>The left bank is actively widening towards SSP4-6 and SSP4-7. The bank is characterized by extensive undercutting and multiple treefalls.</p> <p>Channel flows are constricted by the adjacent valley wall, which exacerbates erosion within the channel reach (VWC4-3).</p>

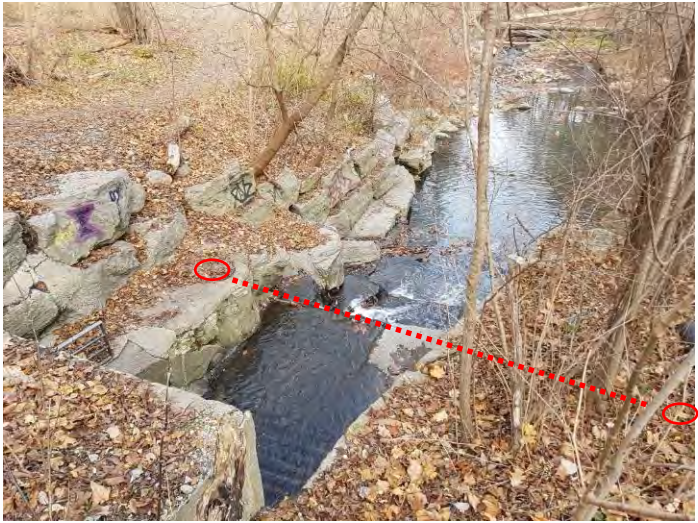
Feature ID	Feature Type	State of Feature	Description	Photograph	Risk Classification and Recommended Action
SSC4-2*	Sanitary sewer crossing  Asset I.D.: SL204052  HDPE pipe  Maintenance: Toronto Water  Constructed in 2004	Condition: Moderately stable  1.30 m of cover (concrete, armourstone) based on measure-down assessment  Impact: High	A sanitary sewer crosses the channel beneath a concrete reinforced drop structure.  The adjoining manhole chimney MH5512528293 is partially exposed to flows as a result of concrete degradation.  Channel flow is constricted by AW4-2, which enhances the potential for erosion.

Recommended Action: Reinforce manhole chimney with additional concrete  Rehabilitation Timing: 10 to 15 years  Risk Classification: Low
AW4-2	Armourstone wall and drop structure (left and right banks)  Constructed in 2007	Condition: Moderately unstable  Impact: Moderate	The Burke Brook outlet and OF4-3 banks are reinforced with an armourstone wall.  Erosive flows stemming from the adjacent concrete reinforced drop structure has displaced the underlying materials at the toe of the treatment. This has resulted in slumping of select armourstone (see arrow).  Manhole MH3006509 is protected by a stable portion of AW4-2 near the top of bank.

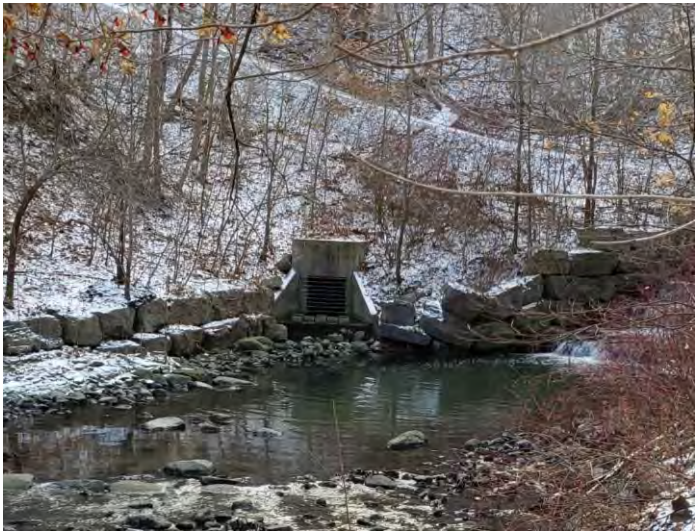
Feature ID	Feature Type	State of Feature	Description	Photograph	Risk Classification and Recommended Action
OF4-3*	<p>Outfall feature (right bank)</p> <p>Adjoining concrete pipes (600 mm and 400 mm diameter)</p> <p>Constructed in 2004</p>	<p>Condition: Stable</p> <p>Feature protected by AW4-2</p> <p>Impact: Moderate</p>	<p>A concrete box outfall discharges into Burke Brook from the right channel bank. The feature is protected by AW4-2.</p> <p>The structure is intact and set back from the main channel. The receiving pool is lined with boulders to mitigate scouring.</p>

<p>Recommended Action: Do Nothing / Monitor condition of OF4-3</p> <p>Reinforce outlet pool bed with additional cover (see AW4-2)</p> <p>Rehabilitation Timing: 15+ years</p> <p>Risk Classification: Very Low</p>
CC4-1*	<p>Channel culvert (outlet)</p> <p>1800 mm diameter concrete box</p> <p>Maintenance: Toronto Water</p> <p>Constructed in 1963</p>	<p>Condition: Stable</p> <p>Impact: Moderate</p>	<p>The Burke Brook culvert beneath Bayview Avenue consists of an 1800 mm diameter concrete box. The structure is undersized relative to the channel but is in good overall condition.</p> <p>The feature is protected by AW4-2.</p>
