Bank Condition and Flow Capacity Assessment

Flow Capacity and Bank Condition Assessment Memorandum

08 April 2024

To	Daniel McCreery	Contact No.	905-814-4355
Copy to	Bill Snodgrass	Email	Jeff.Doucette@ghd.com
From	Jeff Doucette	Project No.	11209954-MEM-4
Project Name	City of Toronto-Yellow Creek MP		
Subject	Flow Capacity and Bank Condition Assessment

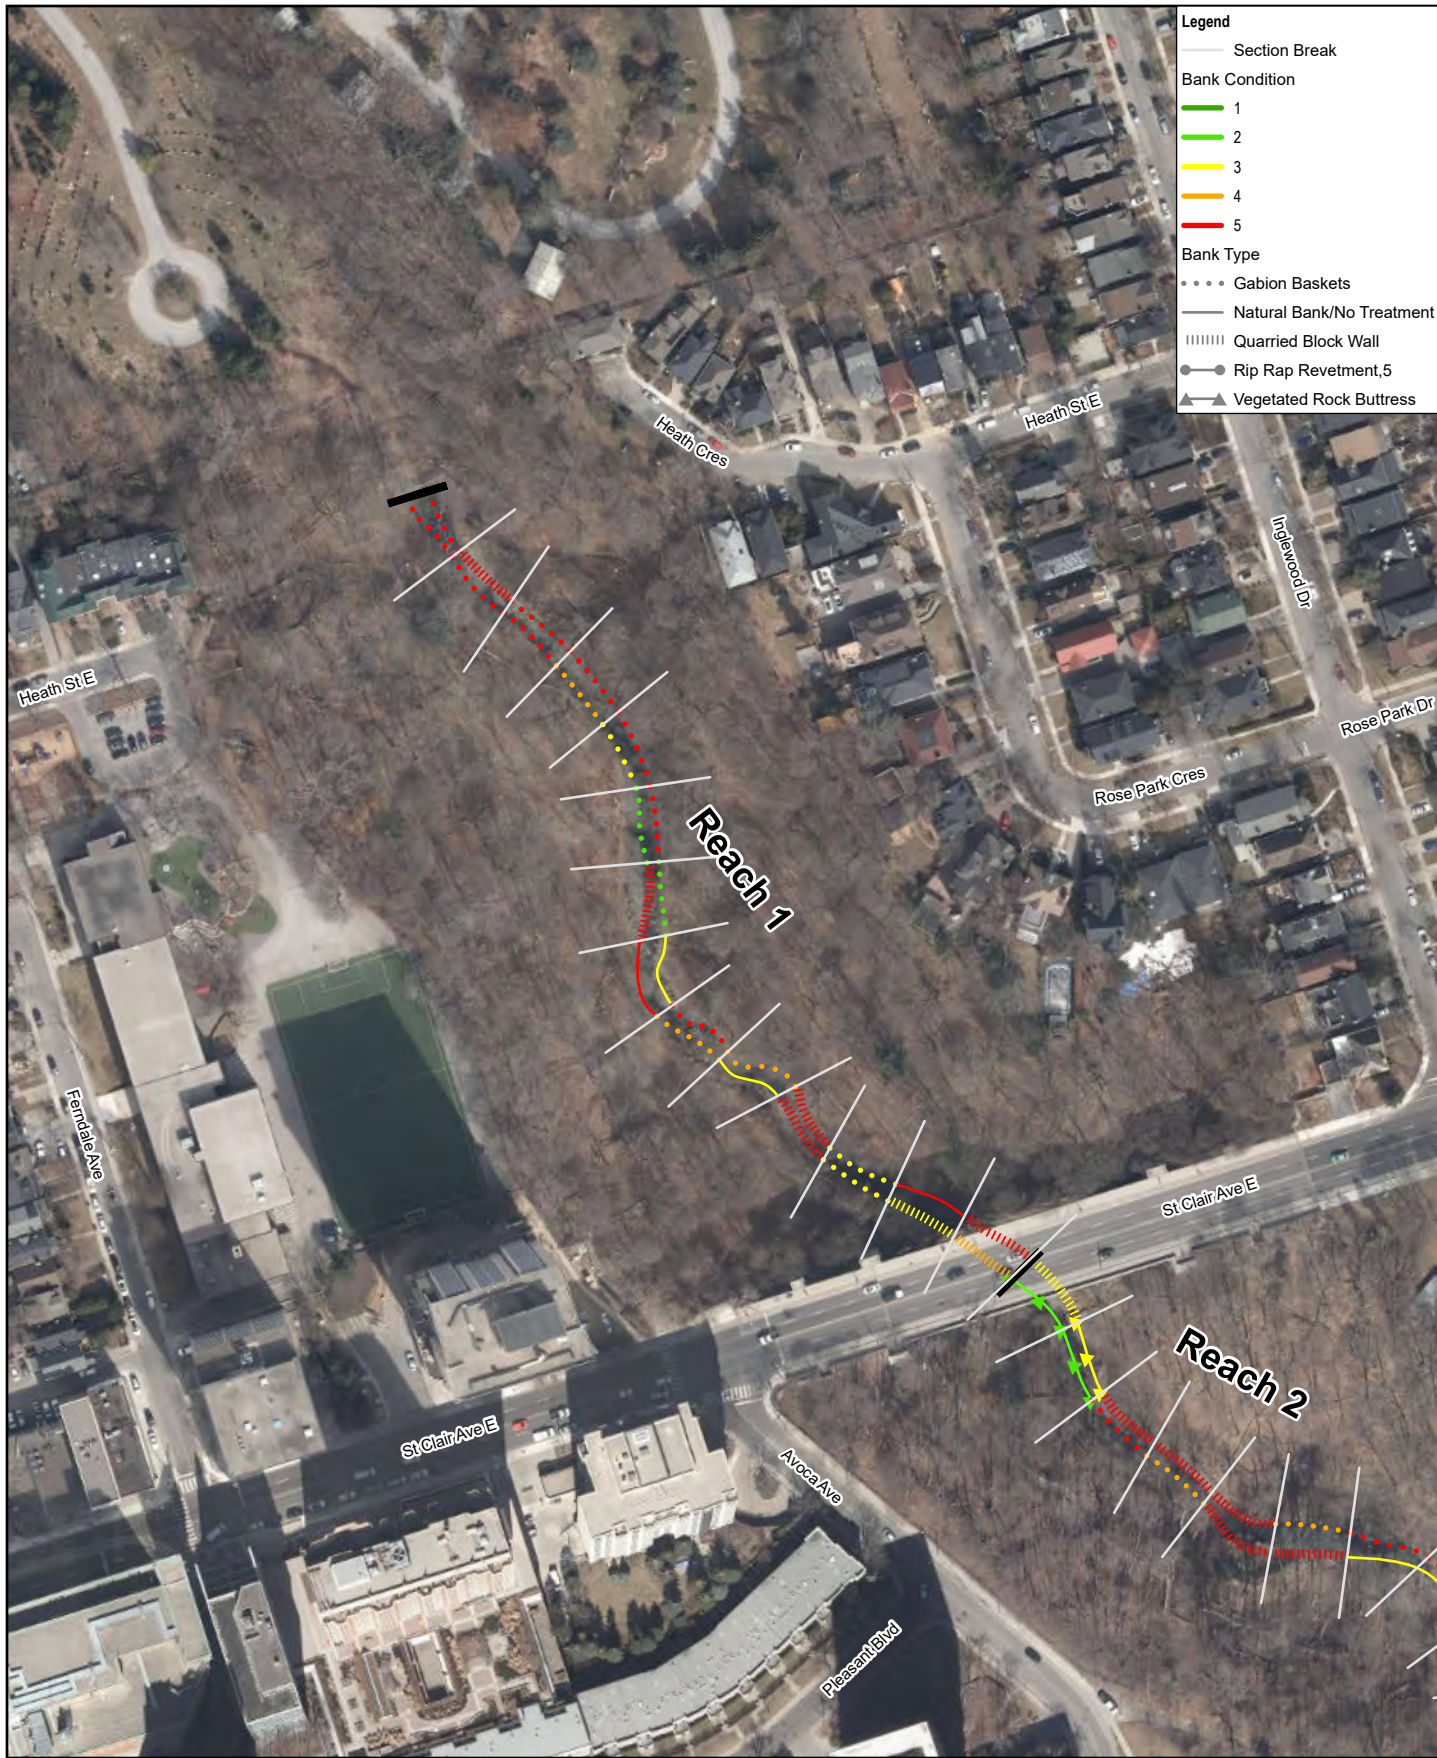
FIGURE 2-1

The bank condition assessment revealed that most of the gabion basket and many of the quarry block wall bank treatments were failing (4) or have failed (5). Reaches 1 and 2 had the highest percentage of failed and failing banks as 71% and 60% of the banks, respectively, were failing or had failed. This corresponds to approximately 400 m and 600 m of failing or failed banks in reaches 1 and 2, respectively.

CITY OF TORONTO
YELLOW CREEK GEOMORPHIC SYSTEMS
MASTER PLAN SHORT-TERM EROSION MONITORING
**YELLOW CREEK
REACH 1
BANK CONDITION ASSESSMENT**

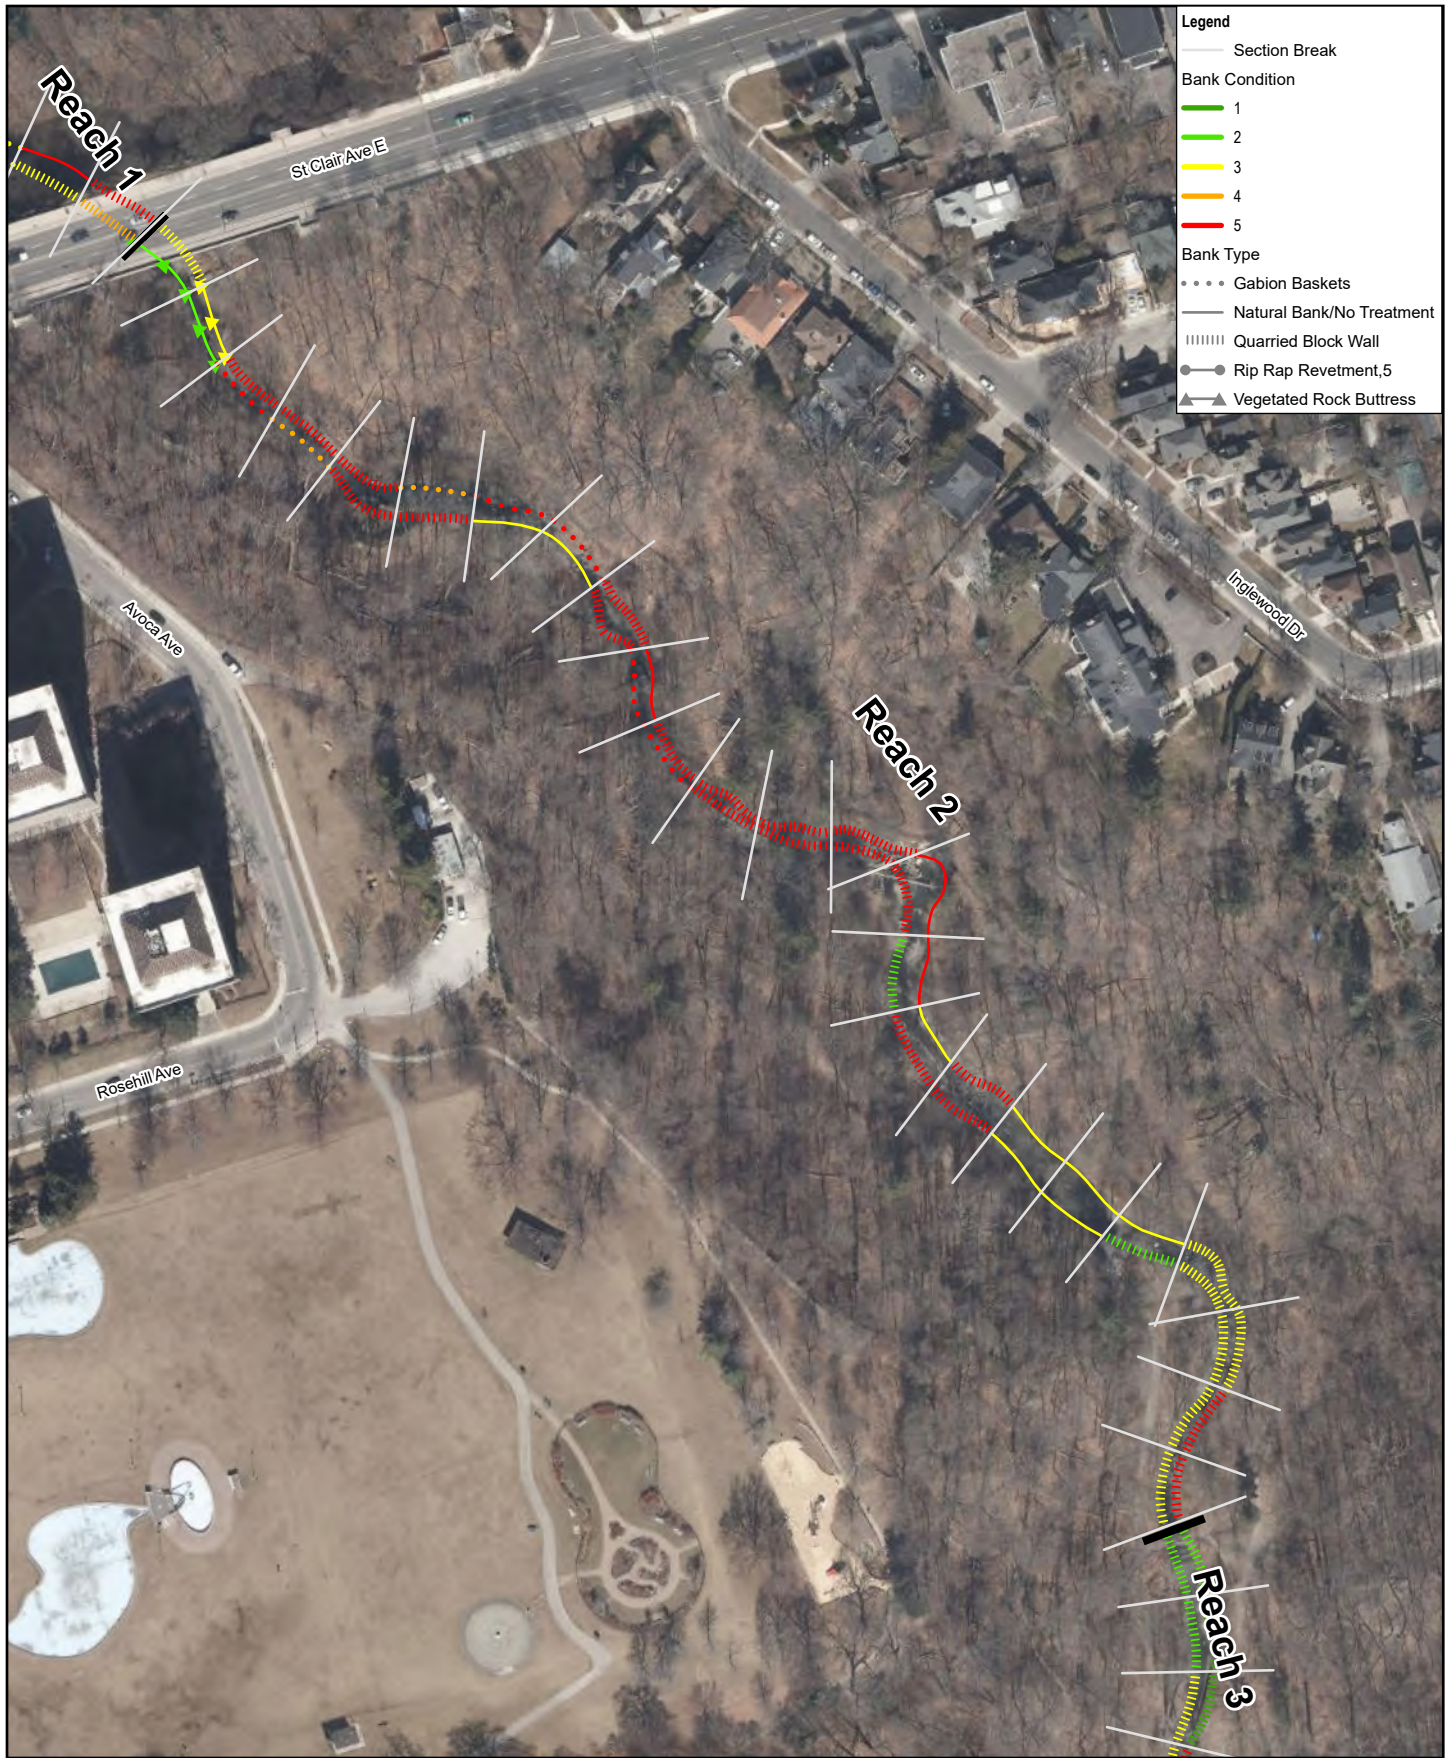
FIGURE 2-2

CITY OF TORONTO
YELLOW CREEK GEOMORPHIC SYSTEMS
MASTER PLAN SHORT-TERM EROSION MONITORING
**YELLOW CREEK
REACH 2
BANK CONDITION ASSESSMENT**

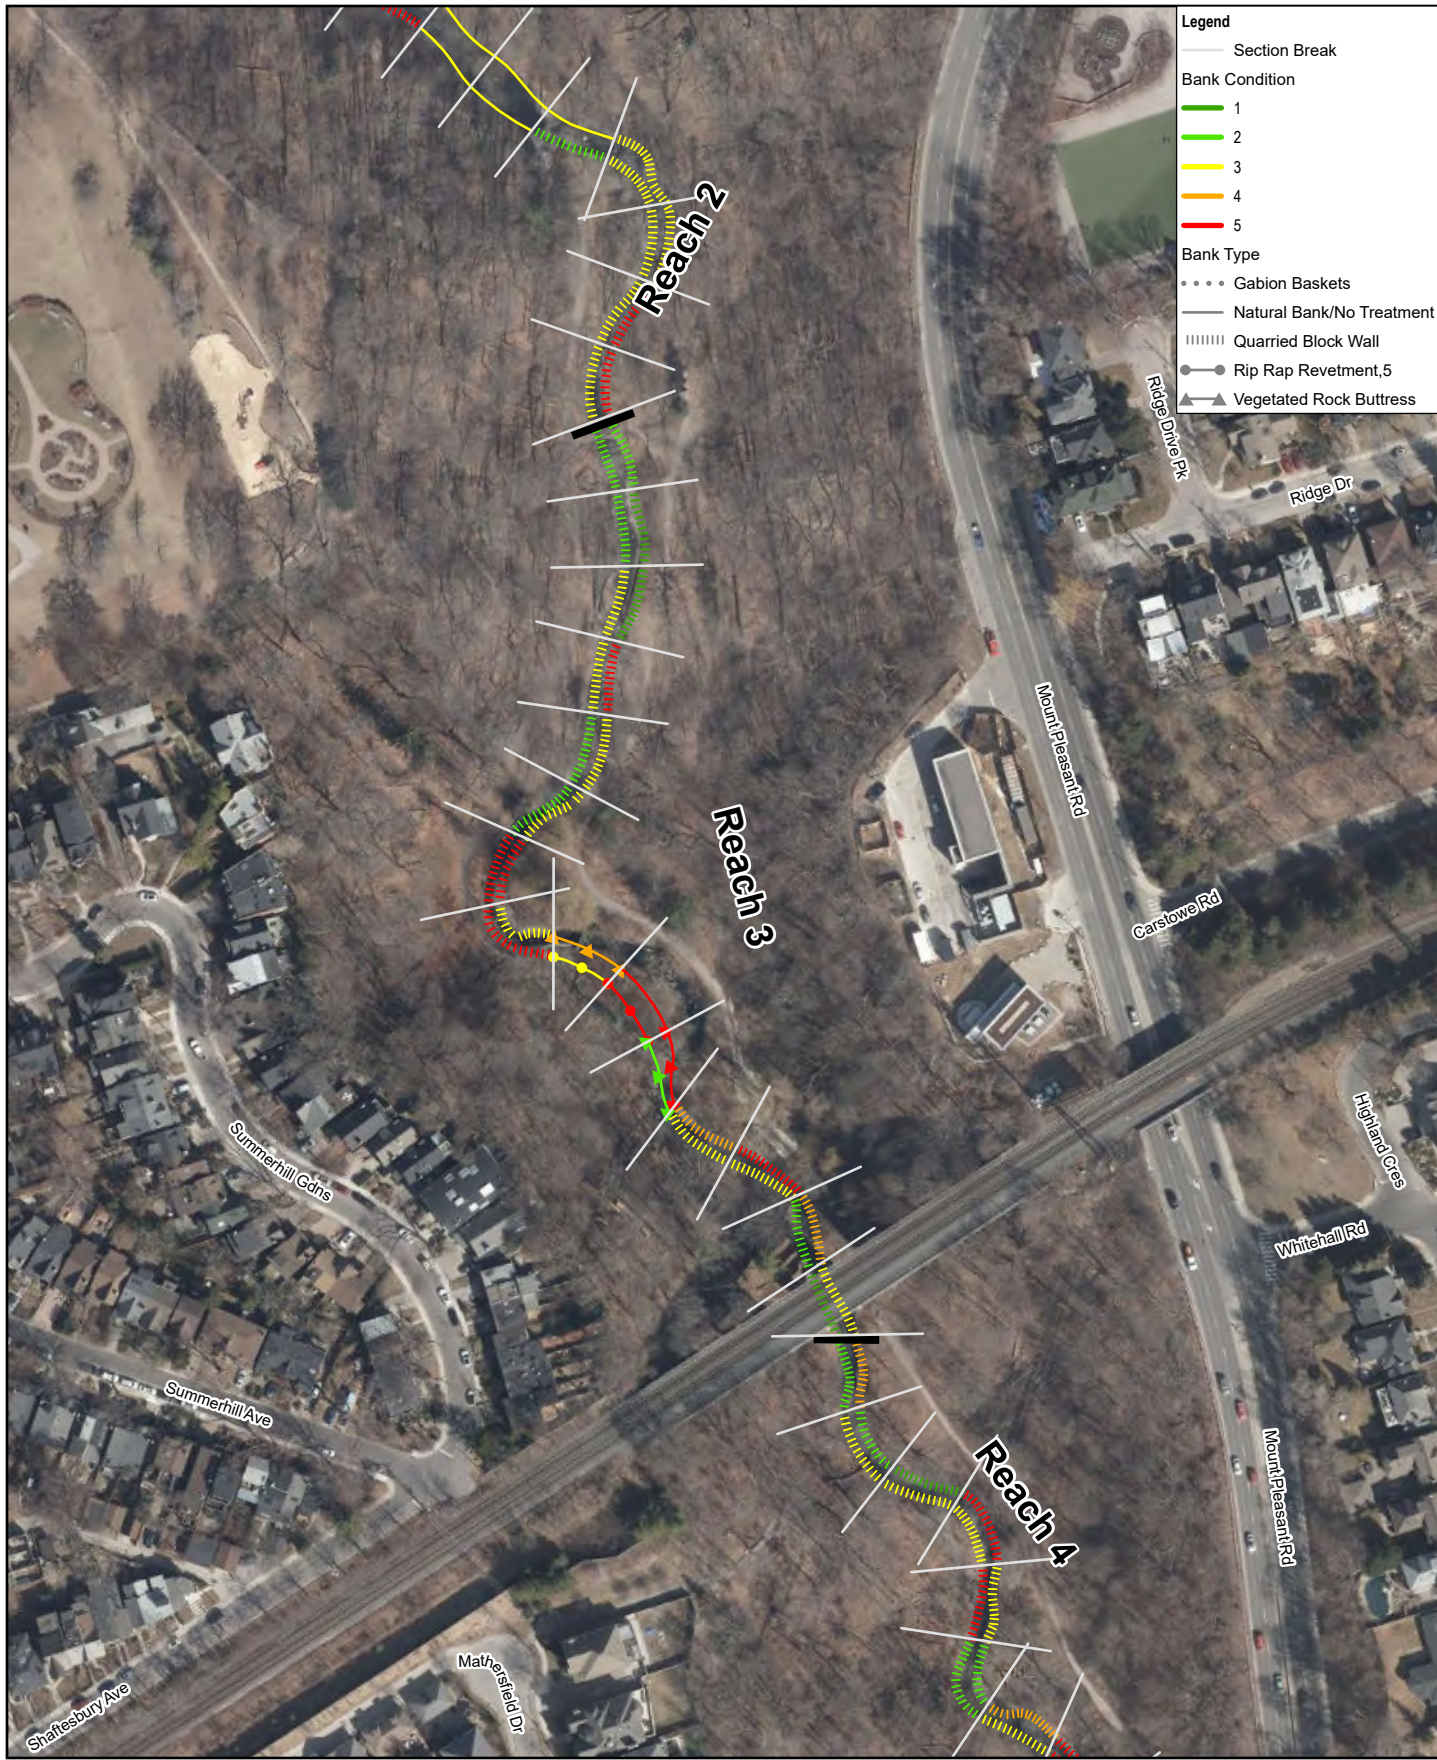
FIGURE 2-3

CITY OF TORONTO
YELLOW CREEK GEOMORPHIC SYSTEMS
MASTER PLAN SHORT-TERM EROSION MONITORING
**YELLOW CREEK
REACH 3
BANK CONDITION ASSESSMENT**

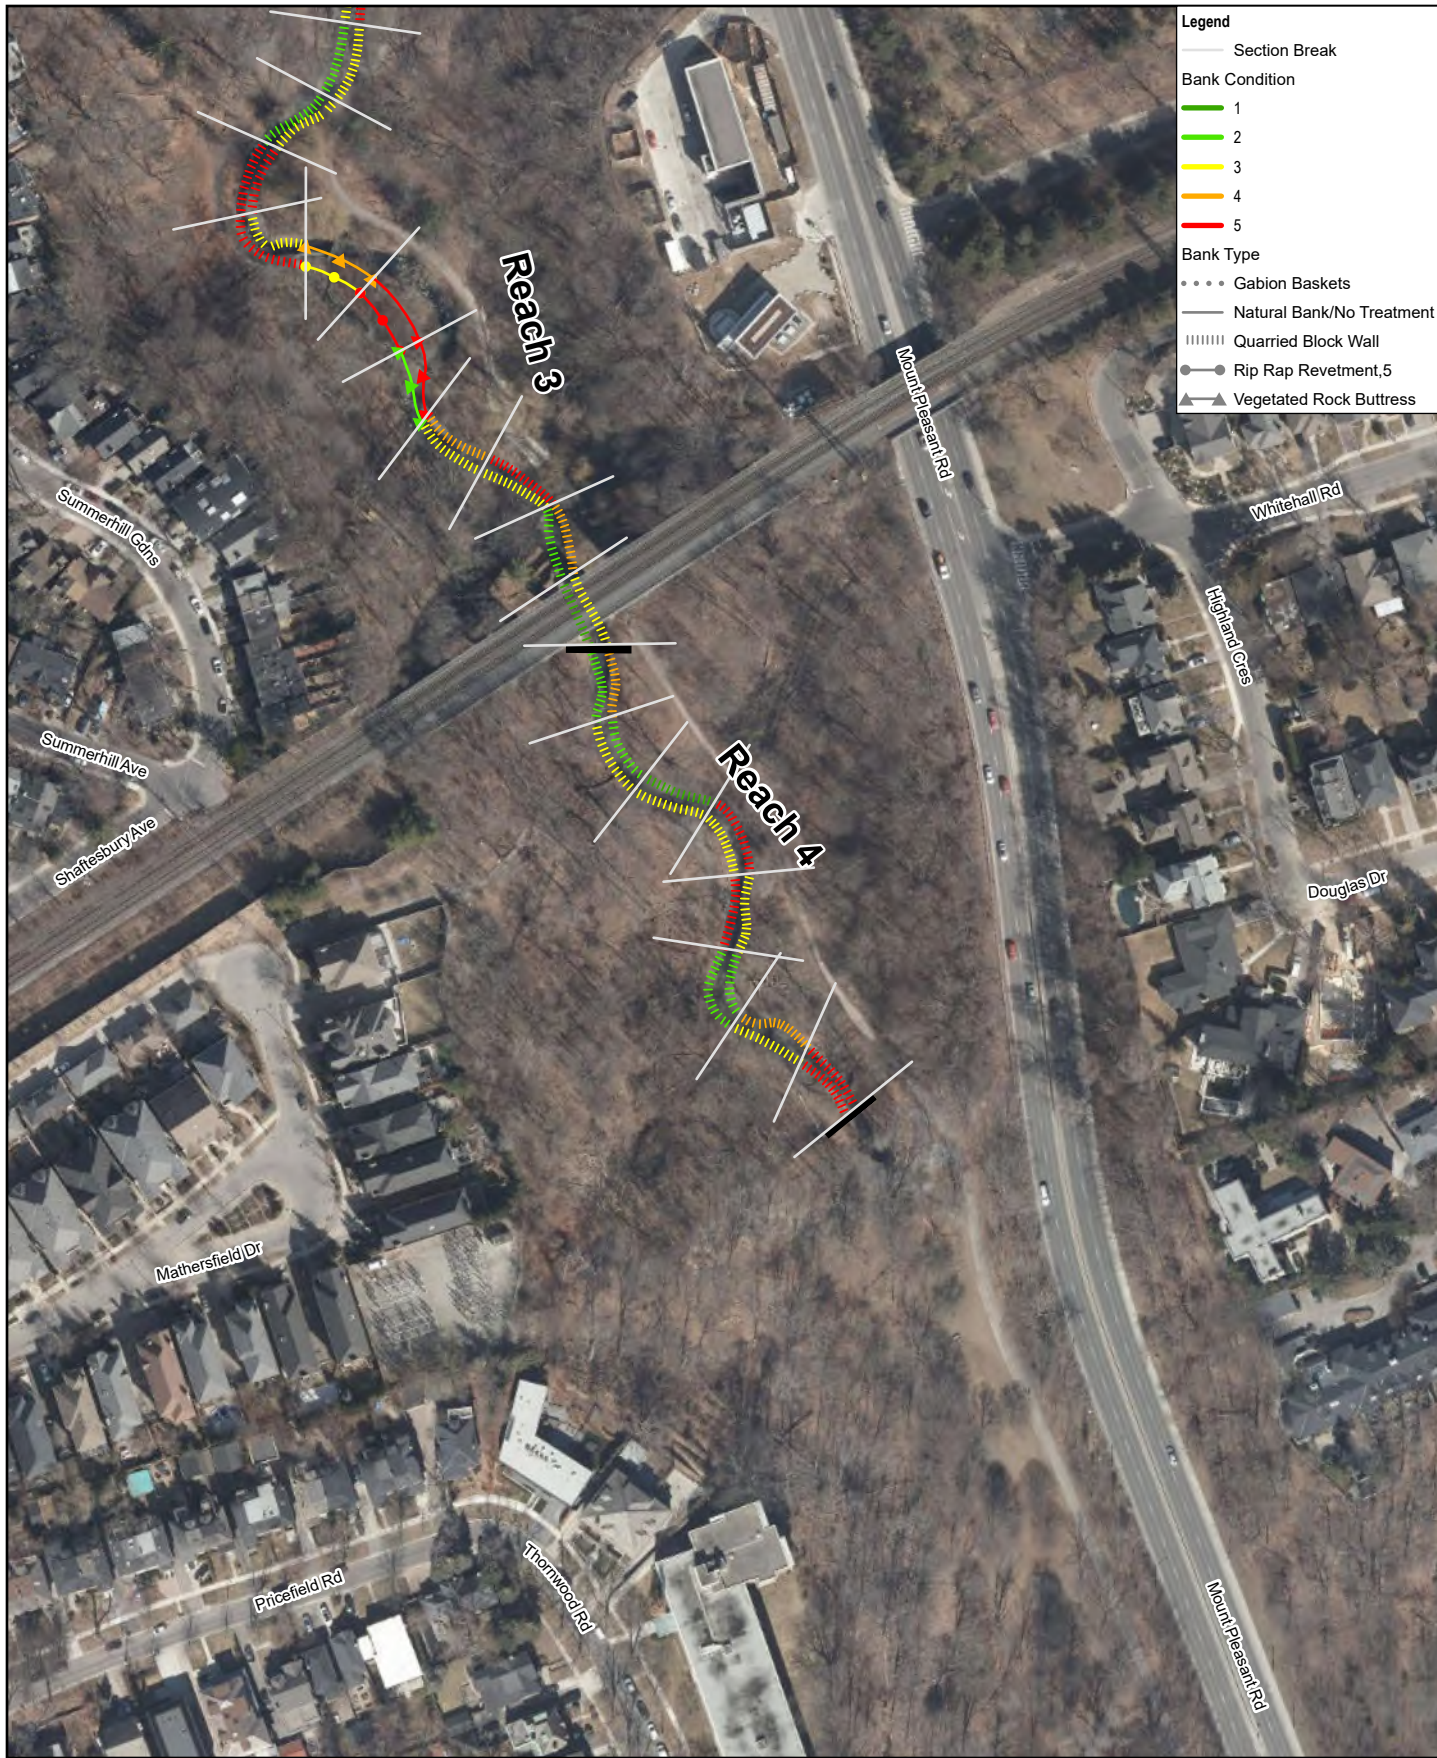
FIGURE 2-4

CITY OF TORONTO
YELLOW CREEK GEOMORPHIC SYSTEMS
MASTER PLAN SHORT-TERM EROSION MONITORING
**YELLOW CREEK
REACH 4
BANK CONDITION ASSESSMENT**

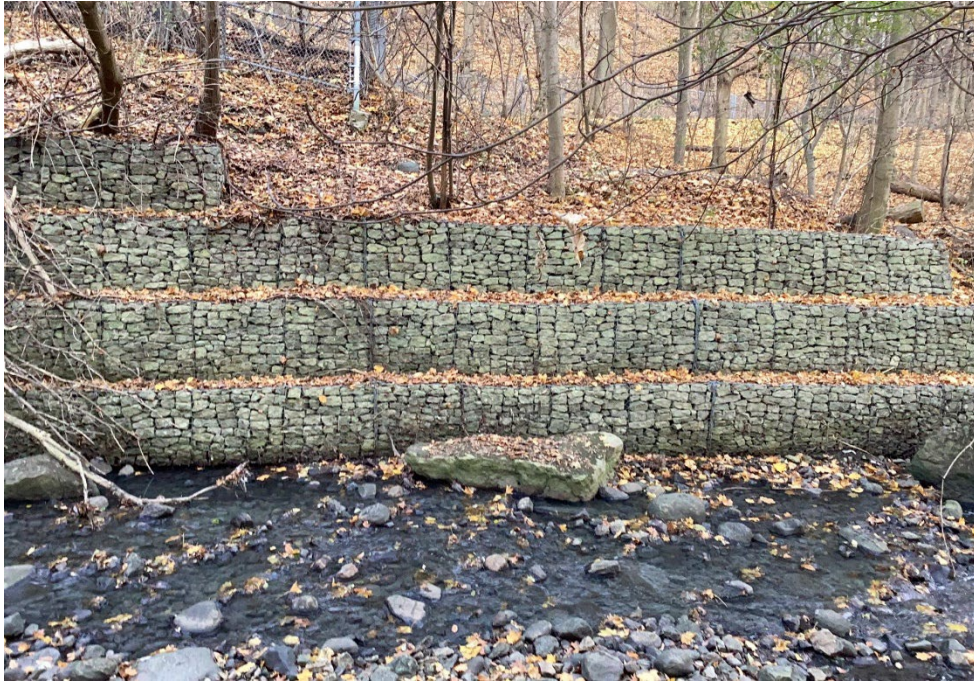
Photo 1 - November 20th, 2023 – Example of fair (2) gabion baskets. Some undermining visible.

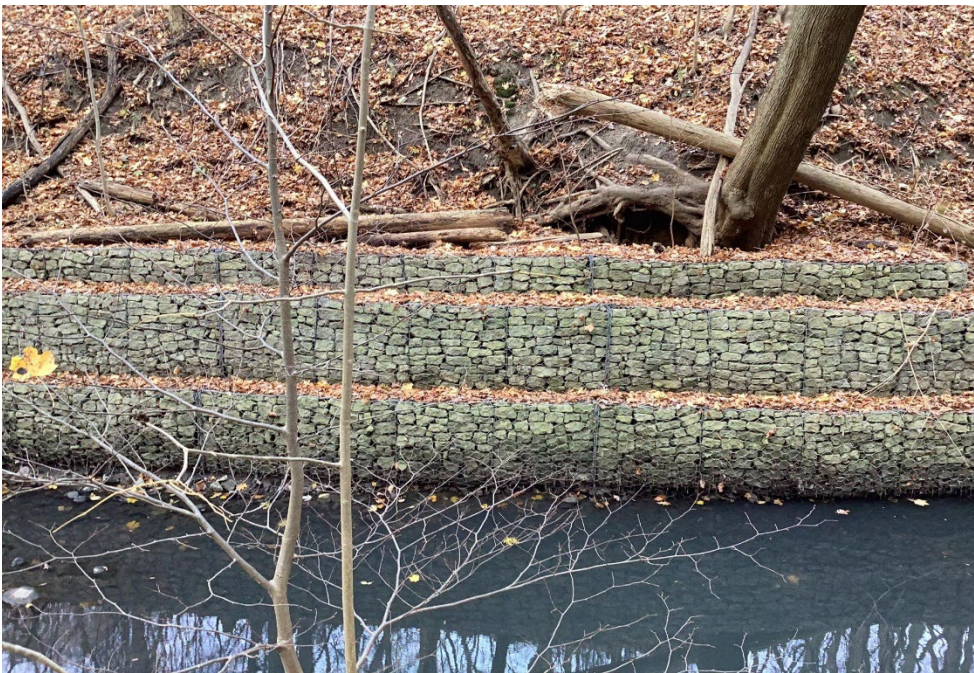
Photo 2 - November 20th, 2023 – Example of poor (3) gabion baskets. Slightly slumping and undermining visible.

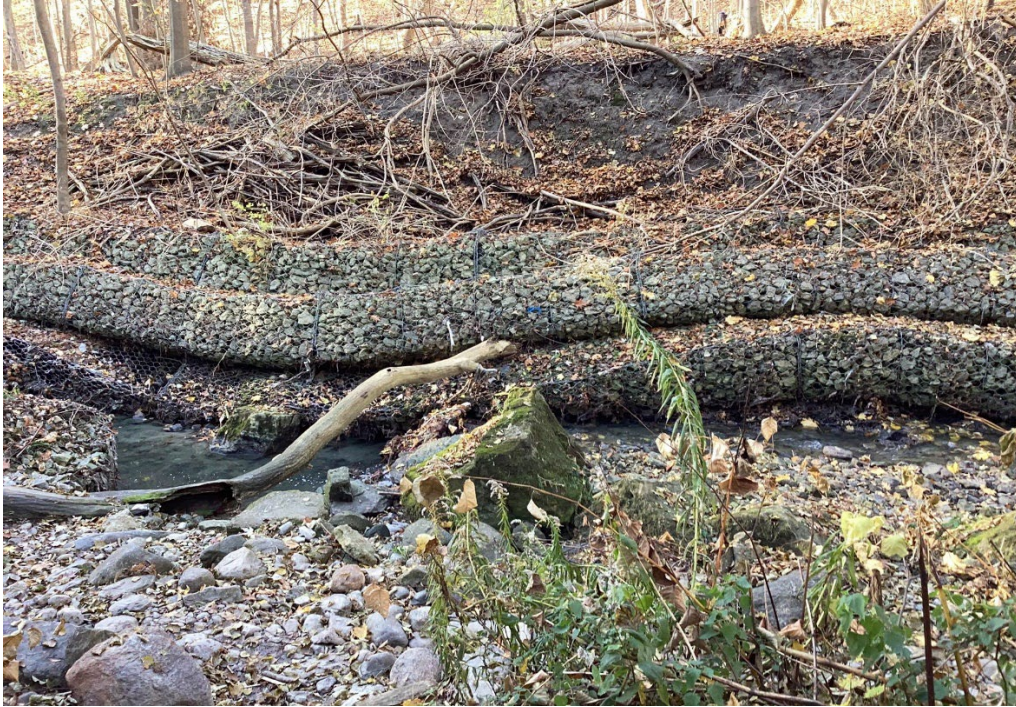
Photo 3 - November 20th, 2023 – Example of failed (5) gabion baskets.

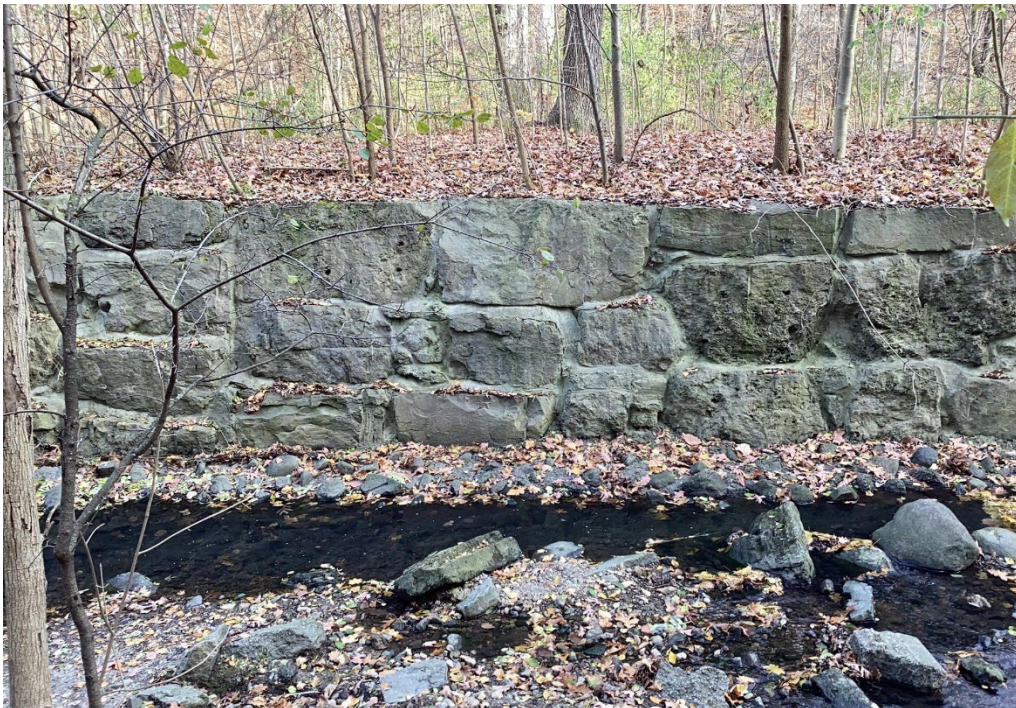
Photo 4 - November 20th, 2023 – Example of good (1) quarried block wall.

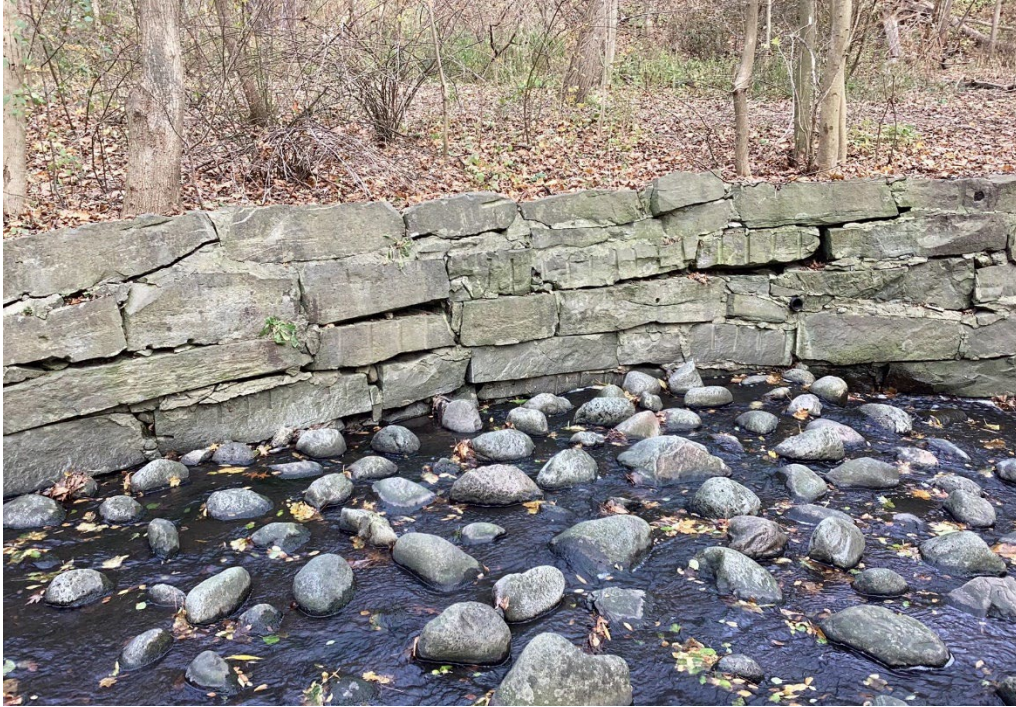
Photo 5 - November 20th, 2023 – Example of poor (3) quarried block wall. Misaligned and cracked stones visible.

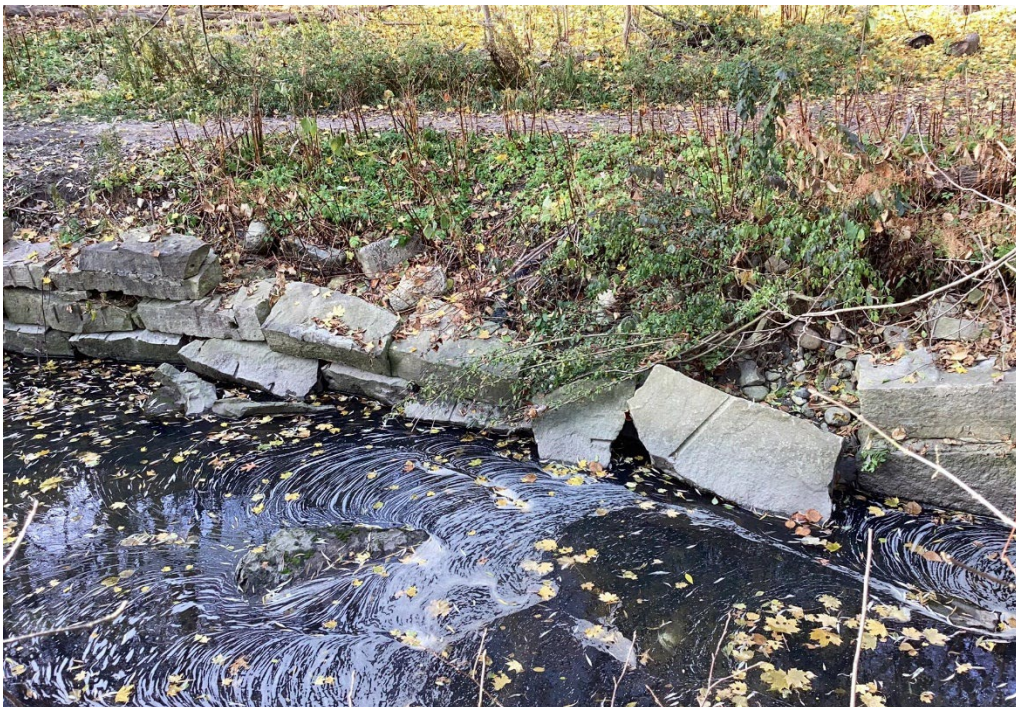
Photo 6 - November 20th, 2023 – Example of failed (5) quarried block wall.

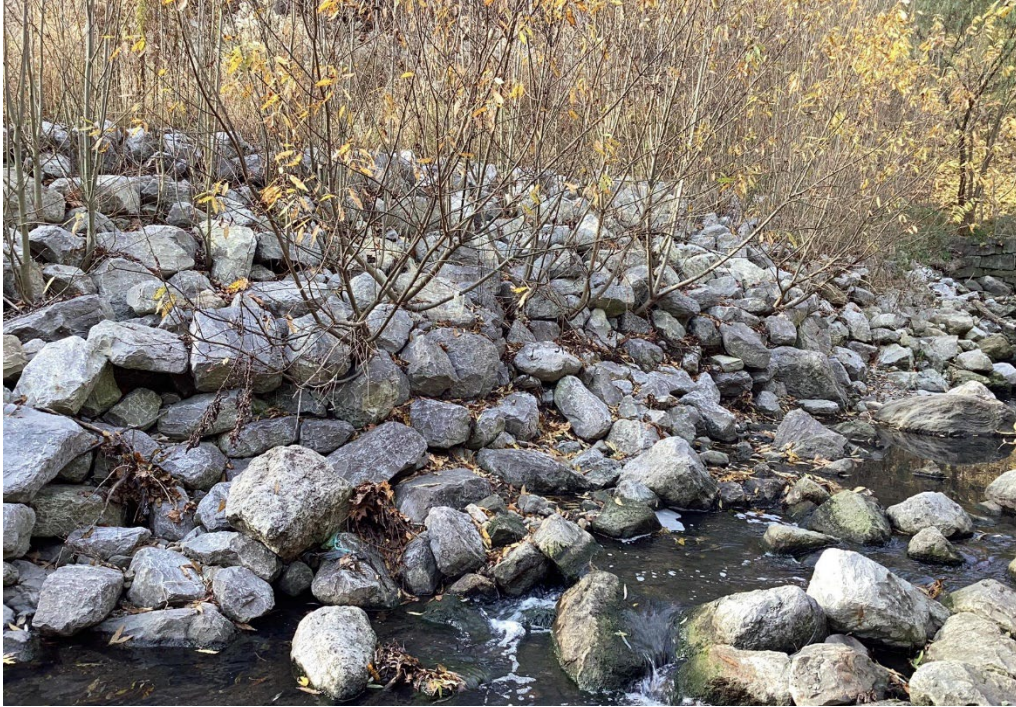
Photo 7 - November 20th, 2023 – Example of poor (3) rip rap revetment. Displaced rip-rap visible in the channel.

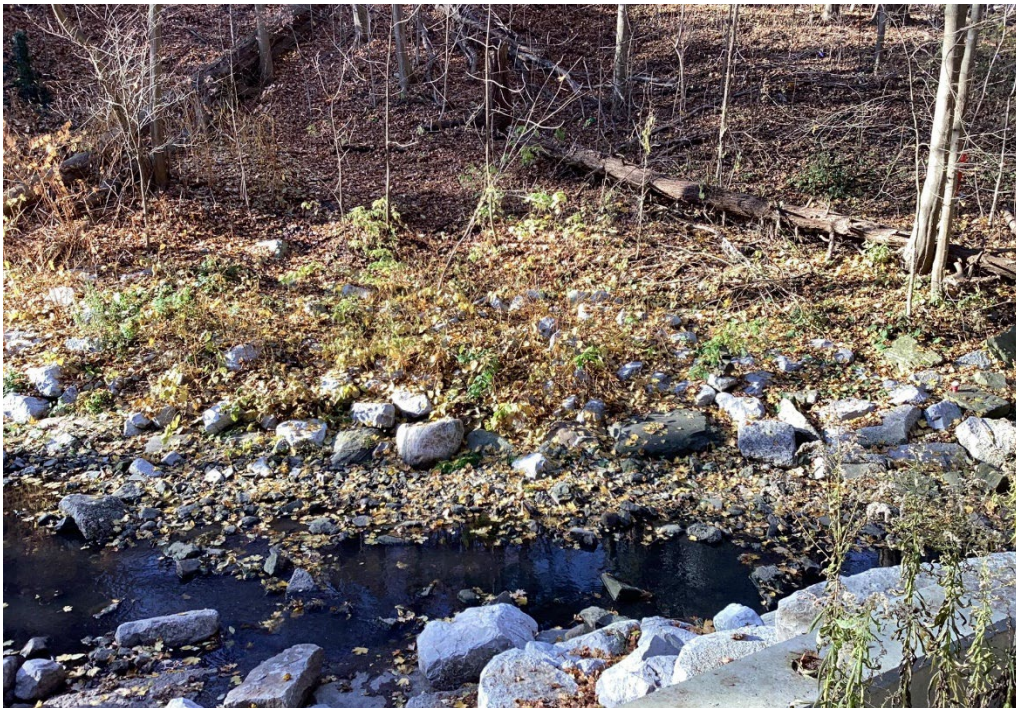
Photo 8 - November 20th, 2023 – Example of fair (2) vegetated rock buttress.

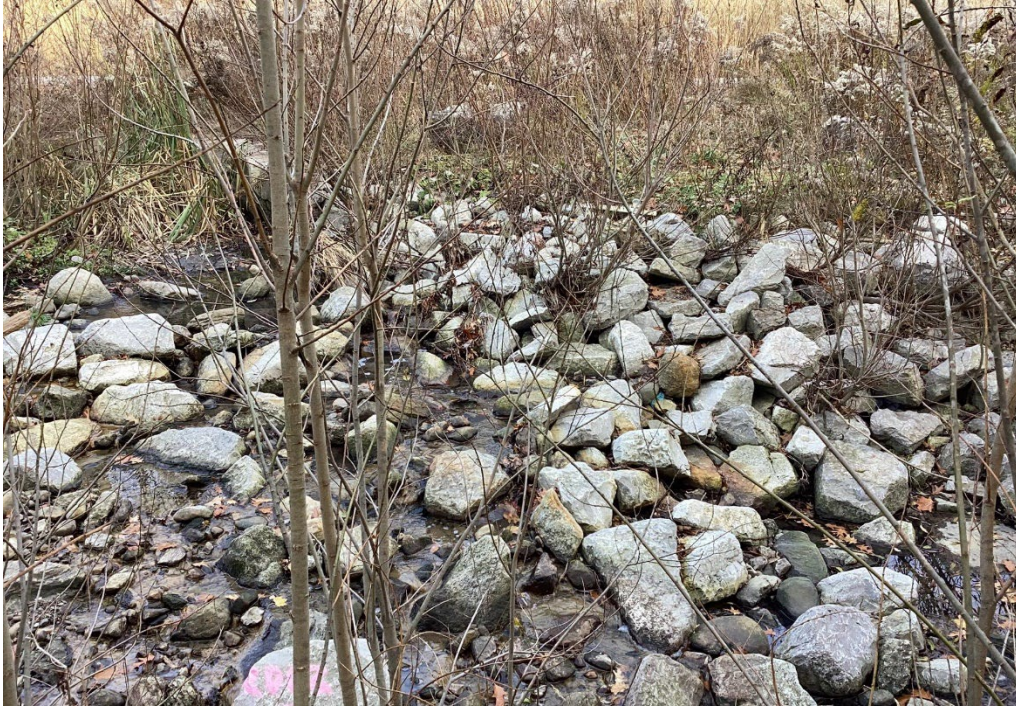
Photo 9 - November 20th, 2023 – Example of failed (5) vegetated rock buttress. Most of the rip rap is displaced.

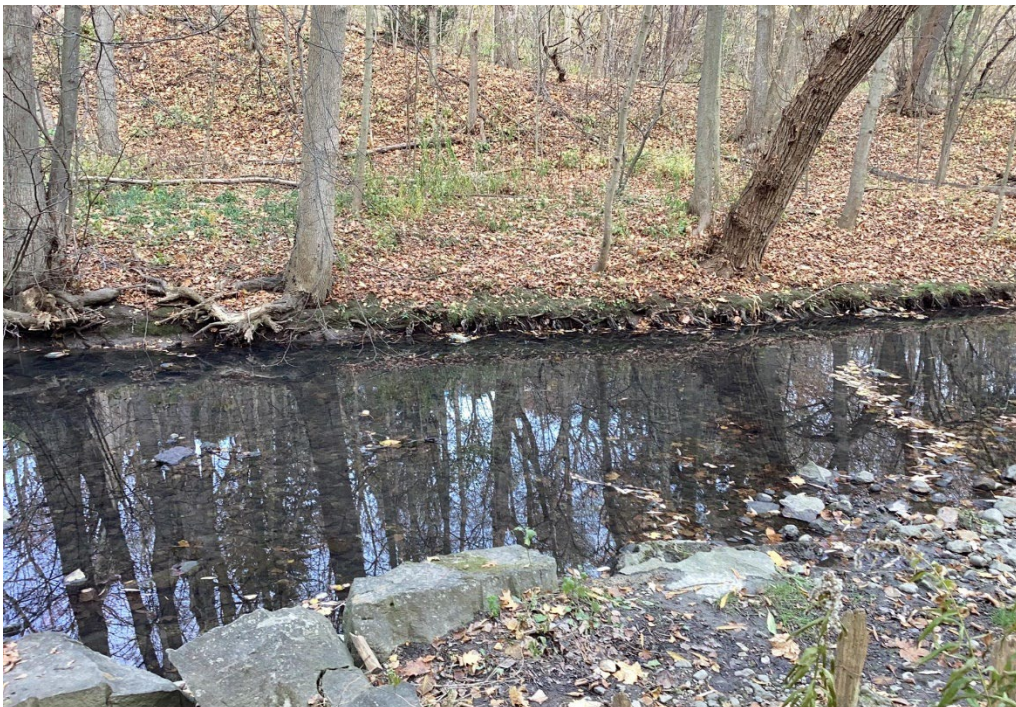
Photo 10 - November 20th, 2023 – Example of poor (3) natural bank. Evidence of scour visible.

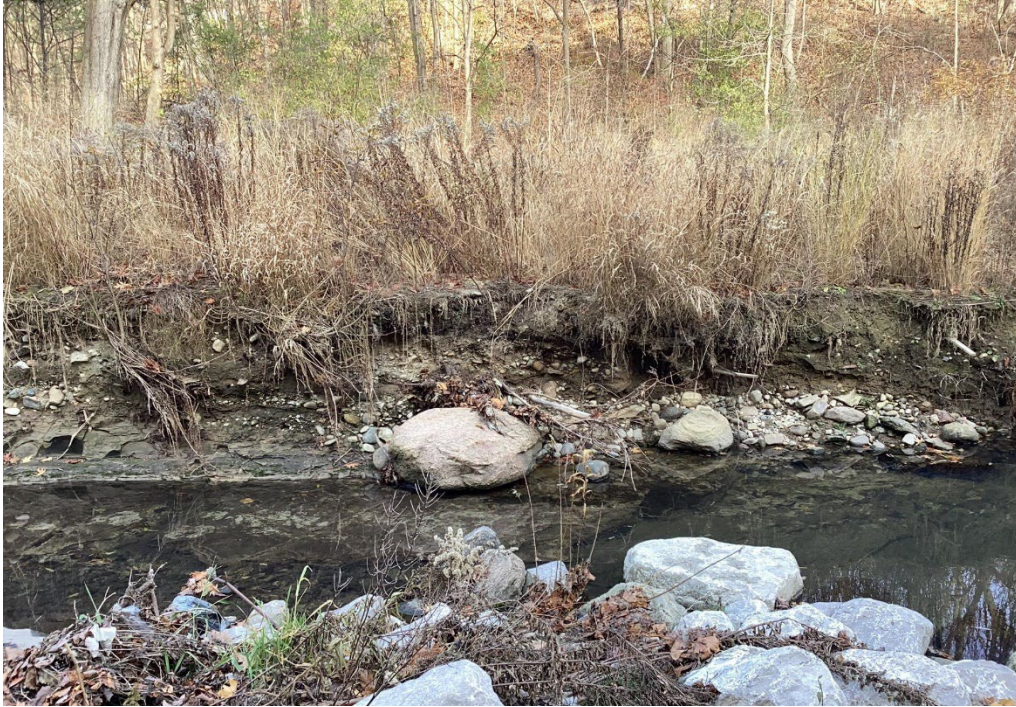
Photo 11 - November 20th, 2023 – Example of failed (5) natural bank. Severe scour visible.
