# Yellow Creek Geomorphic Systems Master Plan

**Municipal Class Environmental  
Assessment**

City of Toronto

20 February 2025

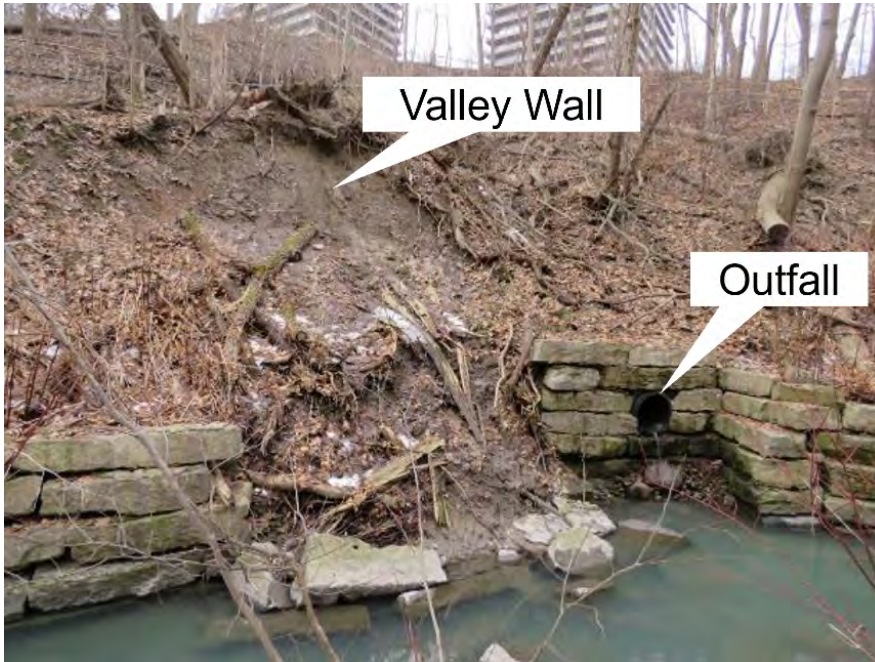
**Project 1A would focus on the retrofit of the storm sewer outfall at Site 4 and local channel realignment**

Project 1 involves channel engineering works for approximately 340 m of watercourse. The Project has been divided into Project 1A and Project 1B to reflect the higher priority need of the Site 4 storm sewer outfall. Project 1A consists of an 85 m section of creek and will involve the retrofit of the storm sewer outfall at Site 4 and provide a local realignment to protect the outfall. Project 1B consists of a 255 m length of creek and will involve the removal of the failed concrete spillway at the historic sawmill site.

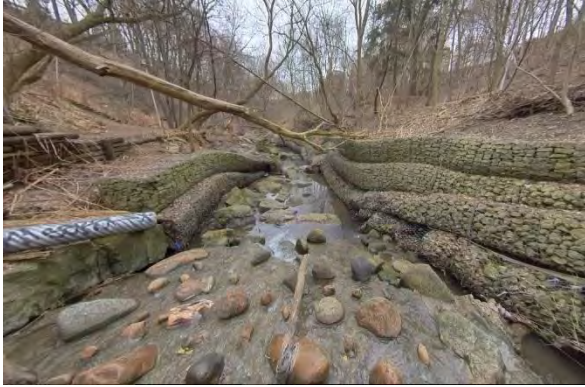
**Photo 1.1** Source outfall, facing south. Failed concrete apron and failed gabion bank treatments. CSP outlet on left bank.

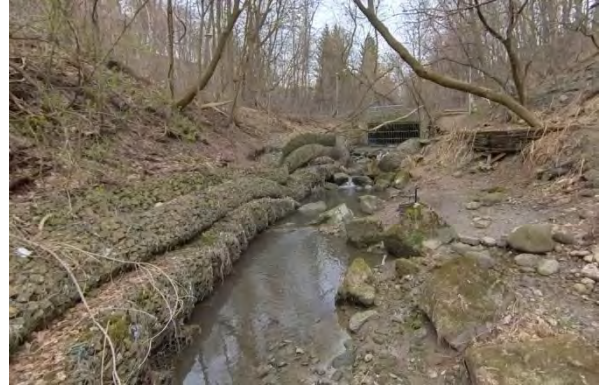
**Photo 1.2** Facing north. Outlet of Yellow Creek at the upstream limit of the aboveground portion of the creek. Gabion baskets failing along both banks.

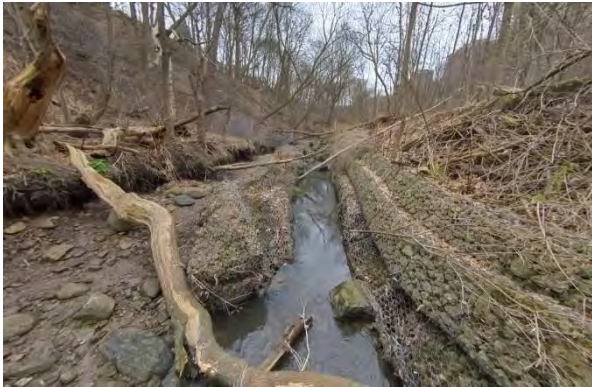
**Photo 1.3** Facing south. Undermined and outflanked gabion baskets failing along both banks.

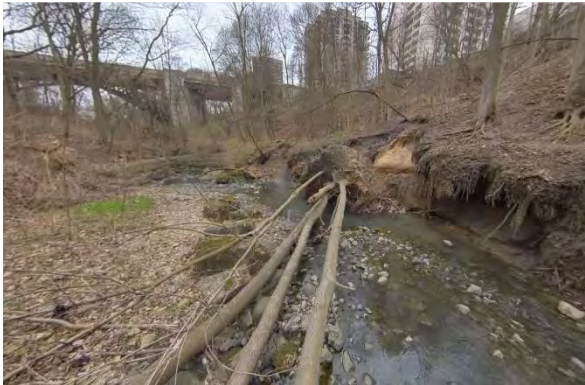
**Photo 1.5** Facing south. Historical armourstone channel visible in left side of photo. Creek migrating west into valley wall resulting in severe scour and loss of mature trees.

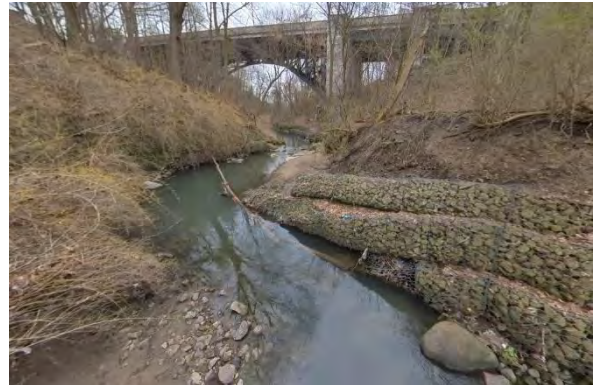
**Photo 1.6** Facing south. Collapsed gabion on right bank due to undermining and scour behind the wall.

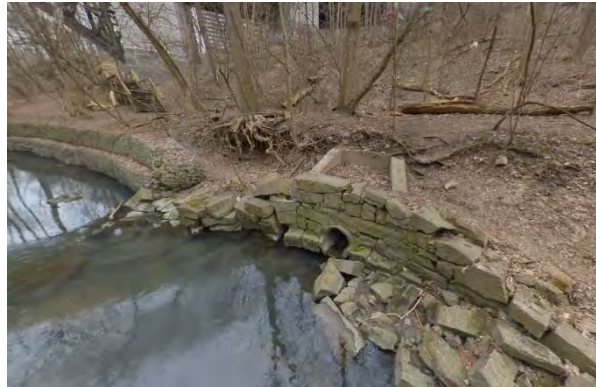
**Photo 1.7** Facing south. Outflanked stormwater outfall OF3862313685 on right bank. Evidence of scour on bank above outfall.

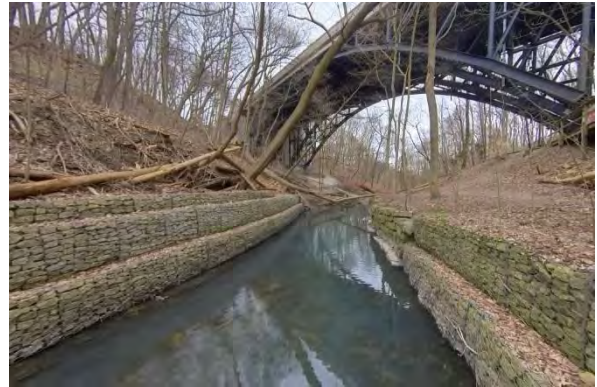
**Photo 1.8** Facing south. Gabion baskets on both banks are stable but shows signs of degradation.

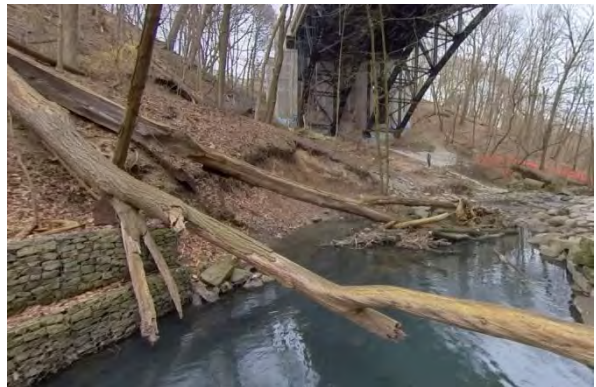
**Photo 1.9** Facing south. Large erosion scar on left bank downstream of gabion.

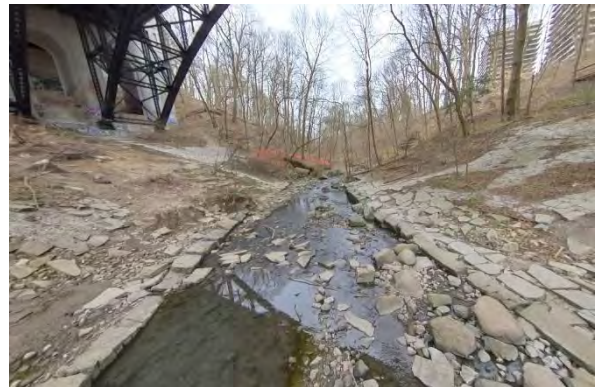
**Photo 1.10** Facing south. Armourstone and shale tile line banks through St Clair bridge crossing. Debris from slope failure visible in left side of photo.

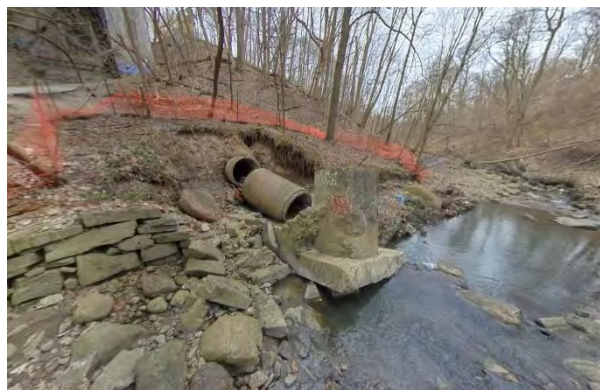
**Photo 2.1** Facing south. Failed stormwater outfall on left bank.

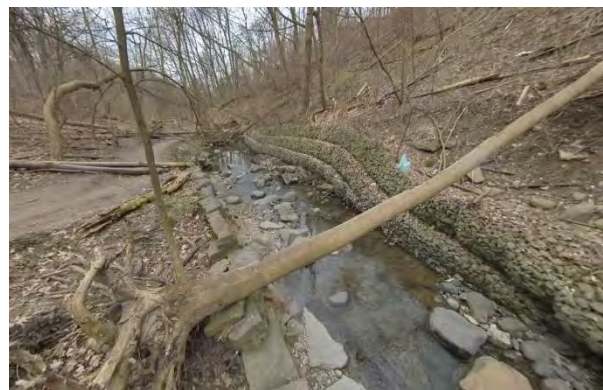
**Photo 2.2** Facing south. Collapsed gabion on right bank and partially outflanked armourstone wall on left bank.

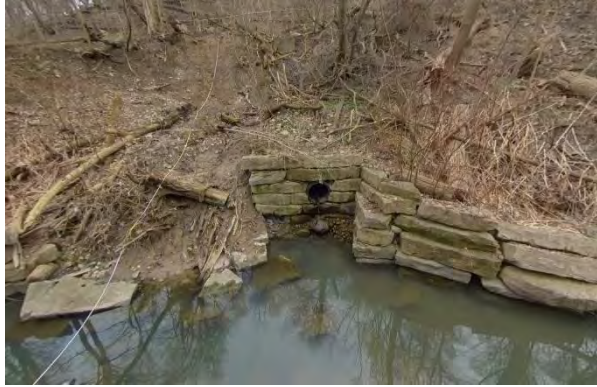
**Photo 2.3** Facing west. Stormwater outfall on right bank with failing headwall and surrounding armourstone walls. Slope failure behind outfall. Large downstream erosion scars on the right bank.

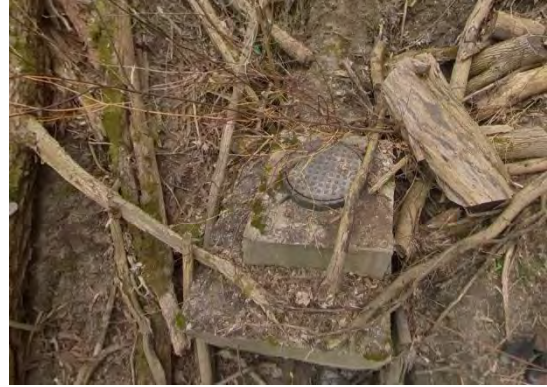
**Photo 2.4** Facing west. Storm sewer pipe connecting to maintenance hole is exposed due to loss of material associated with slope failure.

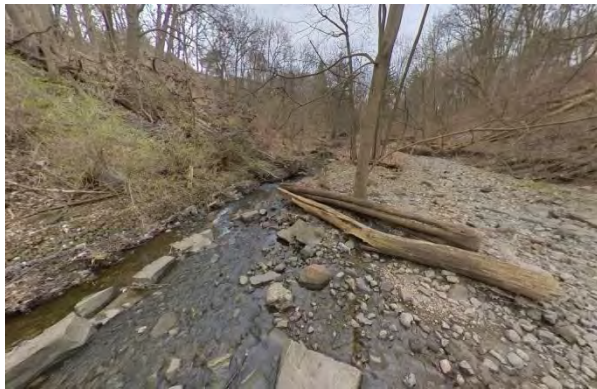
**Photo 2.5** Facing south. Flood flow channel and cobble bar visible in right side of photo. Creek migrating east into valley wall resulting in collapse of gabion on east bank.

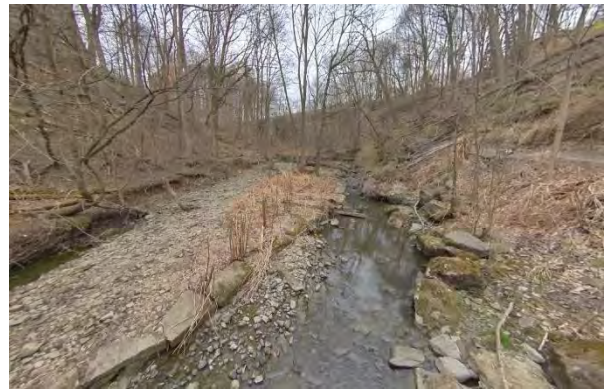
**Photo 2.6** Facing north. Flood flow channel and cobble bar visible in left side of photo. Creek migrating east into valley wall resulting in collapse of gabion on east bank.

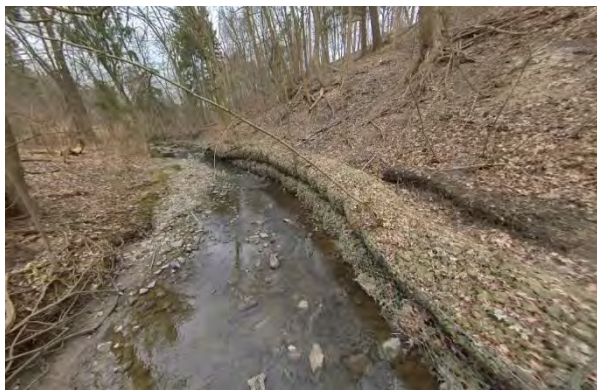
**Photo 2.7** Facing south. Undermined and slumping gabion baskets on right bank.

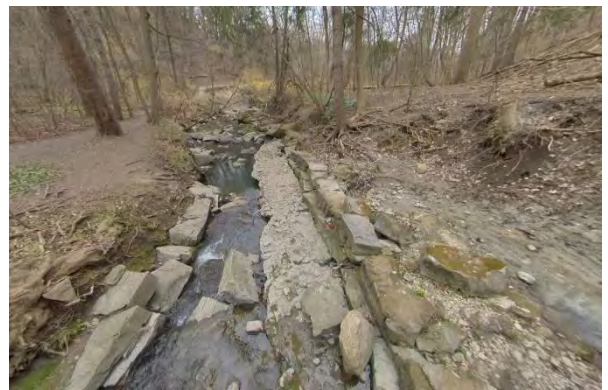
**Photo 2.8** Facing south. Outflanked armourstone wall and failed concrete bed.

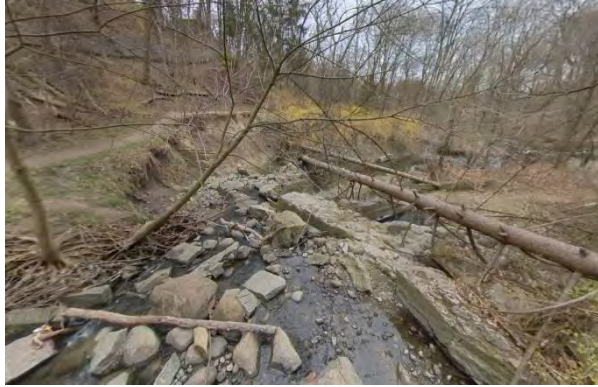
**Photo 2.9** Facing east. Outflanked concrete spillway in the foreground and large erosion scour in the background.

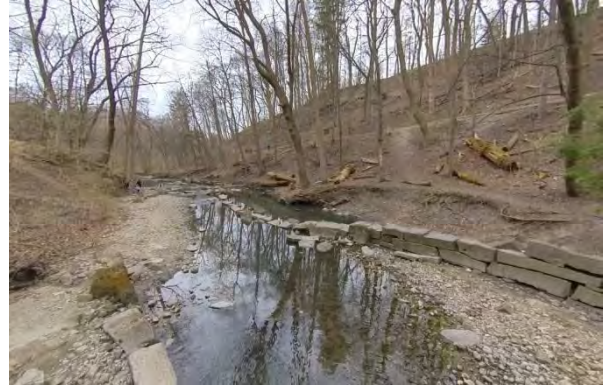
**Photo 2.10** Facing south. Channel has widened beyond historical banks, leaving armourstone in the middle of channel.

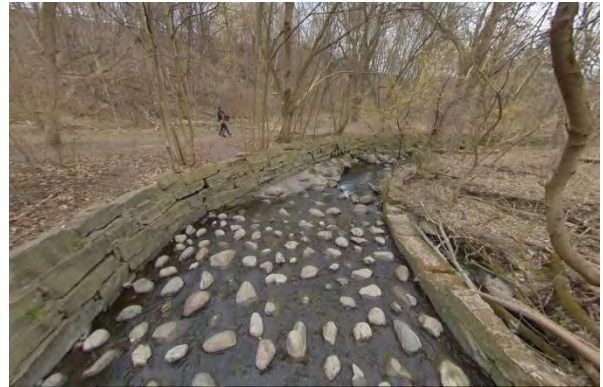
**Photo 2.12** Facing east. Concrete bed embedded with roundstone. Evidence of scour behind armourstone wall on right bank.

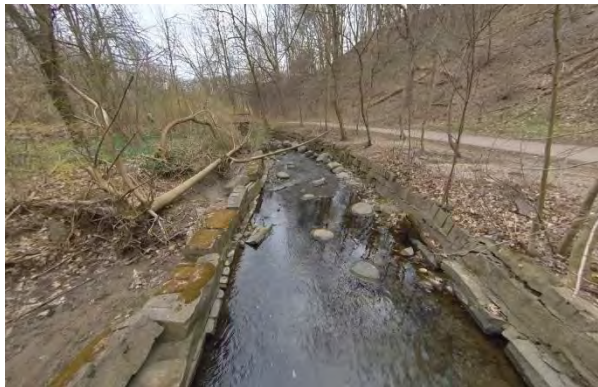
**Photo 2.13** Facing south. Armourstone lined banks with evidence of scour behind wall on left bank.

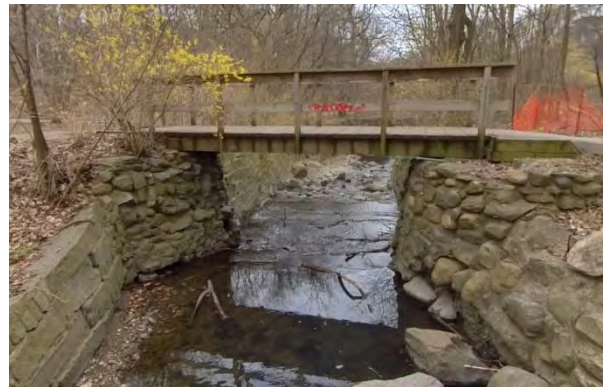
**Photo 2.14** Facing south. Wooden pedestrian crossing. Abutments on both banks are undermined.

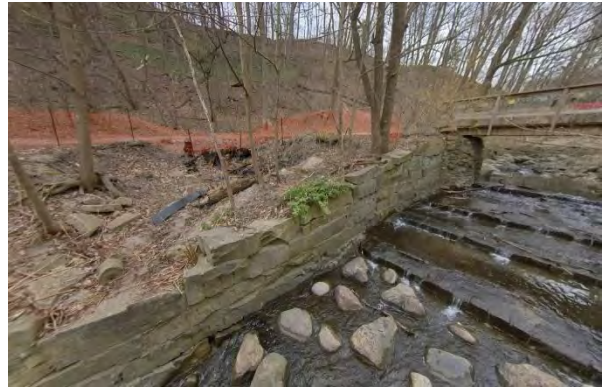
**Photo 3.2** Facing west. Erosion and exposed geowebbing on right overbank.

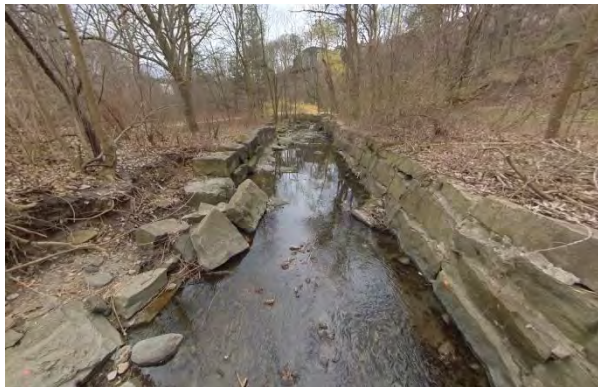
**Photo 3.5** Facing south. Armourstone lined banks with failure on left bank.

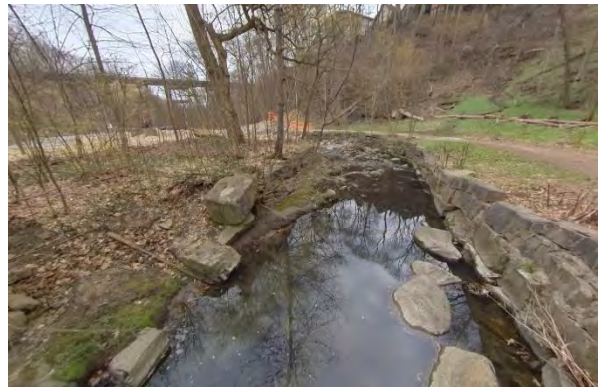
**Photo 3.6** Facing south. Armourstone lined banks with failure on left bank.

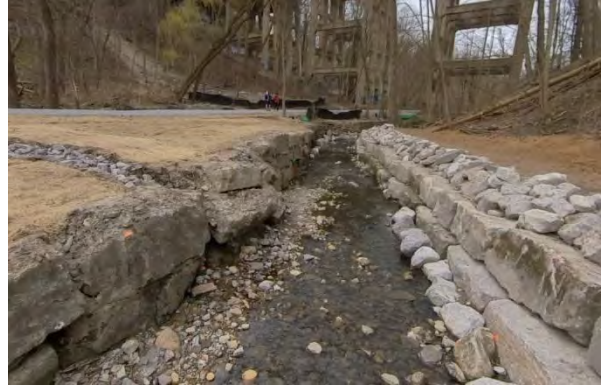
**Photo 3.8** Facing south. Failing armourstone wall on left bank.

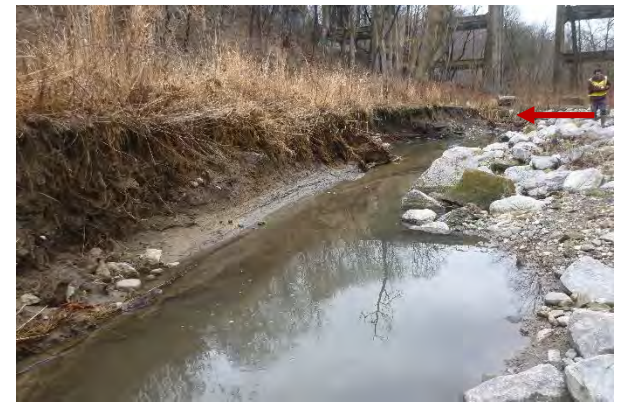
**Photo 3.10** Facing downstream. Erosion on left bank. Stormwater outfall channel connects to main channel at red arrow.

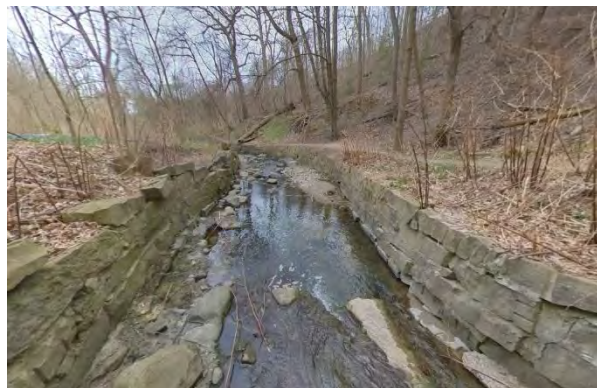
**Photo 4.1** Facing south. Armourstone lined banks with displaced armourstones on left bank.

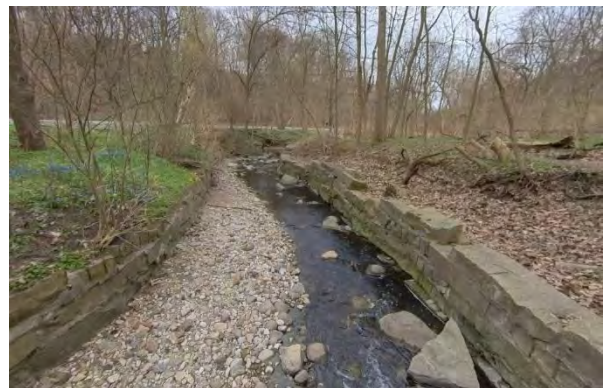
**Photo 4.2** Facing east. Armourstone lined banks with erosion behind wall on right bank.

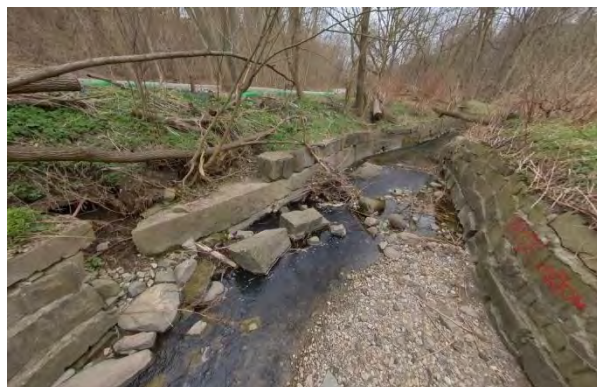
**Photo 4.3** Facing south. Armourstone lined banks with failure on left bank.

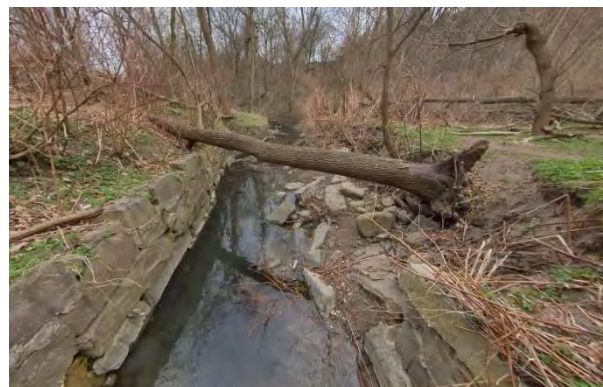
**Photo 4.4** Facing south. Armourstone lined banks with failure on right bank.

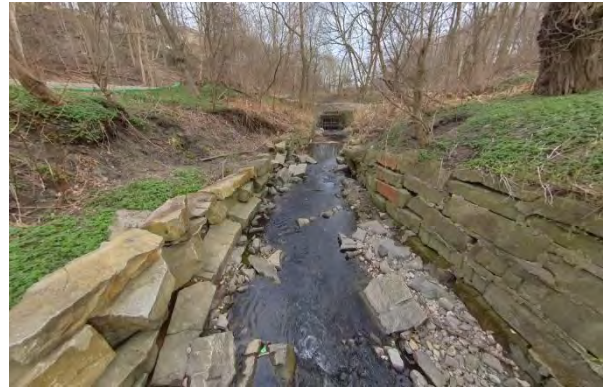
**Photo 4.6** Facing south. Armourstone lined banks with failure on left bank.

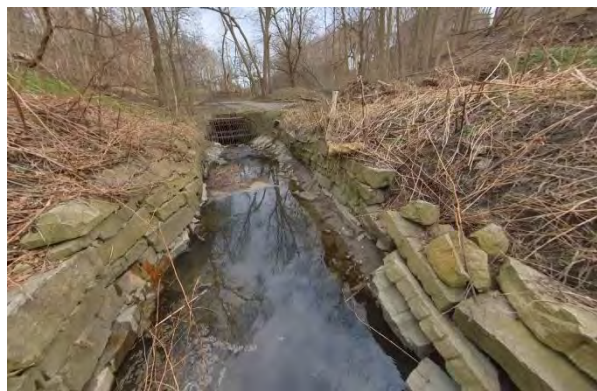
**Photo 4.7** Facing south. Armourstone lined banks with failure on right bank.

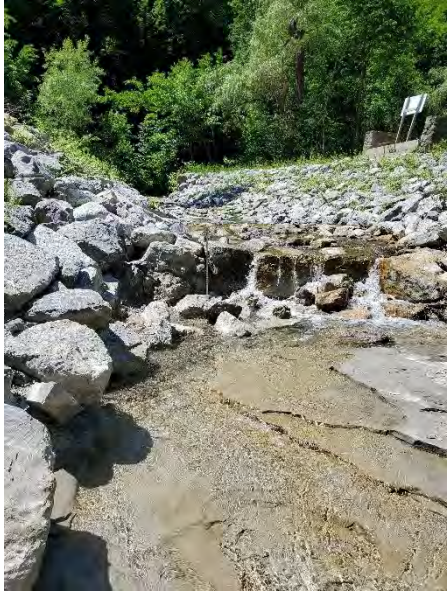
Barrier	Photo
<p>FB-4: At the time of the aquatic habitat assessment, a knickpoint at an armourstone step within the TRCA interim channel works had created a 0.8 m vertical drop that would restrict fish migration upstream of this location. Note that this location is constantly changing due to significant erosion and transport of bed and bank material.</p>

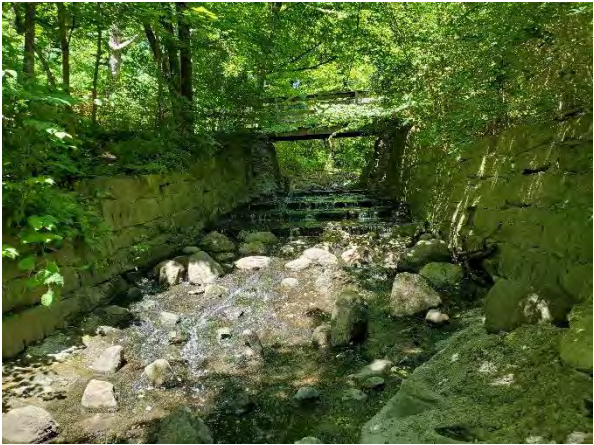
<p>FB-5: A series of concrete steps 0.15 m to 0.23 m in height, in combination with a concrete grade control apron embedded with rock, create a barrier to fish passage at the pedestrian bridge crossing.</p>

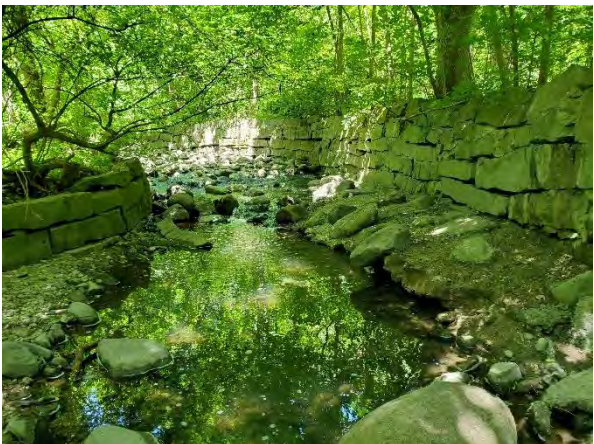
<p>FB-6: Approximately 100 m upstream of the pedestrian bridge, a third concrete grade control apron embedded with rock and steeper grade create a potential barrier to fish movement.</p>

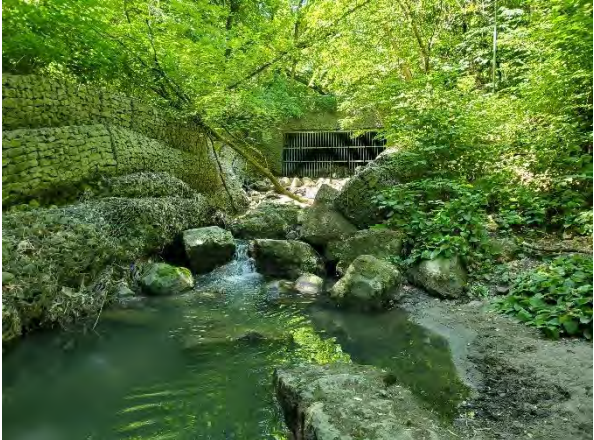
Barrier	Photo
<p>FB-7: The source outfall at the upstream extent of the reach has two vertical drops of approximately 0.8 m in height that would prevent fish migration upstream of this point, however all upstream habitat has been piped underground.</p>
