Appendix F

Detailed Geomorphic Assessment Summary

Fluvial Geomorphology Summary

Yellow Creek, Don River Watershed

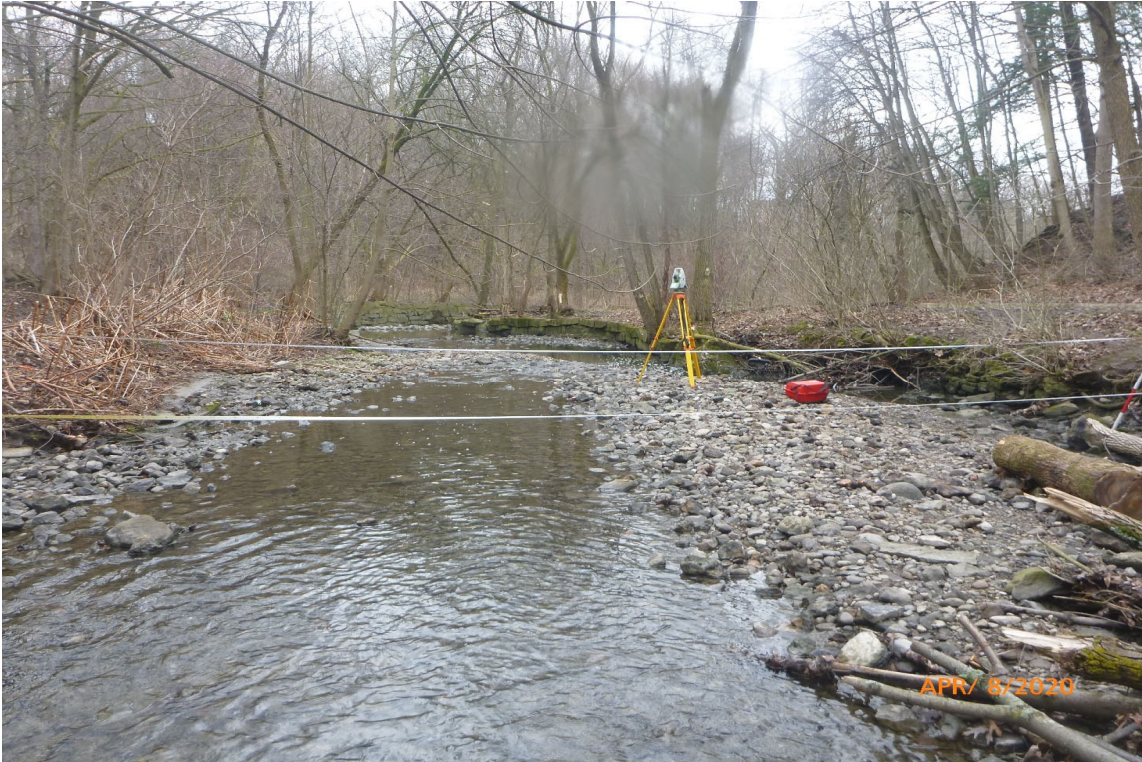
Downstream view of cross section # 3

Channel substrate was a combination of native material and material displaced from failed gabion. Substrate sorting was moderate throughout the site. Scour was observed along both banks at multiple cross-section. Banks at the water edge were moderate in height and angle, while steeper and higher banks were set back from the edge. Exposed roots and fallen and leaning trees were observed.
