**Short Term Erosion Monitoring Memos –  
Short Term Monitoring Memo (Part 1 of 3)**

18 December 2023

| <b>Project Name</b> | City of Toronto-Yellow Creek MP | | |
| <b>Subject</b> | Short-Term Erosion Monitoring | | |

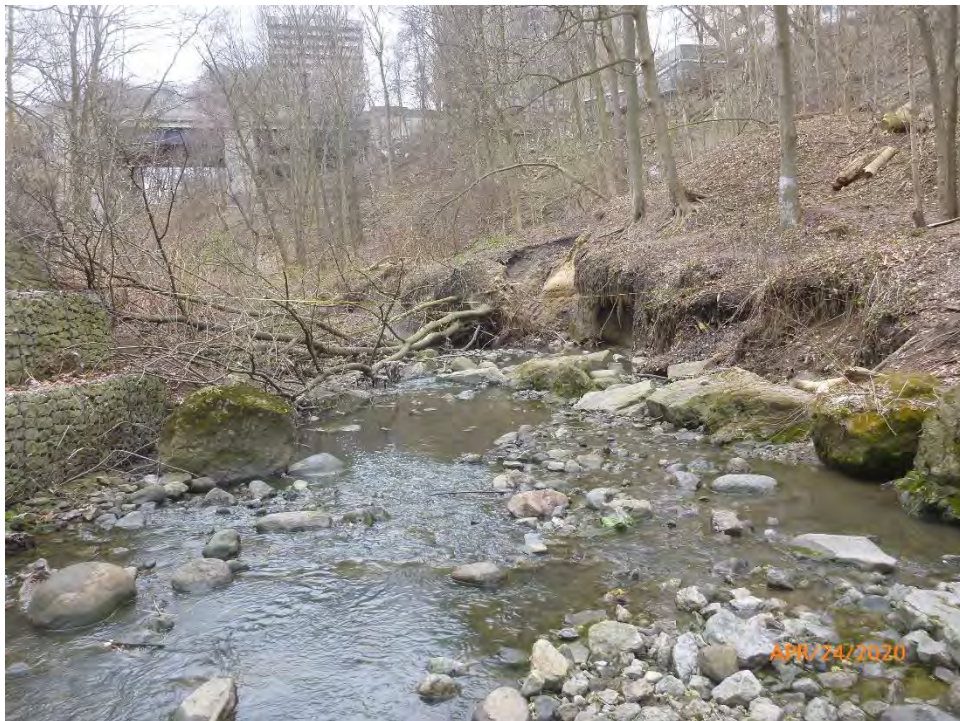
Photo 16 April 24, 2020. M1, facing downstream.

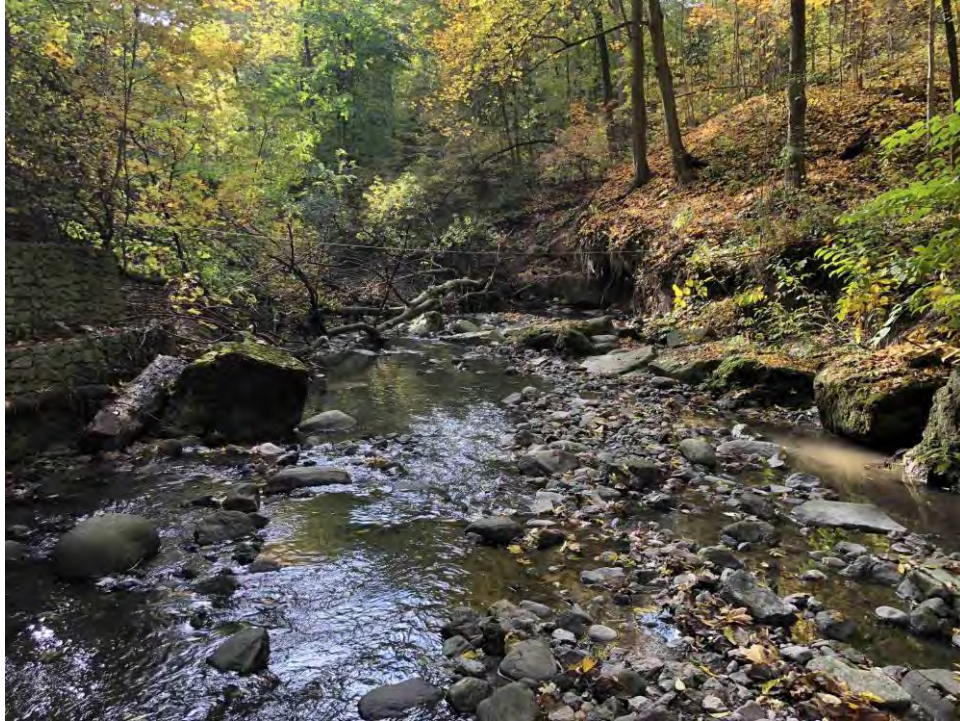
Photo 17 October 28, 2020. M1, facing downstream.

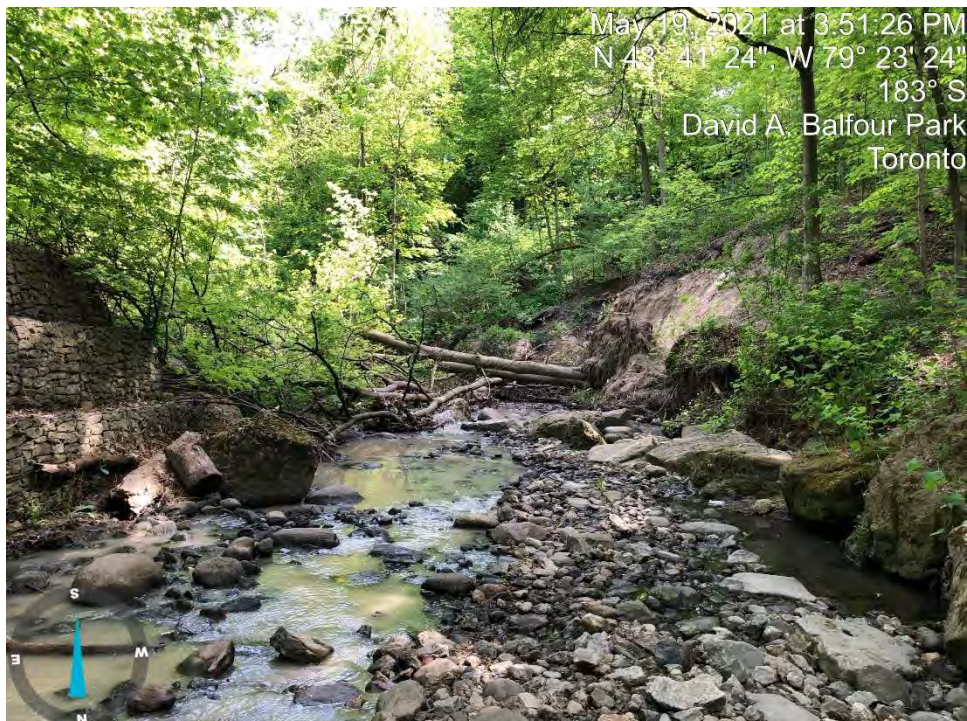
The photographs facing downstream at M1 show two large trees that have fallen into the creek on the right bank due to slope failure sometime between October 2020 and May 2021. This indicates that active toe erosion was occurring between M1 and M2 on the unprotected section of bank.

Photo 18 May 19, 2021. M1, facing downstream. Note 2 trees had fallen from the right bank downstream of the cross section.

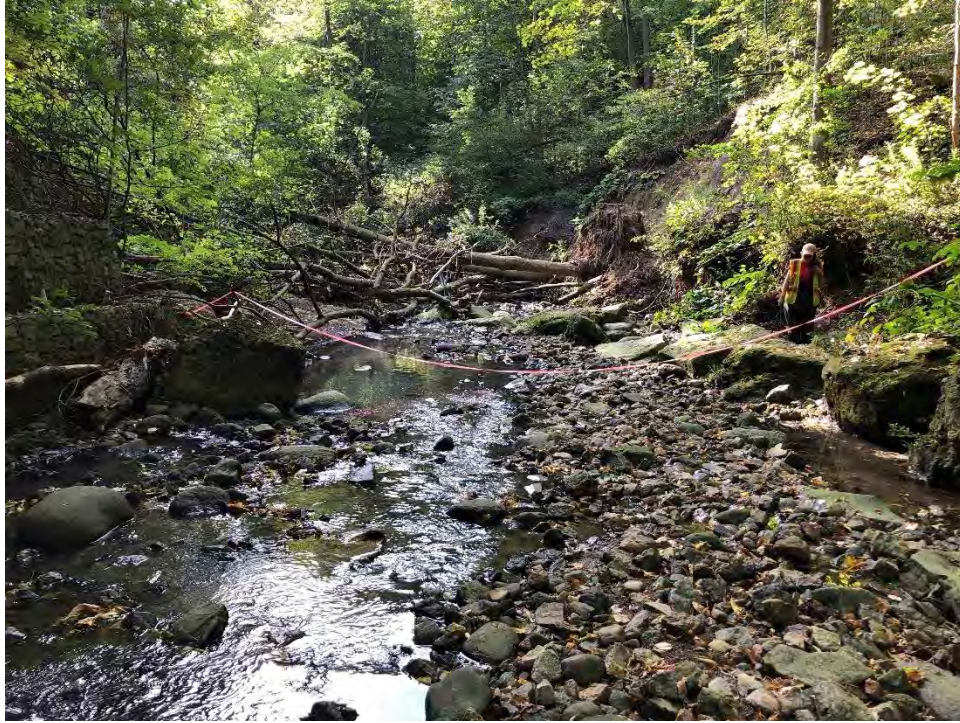
Photo 19      October 20, 2021. M1, facing downstream.

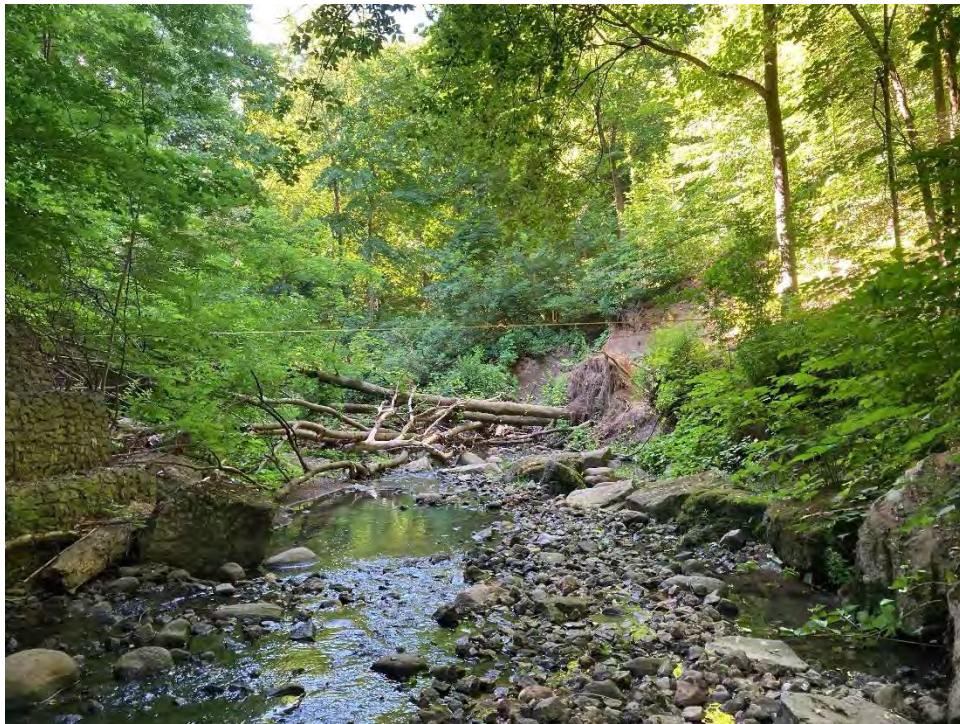
Photo 20      June 27, 2022. M1, facing downstream.
