1337 Queen Street West, Toronto, ON

Designated Substance Survey

Designated Substance Survey – 1337 Queen Street West, Toronto, ON

GTR-22012367-A0

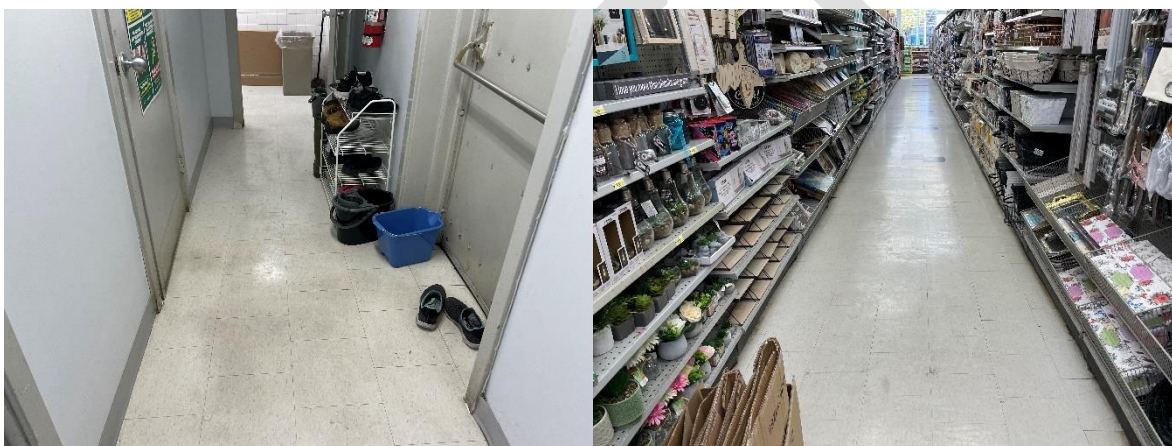
Non-friable asbestos-containing off-white coloured vinyl floor tiles with grey streaks, measuring 12"x12" were found to contain 2% Chrysotile asbestos and identified on the mezzanine level and ground floor of the subject building. Refer to Photograph No. 2.1 and 2.2 in Appendix D of this report.

Photograph No. 2.1 and 2.2: View of asbestos-containing Off-white colour vinyl floor tiles identified throughout the mezzanine level and ground floor of the subject building.

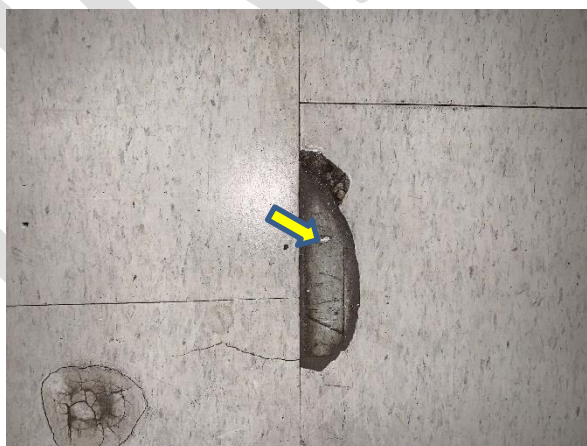
Non-friable asbestos-containing white coloured vinyl floor tiles (2nd layer) were identified underneath asbestos-containing off-white with grey Streaks VFT (1st layer) within the subject building. The vinyl floor tiles were found to contain 2% Chrysotile asbestos. Refer to Photograph No. 3 in Appendix D of this report.

Photograph No. 3: View of asbestos-containing white vinyl floor tiles (2nd layer) identified underneath off-white asbestos containing vinyl floor tiles throughout the retail area on the ground floor of the subject building.

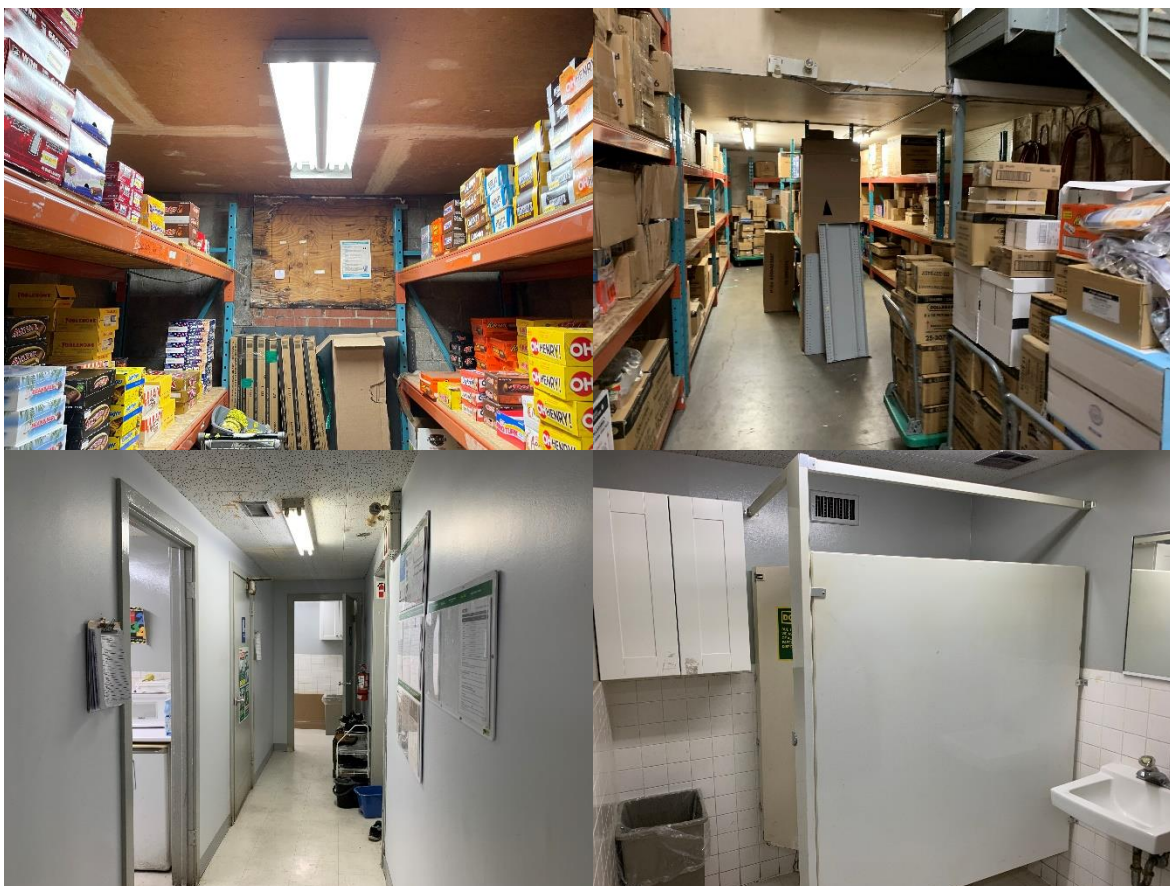
Non-friable asbestos-containing joint compound associated with gypsum wallboard and ceiling board was identified throughout the mezzanine level and ground floor of the subject building. The joint compound was found to contain 3% Chrysotile asbestos. As per O. Reg. 278/05, when joint compound is identified as an ACM, the entire gypsum board is considered as ACM. Refer to Photograph No. 4.1, 4.2, 4.3 and 4.4 in Appendix C of this report.

Given the current sampling and analytical results, all gypsum wallboard and ceiling board throughout the mezzanine level and ground floor have to be considered as an ACM. It is imperative to note that most buildings of this type undergo constant renovations, including removal and replacement of gypsum ceiling board and wallboard partitions, therefore extensive sampling of joint fill compound would be necessary to confirm the extent of asbestos content. Furthermore, any attempt to distinguish and delineate old asbestos-containing joint compound from new non-asbestos-containing joint compound is often unachievable, therefore all gypsum wall board and ceiling board throughout the mezzanine level and ground floor should be considered as ACM unless sampling and analysis confirms otherwise.

The asbestos-containing vinyl floor tiles and gypsum board was observed to be damaged in isolated locations within the subject building with potential for disturbance during maintenance activities. This material was assigned a Hazard Rank of 1 (High Risk) and must be repaired or removed properly in accordance with O. Reg. 278/05. Waste generated must be disposed of asbestos waste in accordance with O. Reg. 347.

Photograph No. 4.1, 4.2, 4.3 and 4.4: View of asbestos-containing drywall/gypsum wallboard and ceiling board identified throughout mezzanine level and ground floor of the subject building.

- *Damaged asbestos-containing materials must be repaired or removed following appropriate asbestos abatement work measures and procedures (Type 1, Type 2 or Type 3) as detailed in O. Reg. 278/05 and disposed of as asbestos waste under O. Reg. 347;*

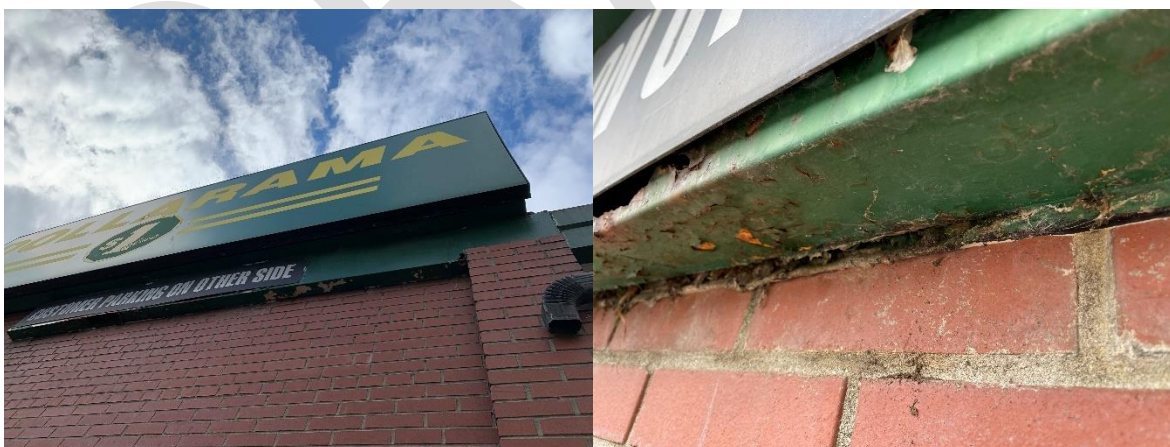
Non-friable asbestos-containing white caulking associated with the Dollarama signs was identified on the exterior of the subject building. The caulking was found to contain 3% Chrysotile asbestos. Refer to Photograph No. 5.1 and 5.2 in Appendix D of this report.

Photograph No. 5.1 and 5.2: View of asbestos-containing white caulking associated with Dollarama signs was identified on the exterior of the subject building.

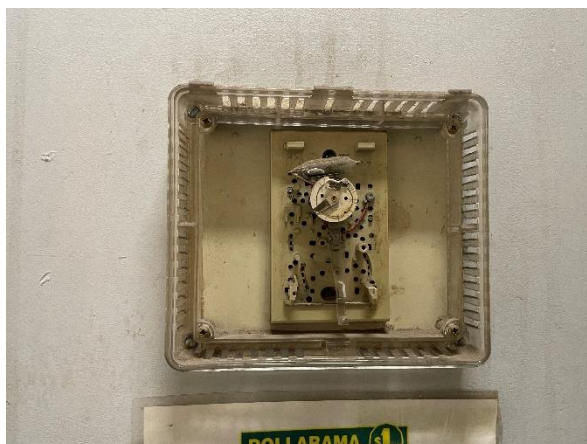
The thermostat switches within the subject building were observed to contain vials of liquid mercury.

Photograph No. 6: View of a thermostat switch containing a single vial of liquid mercury.

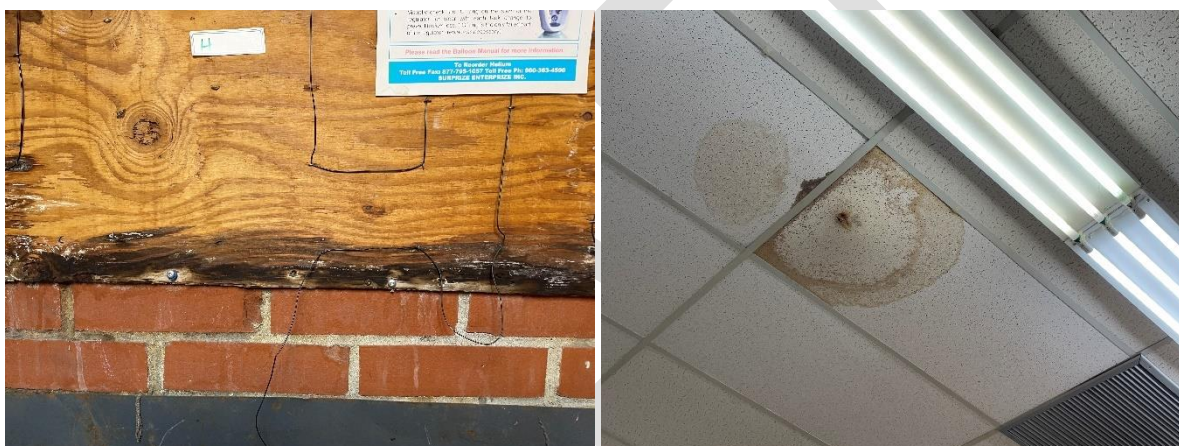
Visible mould growth and signs of water damage were observed on the building materials in isolated locations within the subject building at the time of site visit. Refer to Photograph No. 7.1 and 7.2 in Appendix D.

Signs of water damage and visible mould growth were observed on the building materials in various isolated locations within the subject unit of the building at the time of site visit. Refer to Photograph No. 7.1 and 7.2 in Appendix D.

Photograph No. 7.1 and 7.2: Visible mould Growth and signs of water damage observed on the building materials within the subject building.

- *Prior to mould remediation, which may disturb potentially asbestos-containing materials, these materials must be cross referenced with any existing information or tested for asbestos and if identified as asbestos- and lead containing, appropriate precautions (Type 1/2/3) must be taken during remediation and disposal in accordance with O. Reg. 278/05;*
- *Water damaged building materials should be repaired or removed to prevent mould growth;*
- *Mould impacted building materials should be removed following appropriate mould removal measures and procedures (i.e. Level 1, 2 or 3) as per EACC Mould Abatement Guidelines Edition 3 (2015) document; and,*
- *Prior to the re-instatement of building materials, all sources of water intrusion must be repaired.*
