4.11 Priority Site #9: Exposed Sanitary Sewer Crossing at Finch Avenue and Bayview Avenue

4.12 Priority Site #10: Exposed Watermain Chamber at Manorcrest Drive

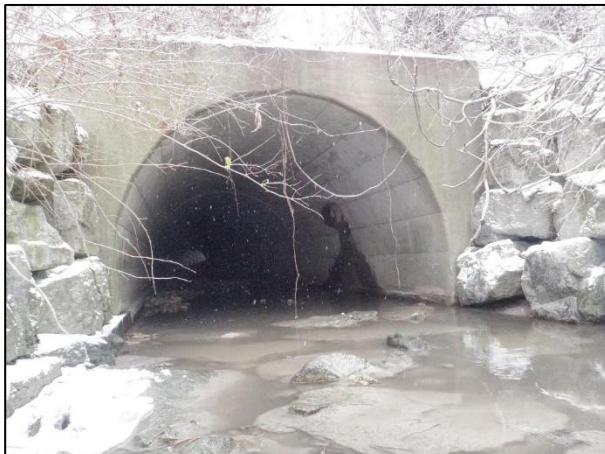
Priority Site #9, is located at the upstream extents of Reach N2, immediately downstream of the arched culvert crossing that conveys flows under the intersection of Bayview Avenue and Finch Avenue (Figure 4-49). Air photo analysis, indicates the channel has been straightened downstream of the culvert opening, through the construction of an engineered channel segment with armourstone bed and bank treatments. The armourstone bed is constructed as a series of cascades designed to dissipate energy (Figure 4-50). The bed and bank treatments are in poor condition, as a number of armourstone blocks have started to slump and become dislodged (Figure 4-51) as the finer materials between the larger blocks erode forming void spaces.

Figure 4-49: Arched Culvert conveying Flows under the Intersection of Bayview Avenue and Finch Avenue

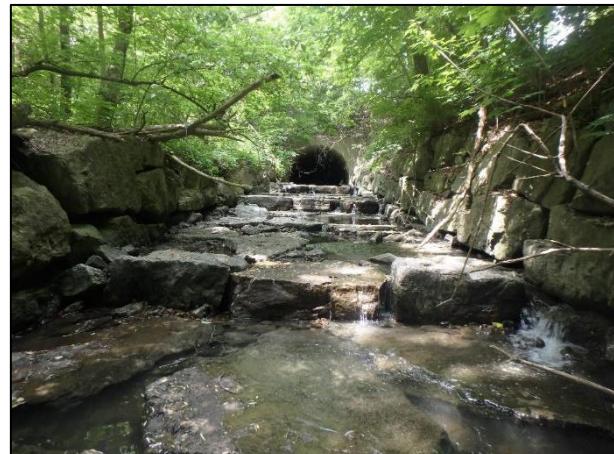
A 675 mm sanitary sewer crosses the creek at a diagonal, and has become effectively exposed within the armourstone bed (minimal cover overtop of failing bed treatments). At the downstream extents of the engineered channel works the armourstone wall has become outflanked and has started to fail as a number of blocks have become dislodged and fallen into the creek. This is contributing to the outflanking and exposure of a sanitary sewer maintenance hole that is no longer effectively protected from lateral erosion forces by the failed retaining wall and washed-out rip-rap (Figure 4-52). It should also be noted that near the downstream end of the armourstone bed, the bed works are in especially poor condition, with a deep scour pool having formed.

Figure 4-50: Armourstone Bed works over the 675 mm Sanitary Sewer Crossing, Constructed as a Series of Cascades

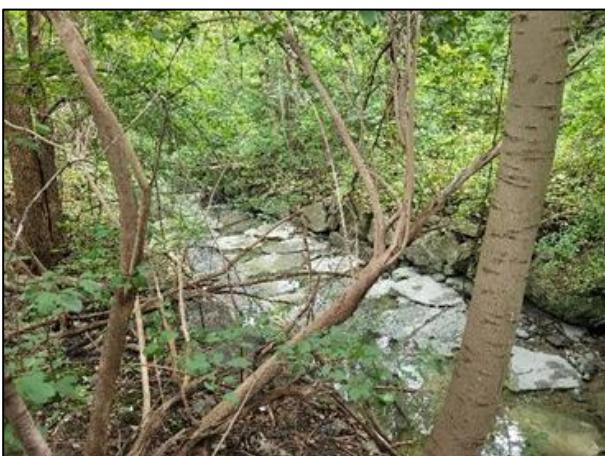
Figure 4-51: Degraded Armourstone Bed and Bank Treatments

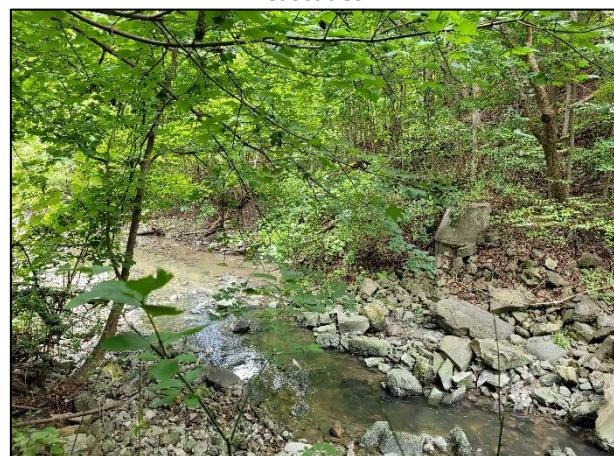
Figure 4-52: Exposed Sanitary Sewer Maintenance Hole Downstream of the Engineered Channel Works

- Mitigate a major lateral erosion risk to an exposed sanitary sewer maintenance hole (Priority Site #8 - SL4033483) through a combination of minor channel realignment and construction of an armourstone retaining wall.

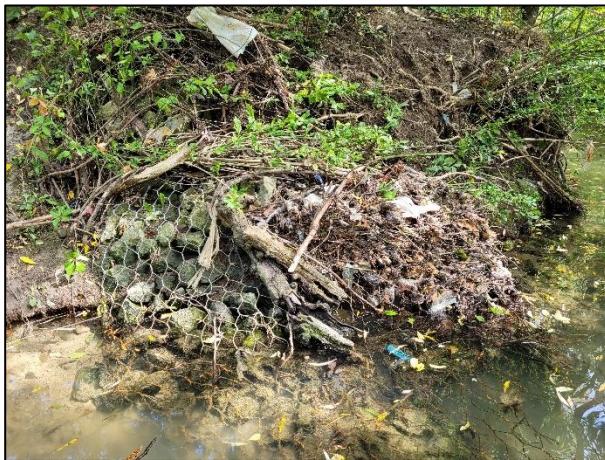
Priority Site #10 is located in Reach N3 of Newtonbrook Creek, approximately 285 metres upstream of Bayview Avenue, where a 1,350 mm diameter watermain crosses the watercourse. As-Built Drawing records (drawing 157-M2) indicate the watermain was constructed beneath a gabion basket lined segment of channel in the early 1970's. Over the last fifty (50) years, channel erosion processes have completely removed the gabion basket bed and bank protection works overtop of the watermain crossing (Figure 4-55). This has resulted in the exposure of a watermain chamber setback from the main channel in the bank of the creek (Figure 4-56).

Figure 4-55: Failed Gabion Basket Bank Protection

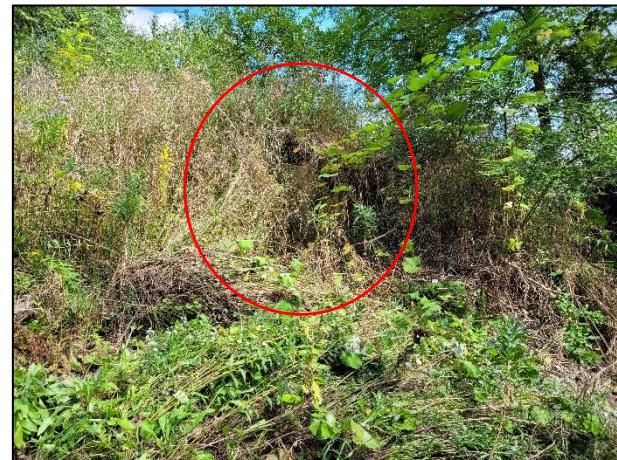
Figure 4-56: Exposed Watermain Chamber

- Mitigate the lateral erosion risk to the exposed watermain chamber through the construction of vegetated buttress bank protection works.
- Increase the depth of cover overtop of the upstream sanitary trunk sewer crossing (Priority Site #43 - SL4031891) from 1.88 metres to a minimum of 2.0 m.

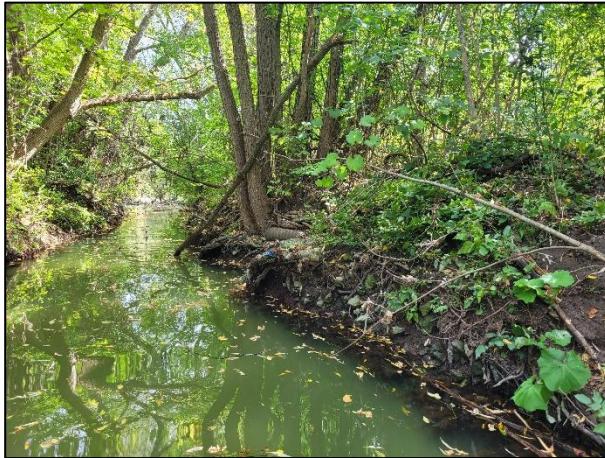
The depth of cover overtop of the watermain crossing has also decreased overtime to approximately 0.42 m. There is an existing gabion basket retaining wall that is still intact downstream of the watermain crossing. The retaining wall ranges in condition from poor to very poor (Figure 4-57), with some baskets partially buried into the slope, while others have slumped into the bed and in some cases emptied where the wire mesh has broken or corroded away (Figure 4-58).

Figure 4-57: Channel Conditions Upstream of Watermain Crossing

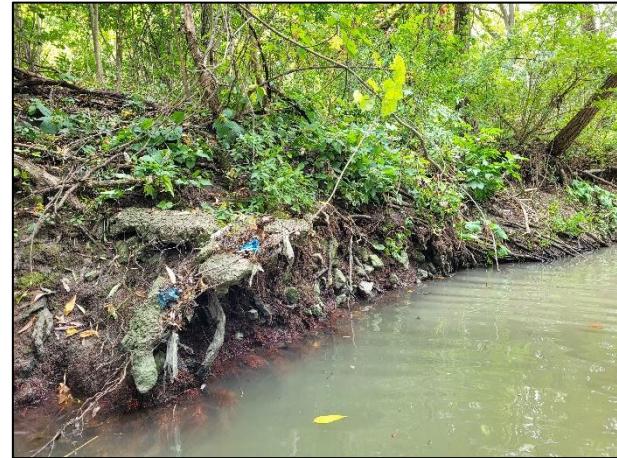
Figure 4-58: Undermined and Emptied Gabion Baskets Upstream of Watermain Crossing

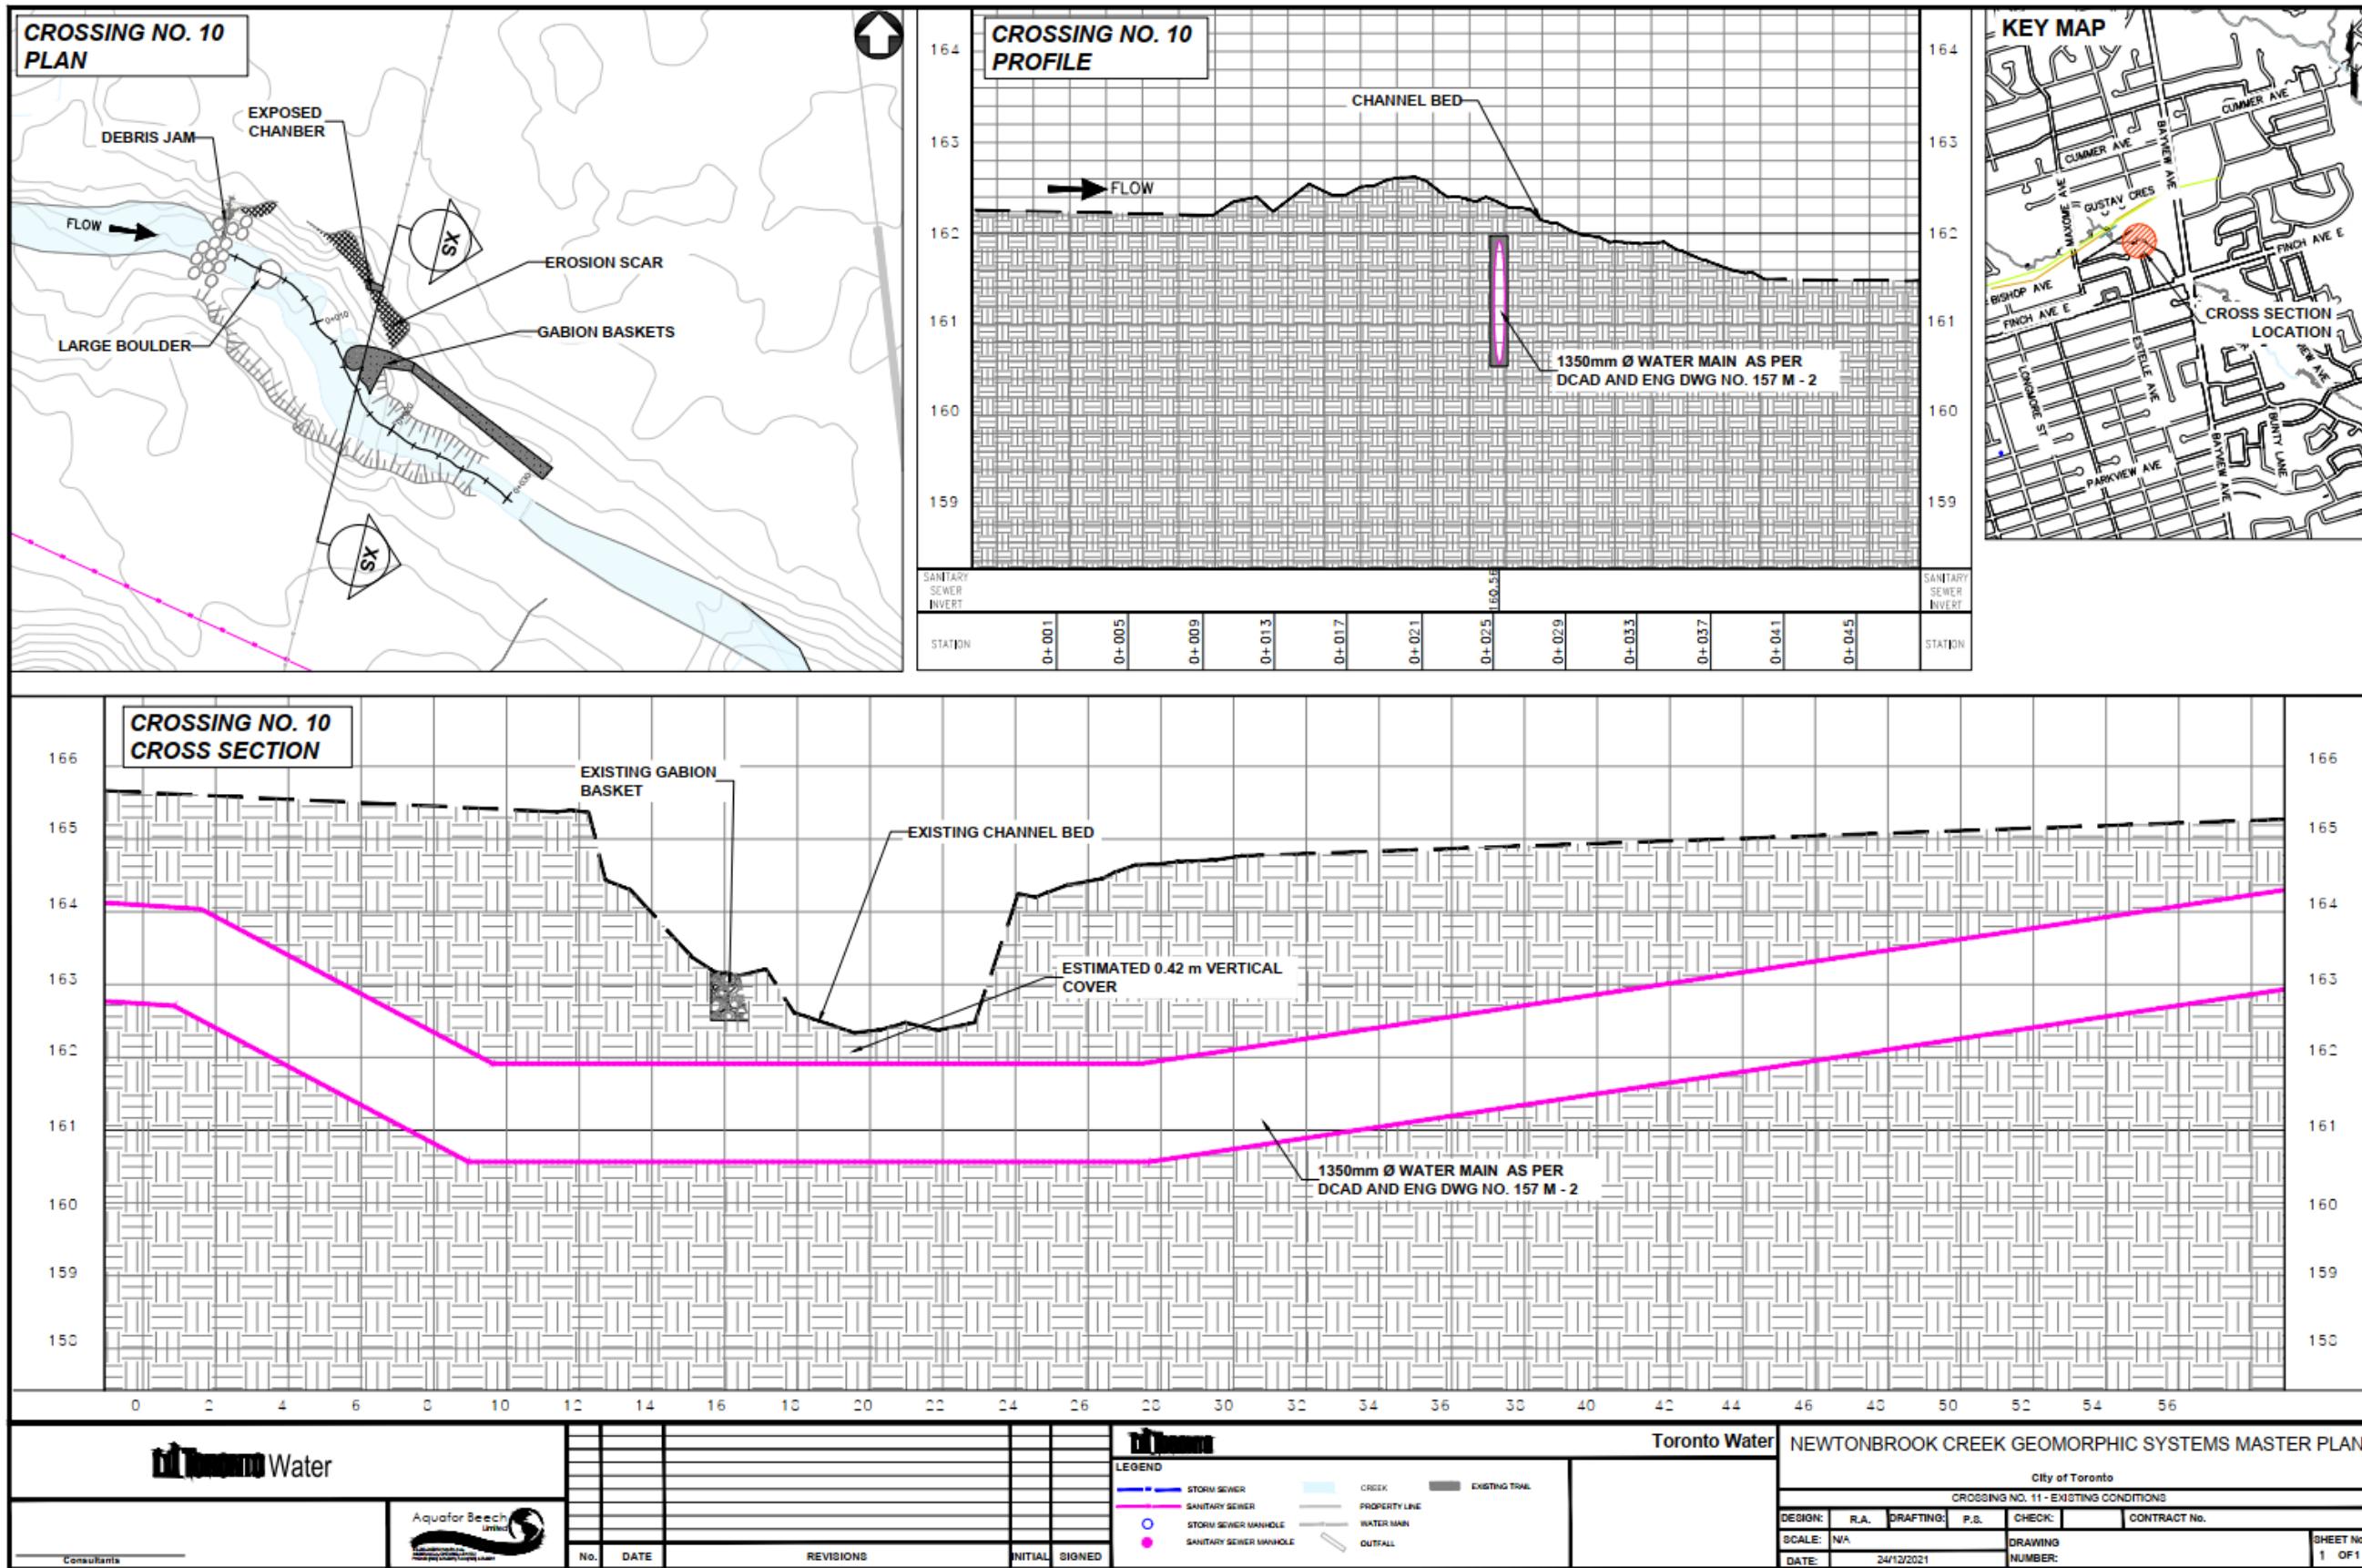
Figure 4-59: Existing Conditions - Priority Site #10

Parameter	Watermain	Watermain Chamber
Toronto Water Asset ID	LN24062	CH4006045
Year of Construction	1971	1972
Diameter	1,350	N/A
Depth of Cover	0.42 m	Exposed
Estimated Time to Contact	19 Years	0 Years
Erodibility of Adjacent Substrate	Moderate	Moderate
