Appendix R

Erosion Hazard Sites

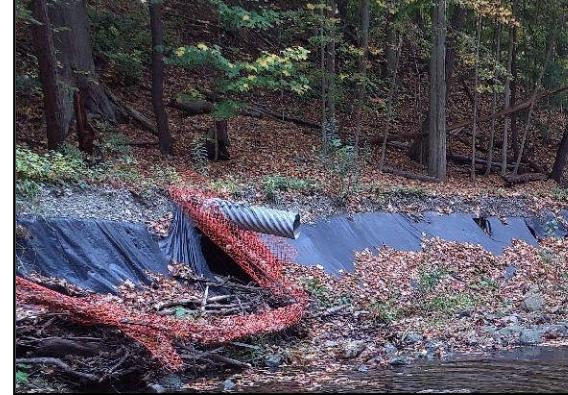
Outfall #	Reach	TW Asset ID	Diameter (mm)	Condition	Condition Outfall Risk Score	Offset from Main Branch (m)	Offset from Main Branch Risk Score	Erosion Protection Works	Erosion Protection Works Condition Risk Score	Storm Sewer Outfall Risk Score	Photo
1	N1	N/A	Not Assessed	Poor	4	0	5	Undermined trail culvert with no bank protection	5	14

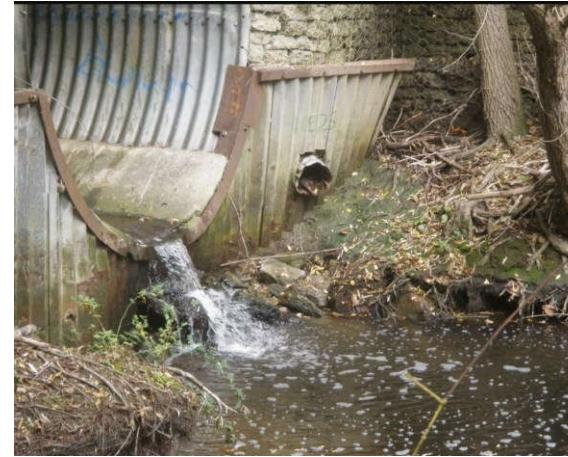
2	N1	OF4854814349	Medium	Poor	4	0	5	Corrugated metal pipe embedded into sheet metal wingwall. Pipe has rusted out of alignment.	3	12

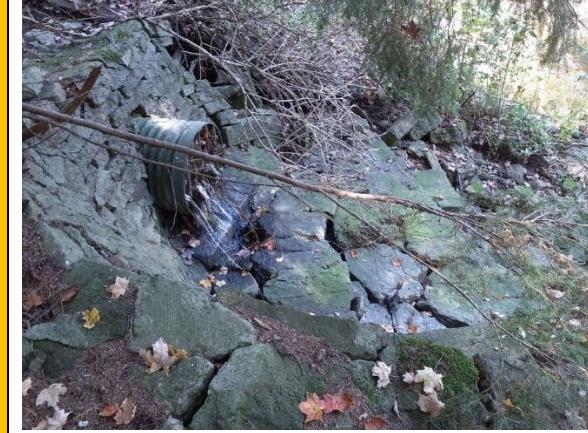
Outfall #	Reach	TW Asset ID	Diameter (mm)	Condition	Condition Outfall Risk Score	Offset from Main Branch (m)	Offset from Main Branch Risk Score	Erosion Protection Works	Erosion Protection Works Condition Risk Score	Storm Sewer Outfall Risk Score	Photo
3	N1	OF4854214333	Medium	Failed	5	7	2	Armourstone headwall and Outlet Channel in poor condition.	4	11

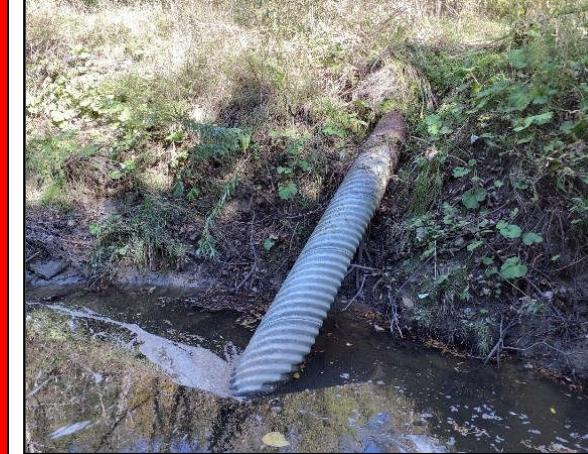
4	N2	N/A	Small	Poor	4	0	5	Trail Culvert creating small discharge channel. Does not appear on City of Toronto Basemapping.	5	14

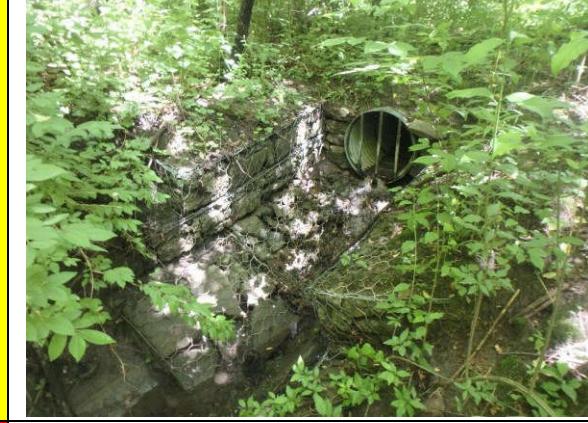
Outfall #	Reach	TW Asset ID	Diameter (mm)	Condition	Condition Outfall Risk Score	Offset from Main Branch (m)	Offset from Main Branch Risk Score	Erosion Protection Works	Erosion Protection Works Condition Risk Score	Storm Sewer Outfall Risk Score	Photo
6	N2	OF4873613982	Medium	Poor	4	11	2	Concrete channel bed is beginning to show signs of erosion and failure, and is in poor condition.	4	10

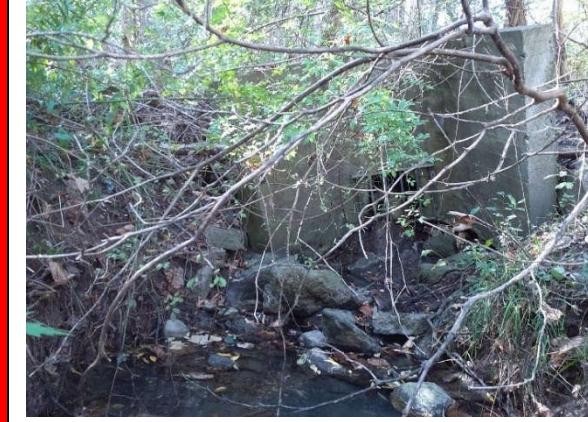
7	N2	OF4884313907	Medium	Failed	5	5	3	Concrete headwall has completely detached. Outfall channel riprap bed has completely washed out. Erosion protection has failed.	5	13

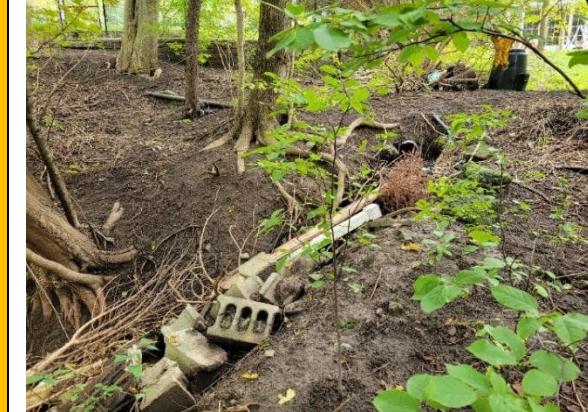
Outfall #	Reach	TW Asset ID	Diameter (mm)	Condition	Condition Outfall Risk Score	Offset from Main Branch (m)	Offset from Main Branch Risk Score	Erosion Protection Works	Erosion Protection Works Condition Risk Score	Storm Sewer Outfall Risk Score	Photo
9	N2	N/A	Small	Good	2	0	5	Trail culvert perched above channel. Bank is stabilized at the toe of slope by boulders. Bank protection is beginning to wash out, possibly posing a risk to buried sanitary sewer infrastructure.	5	12	Photo Not Available
10	N2	OF4902413782	Small	Poor	4	37	2	The rip rap lining the outfall channel has been washed out and accumulated at the mouth of the outfall channel. Outfall channel has scoured a deep gully into high erodible topsoil. No headwall is present.	5	11

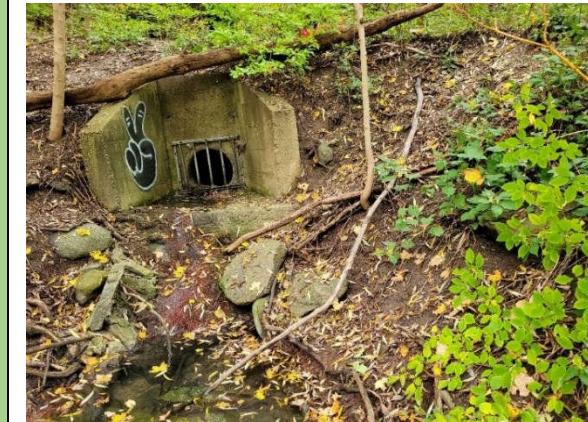
11	N2	OF4907413839	Medium	Moderate	3	36	2	Concrete apron is slightly degraded with significant root growth. Riprap lined channel is in good condition.	2	7

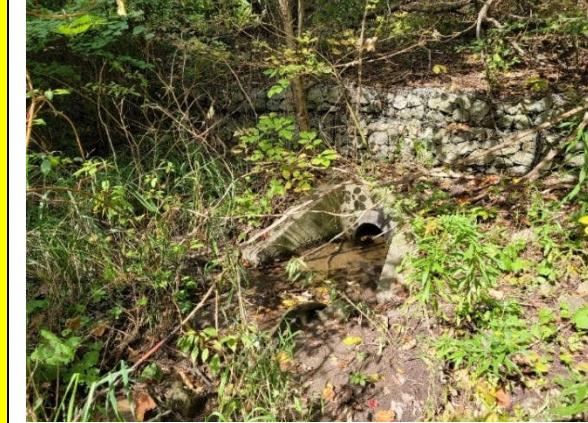
Outfall #	Reach	TW Asset ID	Diameter (mm)	Condition	Condition Outfall Risk Score	Offset from Main Branch (m)	Offset from Main Branch Risk Score	Erosion Protection Works	Erosion Protection Works Condition Risk Score	Storm Sewer Outfall Risk Score	Photo
12	N2	OF4901113668	N/A	Not Assessed. Assumed to be in Fair Condition.	3	85	1	Could not be located in field. Assumed to be in Fair Condition.	3	7	Photo Not Available
13	N2	N/A	Small	Poor	4	12	2	Flooded outfall with gabion basket protection behind headwall. Outfall channel is silted and muddy. Structures in good condition.	2	8

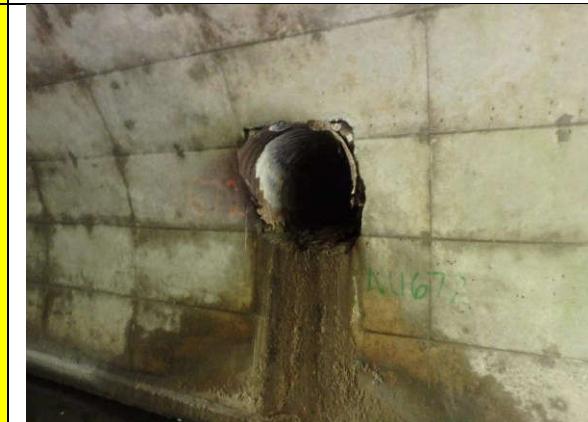
14	N2	OF4920313498	Not Assessed	Moderate	2	0	5	This outfall is part of the culvert crossing the intersection of Bayview Ave. and Finch Ave. Concrete is degrading but culvert is in good condition.	2	9

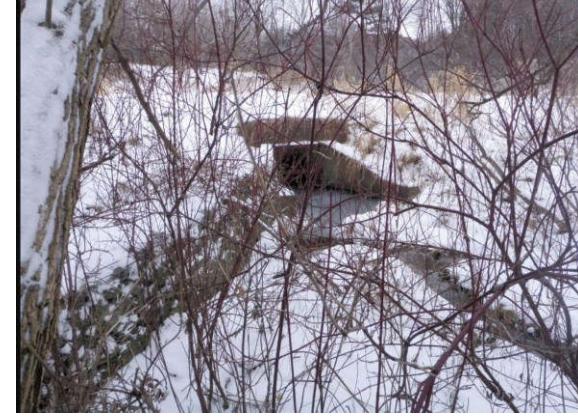
Outfall #	Reach	TW Asset ID	Diameter (mm)	Condition	Condition Outfall Risk Score	Offset from Main Branch (m)	Offset from Main Branch Risk Score	Erosion Protection Works	Erosion Protection Works Condition Risk Score	Storm Sewer Outfall Risk Score	Photo
15	N3	N/A	Medium	Poor	4	1	4	Outfall found in field but not available in DCAD. Main channel contains bank protection on both sides in riprap and boulder treatments. Bed contains multiple cascaded drop structures.	5	13	Photo Not Available
16	N3	OF4940713236	Medium	Moderate	3	13	2	Main channel is well protected with gabion baskets on both sides in good condition.	1	6

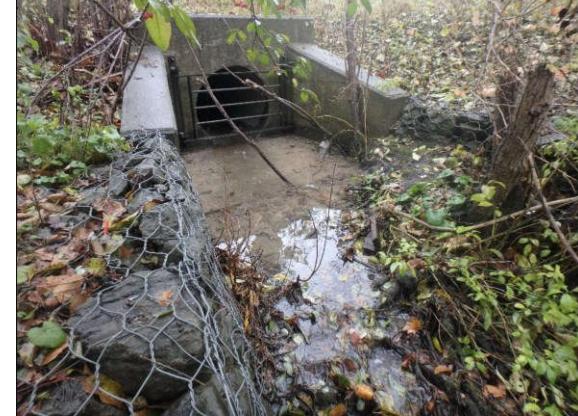
17	N3	OF4950913010	Medium	Good	2	2	4	Outfall is embedded into gabion basket bank protection. Channel bed consists of gabion basket. Gabion basket by outfall in good condition.	2	8

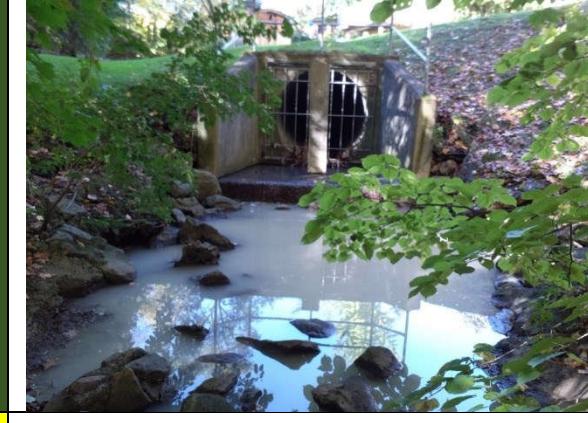
Outfall #	Reach	TW Asset ID	Diameter (mm)	Condition	Condition Outfall Risk Score	Offset from Main Branch (m)	Offset from Main Branch Risk Score	Erosion Protection Works	Erosion Protection Works Condition Risk Score	Storm Sewer Outfall Risk Score	Photo
18	N3	OF4964012829	Large	Excellent	1	89	1	Channel is rip-rap lined upstream and gabion lined downstream. Channel bank protection consists of armourstone and gabion baskets, with the former experiencing some degradation closer to the confluence with main channel.	2	4

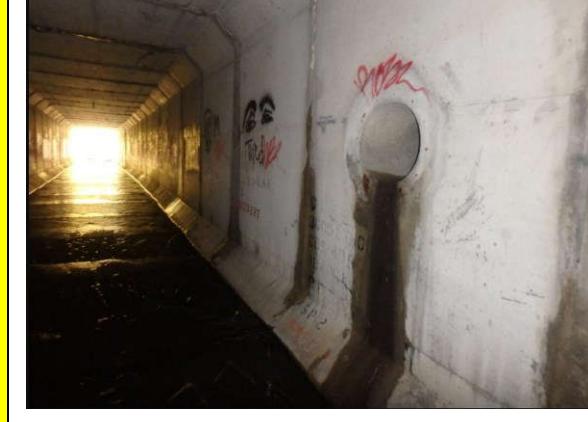
19	N3	OF4943712842	Large	Good	2	0	5	Outfall recessed into road culvert. Some degradation to concrete evident but erosion control in good condition.	2	9

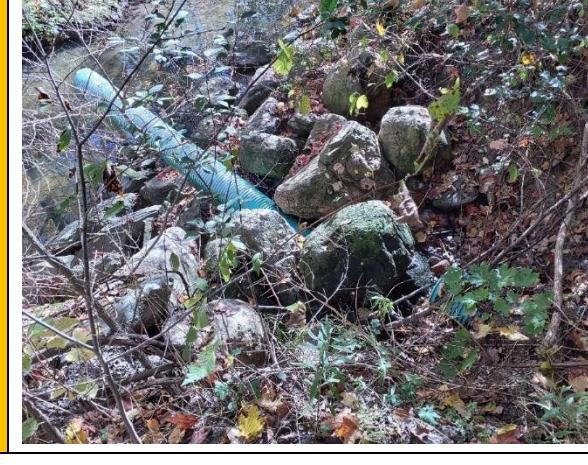
20	N4	N/A	Medium	Poor	4	0	5	Assessed in field but not mapped on DCAD. Perched outfall of known origin above boulder revetment. Pipe is protruding ~1 m out of bank, and about 2 m above the channel bed.	2	11

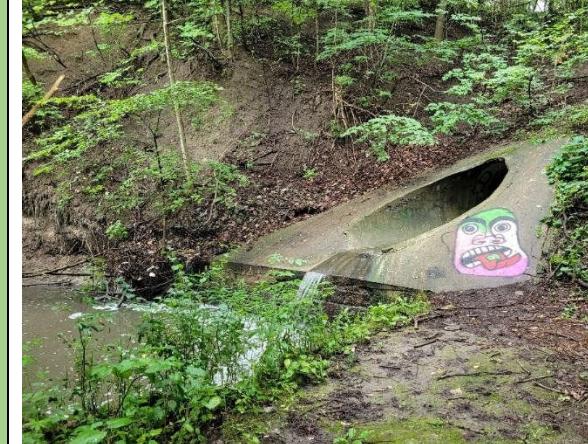
Outfall #	Reach	TW Asset ID	Diameter (mm)	Condition	Condition Outfall Risk Score	Offset from Main Branch (m)	Offset from Main Branch Risk Score	Erosion Protection Works	Erosion Protection Works Condition Risk Score	Storm Sewer Outfall Risk Score	Photo
21	N4	OF4927712537	Large	Poor	4	34	1	Outfall channel contains no observable bed protection. Concrete headwall is beginning to outflank.	2	7

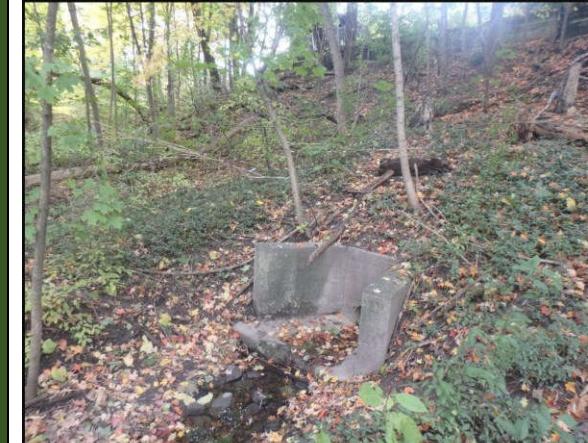
22	N4	OF4937712339	Small	Excellent	1	20	1	Outfall with no defined or constructed channel. Concrete wingwall and headwall concrete apron slightly degraded.	3	5

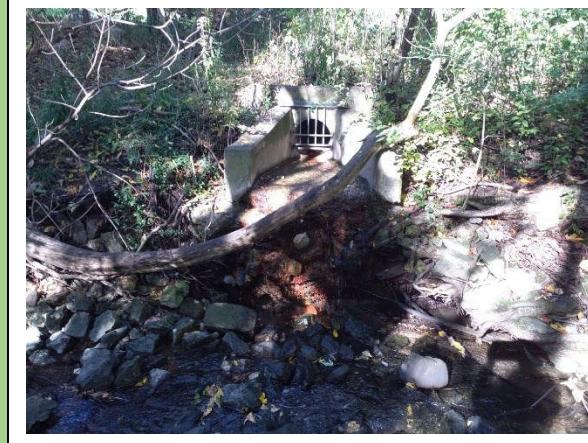
23	N4	Unknown	Small	Good	1	3	3	Loose rip rap outfall channel and gabion stone in poor condition but still acting as sufficient bank protection.	3	7

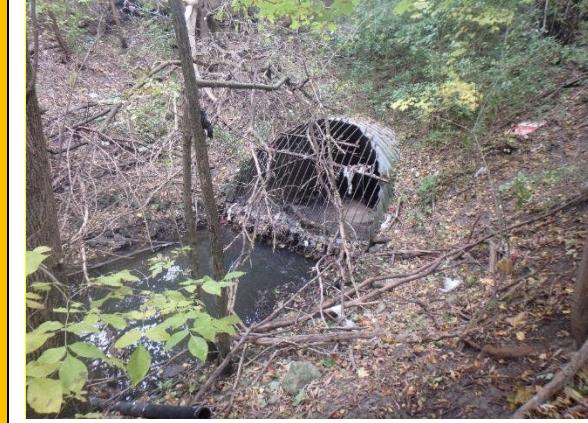
Outfall #	Reach	TW Asset ID	Diameter (mm)	Condition	Condition Outfall Risk Score	Offset from Main Branch (m)	Offset from Main Branch Risk Score	Erosion Protection Works	Erosion Protection Works Condition Risk Score	Storm Sewer Outfall Risk Score	Photo
24	N4	OF4941912085	Large	Moderate	3	0	5	Most upstream culvert for Newtonbrook Creek at Maxome Avenue. Culvert is in moderate shape with little bank protection.	3	11

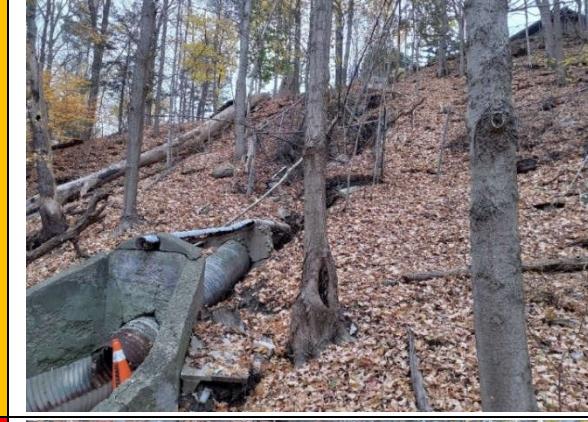
25	BR1	OF4830215159	Medium	Failed	5	35	1	Concrete wingwalls and headwall degraded with cracks and detachment. Concrete pad is degrading from runoff bypassing CMP.	5	11

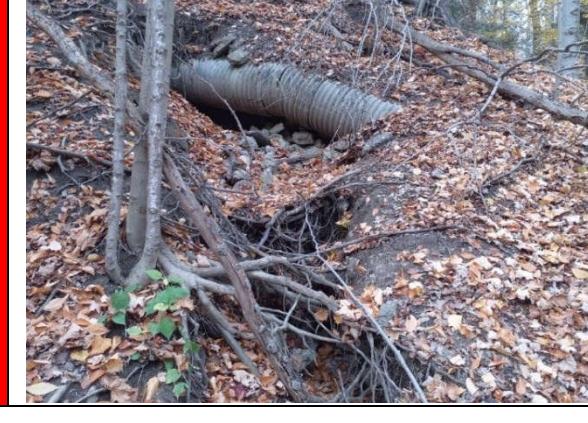
26	BR1	OF4824214956	CMP	Failed	5	3	4	Concrete headwall has completely detached and fallen. Outlet has degraded to the point where original design and outlet location are unknown.	5	14

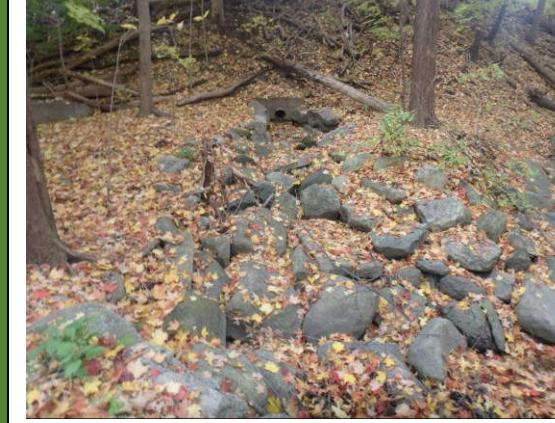
Outfall #	Reach	TW Asset ID	Diameter (mm)	Condition	Condition Outfall Risk Score	Offset from Main Branch (m)	Offset from Main Branch Risk Score	Erosion Protection Works	Erosion Protection Works Condition Risk Score	Storm Sewer Outfall Risk Score	Photo
27	BR3	OF4807414830	Medium	Excellent	1	10	2	Rip rap in good condition.	1	4

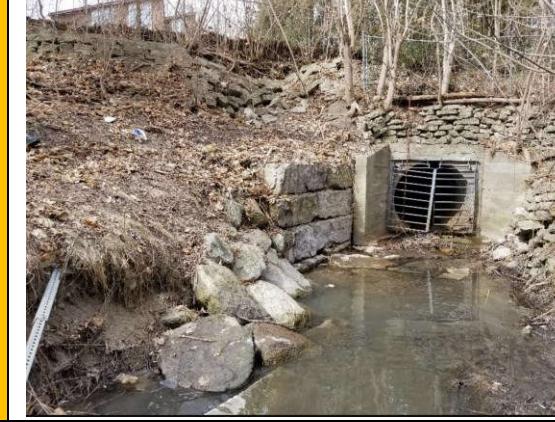
28	BR3	OF4811614623	Large	Moderate	3	0	5	Road culvert for Burbank Drive, discharging into Blue Ridge Creek. Found culvert in field but location of outfall is unknown. Upstream is private property.	3	11

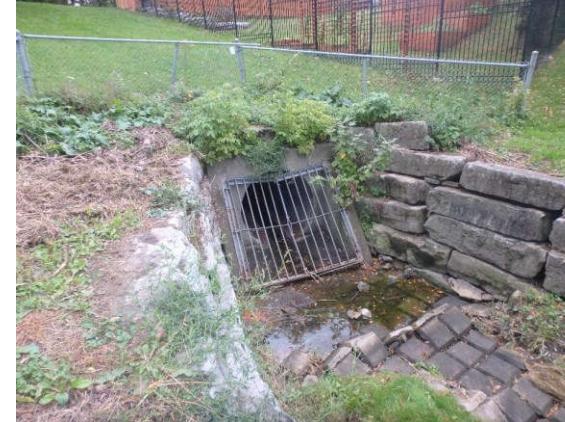
Outfall #	Reach	TW Asset ID	Diameter (mm)	Condition	Condition Outfall Risk Score	Offset from Main Branch (m)	Offset from Main Branch Risk Score	Erosion Protection Works	Erosion Protection Works Condition Risk Score	Storm Sewer Outfall Risk Score	Photo
30	BR3	OF4798014273	N/A	Moderate	3	0	5	Road culvert for Bayberry Cr.	3	11

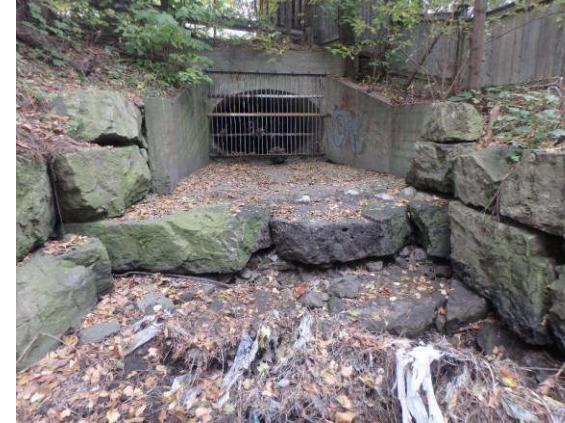
31	BR3	OF4798813684	Large	Moderate	3	0	5	Armourstone bank protection and drop structure in good condition.	2	10

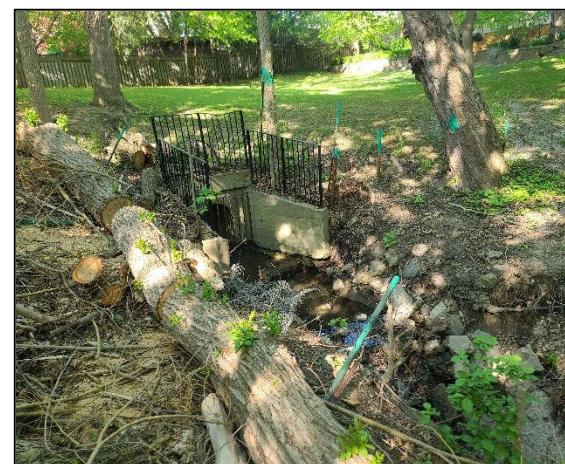
32	BR4	OF4794514800	Medium	Poor	4	0	5	Headwall is cracked and elevated. Concrete apron is undermined. Riprap lining channel bed downstream is washed out. Bank protection along channel downstream is slumped and failing.	3	12
