**Appendix L**

**Outfall Assessment Tables**

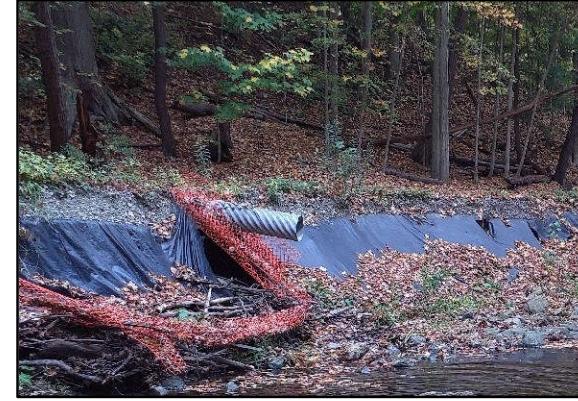
Outfall #	Reach	TW Asset ID	Diameter (mm)	Material	Construction Year	Condition	Headwall	Erosion Protection Works	Comments	Photo
1	N1	N/A	Not Assessed	CSP	N/A	Poor	No headwall	None	Undermined trail culvert

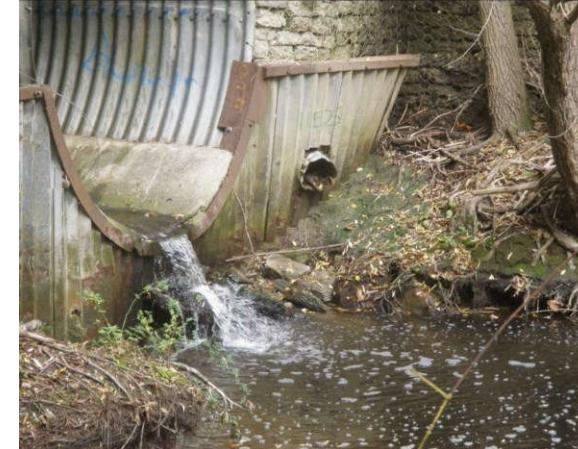
2	N1	OF4854814349	Medium	CSP	1956	Poor	No headwall	None	Storm water pipe on the east side of the culvert. Corrugated metal pipe with no headwall has rusted out of alignment.

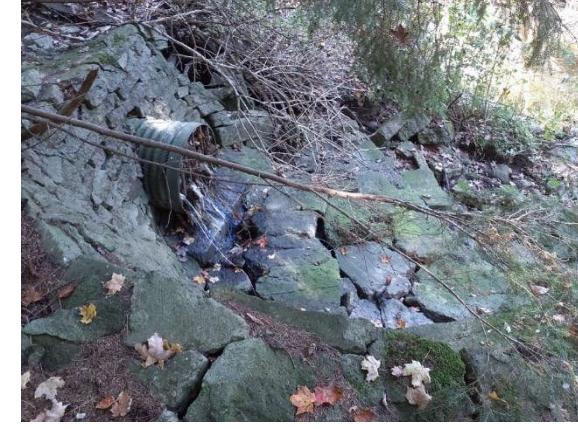
3	N1	OF4854214333	Medium	CSP	1956	Failed	Armourstone Headwall	Armourstone outfall channel	Storm water pipe with stone headwall and outlet channel along west side of Forest Grove culvert. Pipe has detached due to several sinkholes up slope of outlet.

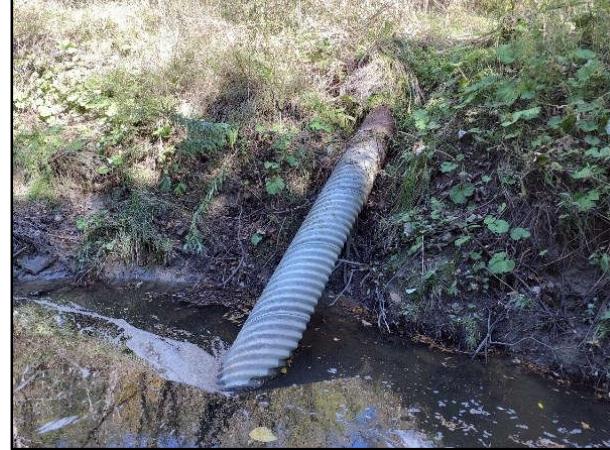
Outfall #	Reach	TW Asset ID	Diameter (mm)	Material	Construction Year	Condition	Headwall	Erosion Protection Works	Comments	Photo
4	N2	N/A	Small	CSP	Unknown	Poor	None	None observed	Trail Culvert creating small discharge channel. Does not appear on City of Toronto Basemapping.

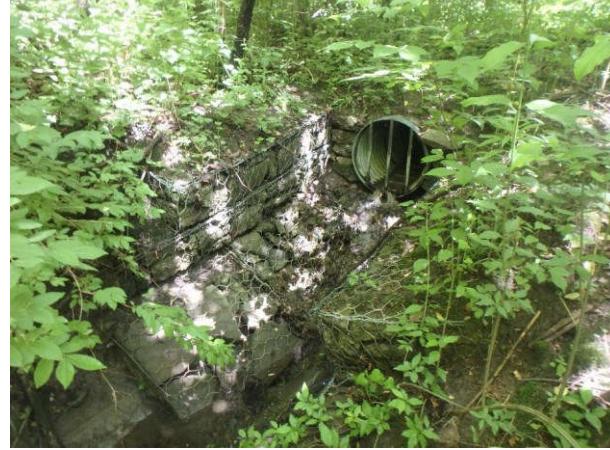
5	N2	OF4865514045	N/A	N/A	1956	Poor	Outfall without Headwall (DCAD)	Armourstone outfall channel	RGA is indicating the channel is widening here, evidenced by eroded slopes and accumulation of large woody debris. Outfall is placed along the cut bank of the channel and has developed a deep scour at the base.	Photo Not Available
6	N2	OF4873613982	Medium	CSP	1956	Poor	Outfall without Headwall (DCAD)	Concrete outfall channel bed	Outfall is discharging into area of active erosion, evidenced by fallen and degraded gabion baskets. The concrete channel bed has been undermined and is failing. Outlet remains perched above scour pool. The outlet channel releases into silted point bar.

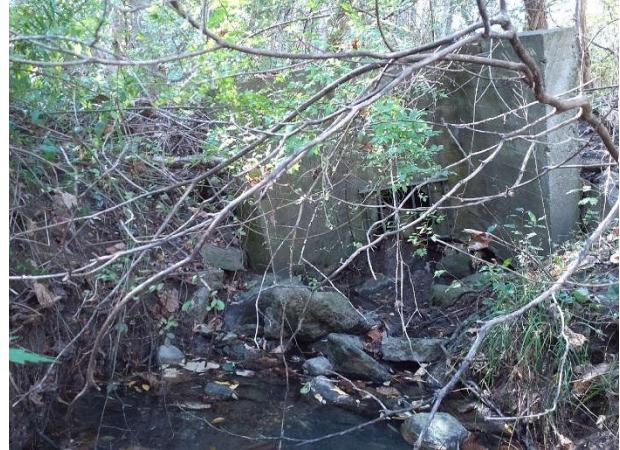
Outfall #	Reach	TW Asset ID	Diameter (mm)	Material	Construction Year	Condition	Headwall	Erosion Protection Works	Comments	Photo
7	N2	OF4884313907	Medium	Concrete	1956	Failed	Concrete headwall	Riprap	Concrete headwall has completely detached. Upslope, the pipe has detached, due to sinkhole and sediment sinking. Outfall is not working as design intended. Outfall channel riprap bed has completely washed out.

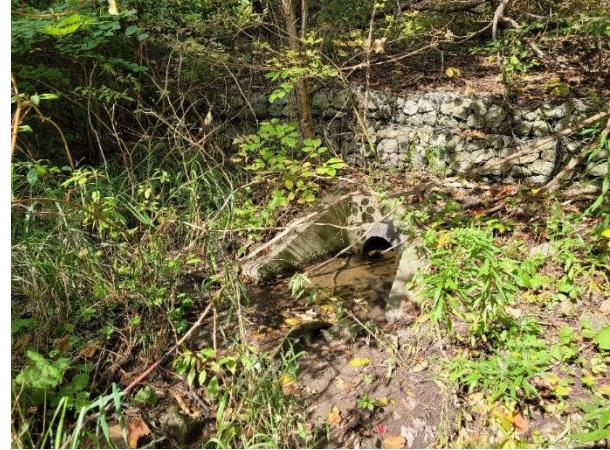
Outfall #	Reach	TW Asset ID	Diameter (mm)	Material	Construction Year	Condition	Headwall	Erosion Protection Works	Comments	Photo
13	N2	N/A	Small	Concrete	N/A	Poor	Concrete Headwall and Wingwalls	None observable	Outfall found in field, but could not be located in DCAD. Flooded outfall with gabion basket protection behind headwall. Outfall channel is silted and muddy

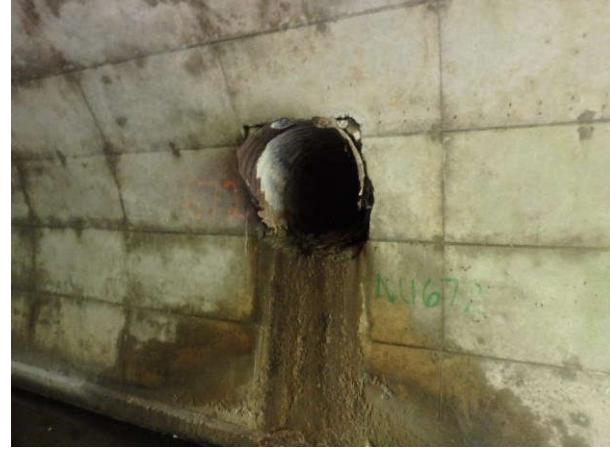
14	N2	OF4920313498	N/A	N/A	1968	Moderate	Outfall without headwall (DCAD)	Armourstone Ribbing structure	This outfall is part of the culvert crossing the intersection of Bayview Ave. and Finch Ave. Outfall was assessed as part of TRCA Inspection.

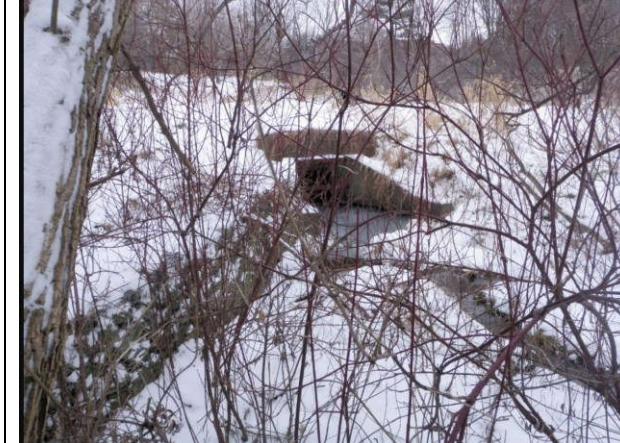
Outfall #	Reach	TW Asset ID	Diameter (mm)	Material	Construction Year	Condition	Headwall	Erosion Protection Works	Comments	Photo
16	N3	OF4940713236	Medium	Concrete (CIP)	1987	Moderate	Outfall without Headwall (DCAD)	N/A	Main channel is well protected with gabion baskets on both sides in good condition. Outfall channel has incised and may promote bank erosion.

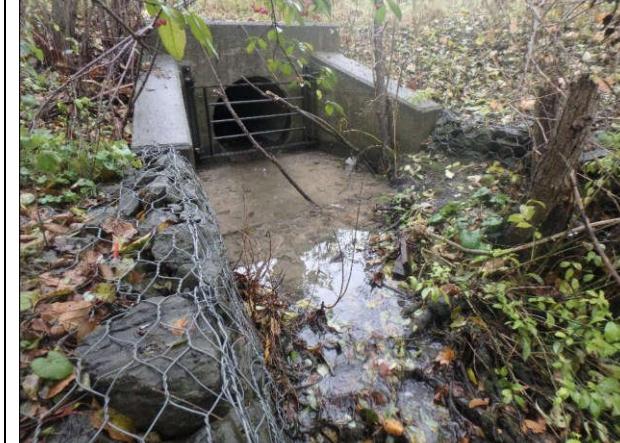
17	N3	OF4950913010	Medium	Concrete	1987	Excellent	Concrete wingwall and headwall	Gabion basket channel bed	Outfall is embedded into gabion basket bank protection. Channel bed consists of gabion basket. The main channel here is highly degraded, but the outfall is in fair condition.

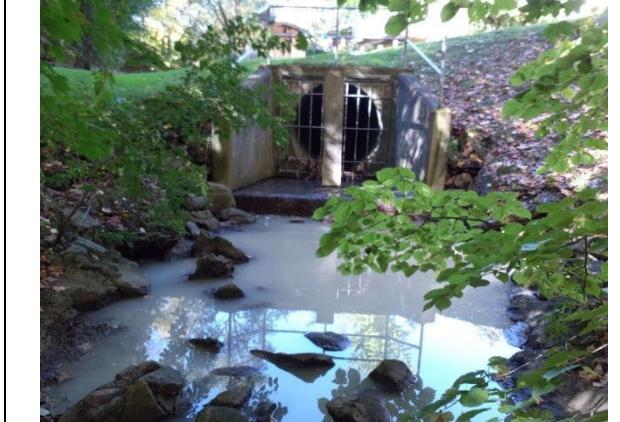
18	N3	OF4964012829	Large	Concrete (CIP)	1963	Excellent	Concrete headwall and wingwalls with concrete apron	Rip-rap lined channel, slightly washed out.	Outfall located at the boundary of private backyard, with channel ~100 m long. Outfall is in good condition. Channel is rip-rap lined upstream and gabion lined downstream. Channel bank protection consists of armourstone and gabion baskets, with the former experiencing some degradation.

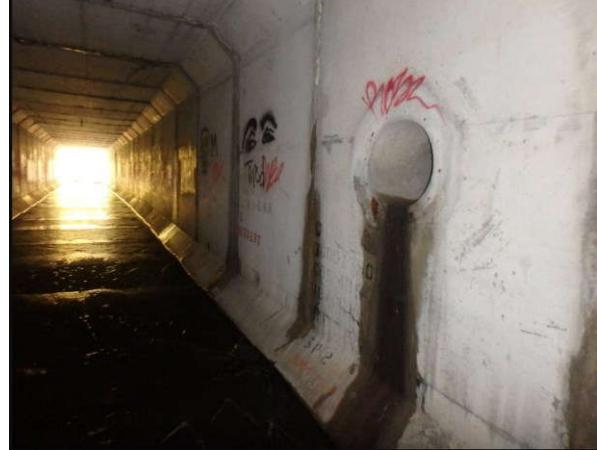
Outfall #	Reach	TW Asset ID	Diameter (mm)	Material	Construction Year	Condition	Headwall	Erosion Protection Works	Comments	Photo
19	N3	OF4943712842	Large	Concrete	1987	Moderate	Box Culvert with boulder wingwalls	N/A	Additional storm drainage to the culvert could not be found. Outfall was assessed as part of TRCA Inspections.

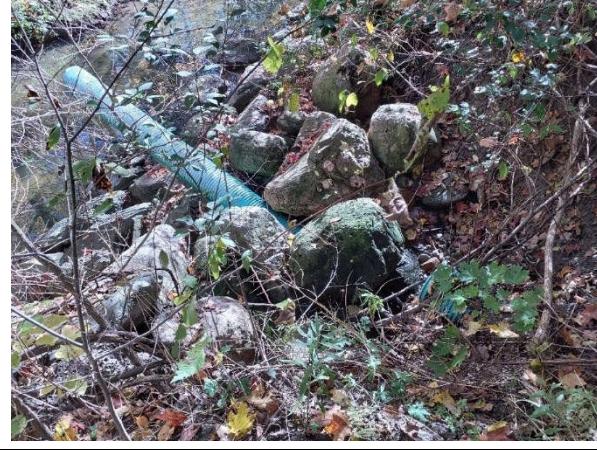
20	N4	N/A	Medium	Unknown	Unknown	Poor	None	Boulder revetment	Assessed in field but not mapped on DCAD. Perched outfall of known origin above boulder revetment. Pipe is protruding ~1 m out of bank, and about 2 m above the channel bed.

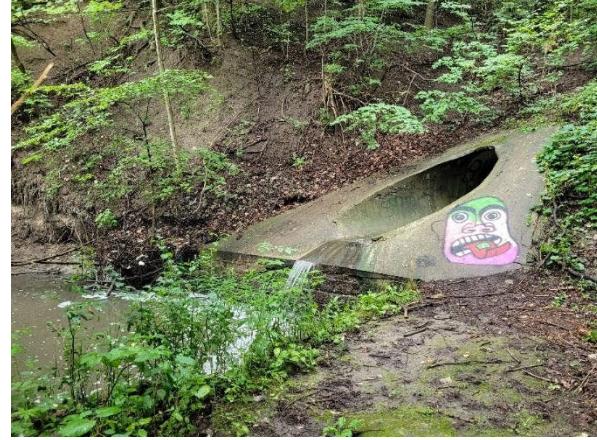
21	N4	OF4927712537	Large	Concrete (CIP)	1989	Poor	Concrete Headwall	None observable	Outfall channel contains no observable bed protection. Concrete headwall is beginning to outflank with a large scour pool developing at the base. Slightly perched about the outfall channel.

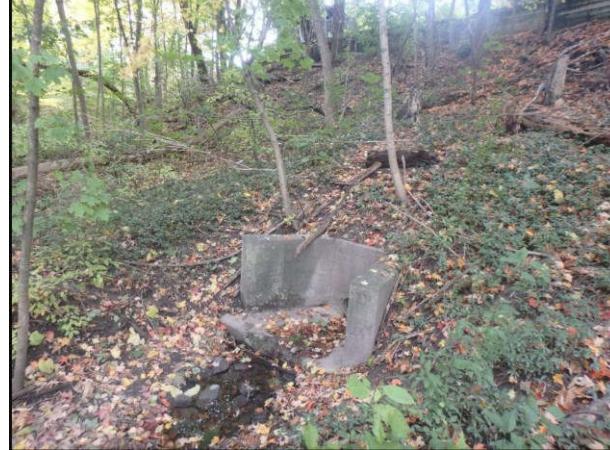
Outfall #	Reach	TW Asset ID	Diameter (mm)	Material	Construction Year	Condition	Headwall	Erosion Protection Works	Comments	Photo
22	N4	OF4937712339	Small	Concrete (CIP)	1957	Excellent	Concrete wingwall and headwall.	None observable	Outfall with no defined or constructed channel. Concrete wingwall and headwall concrete apron slightly degraded. Located ~50 m from main channel.

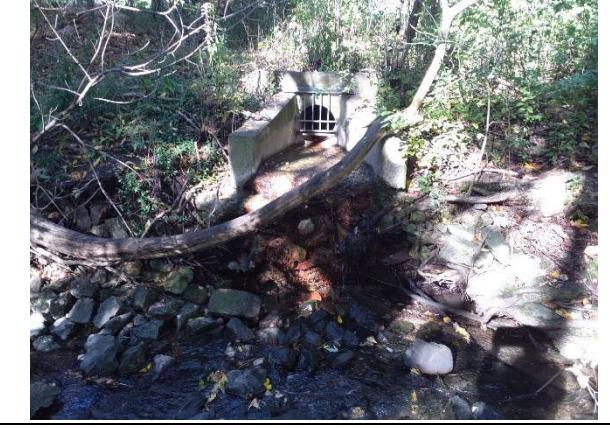
23	N4	Unknown	Small	Good		Excellent	Concrete wingwall and headwall	Loose rip rap outfall channel and gabion stone in poor condition but still acting as sufficient bank protection.	Outfall embedded in gabion basket. Gabion basket has since degraded but original stone is still in place. Outfall channel is slightly perched.

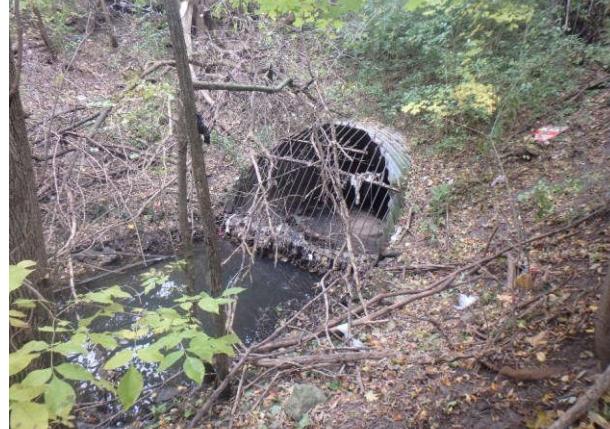
24	N4	OF4941912085	Large	corrugated metal, scour at base approx 0 .4 m	1957	Moderate	Outfall with Headwall	N/A	Most upstream culvert for Newtonbrook Creek at Maxome Avenue. Culvert is in moderate shape.

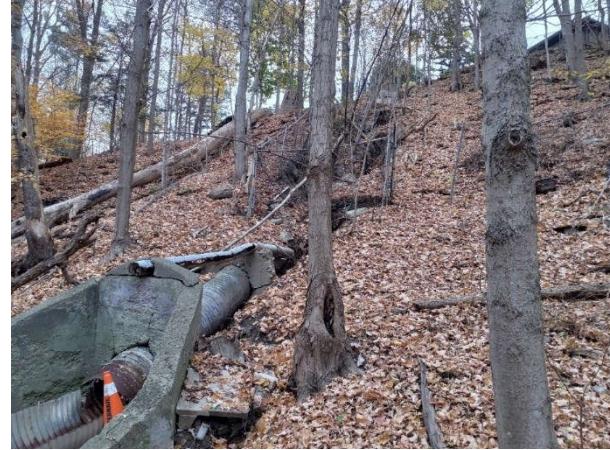
Outfall #	Reach	TW Asset ID	Diameter (mm)	Material	Construction Year	Condition	Headwall	Erosion Protection Works	Comments	Photo
25	BR1	OF4830215159	Medium	Concrete (CIP)	1977	Failed	Concrete headwall and wingwalls.	Gabion basket bank protection and concrete channel bed.	Outfall is highly degraded in the slope. CMP is completely detached and exposed at several locations along the slope. Concrete wingwalls and headwall degraded with cracks and detachment. Concrete pad is degrading from runoff bypassing CMP.

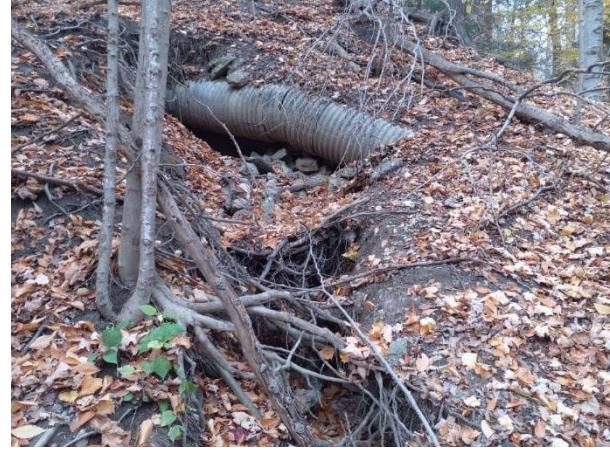
26	BR1	OF4824214956	CMP	Medium	1977	Failed	Concrete headwall	None observable	Concrete headwall has completely detached and fallen. Outlet has degraded to the point where of original design and outlet location are unknown. Upslope, CMP is exposed and detached in several locations.

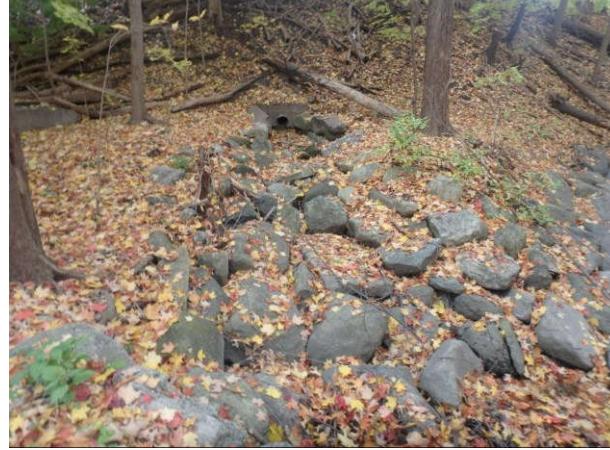
27	BR3	OF4807414830	Medium	Unknown	1955	Excellent	Concrete Headwall and Wingwall	Boulder channel treatment	Upstream of engineered channel. In good condition.

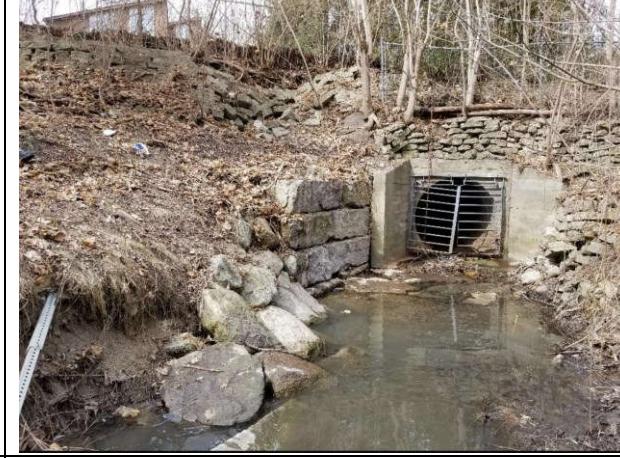
Outfall #	Reach	TW Asset ID	Diameter (mm)	Material	Construction Year	Condition	Headwall	Erosion Protection Works	Comments	Photo
28	BR3	OF4811614623	Large	Concrete (CIP)	1955	Moderate	Outfall without Headwall (DCAD)	N/A	Road culvert for Burbank Drive, discharging into Blue Ridge Creek. Found culvert in field but location of outfall is unknown. Upstream is private property.

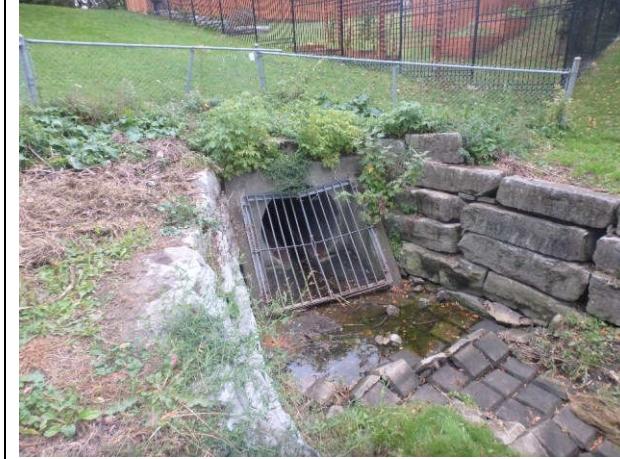
29	BR3	OF4800014319	N/A	N/A	1955	Not Assessed	Outfall without Headwall (DCAD)	N/A	Location of outfall is upstream culvert of Bayberry Crescent. Located on private property. Not-accessible and not verified in field.	Photo Not Available
30	BR3	OF4798014273	N/A	N/A	1955	Moderate	Outfall without Headwall (DCAD)	Cablecrete bed protection with armourstone wingwalls	Road culvert for Bayberry Cr.

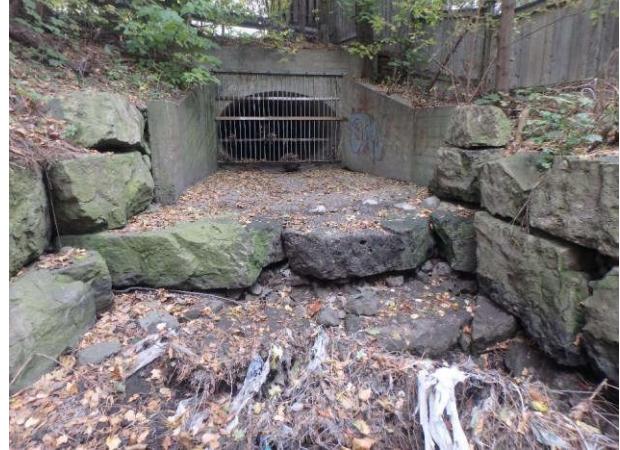
Outfall #	Reach	TW Asset ID	Diameter (mm)	Material	Construction Year	Condition	Headwall	Erosion Protection Works	Comments	Photo
31	BR3	OF4798813684	Large	Concrete (CIP)	1965	Moderate	Outfall without Headwall (DCAD)	Gabion basket channel bed and armourstone banks.	Most upstream culvert for Blue Ridge Creek. Armourstone bank protection and drop structure. Downstream of drop structure is gabion basket channel bed.

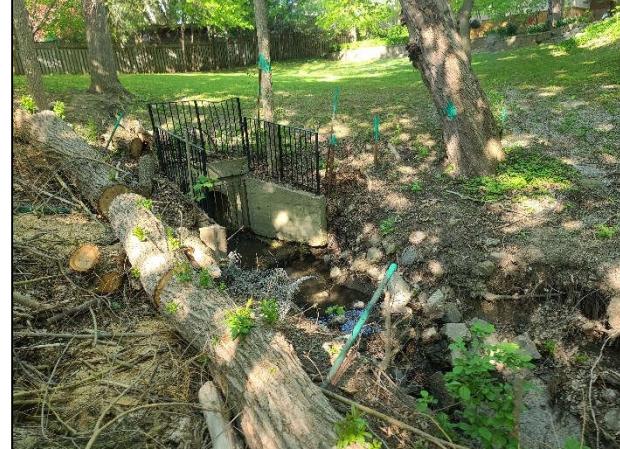
32	BR4	OF4794514800	Medium	Concrete (CIP)	1977	Poor	Concrete headwall and wingwall (DCAD)	Rip-rap channel bed	Large Culvert for tributary of Blue Ridge Creek off Sifton Crescent. Headwall is cracked and elevated. Concrete apron is undermined. Rip-rap lining channel bed downstream is washed out. Bank protection along channel downstream is slumped and failing.
