4.3 Priority Site #1: Exposed Sanitary Sewer Crossing, Maintenance Hole, and Lateral Risk to Sanitary Sewer

4.4 Priority Site #2: Exposed Sanitary Sewer Crossing at Restwell Crescent

4.5 Priority Site #3: Detached Storm Sewer Outfall and Exposed Maintenance Hole at Forest Grove Drive

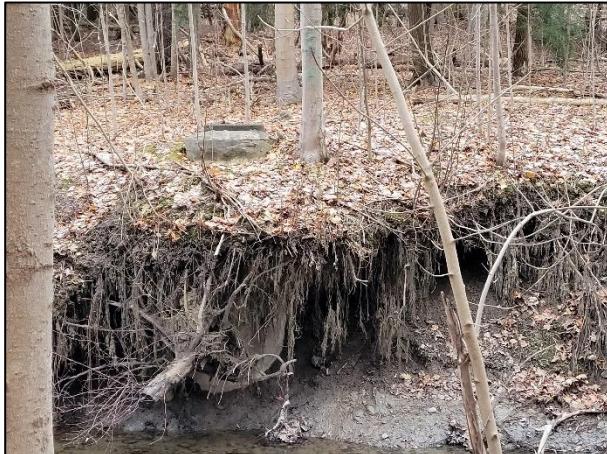
Priority Site #1 is located in Reach N1 of Newtonbrook Creek. Channel widening and planform adjustment has exposed the concrete encasement surrounding a 675 mm diameter sanitary trunk sewer and its downstream maintenance hole. Widening of the channel has outflanked the aforementioned sanitary sewer maintenance hole, exposing the structure within the southern bank of the channel (Figure 4-1). On the opposite side of the channel a pedestrian trail runs adjacent to the creek. Active erosion along the outside of the meander bend is encroaching towards the edge of the pedestrian trail (Figure 4-2) creating a potential risk to public safety should the ground beneath the trail become undercut or unstable.

Figure 4-1: Exposed Sanitary Maintenance Hole in Bank

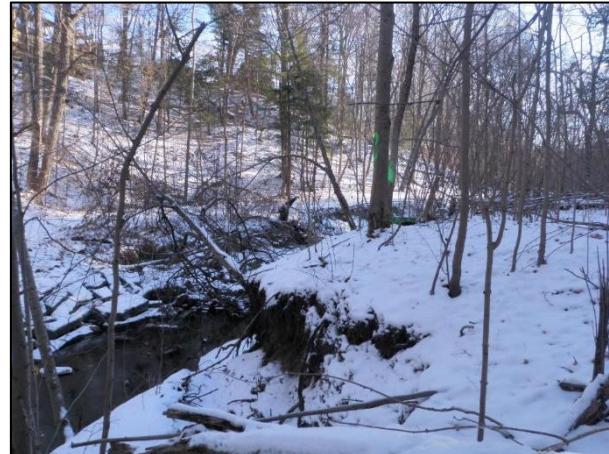
Figure 4-2: Erosion along the Outer Meander Bend
Encroaching Towards the Pedestrian Trail

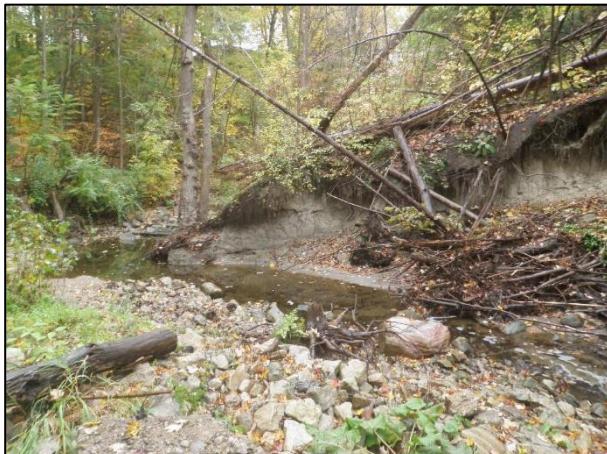
The meander of the creek at this site is sharp, contributing to significant erosion of the local channel bed and bank materials (Figure 4-3). The exposed sewer encasement is flush with the bed of the channel, partially exposed in a location upstream of the maintenance hole. The sewer crosses the channel at an oblique angle passing underneath an island formed from the deposition of large gravel and cobble sized materials (Figure 4-4). The gradient of the channel overtop of the exposed sewer crossing is relatively steep and it is anticipated that if the site is left unaddressed further exposure of the sewer crossing and maintenance hole structure is likely to occur increasing the risk of failure/damage. Undertaking site restoration works to infill and stabilize the eroding bank around the exposed maintenance hole, and increase the depth of cover over the sanitary sewer crossing, is recommended. When developing design alternatives consideration should also be given to protecting the pedestrian trail system.

Figure 4-3: Significant Bank Erosion Between the Exposed
Sewer Crossing and Downstream Maintenance Hole

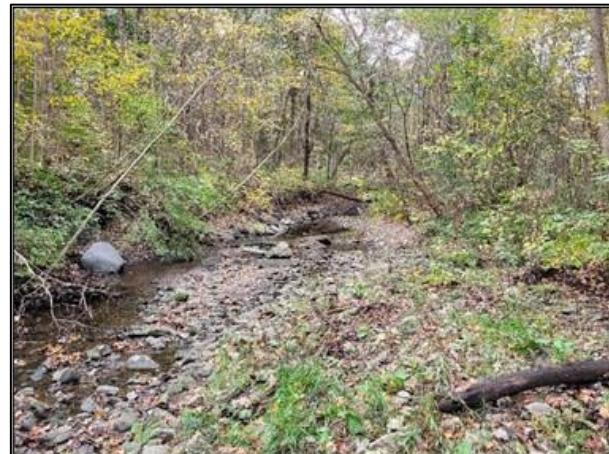
Figure 4-4: Upstream of the Exposure. Note gravel Island
to the Right of the Photograph.

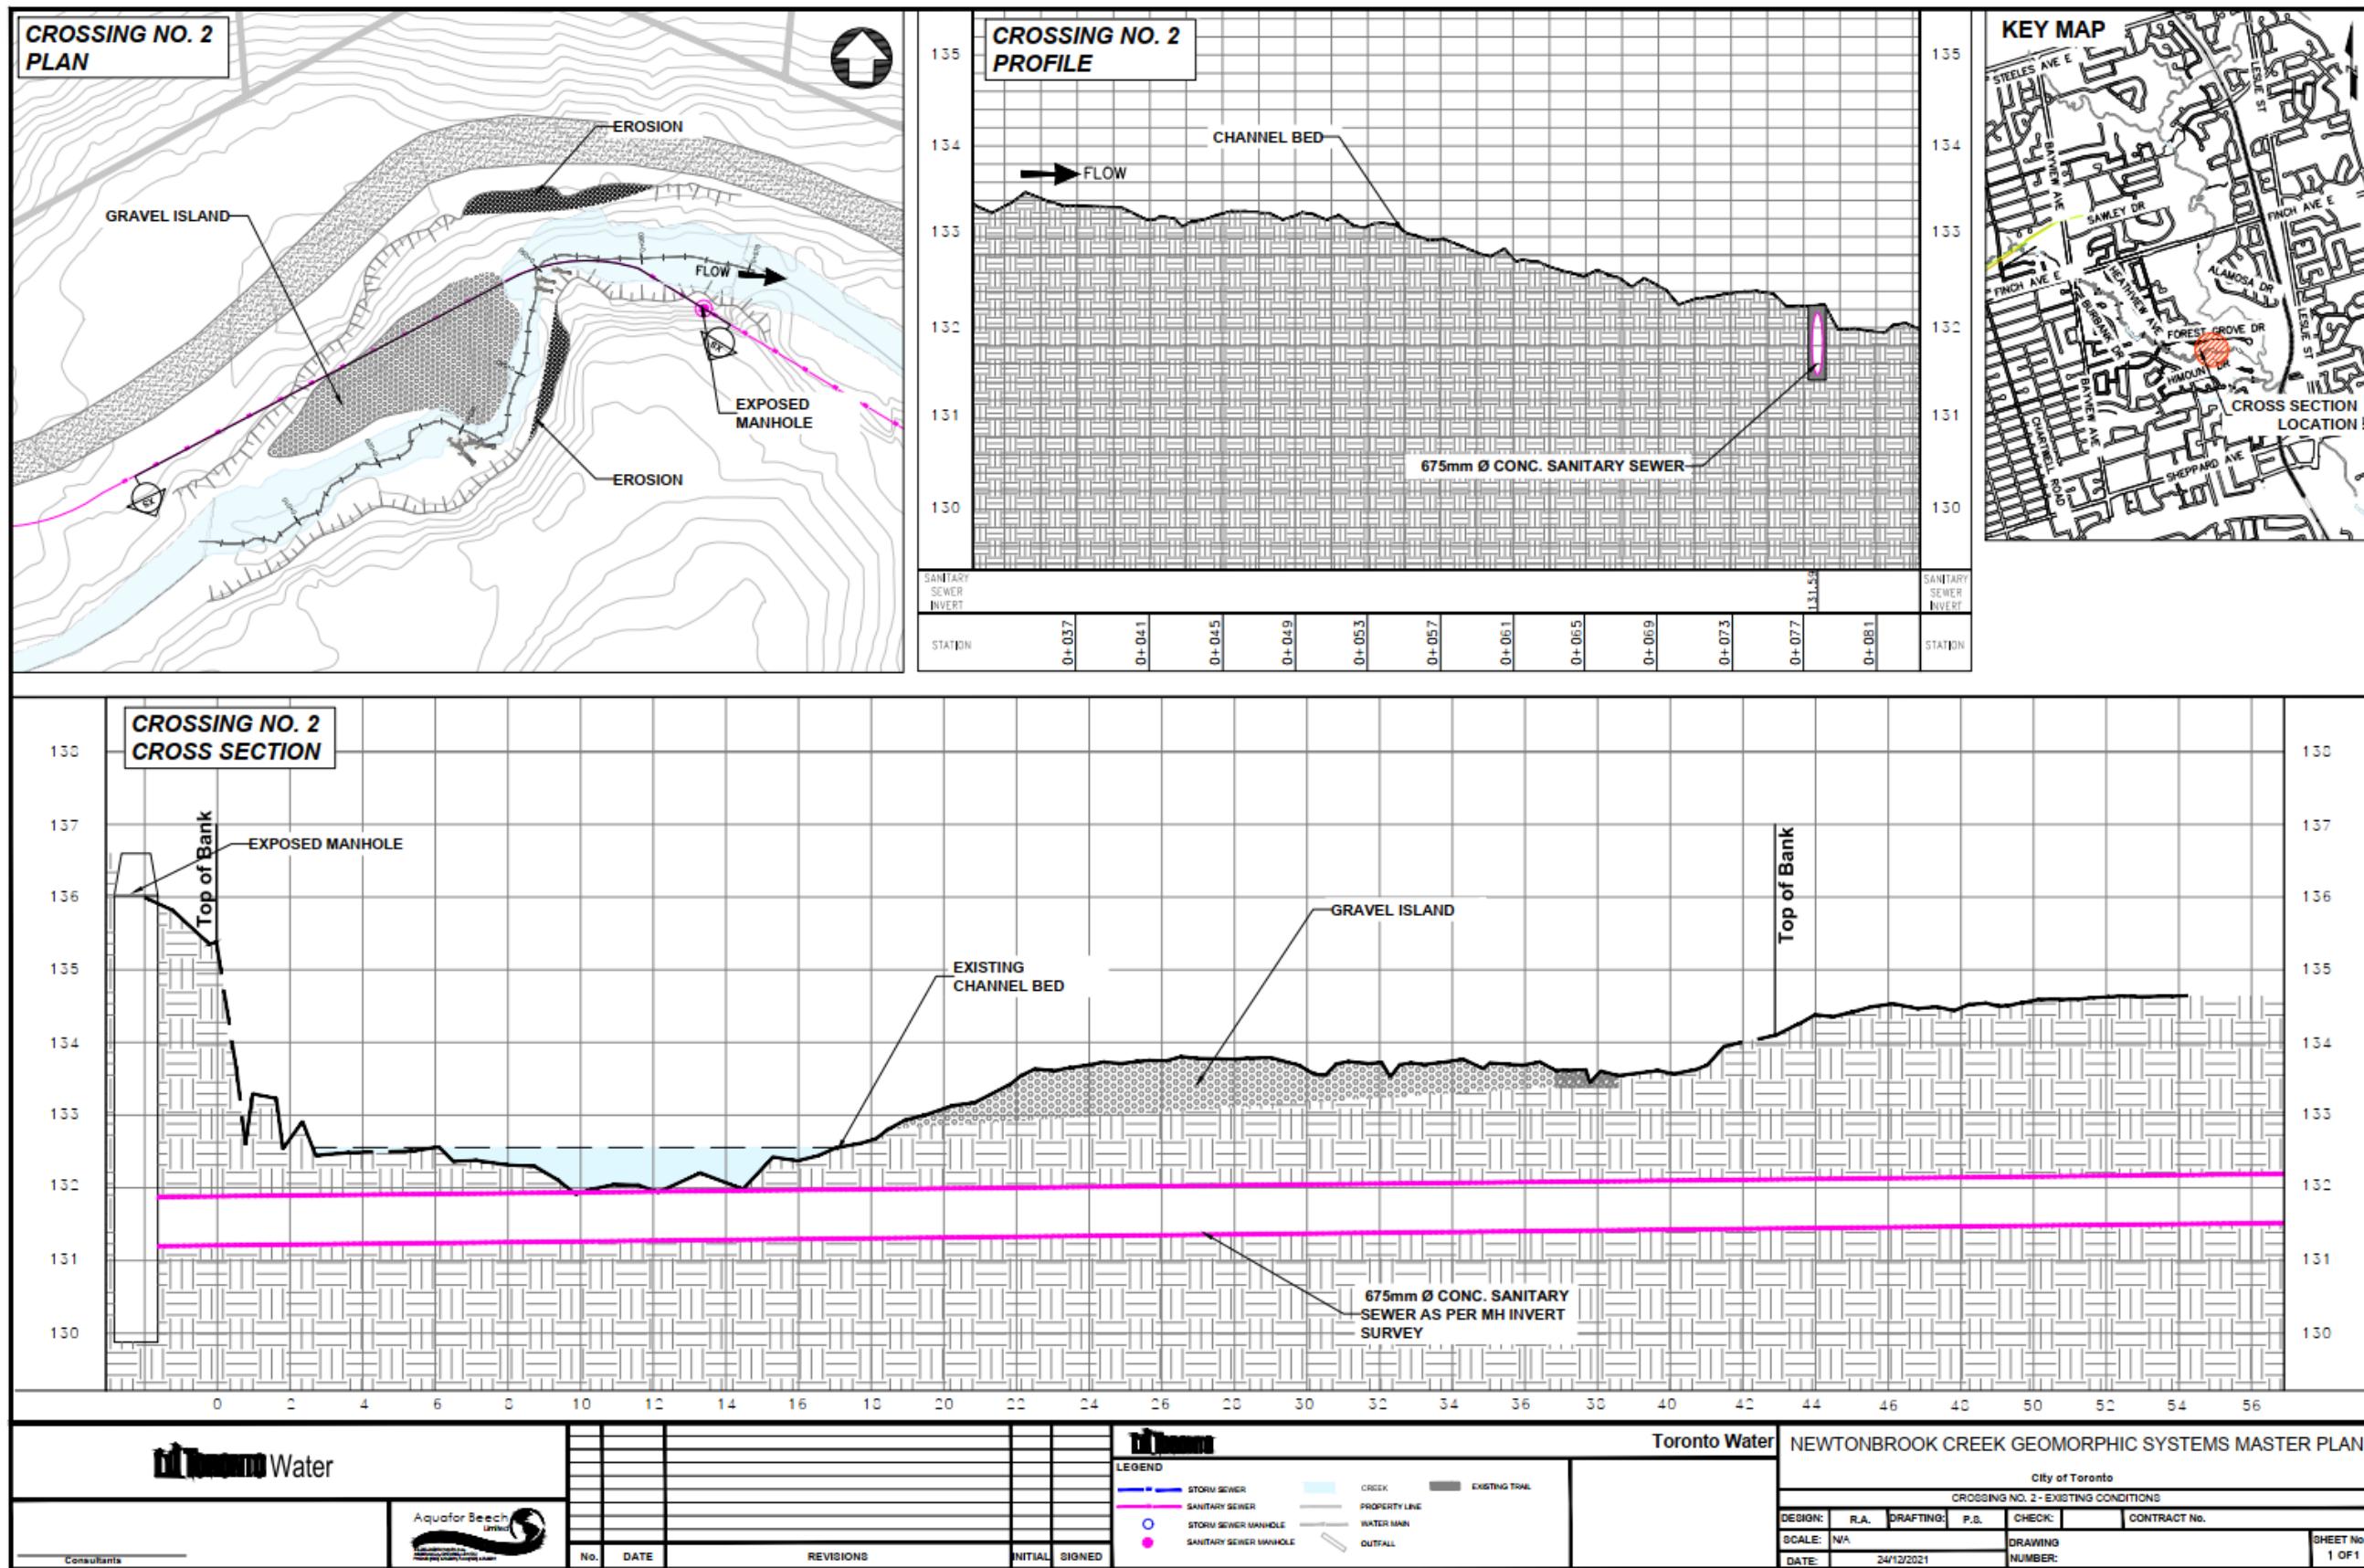
Figure 4-5: Existing Conditions - Priority Site #1

Sanitary Sewer and Maintenance Hole parameters relevant to this priority site are summarized in Table 4-4 with a drawing illustrating the existing conditions of the project site presented in Figure 4-5.

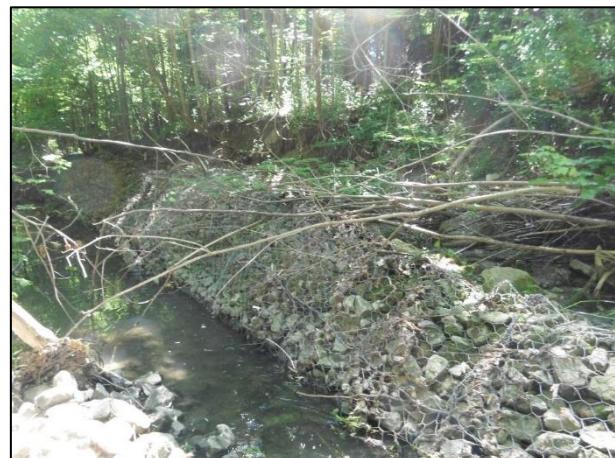
Figure 4-8: Undercut Gabion Basket Retaining Walls Slumping Downwards into Channel

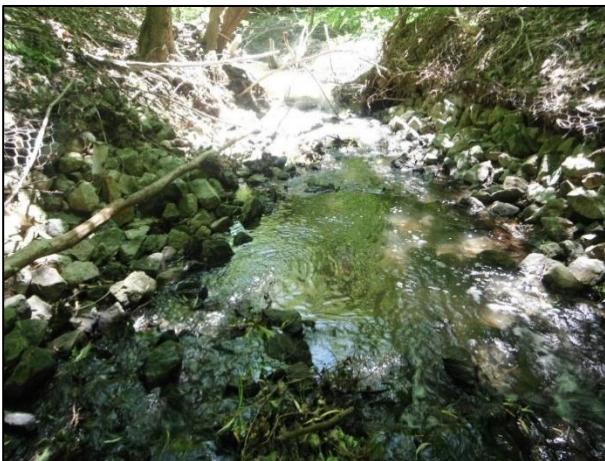
Figure 4-9: Broken Gabion Wire Mesh Leading to the Deposition of Dislodged Gabion Stone in Newtonbrook Creek

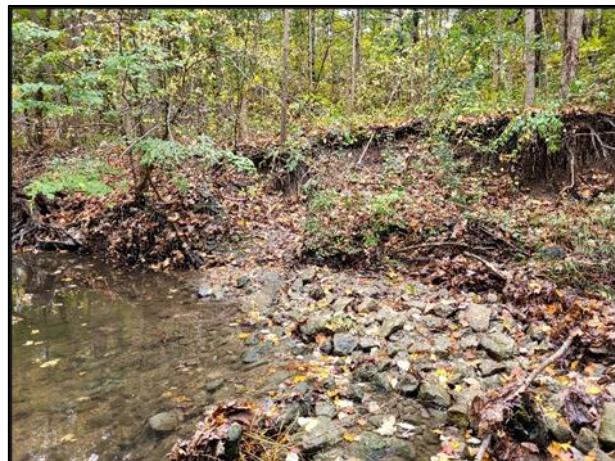
Figure 4-10: Failed Gabion Basket Retaining Wall and Widened Channel due to Unprotected Eroding Banks Downstream of the Exposed Sewer Crossing

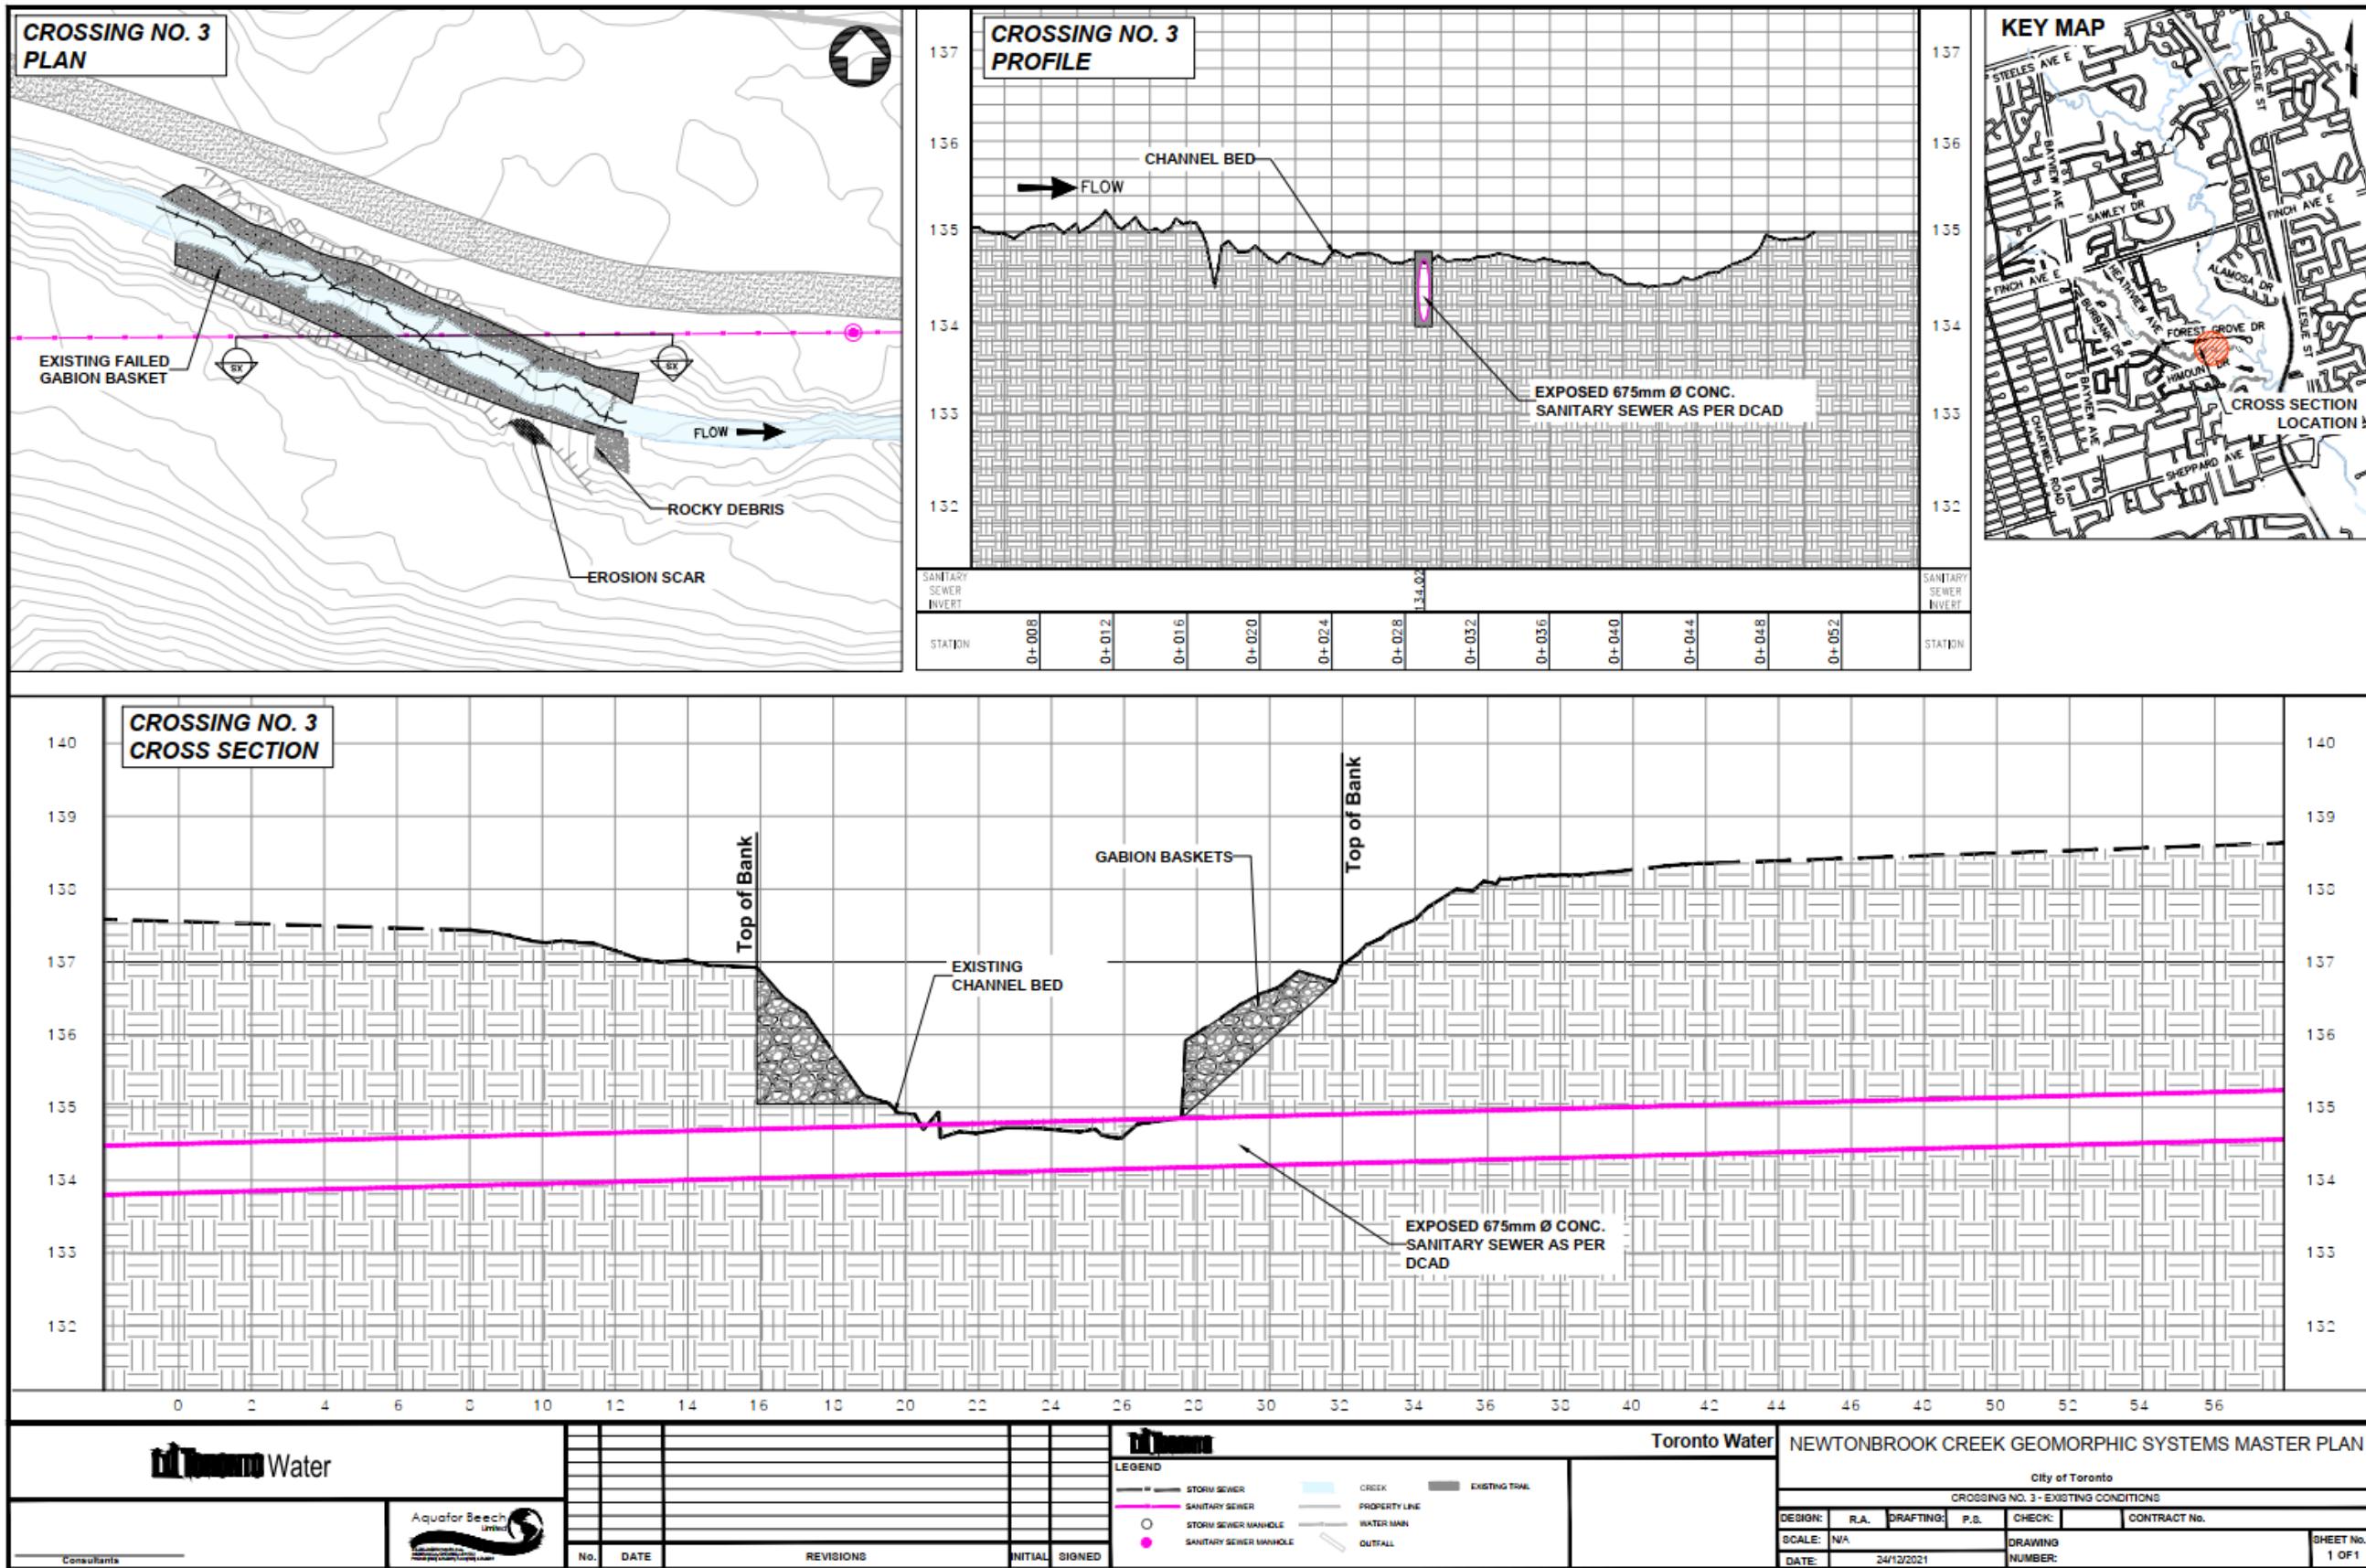
Figure 4-11: Existing Conditions - Priority Site #2

Sanitary Sewer parameters relevant to this priority site are summarized in **Table 4-5**, and a drawing illustrating the existing conditions of the project site is presented in **Figure 4-11**.

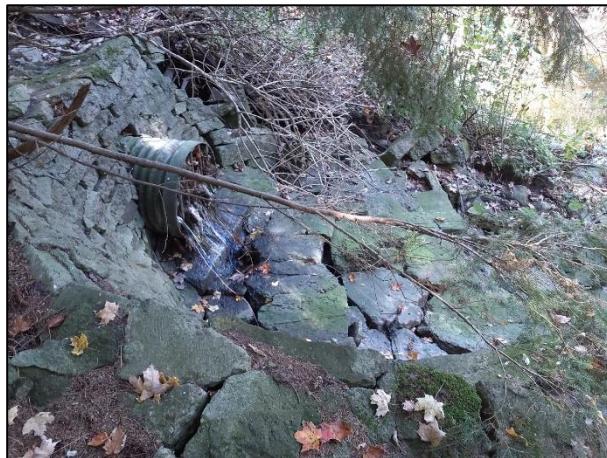
The outlet pipe itself is heavily clogged with accumulated debris. Significant instances of localized slope erosion are visible behind the outfall, along the length of the outlet pipe, in the form of erosion gullies and sinkholes. This erosion of the slope has contributed to detachment of several lengths of CMP pipe (**Figure 4-15**) and exposure of the nearest upstream maintenance hole structure (**Figure 4-16**). The City of Toronto recently completed a CCTV investigation of the upstream 675 mm CMP storm sewer. Based on the results of the CCTV inspection it is recommended that the corrugated metal pipe be removed and replaced with a new concrete pipe between Forest Grove Drive and the Creek Outfall.

Figure 4-13: Stormwater Outlet Clogged with Organic Debris

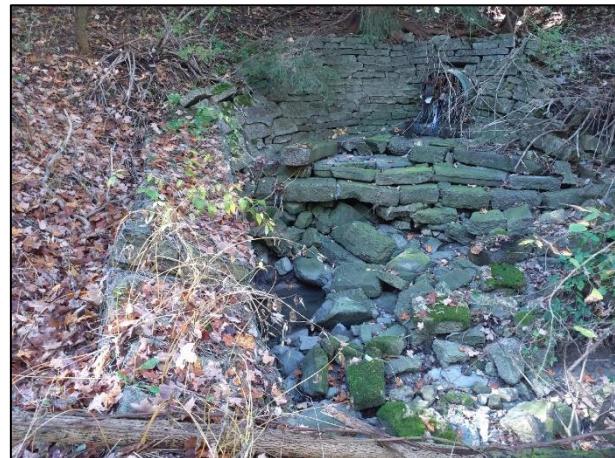
Priority Site #3 is located in Reach N1 of Newtonbrook Creek, immediately downstream of the Forest Grove Drive Culvert, and approximately 580 metres upstream of Priority Site #2. A 675 mm CMP storm sewer outlets to the creek downstream of the road culvert. The outfall pipe is integrated into a low-rise stone retaining wall setback 5-10 metres from the main channel (**Figure 4-13**). Flows from the outfall are directed towards the creek through a stone lined outlet channel that is in poor condition and is starting to fail and fall into the creek (**Figure 4-14**).

Figure 4-14: Degraded Outfall Channel with Loose Angular Stone

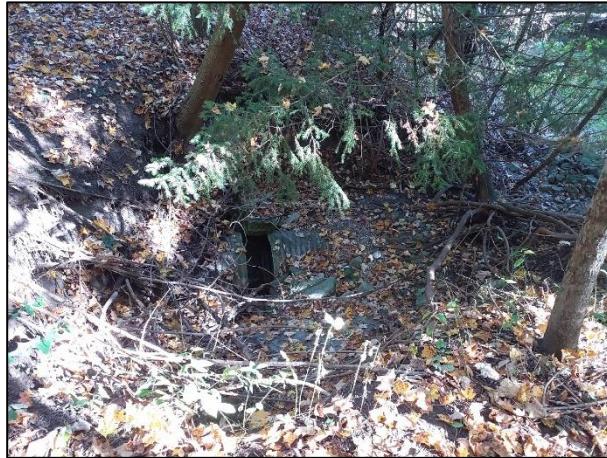
Figure 4-15: Location of Visible Pipe Detachment Upslope of the Outlet

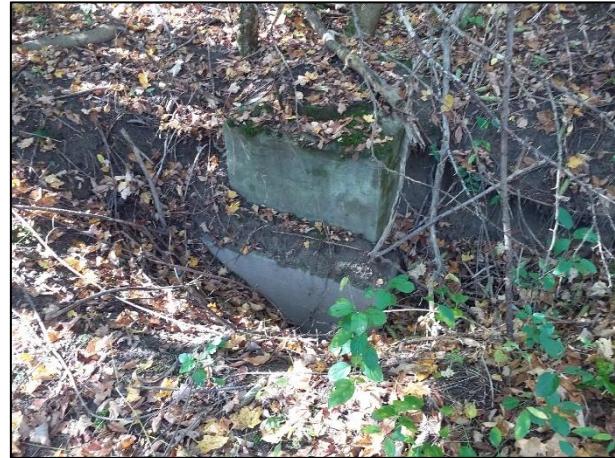
Figure 4-16: Exposed Maintenance Hole in the Slope of Forest Grove Drive Road Embankment

The exposed storm sewer maintenance hole should also be retrofitted to incorporate new inlet and outlet pipes with any structural deficiencies/damage repaired. Erosion sinkholes and gullies to be infilled with engineered fill and appropriately compacted. At the detailed design stage, consideration should also be given to completing a slope stability assessment, with slope stabilization measures (i.e., soil anchors, coir logs, etc.) to be applied as required. The failing stone retaining wall and outlet channel will be removed, along with any accumulated debris, and replaced with a new concrete headwall with armourstone wingwalls. The new outfall will discharge into an engineered scour pool. The scour pool will be designed to drain into a newly constructed outfall channel composed of an engineered substrate mix, with armourstone retaining walls along the banks. The outfall channel will be orientated to flow into the creek at an oblique angle.

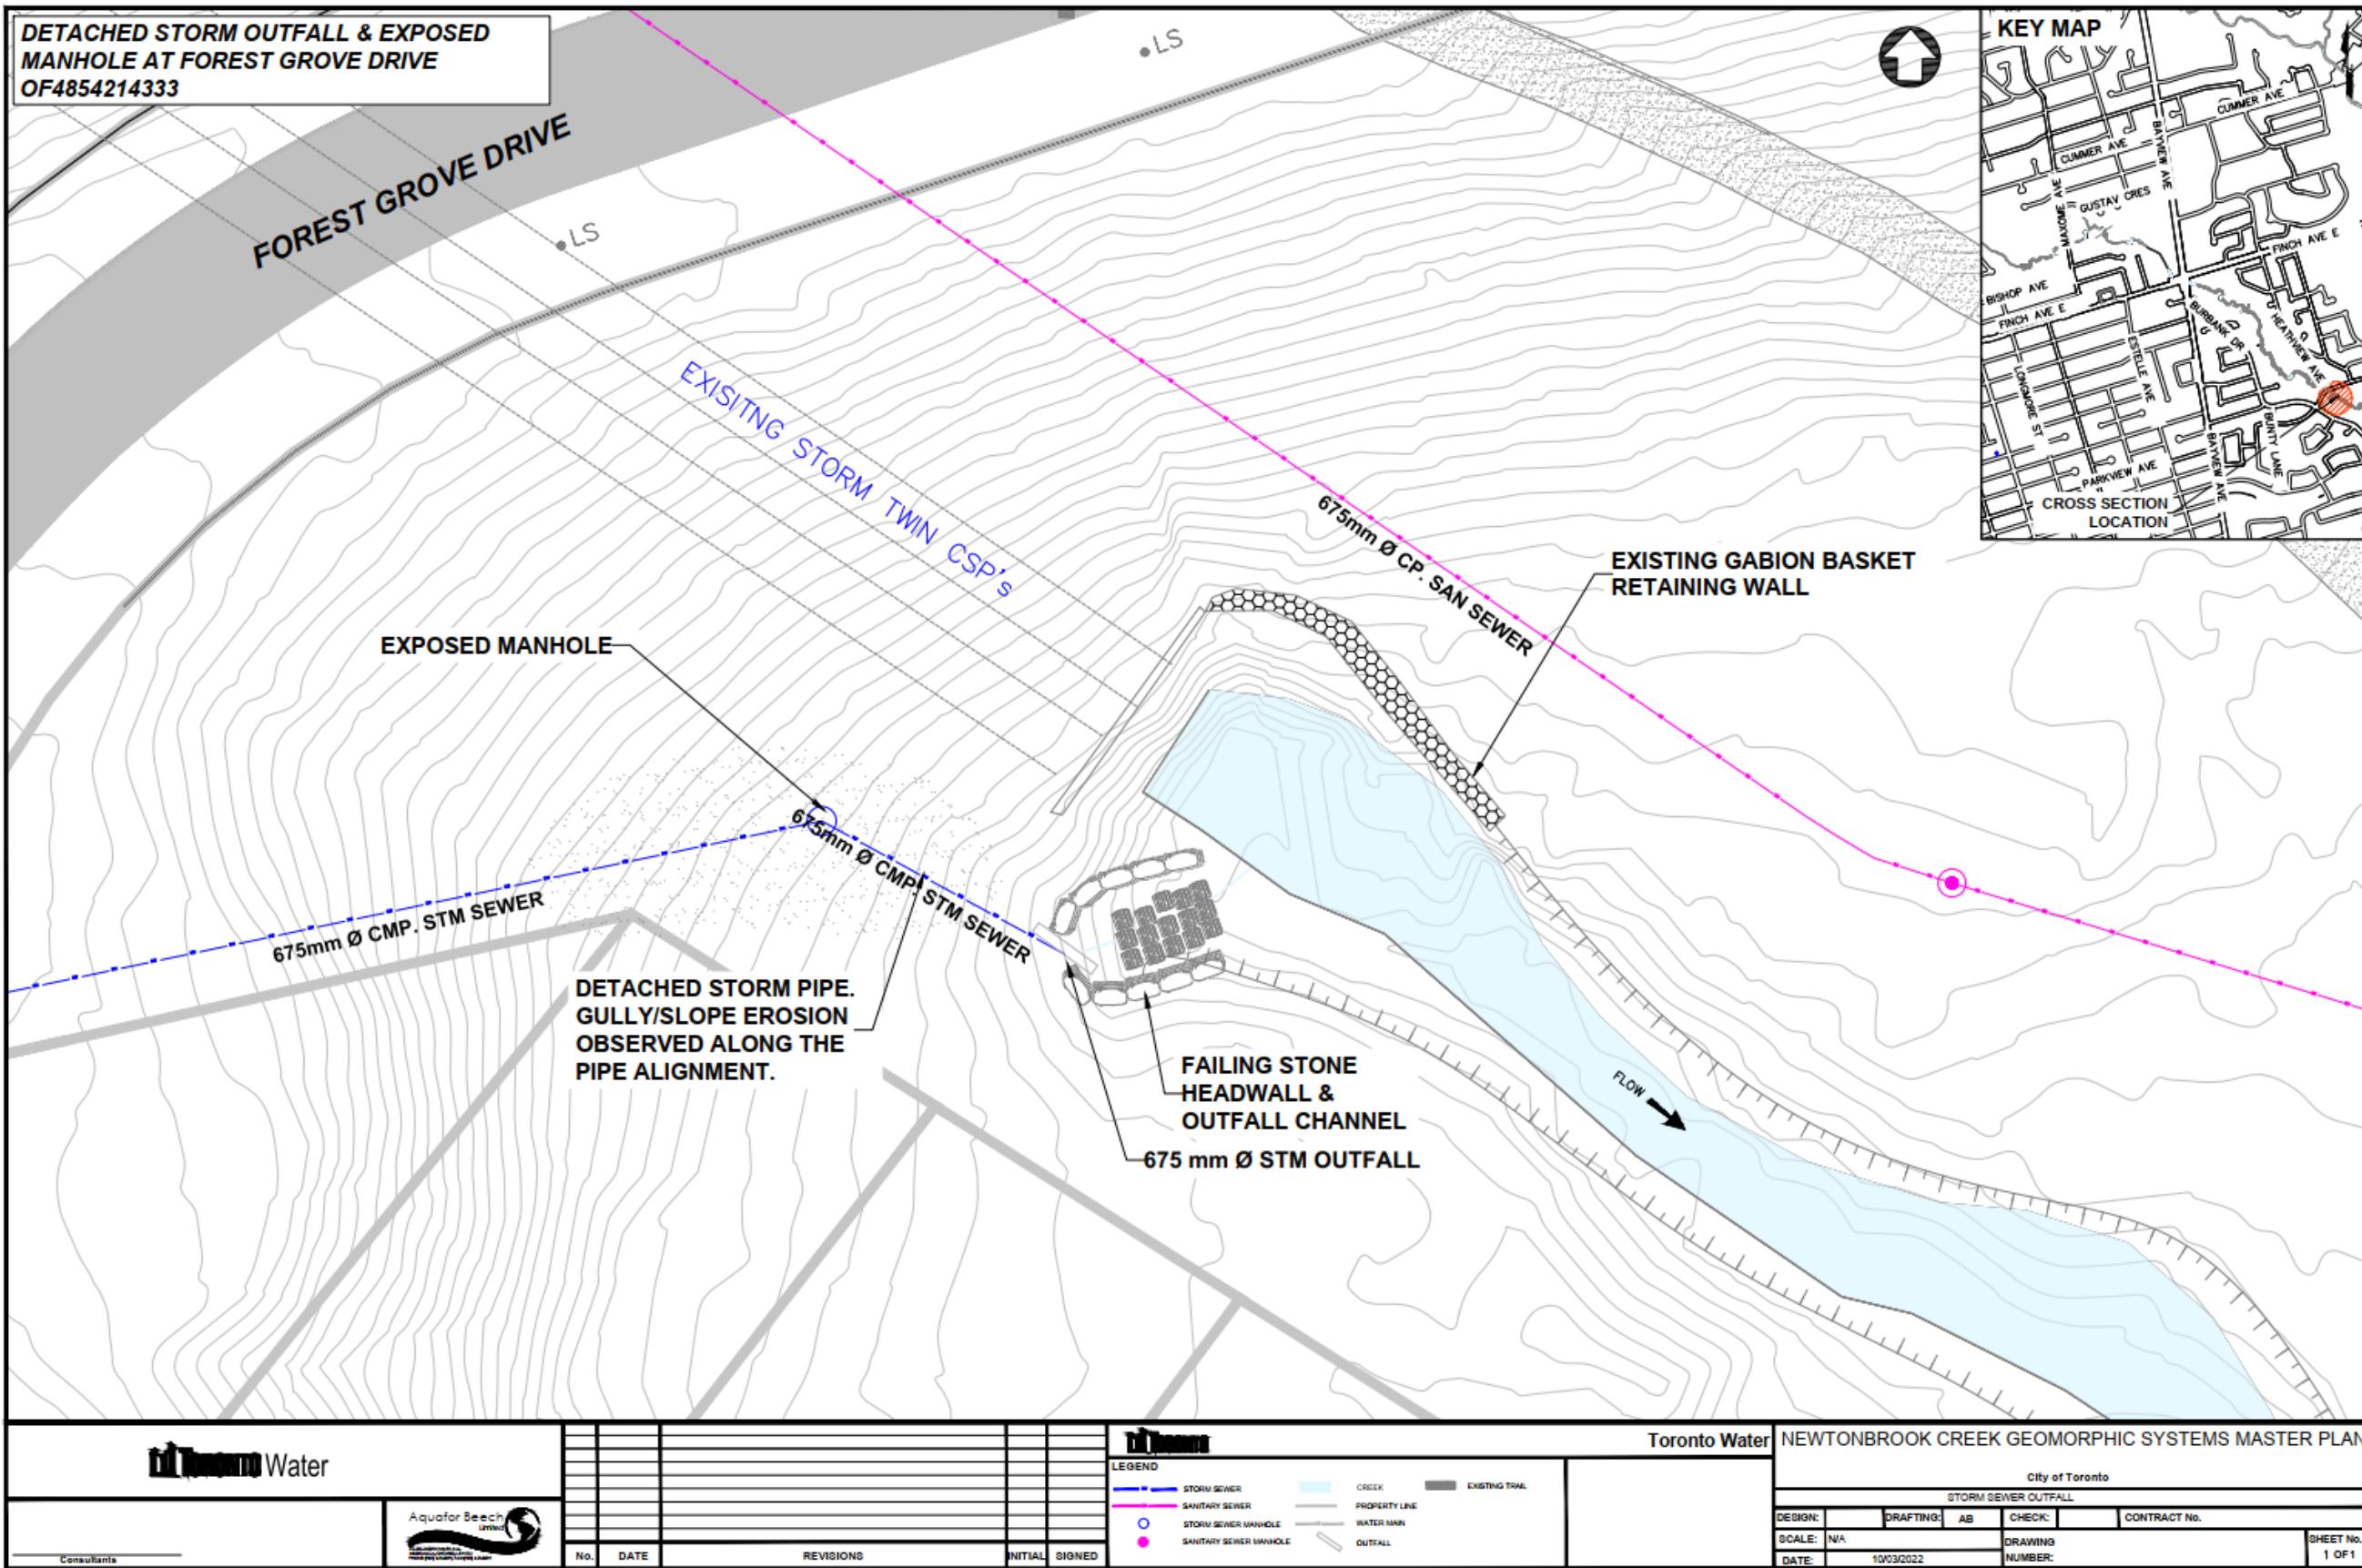
Figure 4-17: Existing Conditions - Priority Site #3

Storm sewer parameters relevant to this priority site are summarized in **Table 4-6** with a drawing illustrating the existing conditions of the project site presented in **Figure 4-17**.
