4.16 Priority Site #14 – Exposed Sanitary Crossing at Sifton Court

4.17 Priority Site #15 – Lateral Risk to Sanitary Sewer Downstream of Sifton Court

4.18 Priority Site #16 – Lateral Risk to Sanitary Sewer at Heathview and Page Avenue

4.19 Priority Site #17 – Lateral Risk to Sanitary Sewer Upstream of Maxome Avenue

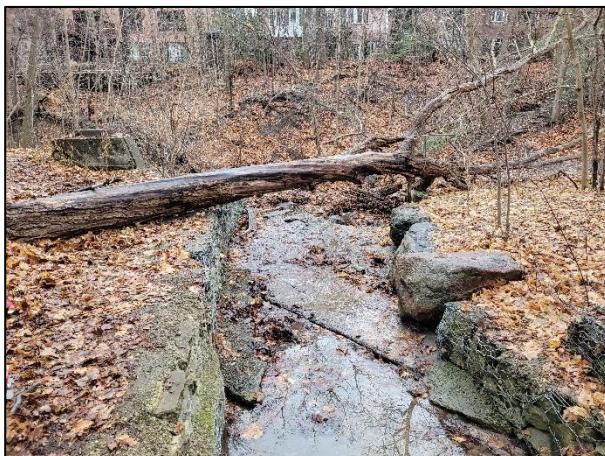
Priority Site #14 is located at the reach break between BR-1 and BR-3 of Blue Ridge Creek. Upstream of the reach break the channel is highly engineered, with a rectangular channel cross-section defined by a concrete channel bed with gabion basket or armourstone retaining walls lining the banks. There is a sanitary sewer crossing upstream of the reach break. The 300 mm diameter sewer is encased in concrete, with the encasement exposed in the concrete bed of the channel (Figure 4-79, Figure 4-80). Water appears to drain underneath the exposure, which may be indicative of washout or piping underneath the encasement. Should the pipe become fully undermined across the length of the channel, there is increased potential for slumping and structural failure. There are also concerns regarding the condition of the downstream sanitary sewer maintenance hole, located on the north side of the crossing a few meters behind a gabion basket retaining wall in the top of bank. The maintenance hole exhibits signs of degradation, with signs of erosion along the slope of the maintenance hole.

Figure 4-79: Exposure of the Concrete Encasement with Water Flowing into the Crack of the Encasement

- Apply approximately 300 metres of channel restoration work using natural channel design principles to establish riffle-pool morphology.
- Provide 1.0 metres of cover overtop of the exposed sanitary sewer crossing.

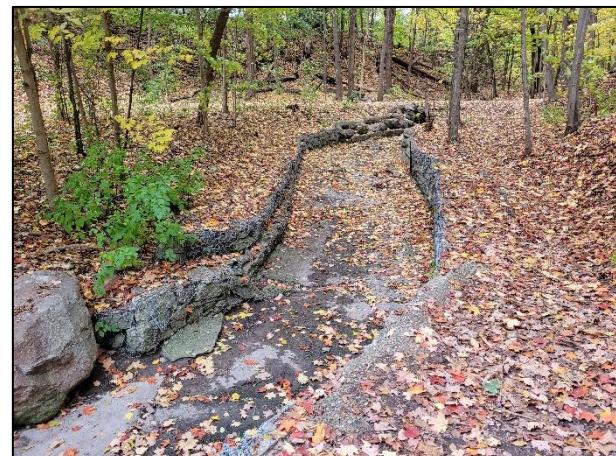
Figure 4-80: View of the Engineered Channel Upstream of the Encasement Exposure

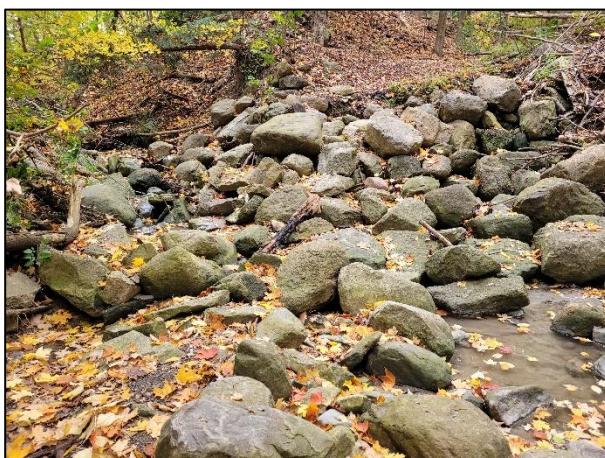
Downstream of the exposed sewer crossing, there is a pronounced, near vertical, drop in grade of over 2.0 m. The creek is held together at this grade change by a pile of large Boulders that act as a grade control structure (Figure 4-81). Downstream of this drop in grade, Reaches BR-3 and BR-4 confluence with the main branch of Blue Ridge Creek (Figure 4-82).

Figure 4-81: Large Drop Downstream of Encasement Exposure with Boulders Providing Grade Control

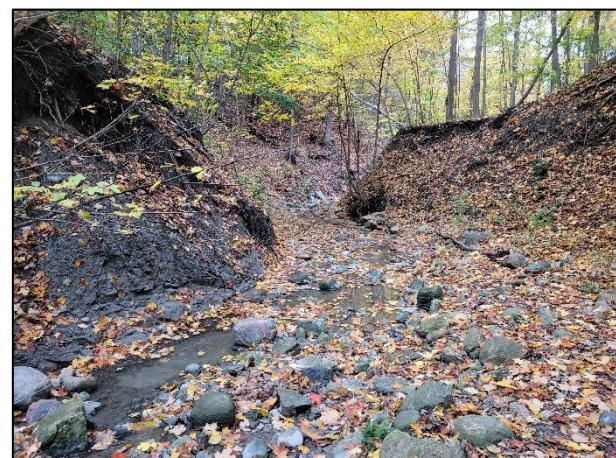
Figure 4-82: Blue Ridge Creek and Valley Setting Downstream of Boulder Pile

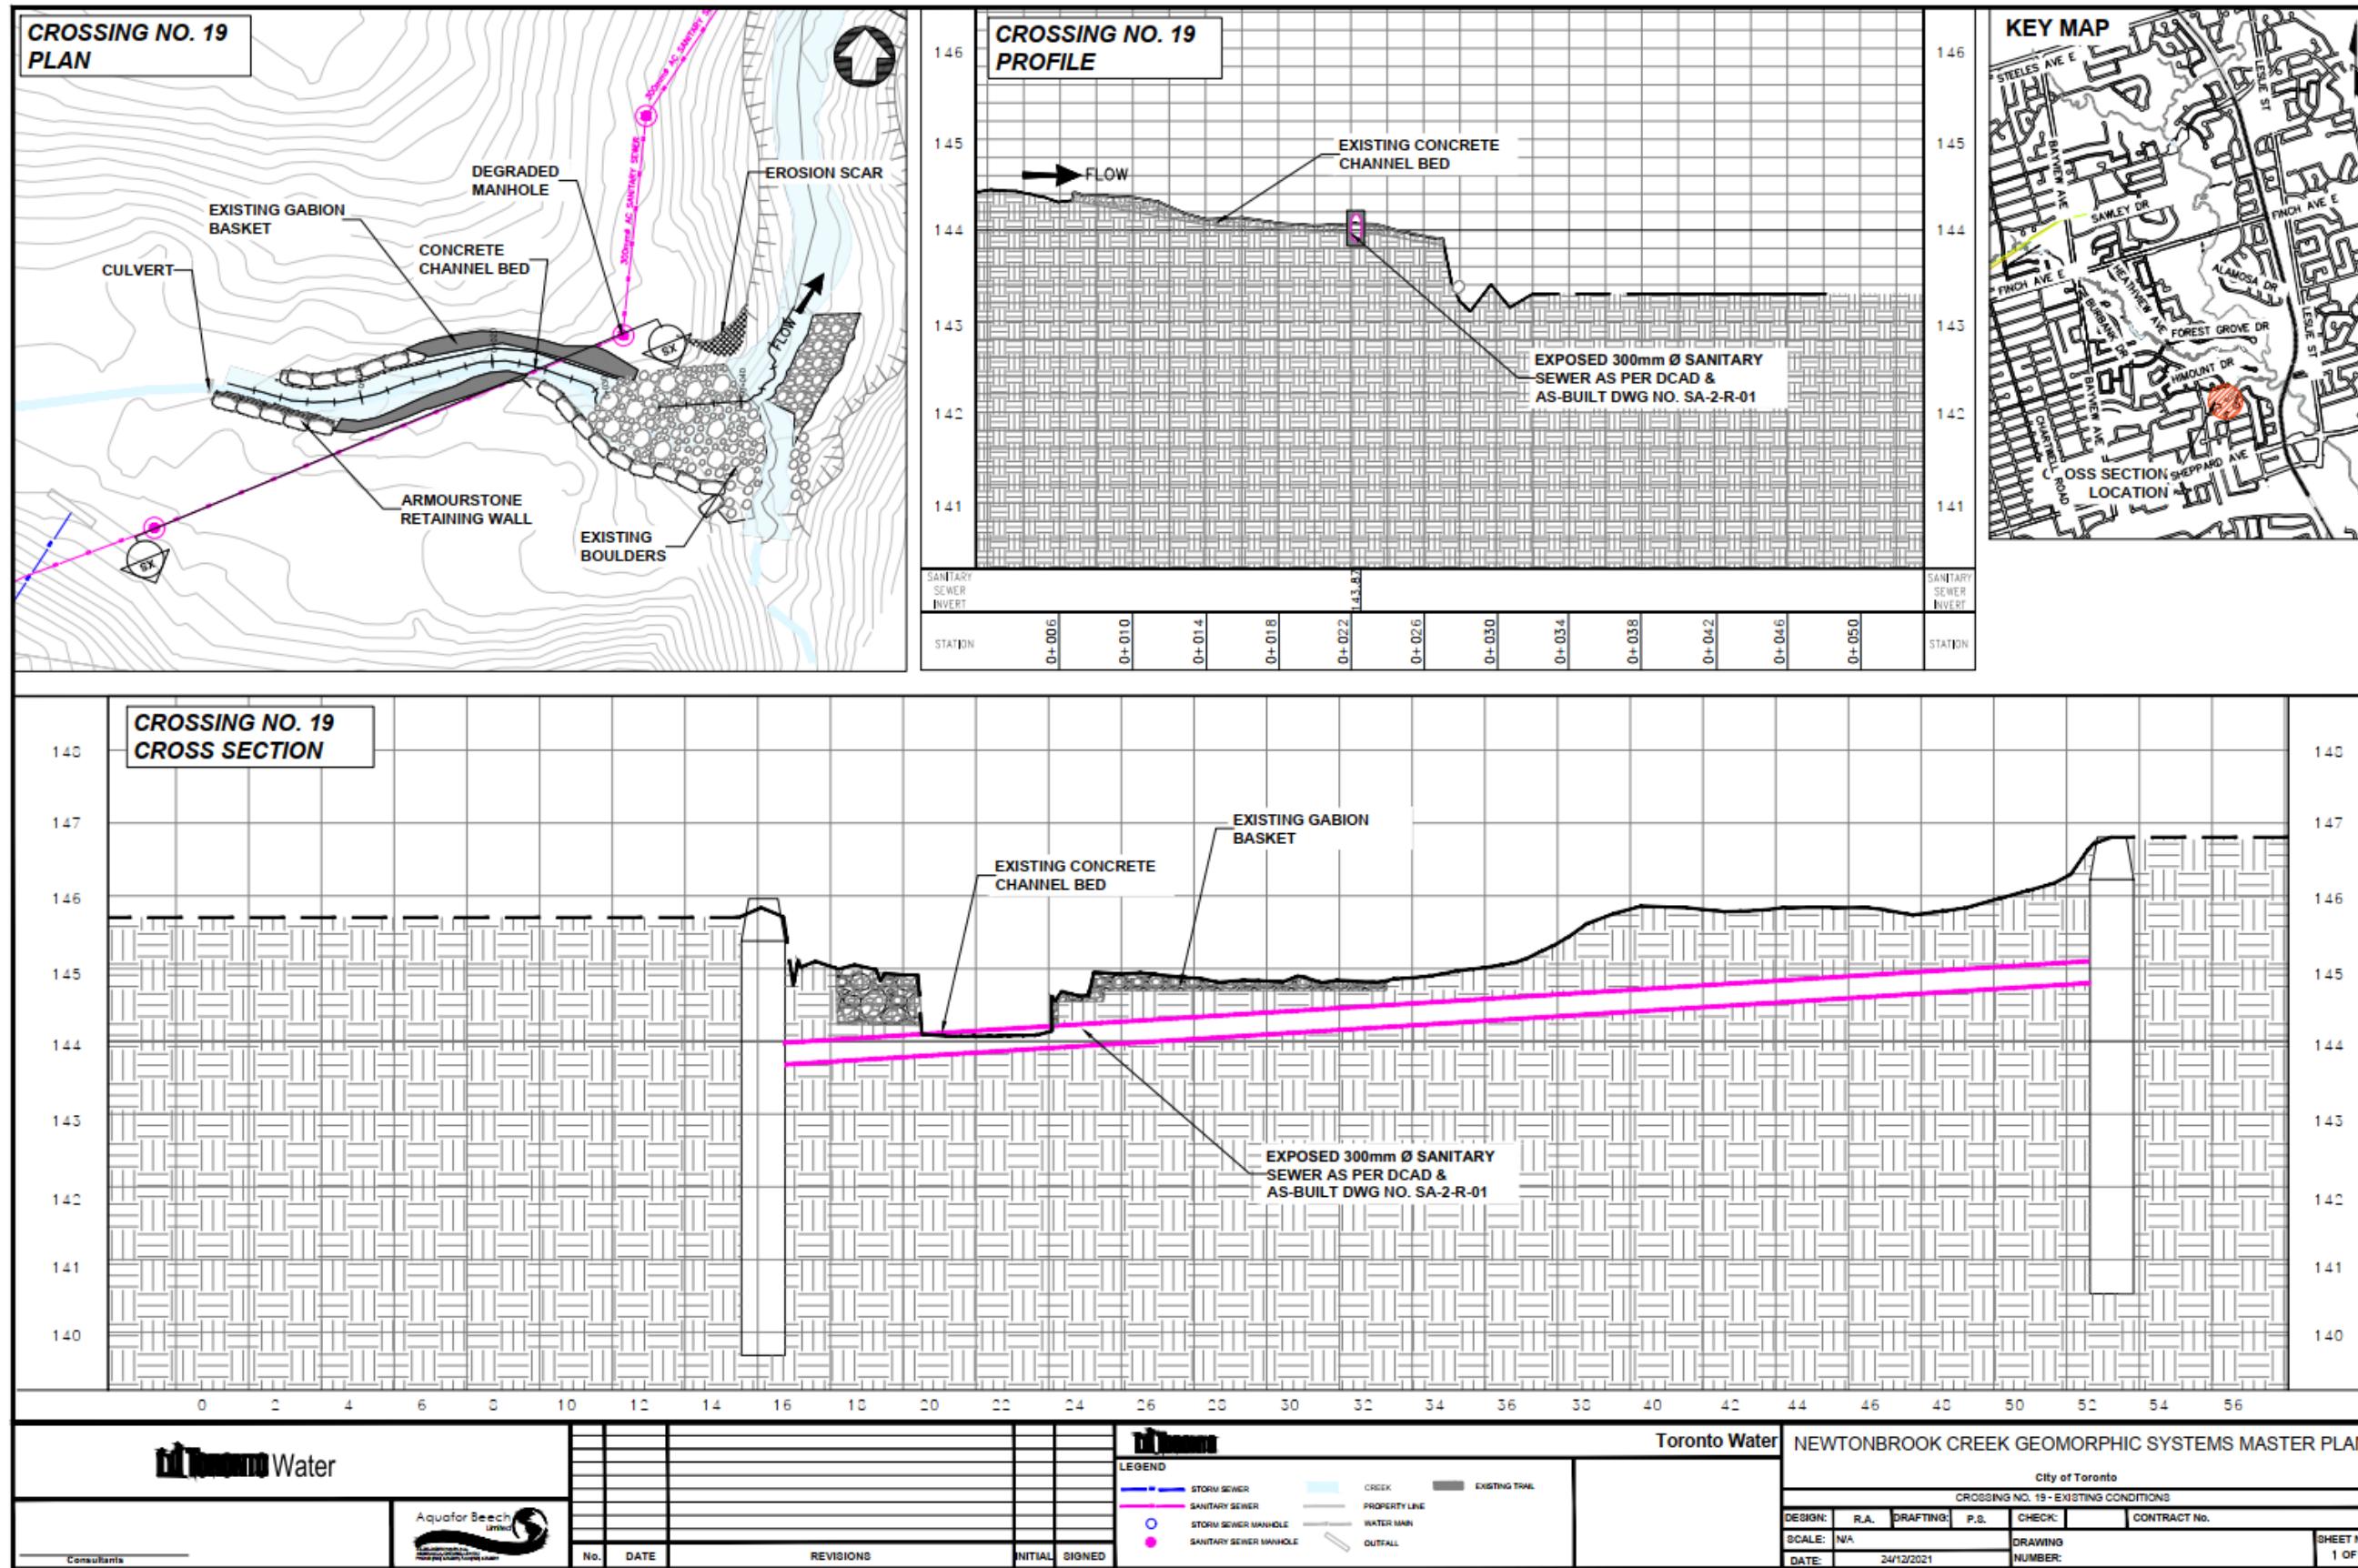
Figure 4-83: Existing Conditions - Priority Site #14

Parameter	Sanitary Trunk Sewer
Toronto Water Asset ID	SL4029711
Year of Construction	1977
Diameter	300
Depth of Cover	0 m
Estimated Time to Contact	0 years
Erodibility of Adjacent Substrate	Low – engineered channel

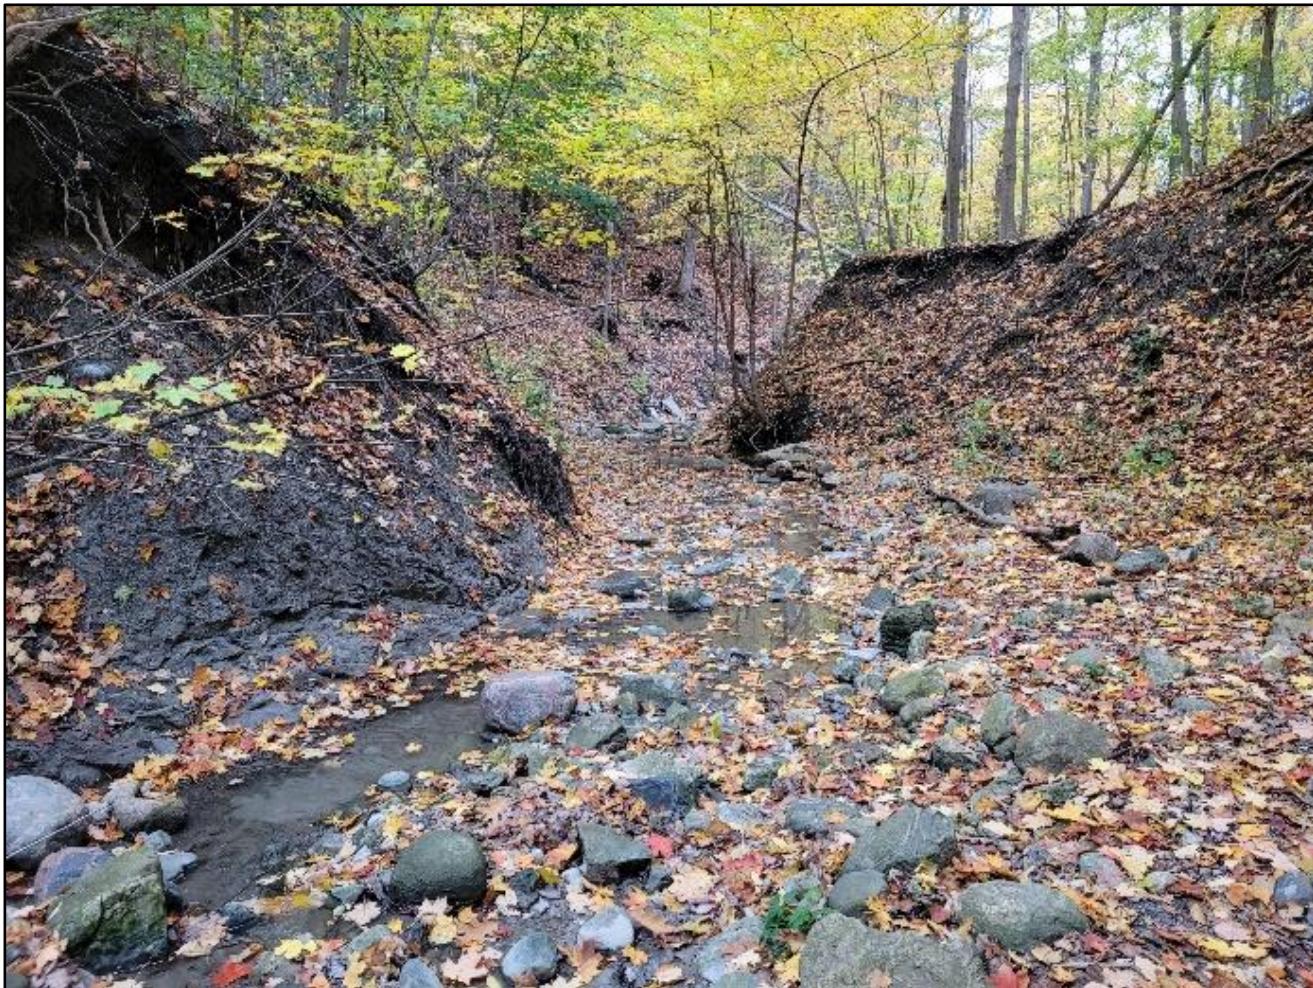
At this priority site location, active bank erosion along an unarmored segment of the creek has reduced the lateral cover between the eroded channel bank and the sanitary sewer line to approximately 0.5 m. Reach BR-1 has an estimated lateral erosion rate of approximately 0.30 m/year, resulting in an estimated time to contact of 1.68 years. The location of this site along the outside of a relatively tight meander bend further exacerbates the degree to which the sewer line is vulnerable to lateral erosion, as evidenced by the Radius of Curvature to Width ratio of 4.49. It is highly recommended that at minimum, localized bank protection works be implemented at this site to prevent exposure, and potential failure, of the at-risk sewer. A photo illustrating the site-specific channel conditions and actively eroding northern bank is presented in **Figure 4-85**.

Figure 4-85: Degraded Channel Conditions at Priority Site #15. The Actively Eroding Westerly Bank has Created a Lateral Risk to a 300 mm Diameter Sanitary Sewer

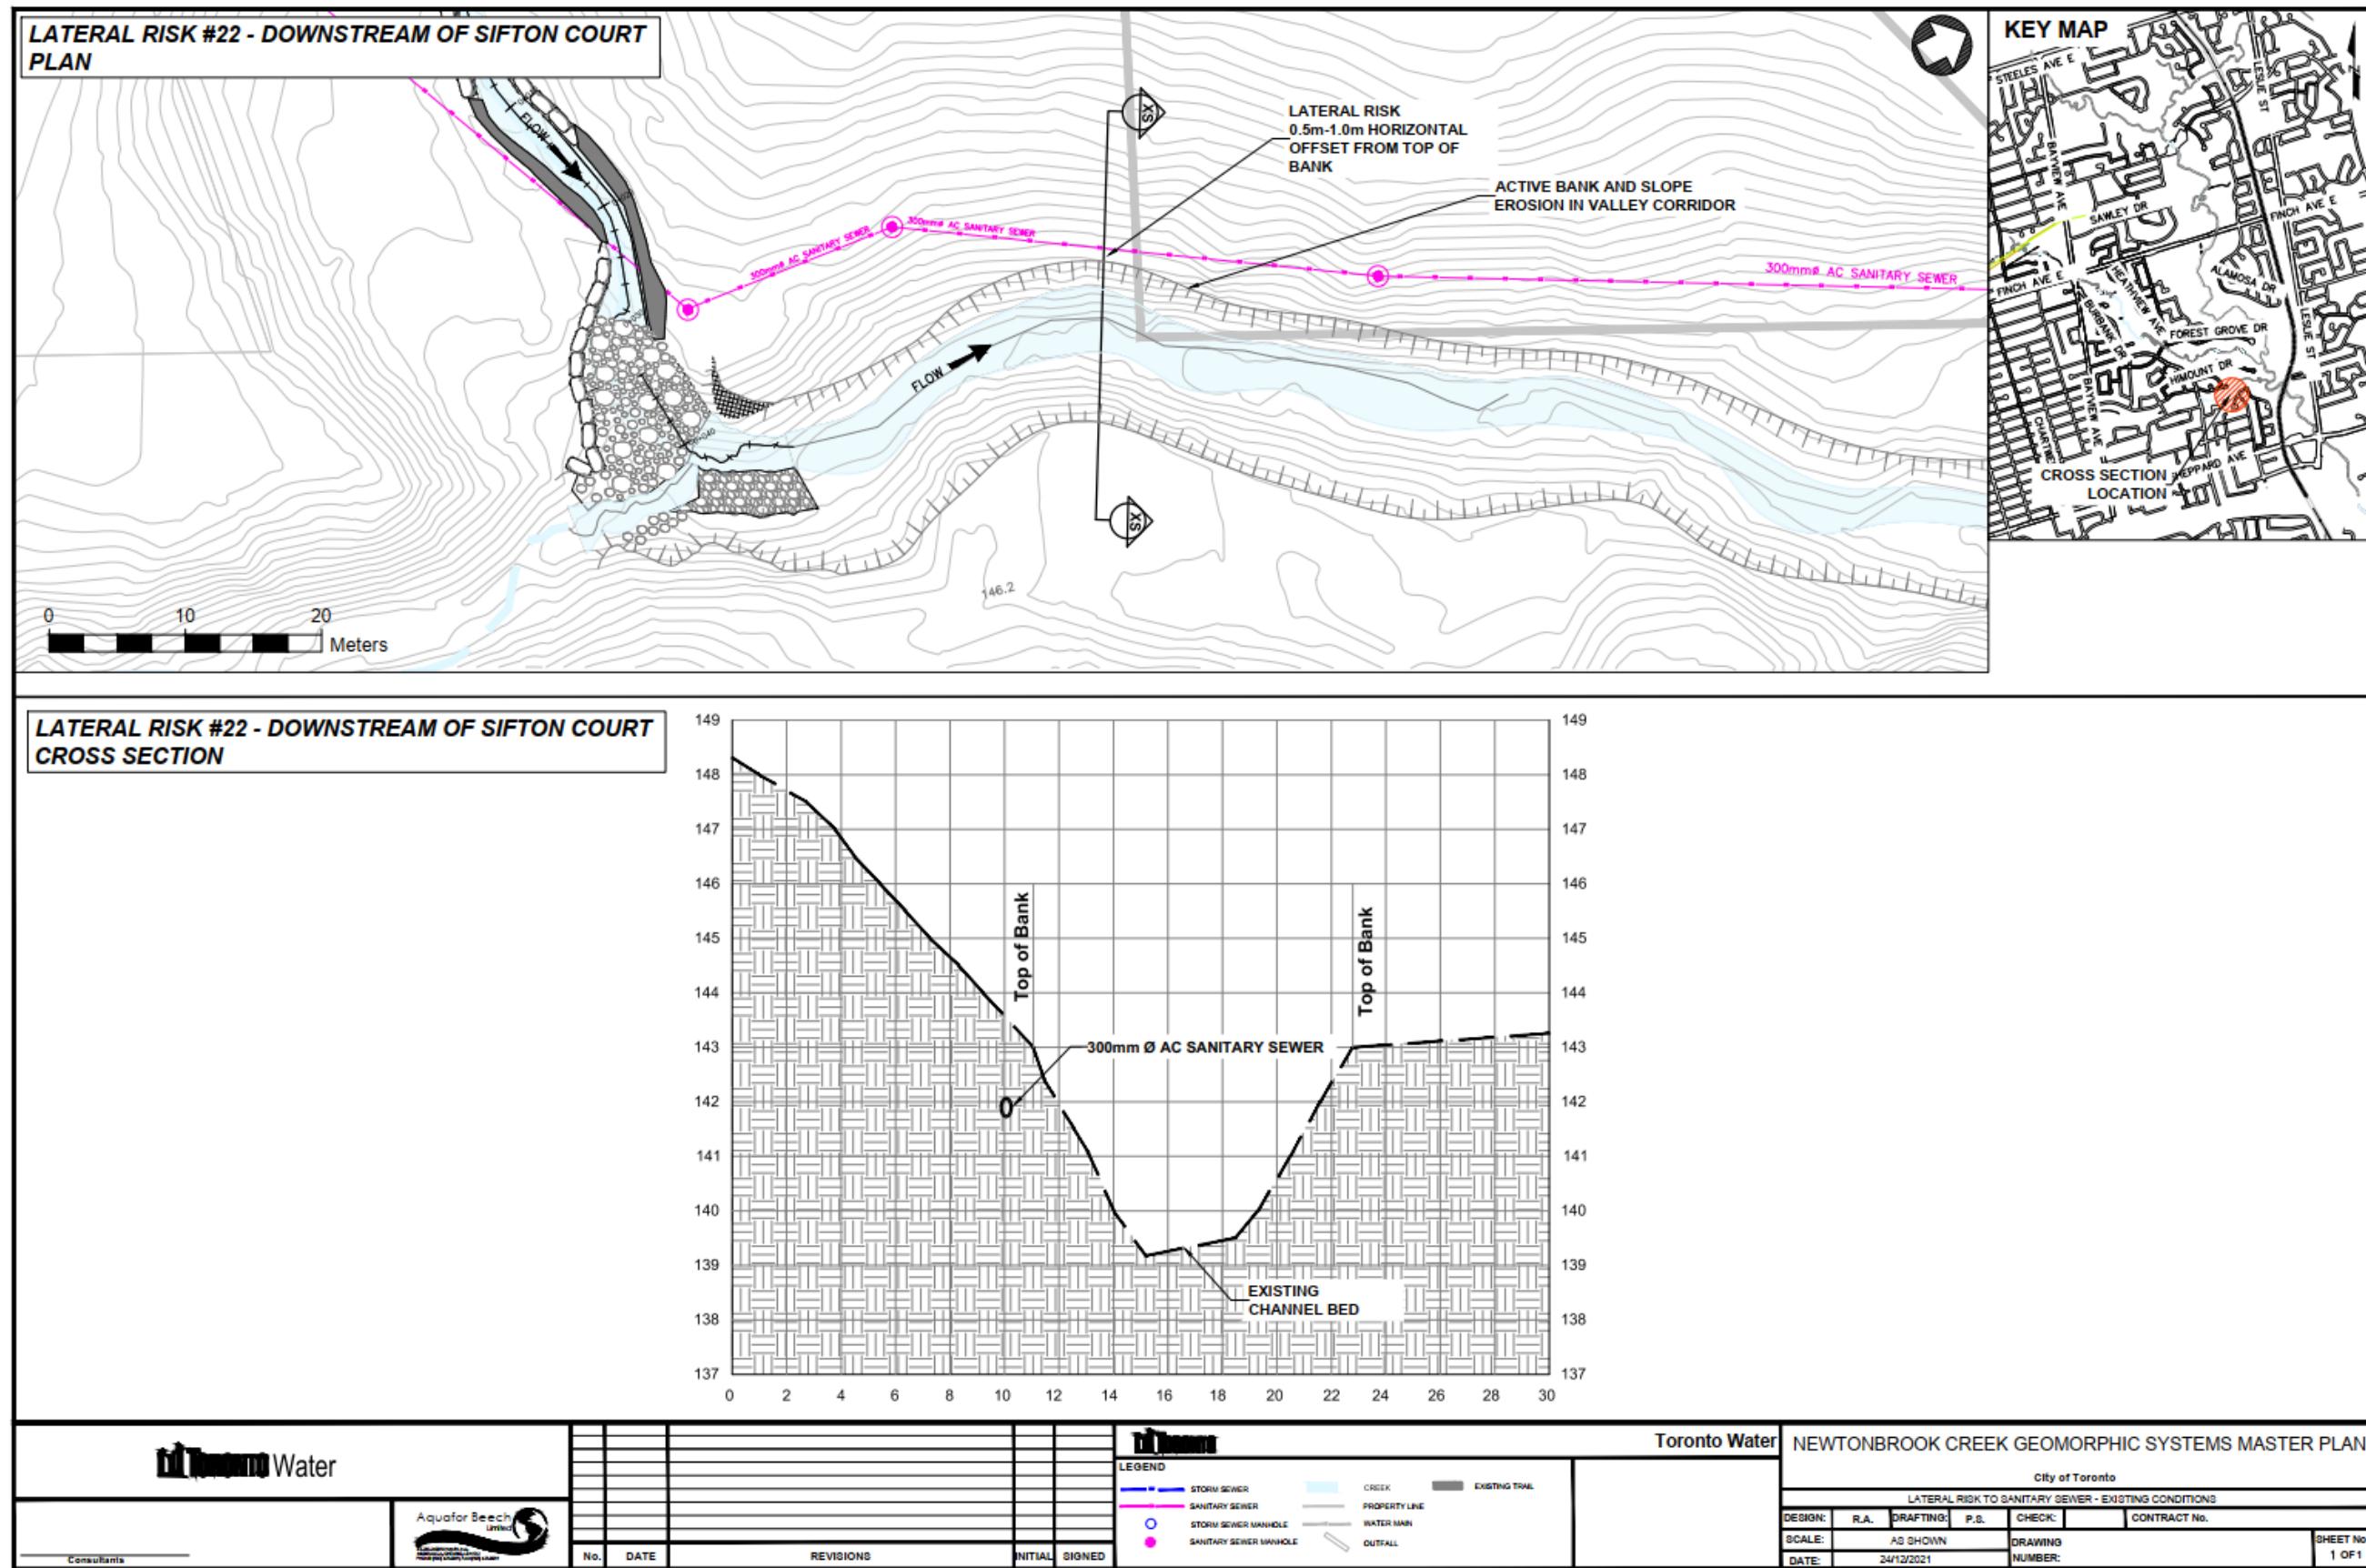
Figure 4-86: Existing Conditions – Priority Site #15

Parameter	Sanitary Trunk Sewer
Toronto Water Asset ID	SL4030293
Year of Construction	1977
Diameter	300
Lateral Depth of Cover	~0.5 m
Estimated Time to Contact	1.68 years
Condition of Bank Protection Works	N/A – No Bank Protection Works Present

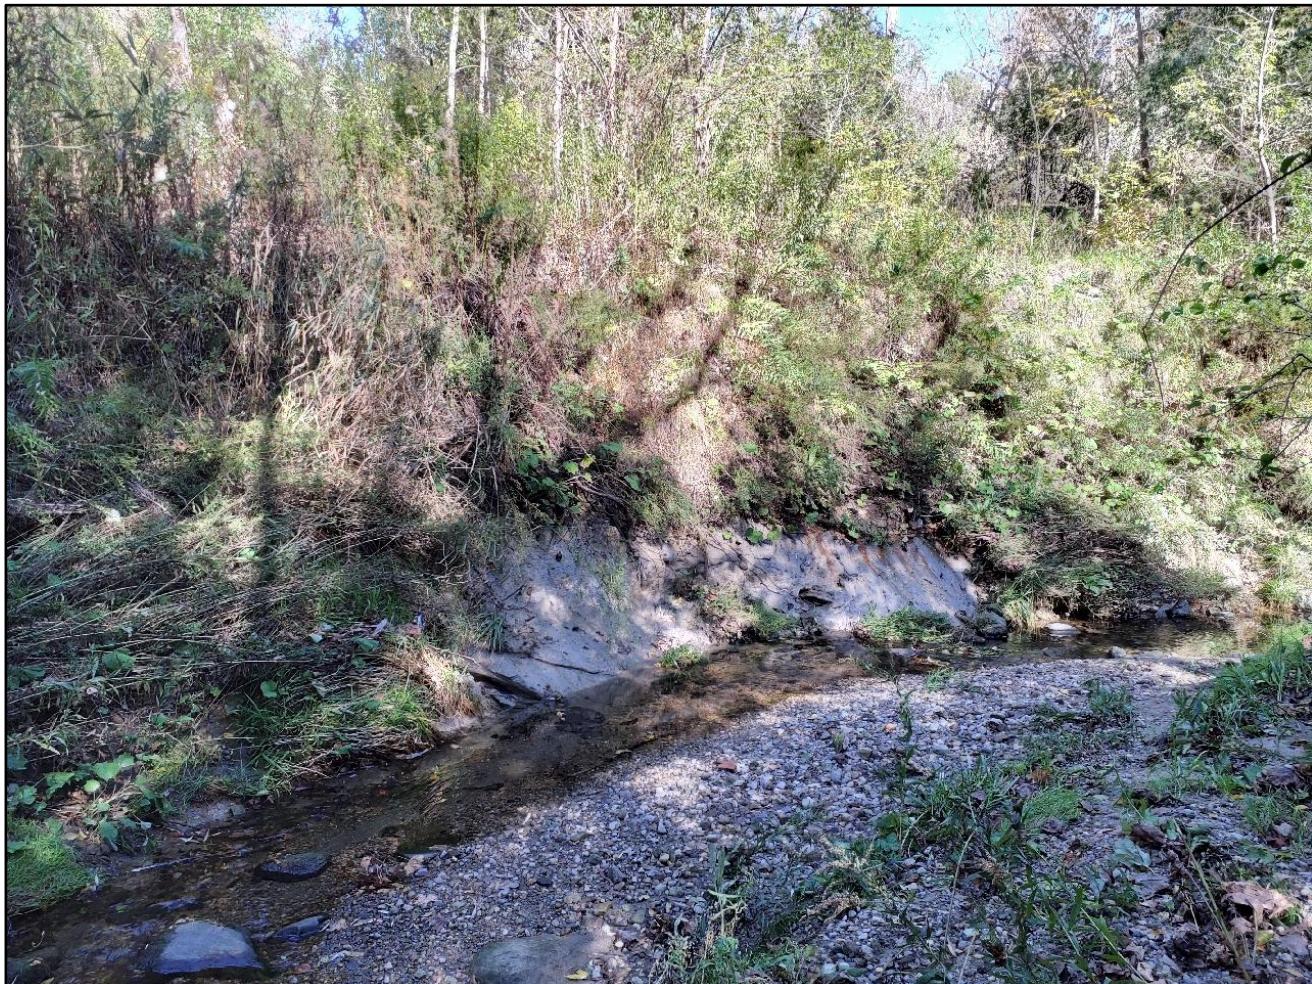
The estimated depth of lateral cover is approximately 4.00 metres with a projected time to contact of 15.61 years. Given that this priority site is located on the outside edge of a tight meander bend, there is significant potential for exacerbated rates of localized erosion, thereby increasing the overall lateral risk to both the sanitary trunk sewer and the multi-use trail. It is strongly recommended that at minimum, localized engineered bank works be implemented to provide erosion control protection. A photo illustrating the site-specific channel conditions and actively eroding bank is presented in **Figure 4-88**.

Figure 4-88: Degraded Channel Conditions at Priority Site #16. The Actively Eroding Bank has Created a Lateral Risk to the Adjacent 675 mm Sanitary Sewer

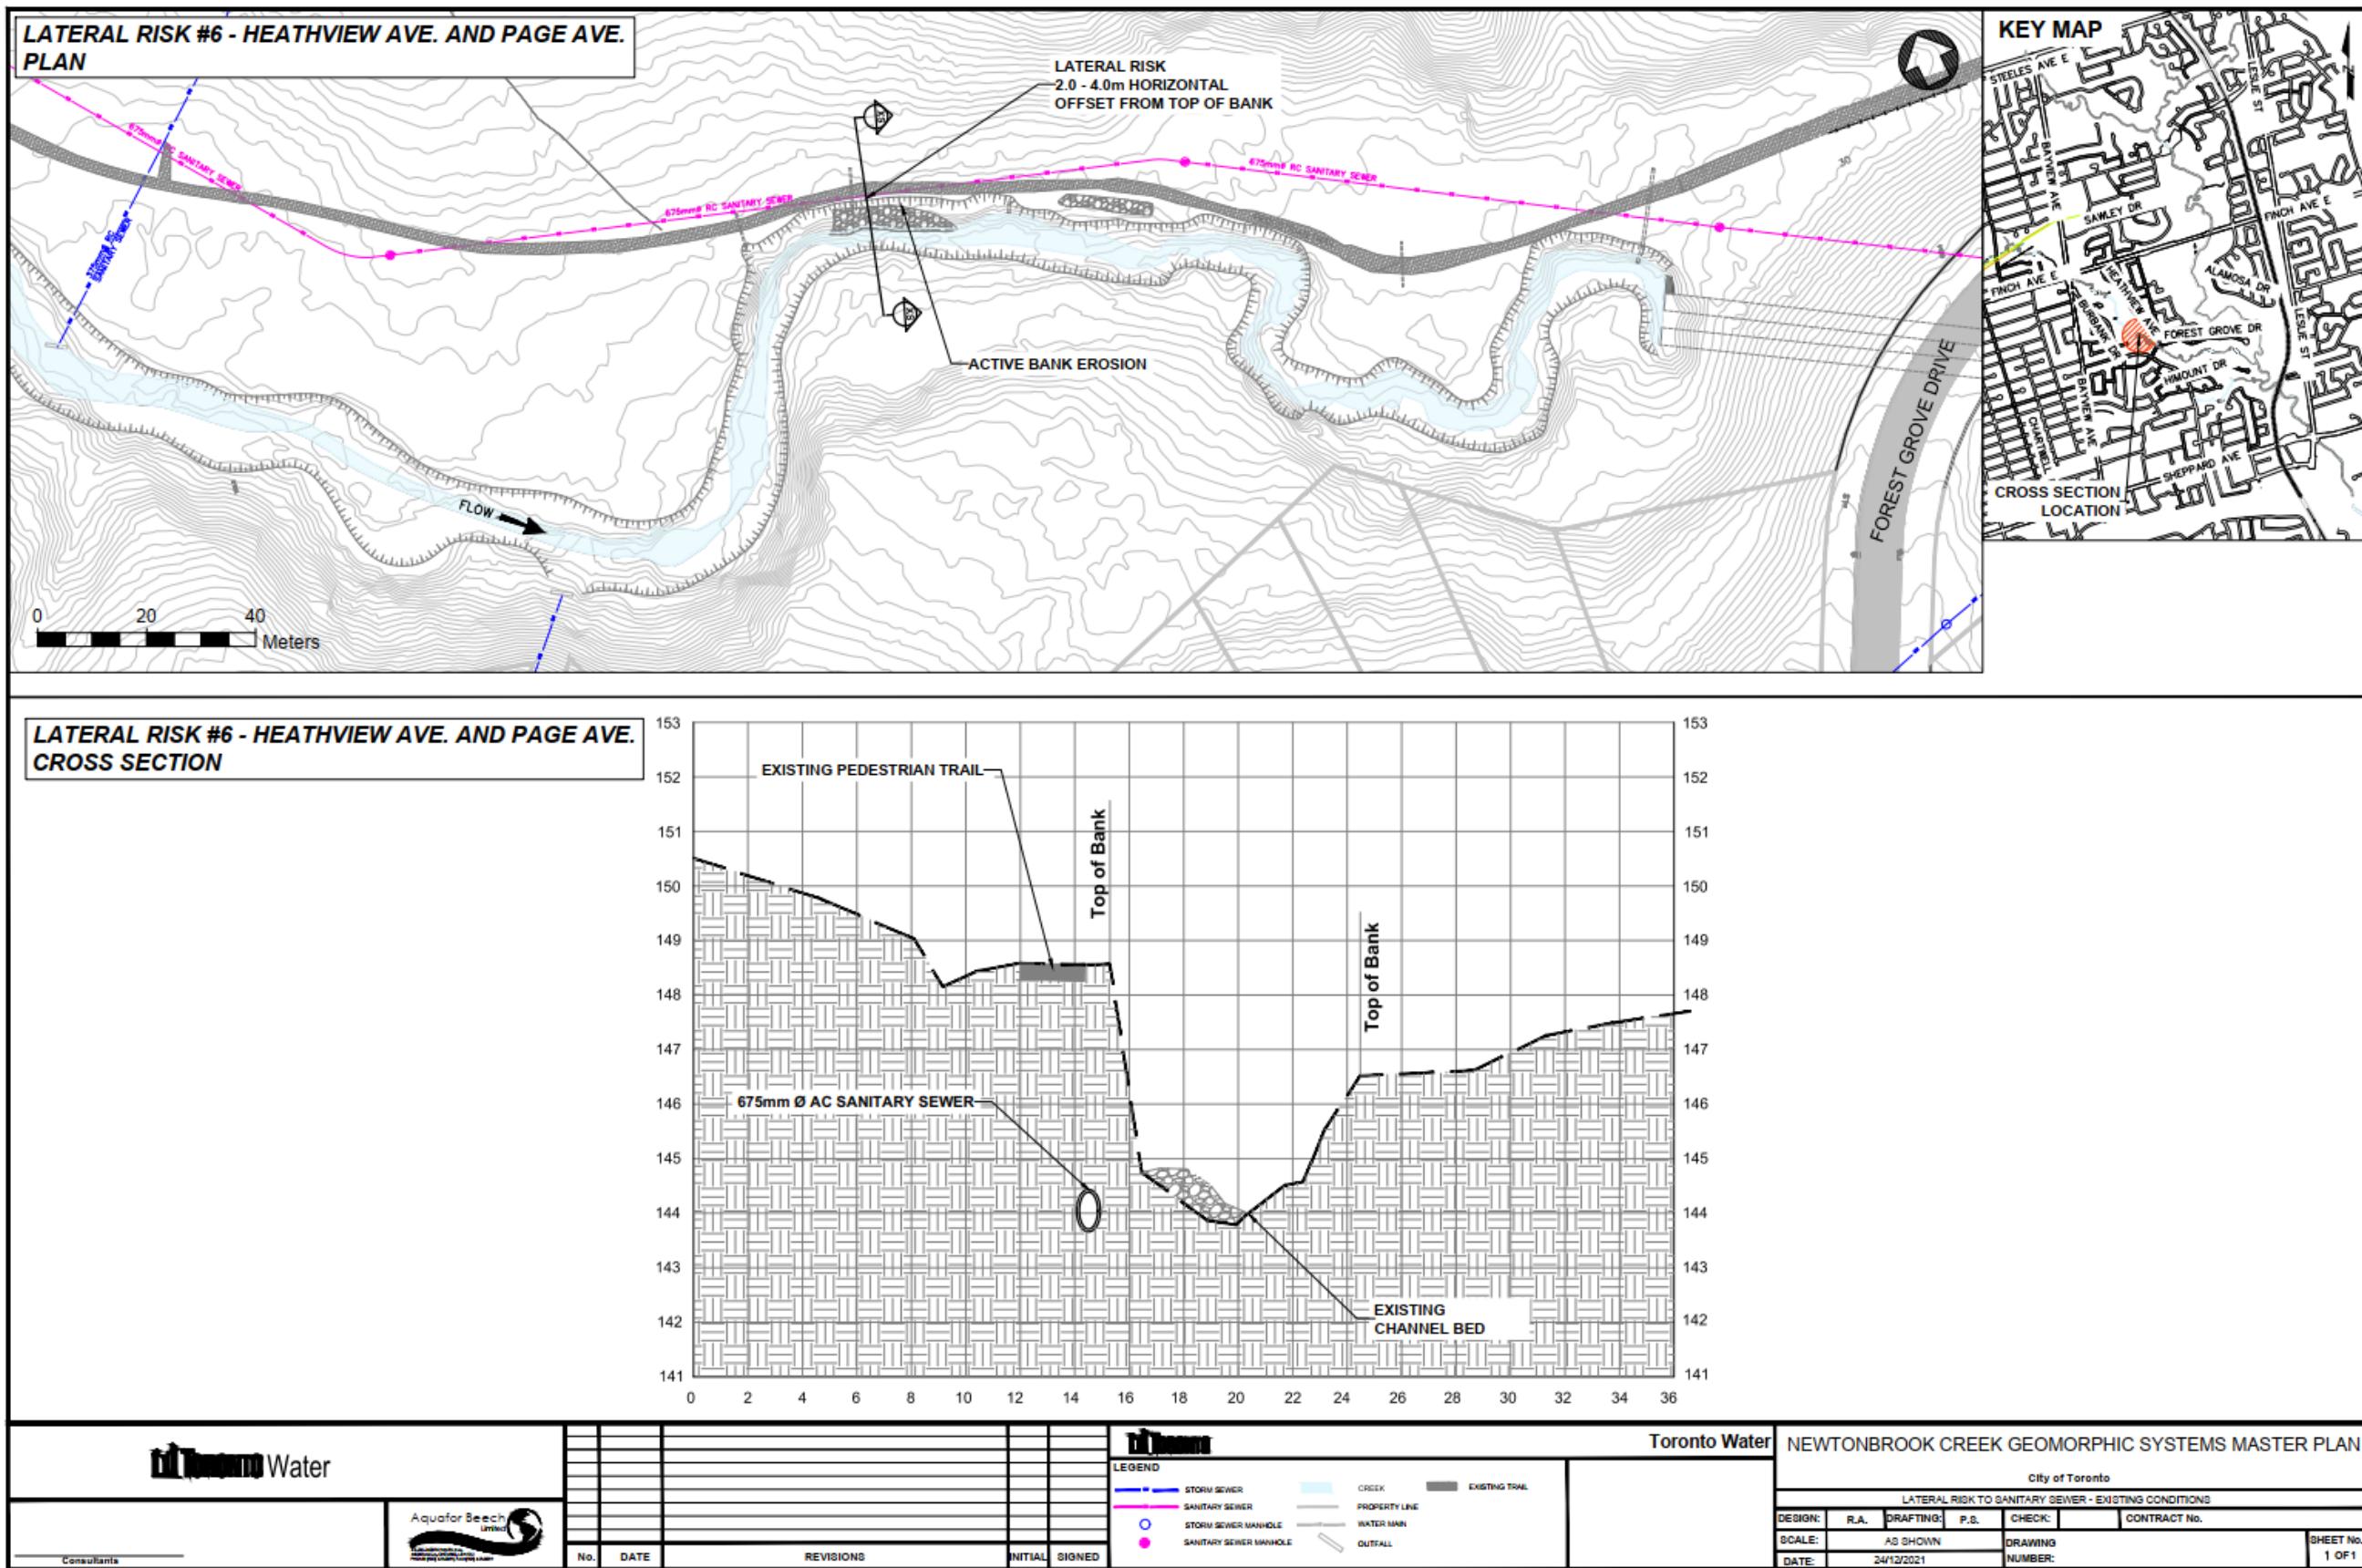
Figure 4-89: Existing Conditions – Priority Site #16

Parameter	Sanitary Trunk Sewer
Toronto Water Asset ID	SL4033585
Year of Construction	1960
Diameter	675
Lateral Depth of Cover	~4.00 m
Estimated Time to Contact	15.61 years
Condition of Bank Protection Works	N/A – No Bank Protection Works Present

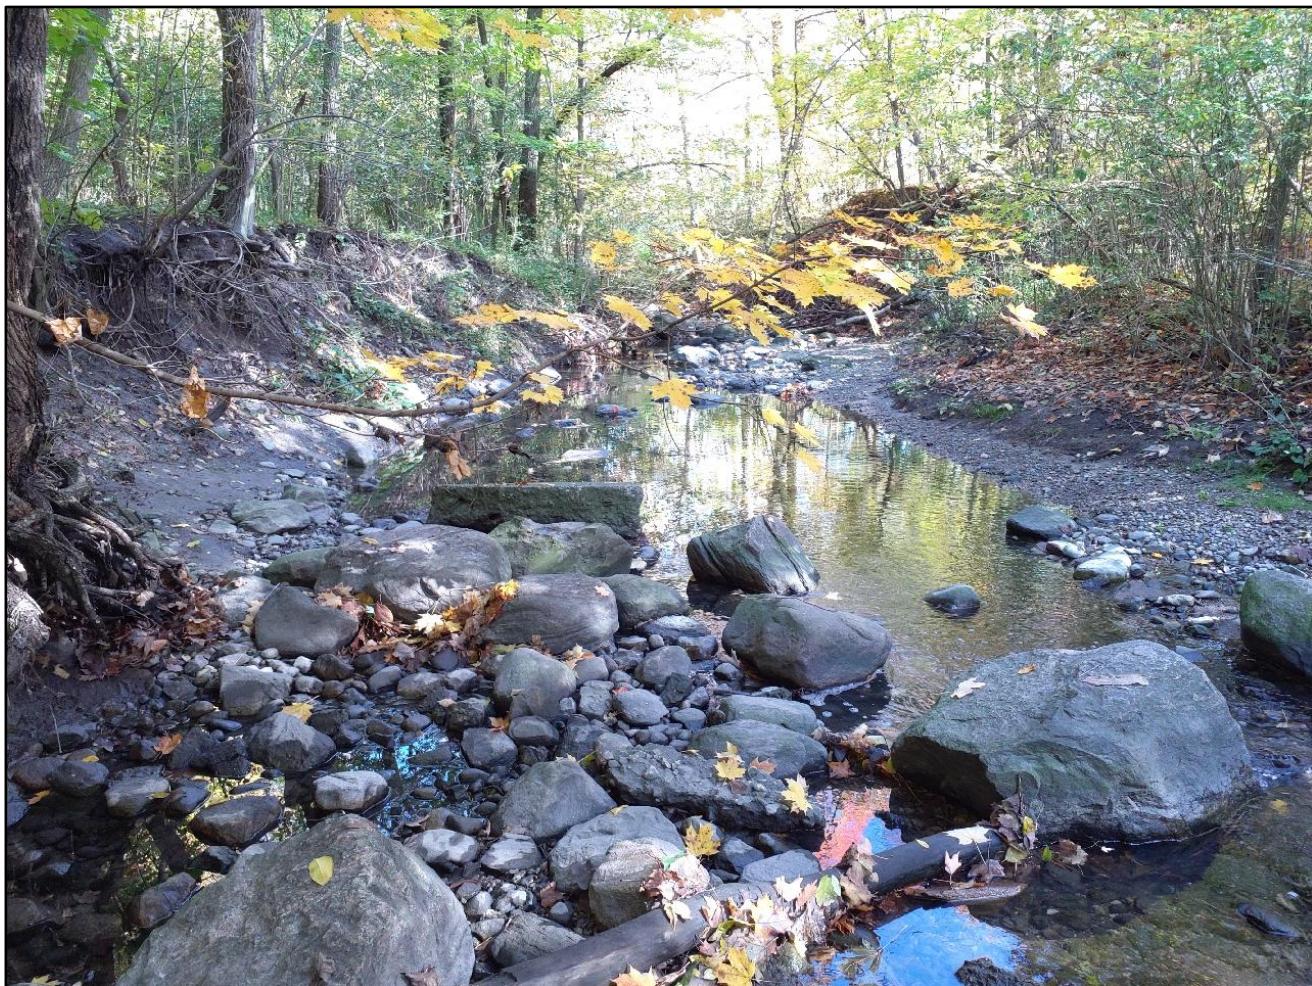
Positioned along the outside edge of a meander bend, this bank is particularly vulnerable to lateral erosive forces. Factoring in the existing rip-rap bank protection, the estimated time to contact is 15.97 years. However, it is highly probable that if the rip-rap lining the toe of the bank begins to wash out the bank will begin to erode more rapidly, potentially resulting in the exposure of the sanitary sewer. A photo illustrating the site-specific channel conditions and actively eroding bank is presented as **Figure 4-91**.

Figure 4-91: Degraded Channel Conditions at Priority Site #17. The Actively Eroding Bank has Created a Lateral Risk to a 675 mm Diameter Sanitary Sewer.

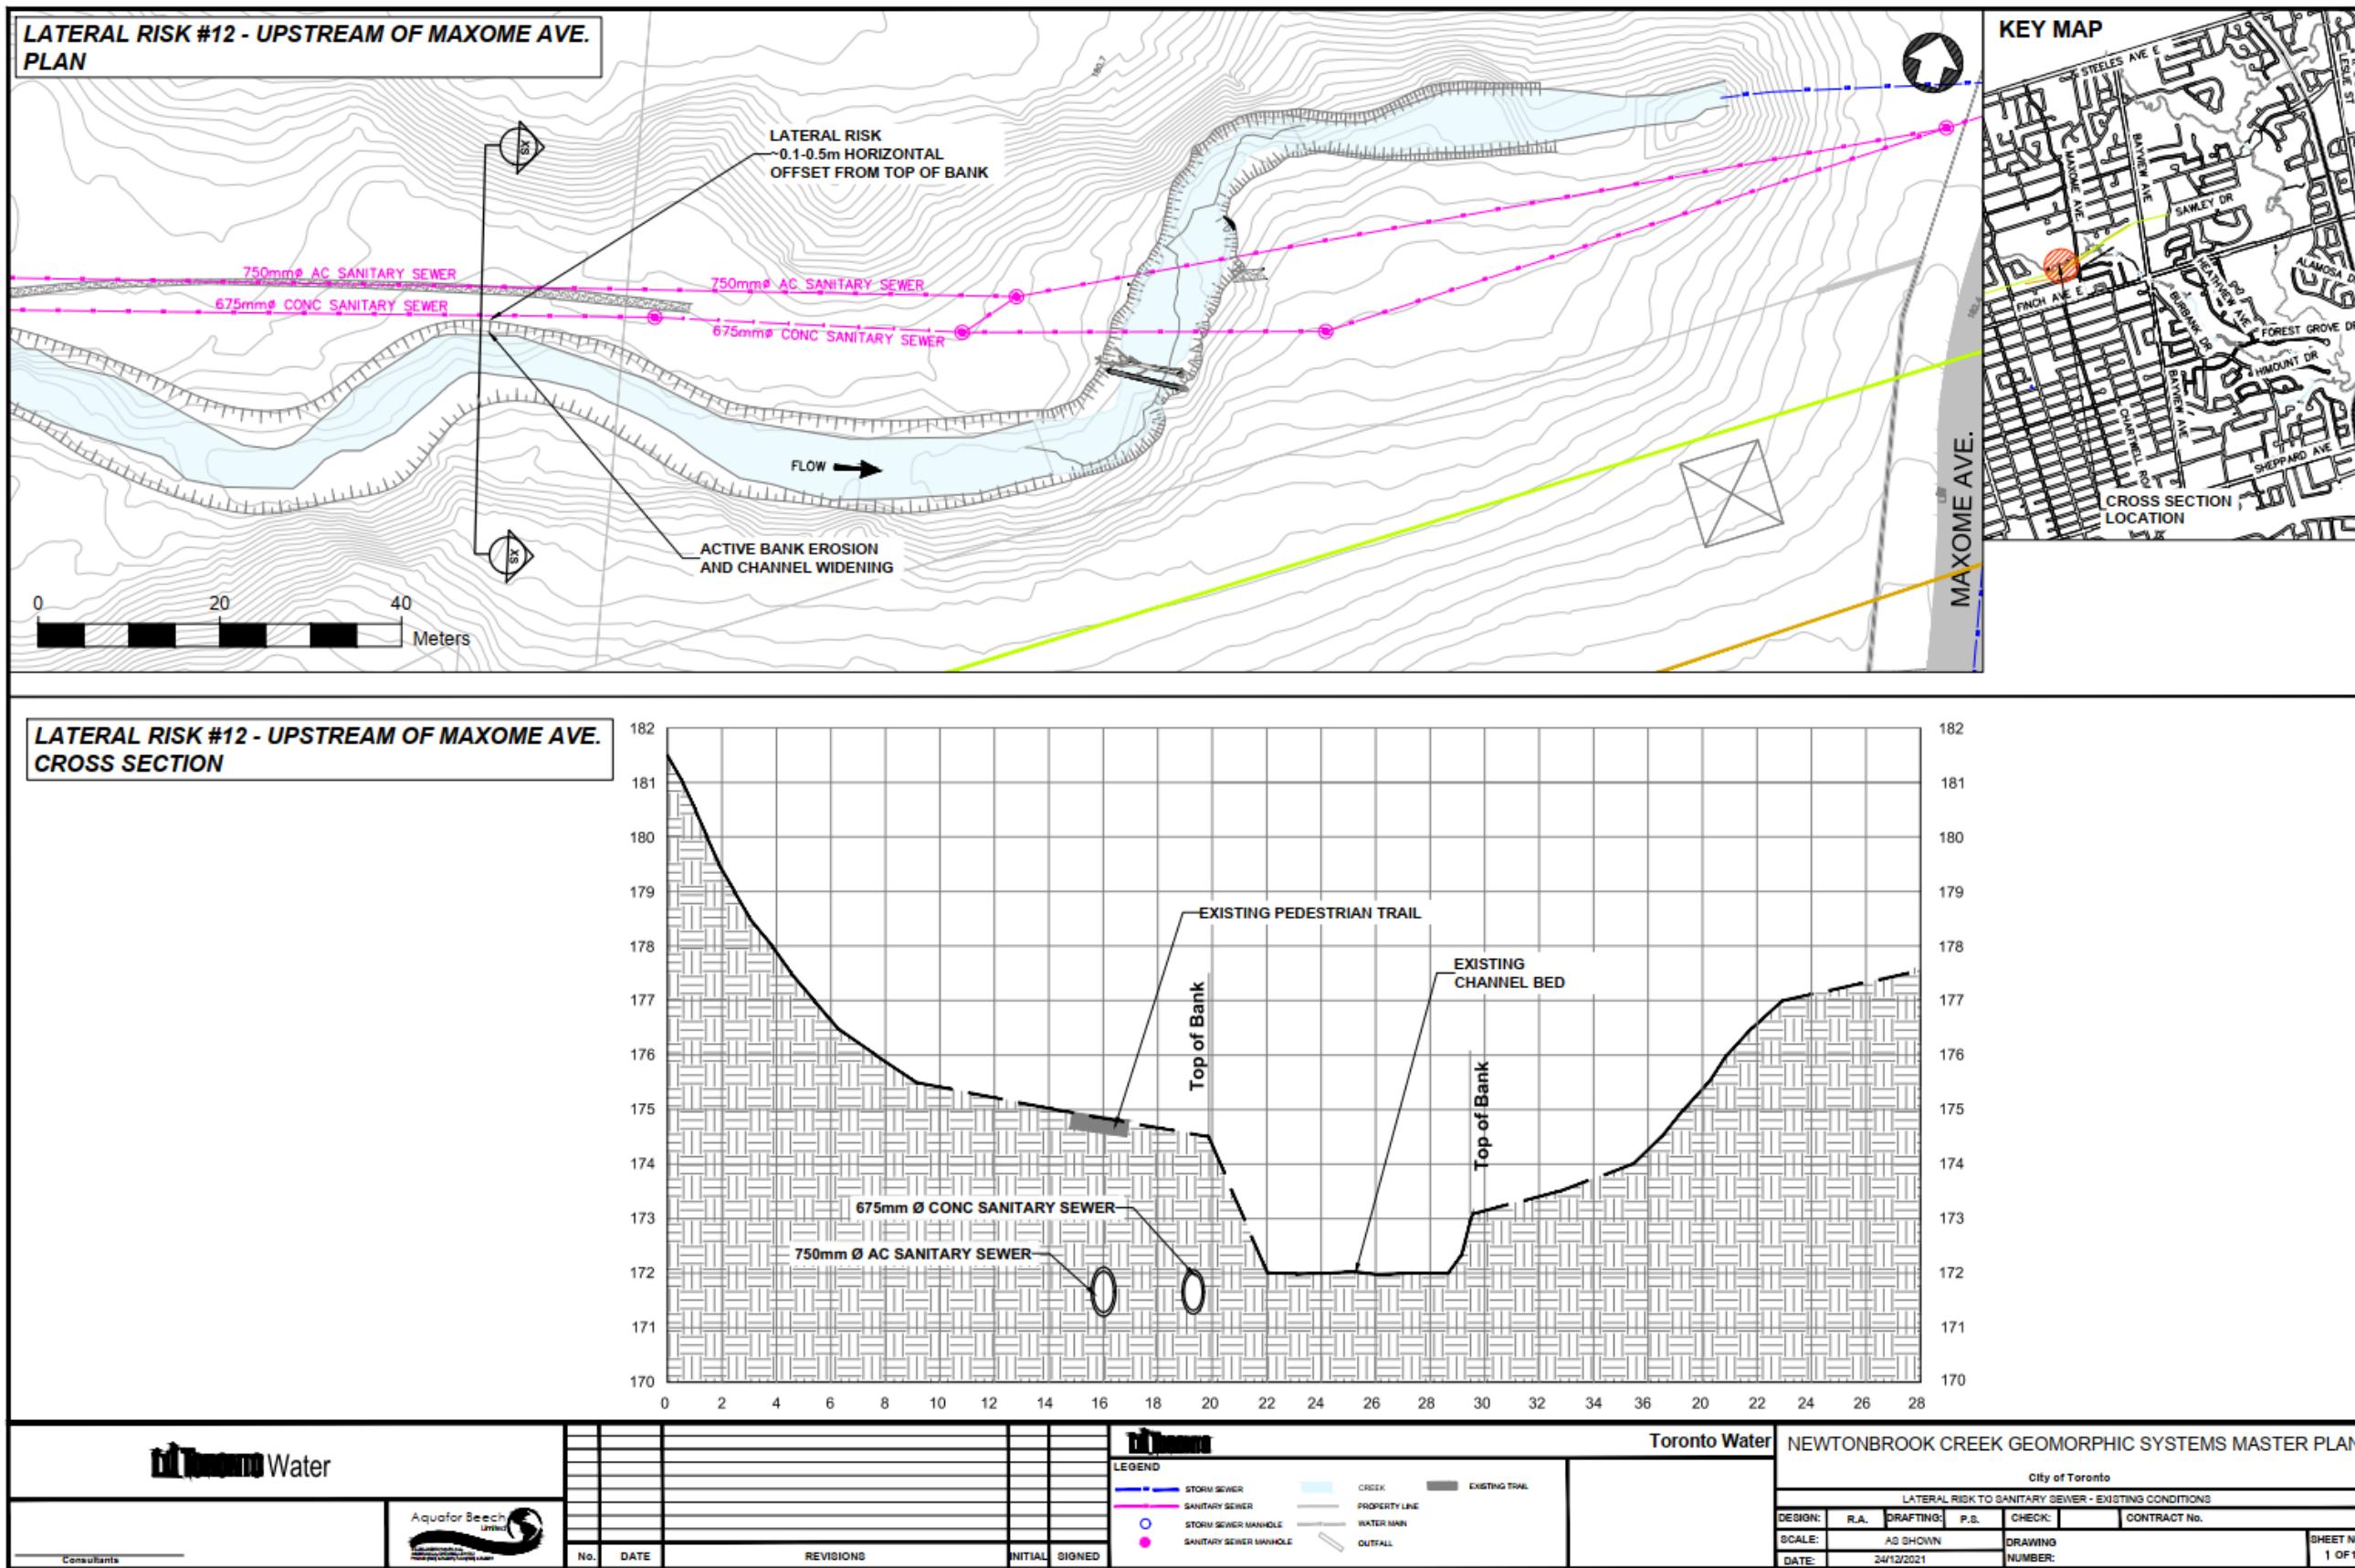
Figure 4-92: Existing Conditions – Priority Site #17

Parameter	Sanitary Trunk Sewer
Toronto Water Asset ID	SL4032958
Year of Construction	1989
Diameter	675
Lateral Depth of Cover	~ 0.10 m
Estimated Time to Contact	15.97 years
Condition of Bank Protection Works	Poor – Minimal Rip-Rap Protection at the Toe of Bank
