4.23 Priority Site #21 – Lateral Risk to Sanitary Sewer at Ambrose Road

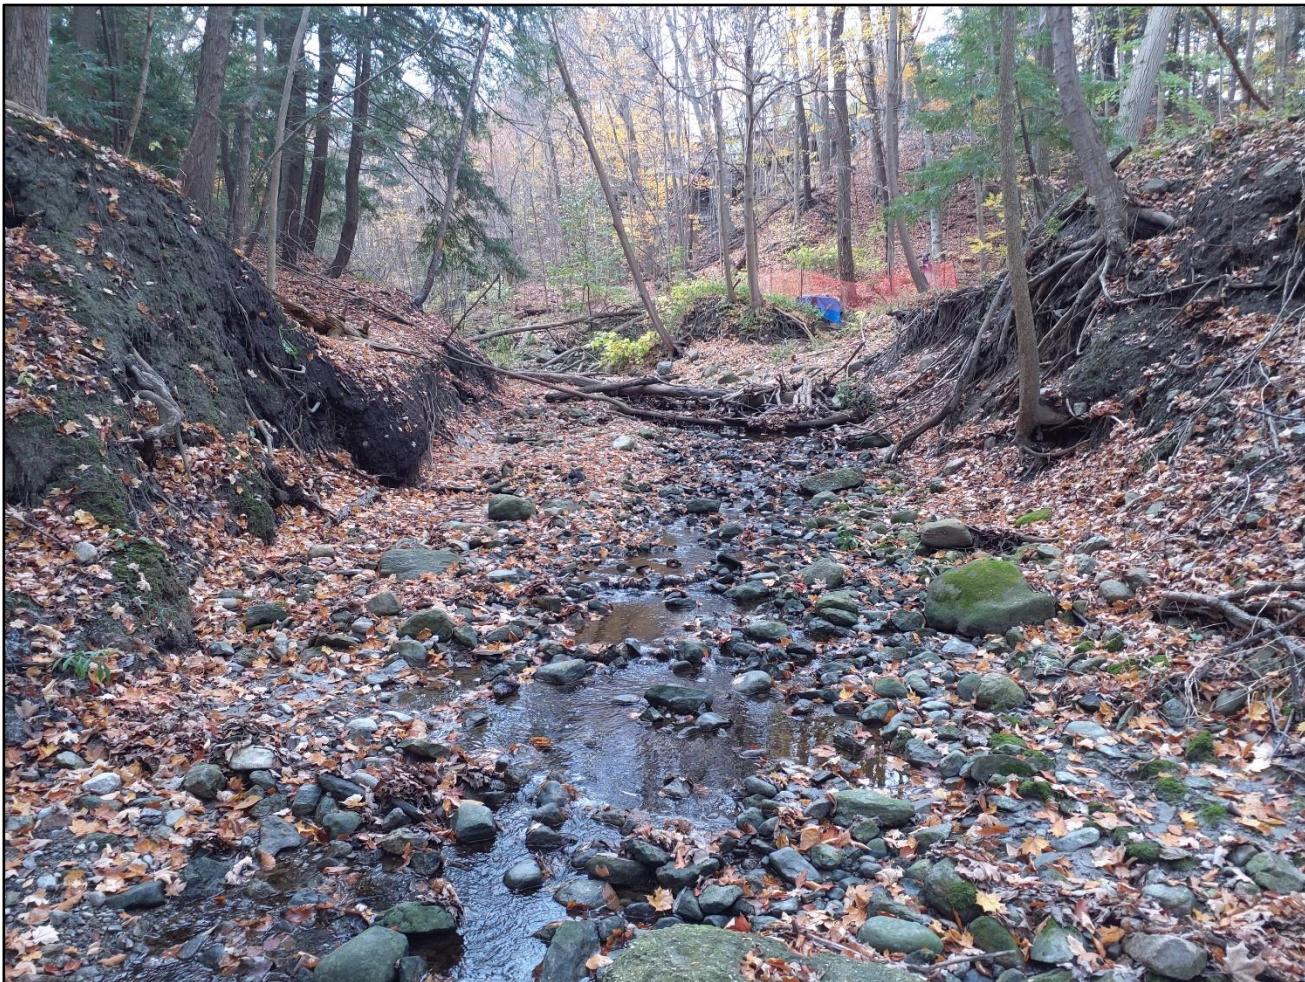
At this priority site location, bank erosion has created a lateral erosion risk to a 300 mm diameter sanitary sewer running parallel to the creek. The exposed bank materials are extremely erodible and are not protected by any engineered bank treatments. With an estimated lateral cover depth of 3.50 m, the projected time to contact is 11.74 years. It is recommended that consideration be given to protecting the sewer through the installation of an engineered bank treatment such as a vegetated buttress or armourstone retaining wall. A photo illustrating the site-specific channel conditions and actively eroding bank encroaching towards the sanitary sewer line is presented in **Figure 4-103**.

Figure 4-103: Degraded Channel Conditions at Priority Site #21, Where Actively Eroding Bank has Created a Lateral Risk to a 300 mm Diameter Sanitary Sewer

Parameter	Sanitary Trunk Sewer
Toronto Water Asset ID	SL4030487
Year of Construction	1977
Diameter	300
Lateral Depth of Cover	3.5 m
Estimated Time to Contact	11.74 years
Condition of Bank Protection Works	N/A – No Bank Protection Works Present

Alternative 2: Local Works – Construct a vegetated buttress, roughly 45 metres in length, centered around the point of minimum lateral cover. The vegetated buttress will provide lateral erosion protection and would tie-into the bank works proposed as part of the local works solution for Priority Site #13, which is the failed storm sewer outfall at Citation Drive. The slope behind the buttress will be regarded to smoothly transition into existing conditions, and will also be stabilized through the application of coir-matting and restoration plantings.

Alternative 3: Sub-Reach-Based Works – Apply natural channel design works for approximately 300 metres of channel length including riffle-pool morphology and engineered bank treatments. These works are intended to build the creek back up and stabilize this segment of Blue Ridge creek from a geomorphic perspective. The proposed works will extend from the confluence between Reaches BR-1 and BR-2 to just upstream of the confluence between Reaches BR-1, BR-3, and BR-4. The proposed works will look to realign the creek away from the sanitary sewer, and implement a vegetated buttress as bank protection works at this priority site location, in order to reduce the lateral erosion risk to the sanitary sewer. Implementation of this sub-reach-based works solution will also have the added benefit of restoring a failed storm sewer outfall identified as Priority Site #13, and protecting an exposed sanitary sewer crossing identified as Priority Site #14. Three (3) additional lateral erosion risks sites identified as Priority Sites #15, #29, and #36 will also be addressed through a combination of minor channel realignment to increase the erosion buffer and implementation of engineered bank treatments in the form of armourstone retaining walls or vegetated buttresses. These works are intended to tie-into a second sub-reach-based works alternative designed to address priority sites #12, #23 & #40 by restoring the remaining downstream portion of Reach BR-1.

- Apply approximately 300 metres of channel restoration work using natural channel design principles to establish riffle-pool morphology.
- Mitigate the identified lateral erosion risk to sanitary sewer infrastructure through a combination of minor channel realignment and the construction of a vegetated buttress to provide bank erosion protection.

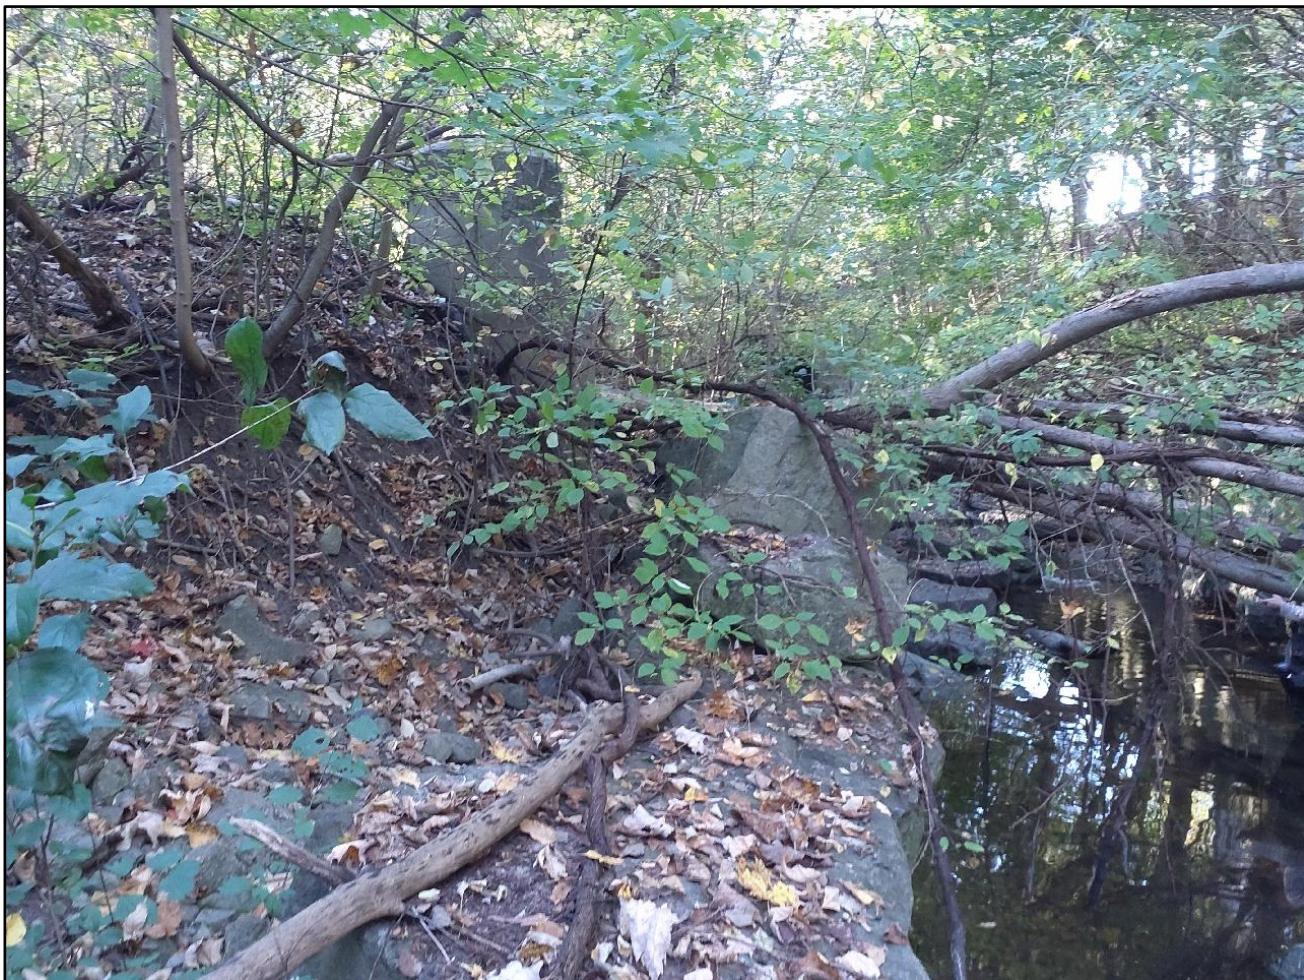
Downstream of the sewer crossing, the armourstone bank treatments have become outflanked and started to fail. This has contributed to the partial exposure of a sanitary sewer maintenance hole in the bank of the creek. The inlets sanitary sewer line is offset roughly 2.0 metres from the edge of the channel, representing a lateral erosion risk to sanitary infrastructure should the channel continue to erode and widen at this location. Considering the current poor-fair condition of the armourstone bank treatments, the projected time to contact is approximately twenty-three (23) years. There is an opportunity to address this lateral erosion risk, as well as the vertical erosion risk to the sanitary sewer crossing upstream through the application of the same local and/or sub-reach-based works design alternatives. A photo illustrating the site-specific channel conditions at this priority site is presented in **Figure 4-106**.

Figure 4-106: Outflanked and Failing Armourstone Retaining Wall Posing Lateral Erosion Risk to 675 mm Diameter Sanitary Sewer, Partial Exposure of Sanitary Sewer Maintenance Hole Present

Parameter	Sanitary Trunk Sewer
Toronto Water Asset ID	SL4033483
Year of Construction	1960
Diameter	675
Lateral Depth of Cover	2.0 m
Estimated Time to Contact	22.81 years
Condition of Bank Protection Works	Poor – Outflanked Armourstone Retaining Wall that is Starting to Fail

Alternative 2: Local Works – Remove the failing armourstone bed and bank treatments and apply channel engineering works for about 70 metres of channel length within reach N2. The works will start at the culvert crossing and extend downstream, establishing a cascade-pool morphology constructed of grouted armourstone ribs and engineered substrate. Both banks will be lined with a new set of armourstone retaining walls, extended beyond the length of the original structures to mitigate lateral erosion related risks to sanitary sewer infrastructure. Any erosion behind the proposed retaining wall will be infilled with approved materials, regraded and then stabilized through the application of coir-matting and restoration plantings. An engineered scour pool will be constructed immediately downstream of the culvert to provide energy dissipation and erosion control, as well as at the downstream extents of the proposed local works solution to facilitate a smooth transition into existing channel conditions. This solution will address erosion related risks to sanitary sewer infrastructure at this priority site, as well as priority site #9.

Alternative 3: Sub-Reach-Based Works – Apply the local works solution described above as part of a proposed 650 metres of channel restoration work intended to increase the depth of cover over four (4) sanitary sewer crossings (priority sites #5, #6, #7 & #9), mitigate lateral erosion risks to sanitary sewer infrastructure at five (5) locations (priority sites #8, #19, #21, #22 & #26), and allow for the rehabilitation of two (2) storm sewer outfalls (priority sites #53 & #65). Targeted realignment of the channel coupled with the implementation of engineered bank treatments will also help to alleviate potential erosion related risks to the pedestrian trail system. The proposed channel restoration works will include a combination of cascade-pool and riffle-pool morphology, coupled with engineered bank treatments (vegetated buttresses, and armourstone retaining walls), designed with the intent of building the creek up to establish a minimum of 1.0 metres of additional cover overtop of all applicable sanitary sewer crossings, and limit the protection of the sewer crossing's dependence on the long-term stability of any downstream grade control structures.

- Mitigate the identified lateral erosion risk to sanitary sewer infrastructure through the construction of a new armourstone retaining wall.
- Address a major lateral erosion risk to an exposed sanitary sewer maintenance hole (Priority Site #8 - SL4033483) through a combination of minor channel realignment and construction of an armourstone retaining wall.

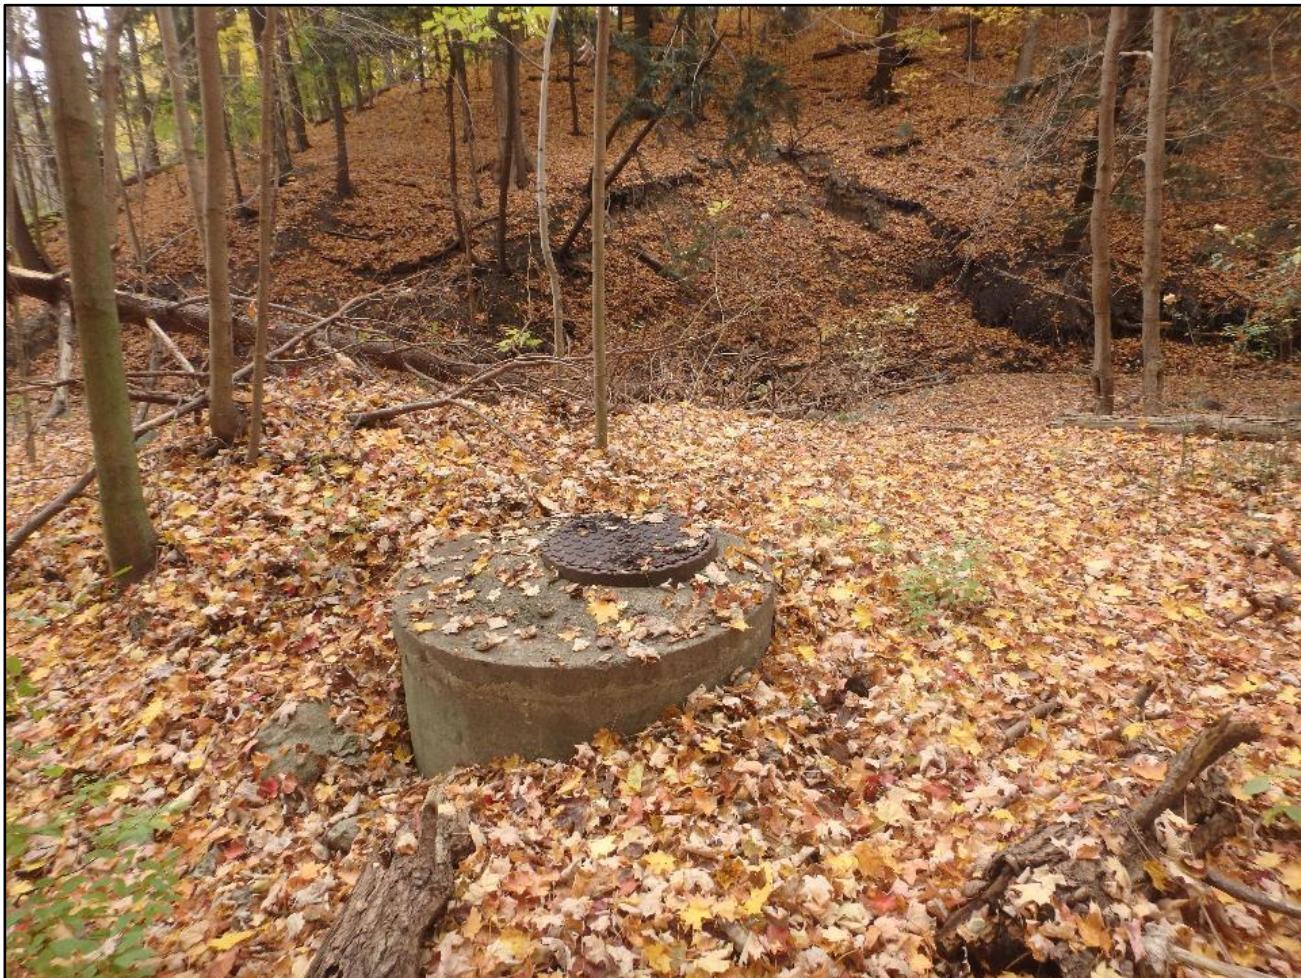
At this priority site location, active bank and slope erosion has reduced the lateral erosion buffer between the creek and the sanitary sewer to roughly twelve (12) meters. No engineered bank protection works have been implemented at this location, and the exposed bank materials are highly erodible. The projected time to contact is approximately forty (40) years. Given that the time to contact is relatively high (greater than 20 years), this erosion risk can be viewed as a lower risk site, that should either be addressed individually in the medium to long term, or more immediately through the implementation of a sub-reach-based solution that is designed to address several other higher priority sites with more imminent risk horizons. A photo illustrating the site-specific channel conditions near this priority site is presented in **Figure 4-109**.

Figure 4-109: Representative Site conditions Near Priority Site #23

Parameter	Sanitary Trunk Sewer
Toronto Water Asset ID	SL4053177
Year of Construction	1977
Diameter	300
Lateral Depth of Cover	12.0 m
Estimated Time to Contact	40.27 years
Condition of Bank Protection Works	NA - No Bank Protection Works Present

Alternative 2: Local Works – Construct a vegetated buttress on the northerly bank, roughly 40 metres in length, centered around the point of minimum lateral cover. The vegetated buttress will help mitigate lateral bank erosion and protect sanitary sewer infrastructure. The slope behind the buttress will be regraded to smoothly transition into existing conditions, and will also be stabilized through the application of coir-matting and restoration plantings.

Alternative 3: Sub-Reach-Based Works – Apply natural channel design principles for an extended length of approximately 275 metres intended to build the creek back up and stabilize this segment of Blue Ridge creek from a geomorphic perspective. The proposed works will extend from the Creek's confluence with the East Don River, upstream to the confluence with Reach BR2, and will include a combination of riffle-pool morphology coupled with a mixture of engineered bank treatments (vegetated buttresses and armourstone retaining walls). Adjustments to the longitudinal profile, planimetric alignment and typical channel dimensions will look to stabilize the creek and provide increased lateral cover to the sanitary trunk sewer that runs through the Blue Ridge Creek Valley Corridor. These works will integrate the restoration of the failed storm sewer outfall at Hi Mount Drive identified above as priority site #12, while also addressing additional lateral risk sites #17 & #18, which have been defined as priority sites #23 & #40 respectively. These works are intended to tie-into a second sub-reach-based works alternative, intended to address priority sites #13, #14, #15, #21, #29, and #36 by restoring the remaining upstream portion of Reach BR1.

- Mitigate the identified lateral erosion risk to sanitary sewer infrastructure through minor channel realignment and construction of vegetated buttress bank protection works.

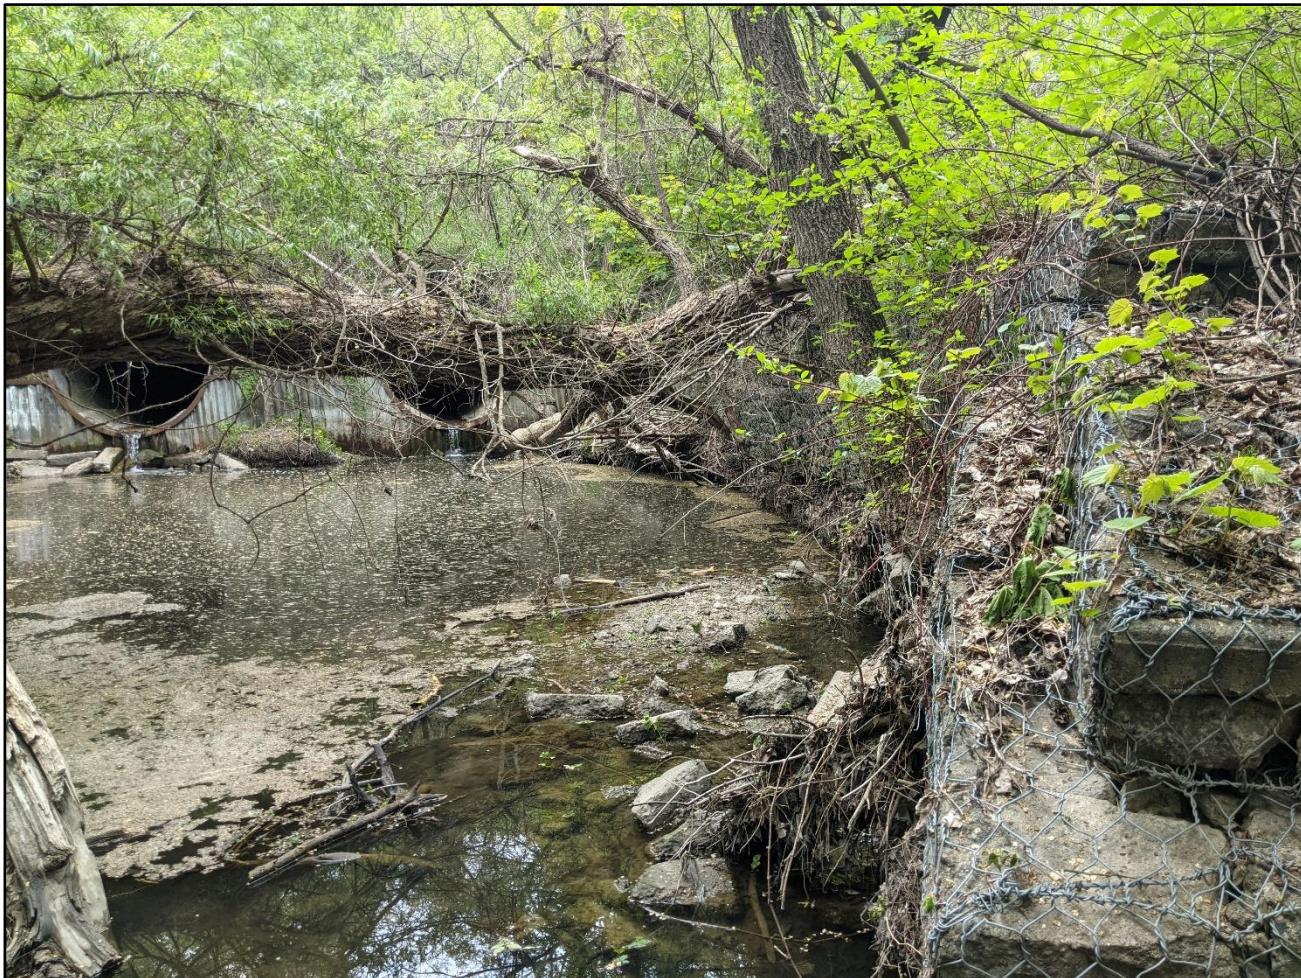
Priority Site #24 is located in Reach N1 of Newtonbrook Creek, immediately downstream of the Forest Grove Culvert Crossing. Expansion of flows exiting the culvert, has resulted in the formation of a large scoured area downstream. The channel is notably wider at this location. Erosion along the northerly bank has created a lateral erosion risk to the 675 mm diameter sanitary trunk sewer that runs through the Newtonbrook Creek valley corridor. Part of the eroding bank is lined with a deteriorated gabion basket retaining wall that provides minimal erosion protection, while the rest of the bank is unprotected. The estimated depth of lateral cover is 10.5 m, and the projected time to contact is forty-three (43) years.

Given that the time to contact is relatively high (greater than 20 years), this erosion risk can be viewed as a lower priority risk site, that should either be addressed individually in the medium to long term, or more immediately through the implementation of a sub-reach-based solution that is designed to address several other higher priority sites with more imminent risk horizons. A failed storm outfall discharges to the channel along the opposite (southerly) bank. This outfall has been identified as priority site #3. Given the close spatial proximity of these sites, there is an opportunity to restore both sites through a single capital project. A photo illustrating the site-specific conditions near this priority site is presented in **Figure 4-112**.

Figure 4-112: Representative Site Conditions Near Priority Site #24.

Parameter	Sanitary Trunk Sewer
Toronto Water Asset ID	SL4033584
Year of Construction	1960
Diameter	675
Lateral Depth of Cover	10.5 m
Estimated Time to Contact	43.25 years
Condition of Bank Protection Works	Partial Coverage with Gabion Baskets in Poor Condition

Alternative 2: Local Works – Construct an armourstone retaining wall with vegetated boulder toe protection along the eroding bank, roughly 35 metres in length, centered around the point of minimum lateral cover. The partially buried retaining wall will help mitigate lateral bank erosion and protect sanitary sewer infrastructure. The slope behind the armourstone wall will be regarded to smoothly transition into existing conditions, and will also be stabilized through the application of coir-matting and restoration plantings.

- Mitigate the lateral erosion risk to sanitary sewer infrastructure through the construction of a buried armourstone retaining wall with vegetated buttress toe protection.
