Appendix N

Erosion Hazard Sites

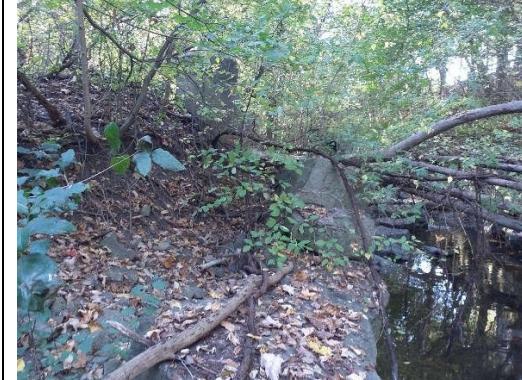
Reach	Owner ID	TRCA Inventory ID	Location	Structure type within 25 m	TRCA Comments	Photos
N2	DR39.1	D-28-38	Rainbow Creek Way (21)	Rip rap revetment	Moderate to major displacement has occurred throughout the entire length of the structure. There continues to be two sections of the intact portion of the structure, measuring 26 m in length at the u/s section and 9 m in length at the d/s section. Multiple scours are present in the areas of displacement. The u/s limit scour measures 12 m in length, 2 m in width and 1.5 m in height. The scour has exposed a portion of the chimney of a sanitary manhole (Asset I.D: MH4918613545) with a max depth of 2.3 m. A privately owned sanitary line crosses the watercourse at the u/s portion of the structure. High priority assigned as scouring and displacement has exposed two sanitary manholes. In addition, a private sanitary encasement is exposed in the channel bed at the midsection of the structure.

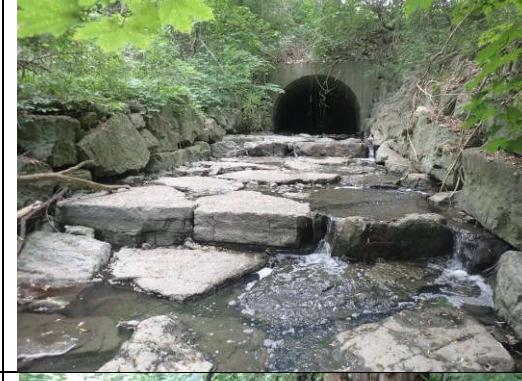
N2	DR39.2	D-28-35	Rainbow Creek Way (21)	Channel armourstone	Several voids and minor slumping are present along both banks above and within the channelized structure. The structure appears to be intact from the u/s limit to the midsection; however, the d/s section adjacent to the left bank has completely displaced (and appears that the material has settled further d/s) with a max length of 15.5 m. There is a scour at the d/s limit that continues into the adjacent structure (DR39.1) measuring 12 m in length, 2 m in width and 1.5 m in height. The sanitary manhole chimney continues to be exposed with a max depth of 2.3 m.

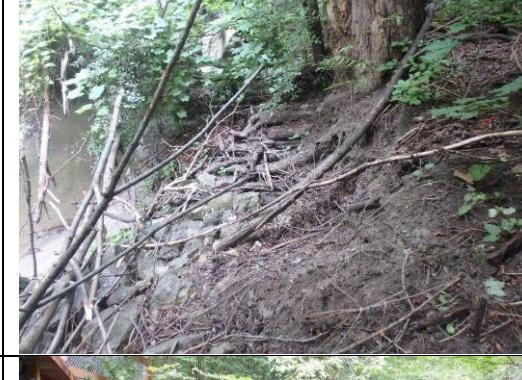
N2	DR39.3	D-28-37	Rainbow Creek Way (21)	Rip rap revetment	Minor displacement and debris buildup is present throughout the structure. A scour (4.25 m long, 1 m wide, 0.8 m high) is present at the u/s limit. An exposed encasement is present at the midsection. Low priority assigned because the structure is in good condition and is not putting public safety at risk at the time of inspection.

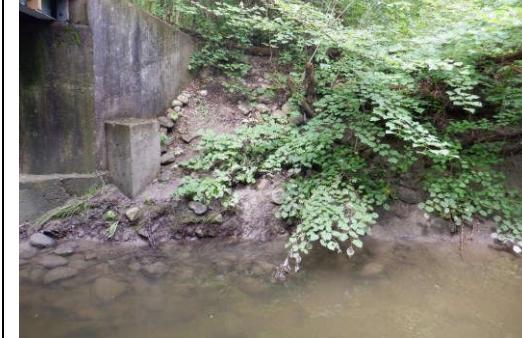
N2	DR77	D-28-61.02	Newtonbrook Park	Fieldstone revetment	Major displacement and sediment buildup is found at the u/s portion of the structure. Complete displacement (2 m long) is found adjacent to the bridge abutment. Minor displacement of fieldstone is evident along the toe of the d/s portion of the structure. Bridge is closed at the time of inspection due to failure of the bridge abutment on the opposite bank. Toe erosion mentioned in the previous record is not found at the time of inspection. The deficiencies are not posing a risk to public safety or essential infrastructure at the time of inspection.

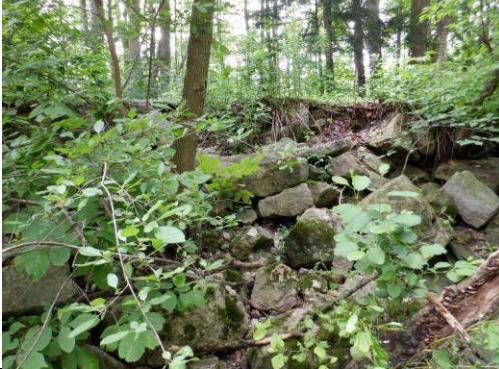
Reach	Owner ID	TRCA Inventory ID	Location	Structure type within 25 m	TRCA Comments	Photos
Don River	DR62	D-16-64	East Don Parklands - Below Black Willoway	Fieldstone rip rap revetment	The fieldstone and riprap revetment is experiencing moderate displacement of fieldstone throughout the entire structure, mainly along the top of the bank. A corrugated metal culvert is partially submerged in the watercourse adjacent to the u/s limit of the structure. A scour (4.9 m long, 0.8 m wide, and 1 m high) is present along the u/s section of the structure. In the area of scouring, moderate to major displacement of fieldstone is present at the toe and geotextile is exposed within the area. The scour is eroding the formal path and downcutting is present in the area of the sanitary line.
