Appendix J

Summary Sheets for Sanitary Sewer Lateral Risk Sites

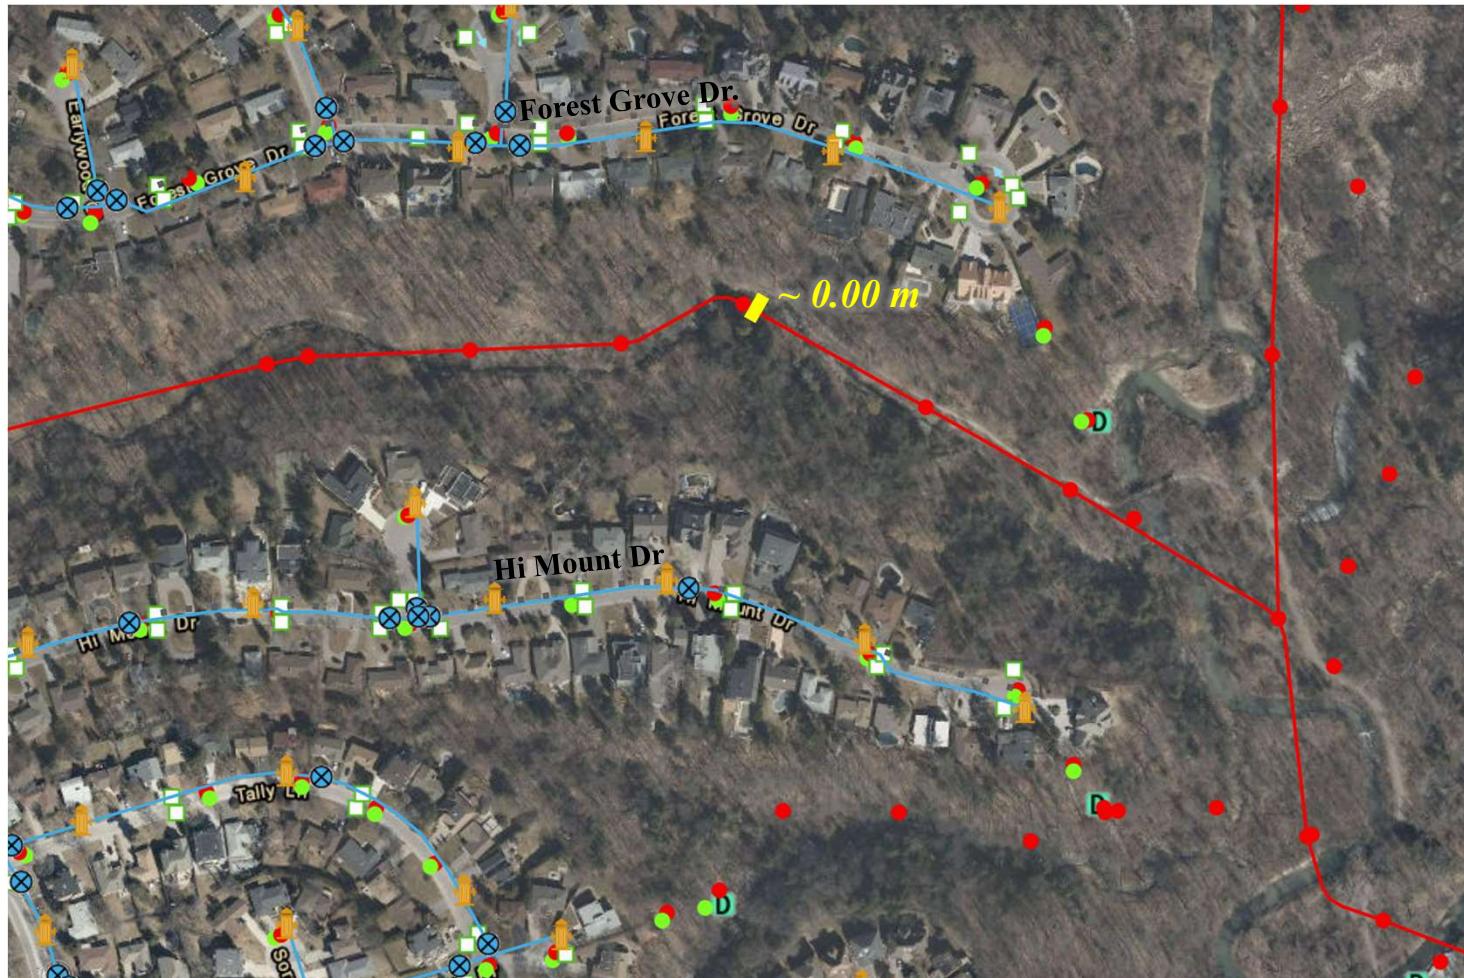
Sanitary Sewer Lateral Risk #1

Horizontal Offset: 0.00 m
Radius of Curvature (R_c): 40.14 m
Width (w): 5.61 m
 $R_c / w = 7.16$
Bank Protection Works: None
Condition of Bank Protection Works: N/A

Downstream migration of the meander bend and channel widening has exposed the manhole casing and poses risk to sewer

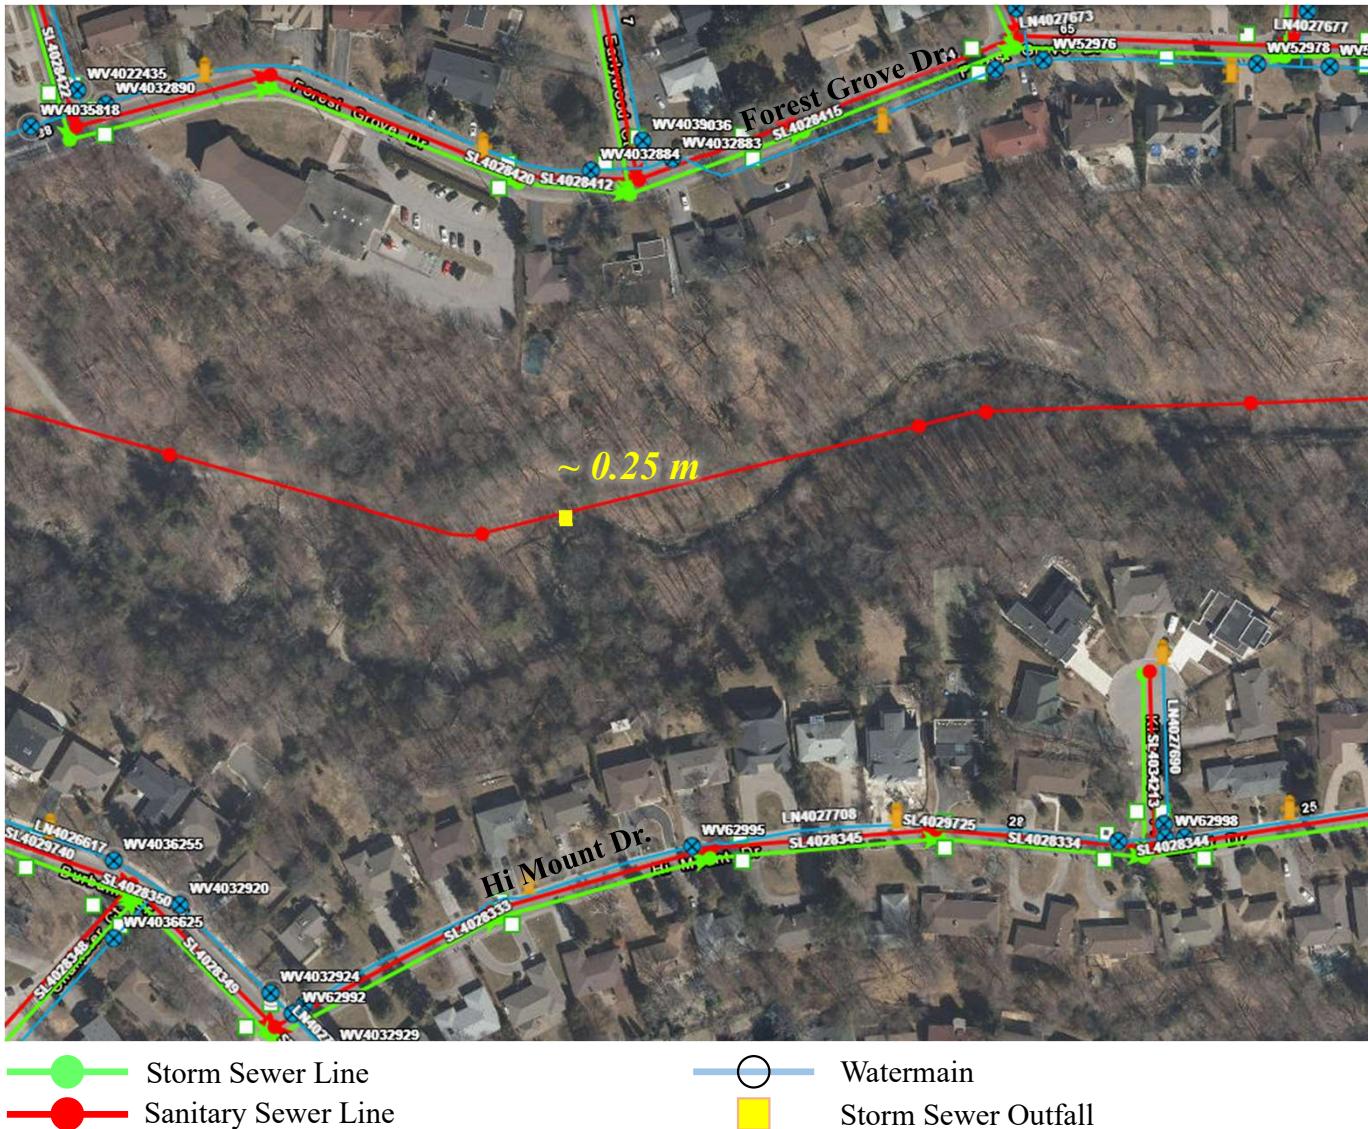
Sanitary Sewer Lateral Risk #2

Horizontal Offset: 0.25 m

$$R_c / w = 2.44$$

Bank Protection Works: Gabion Baskets

Condition of Bank Protection Works: Fair

Sanitary Sewer adjacent to the creek at meander apex.

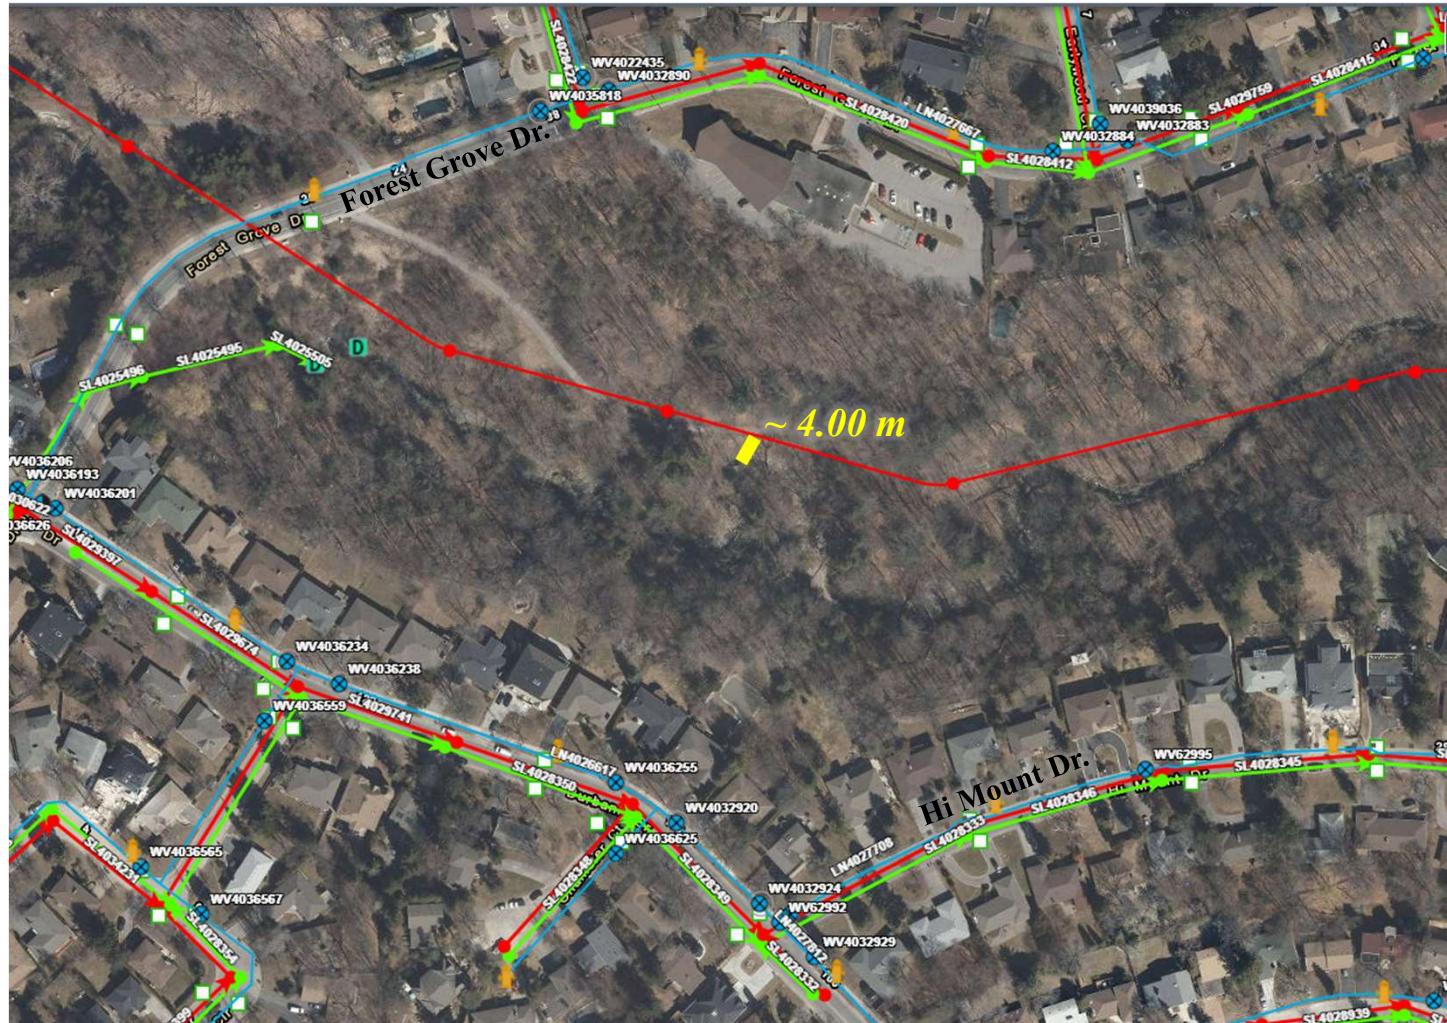
Sanitary Sewer Lateral Risk #3

Horizontal Offset: 4.00

$R_c / w = 1.94$

Bank Protection Works: Concrete Block Wall

Sanitary sewer adjacent to the creek at the meander apex.

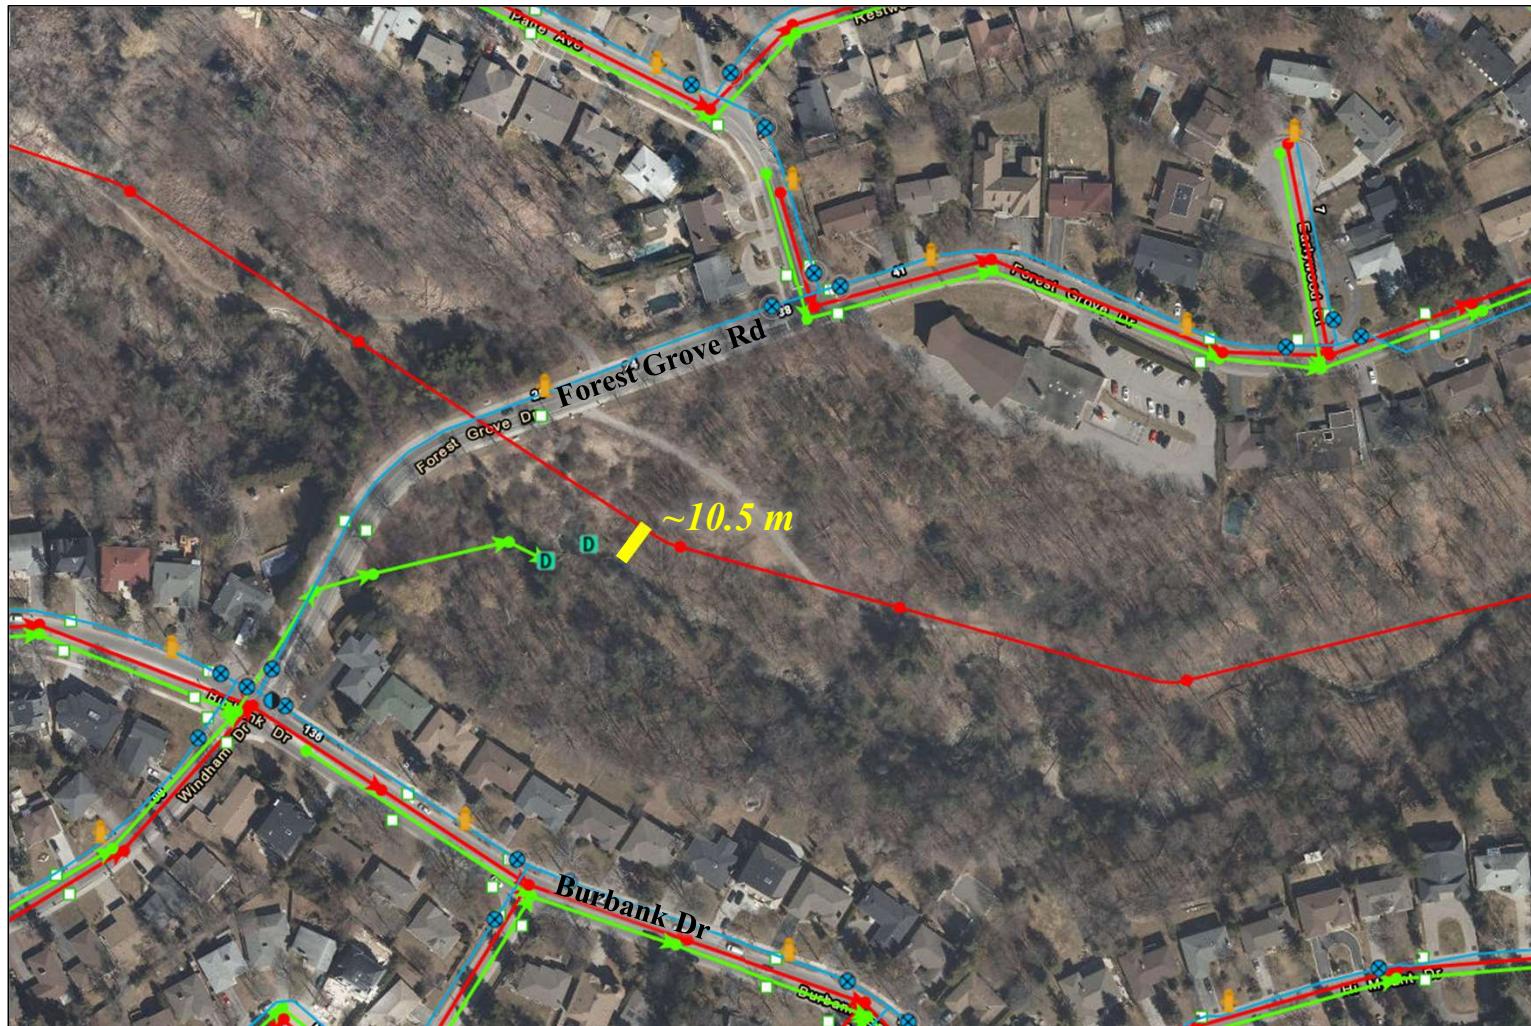
Sanitary Sewer Lateral Risk #4

Horizontal Offset: 10.5 m

$R_c / w = 4.84$

Sewer parallel to Newtonbrook Creek in the valley slope downstream of Forest Grove Dr. Two storm sewer outfalls here, both are priority sites.

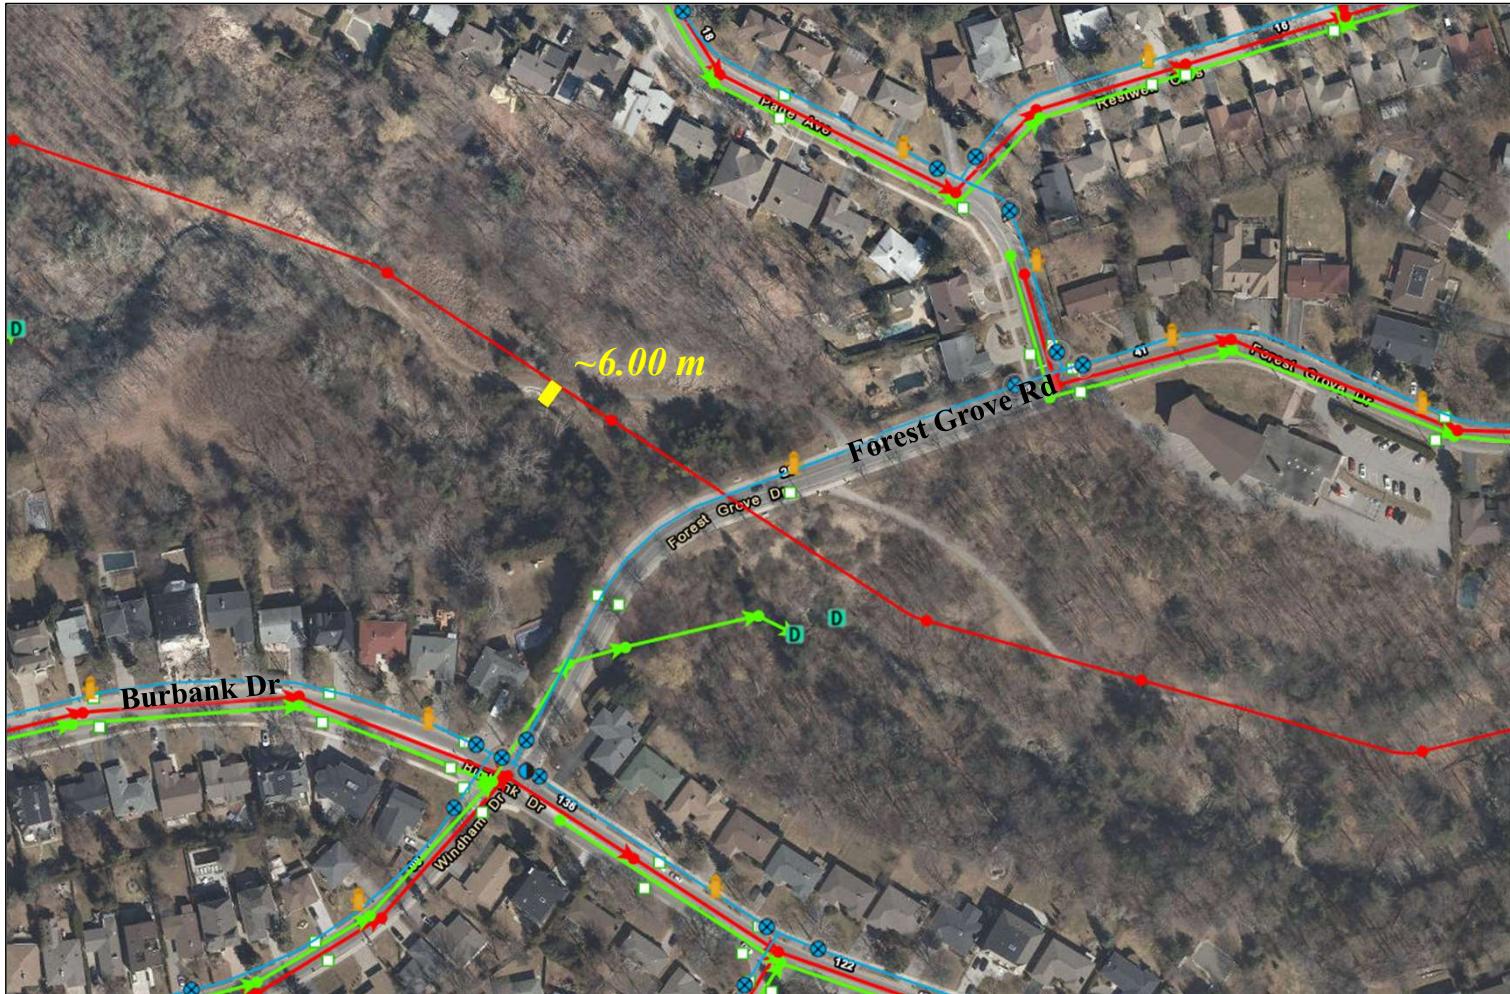
Sanitary Sewer Lateral Risk #5

Horizontal Offset: 6.00 m

$R_c / w = 1.27$

Upstream of Forest Grove Rd.

Active erosion is narrowing pedestrian trail.

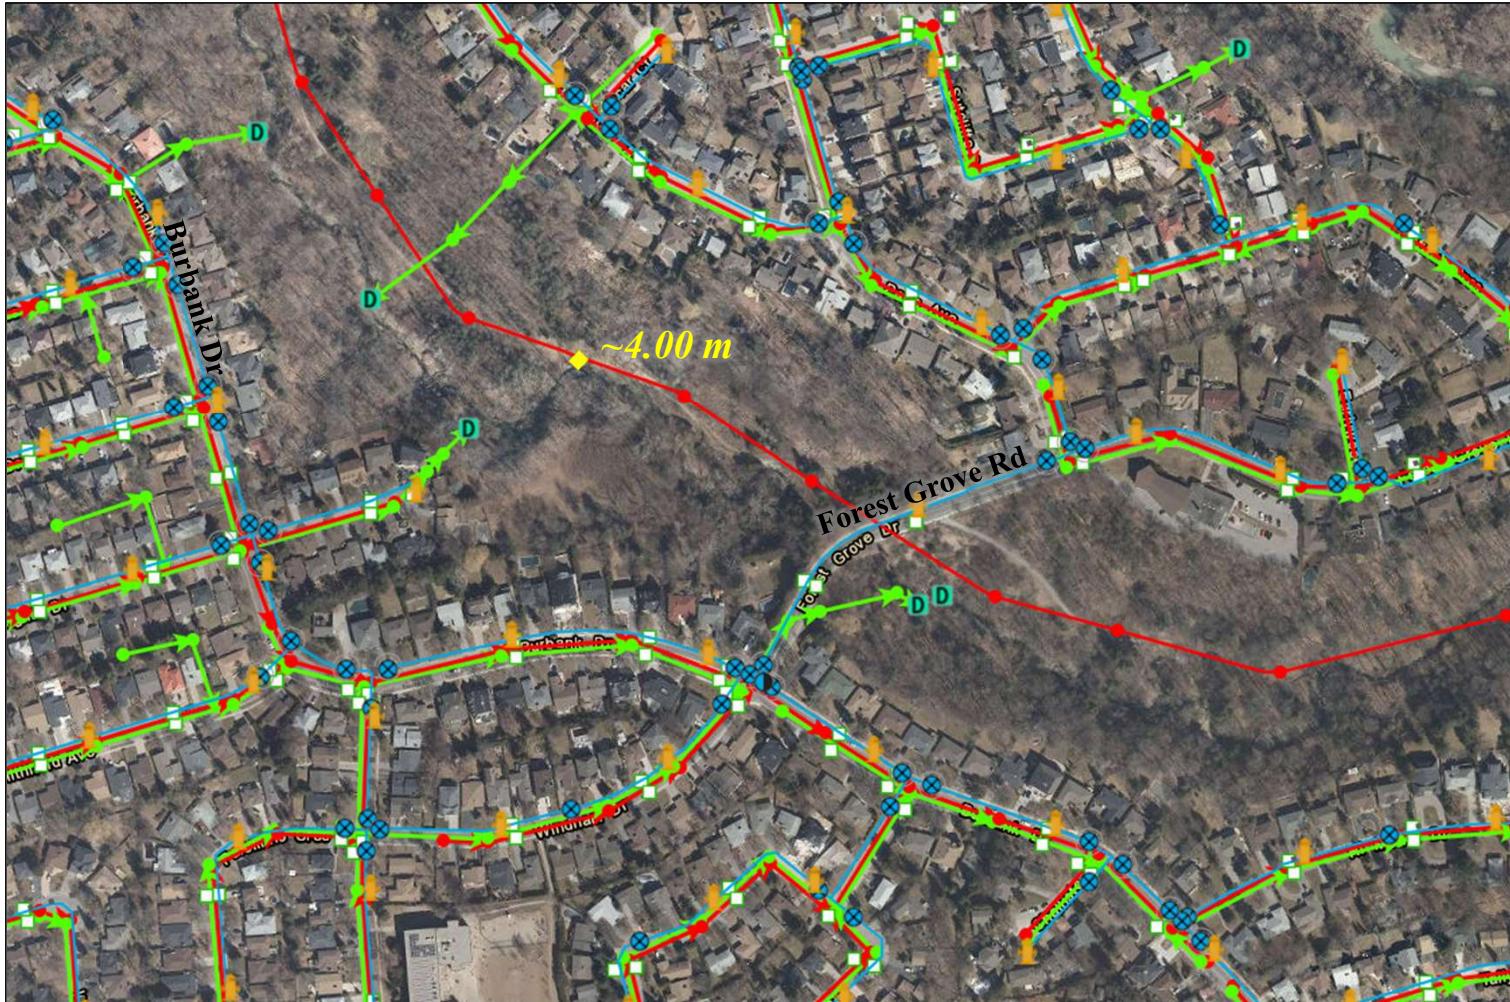
Sanitary Sewer Lateral Risk #6

Horizontal Offset: 4.00 m

$R_c / w = 2.28$

Active erosion into adjacent pedestrian trail with bare soil

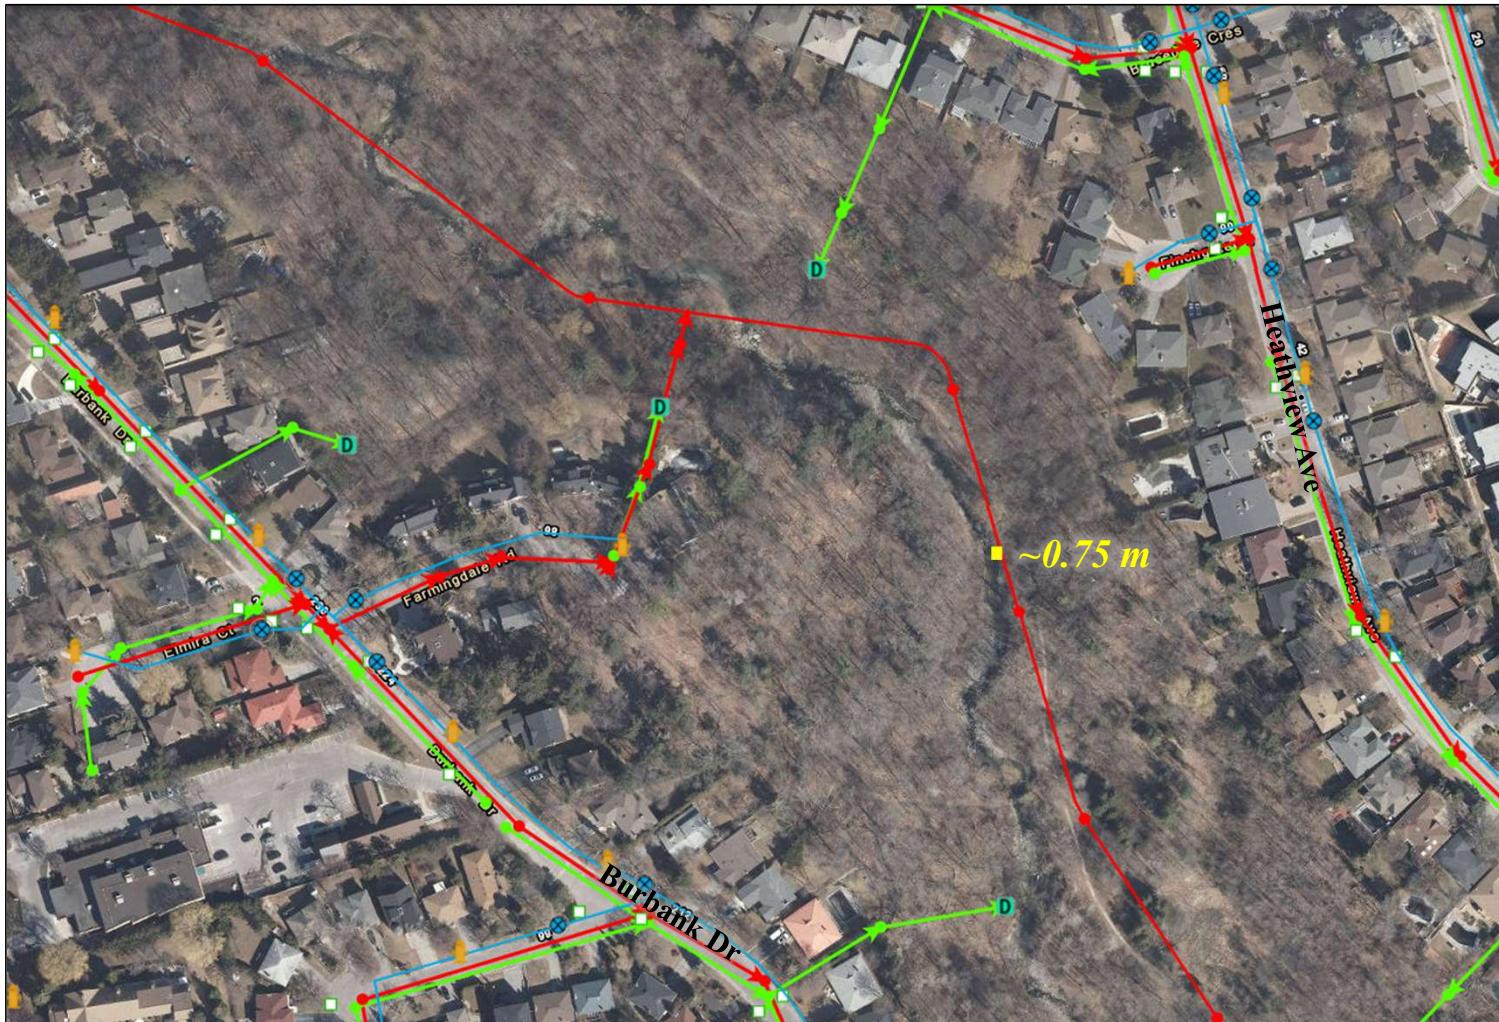
Sanitary Sewer Lateral Risk #7

Horizontal Offset: 0.75 m

$R_c / w = 9.66$

Area of active bank erosion and channel widening

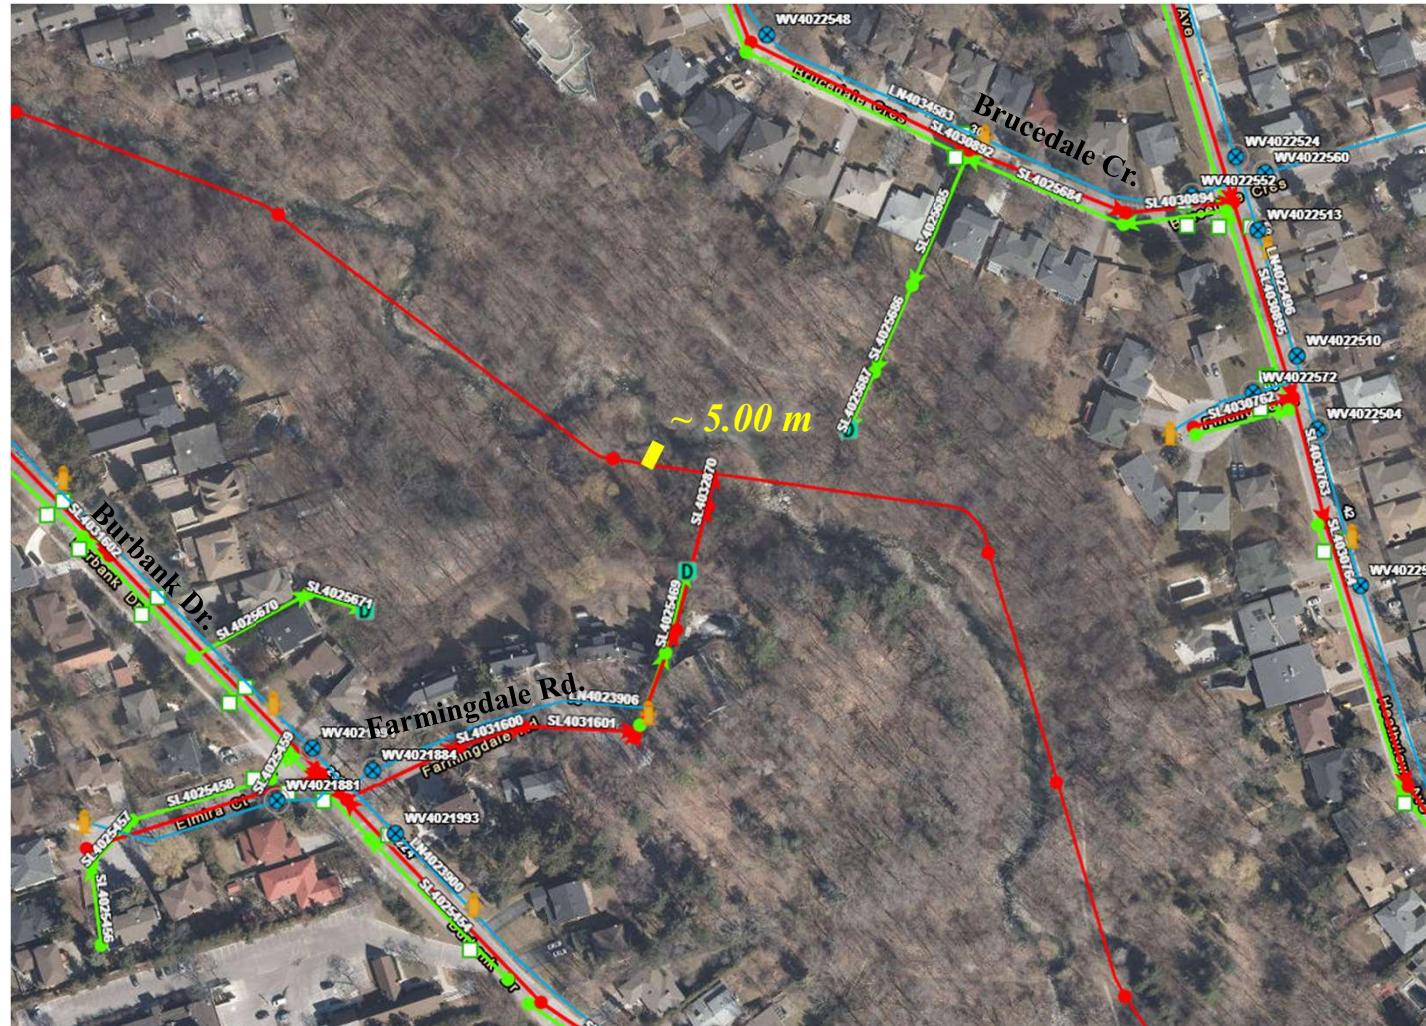
Sanitary Sewer Lateral Risk #8

Horizontal Offset: 5.00 m

$R_c / w = 1.50$

Bank Protection Works: Gabion Baskets

Sewer parallel to Newtonbrook Creek. The closest point of contact is at a section protected by gabion baskets, the bottom baskets have emptied.

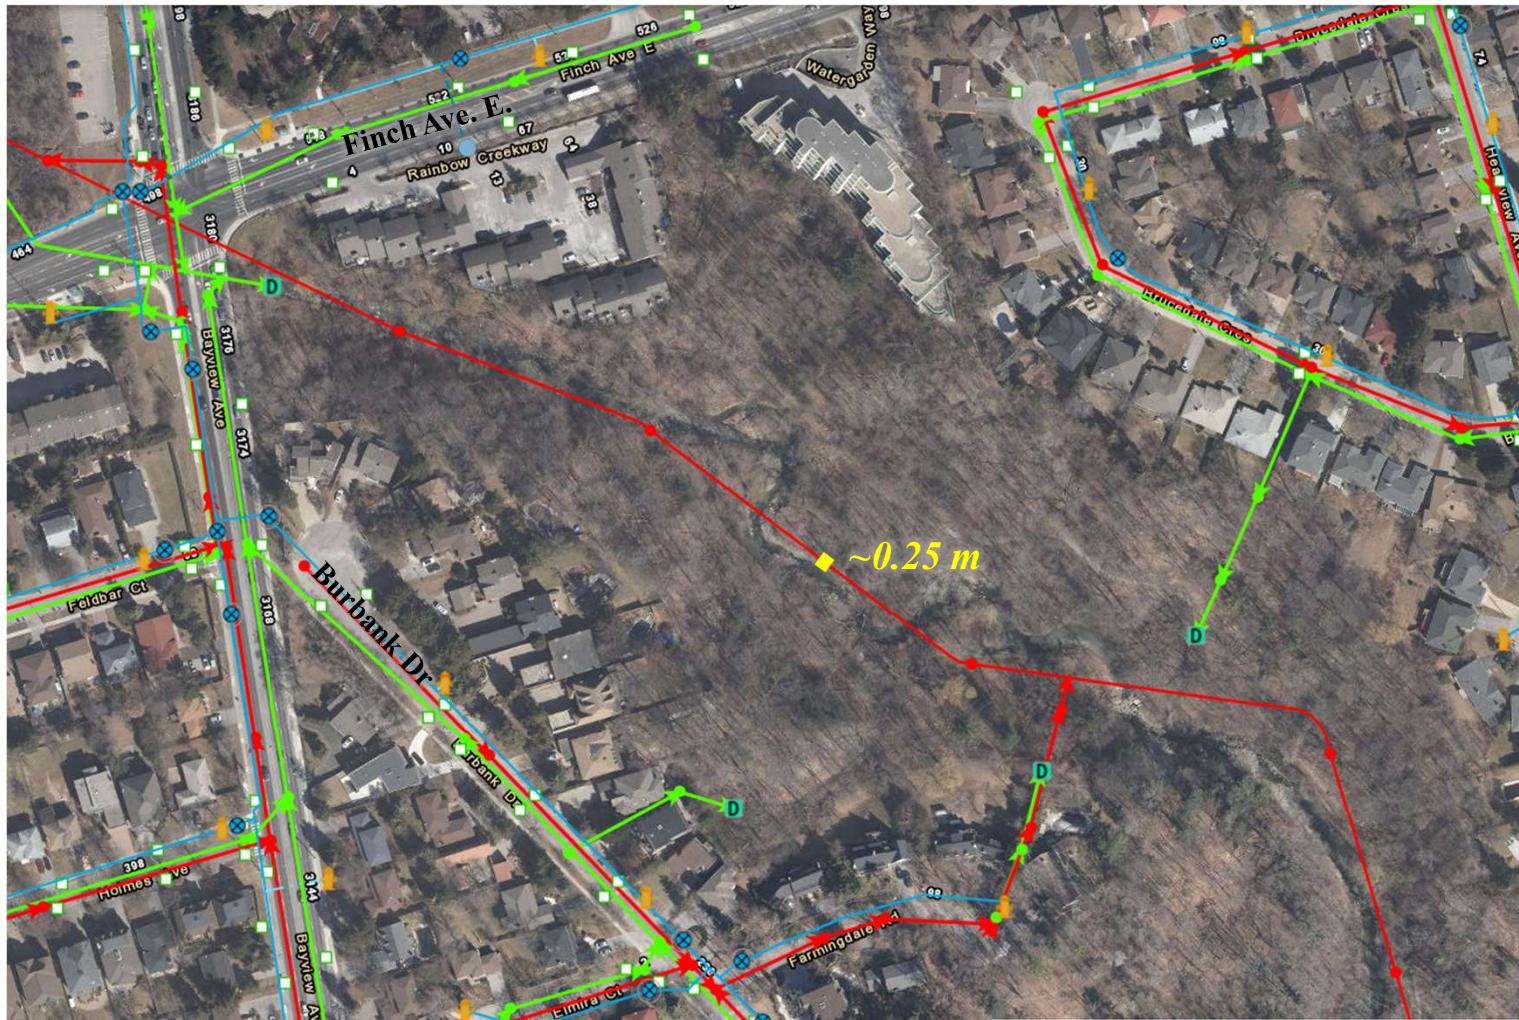
Sanitary Sewer Lateral Risk #9

Horizontal Offset: 0.25 m

$R_c / w = 3.87$

Bank Protection Works: Rip-Rap

Area of active scour with exposed concrete encasements upstream and downstream

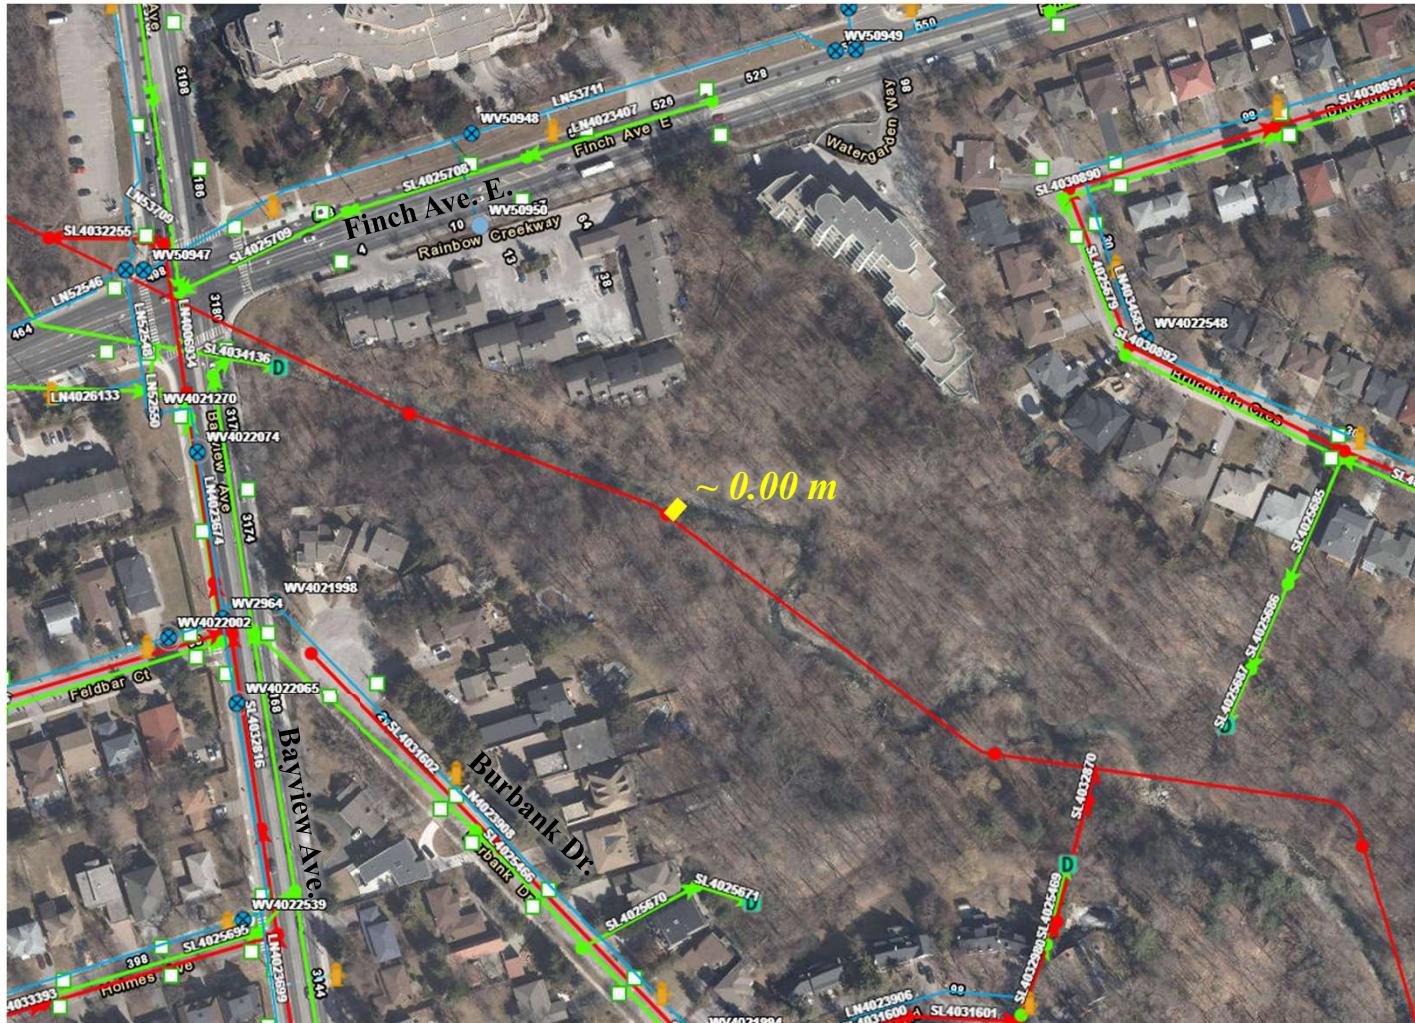
Sanitary Sewer Lateral Risk #10

Horizontal Offset: 0.00 m

$R_c / w = 1.94$

Sewer parallel to Newtonbrook Creek. Substrate rip rap is still intact, banks are unprotected and currently eroding. The offset from risk is minimal.

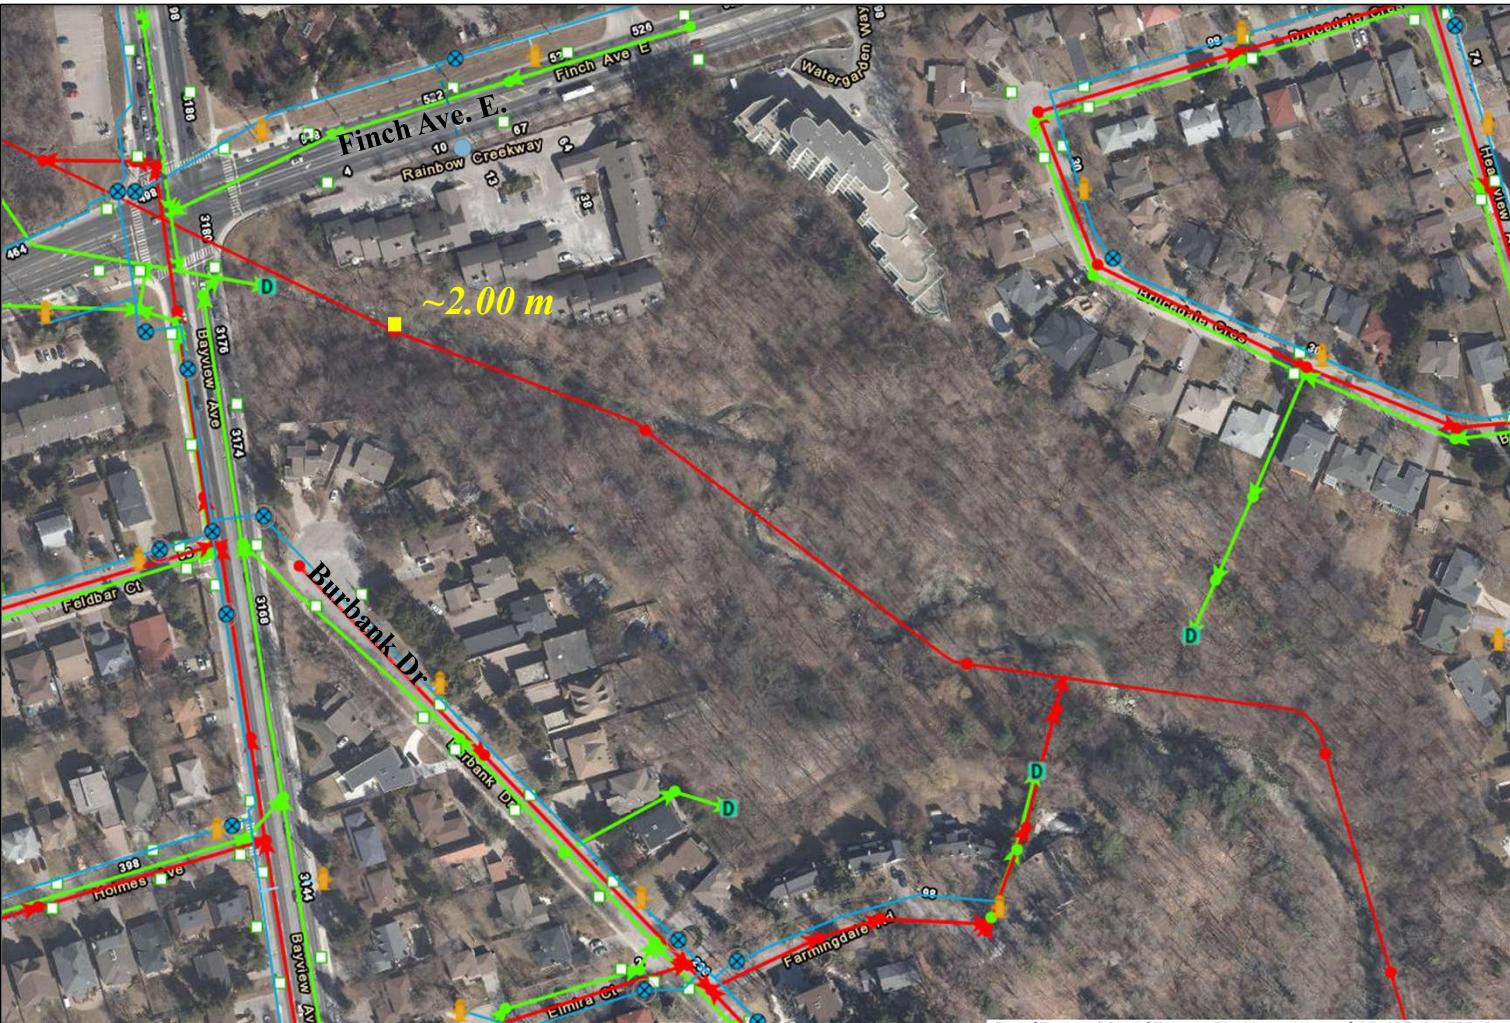
Sanitary Sewer Lateral Risk #11

Horizontal Offset: 2.00 m

$R_c / w = 3.92$

Armourstone wall

Works: Fair

Armourstone wall is outflanking and falling over, with risk to manhole

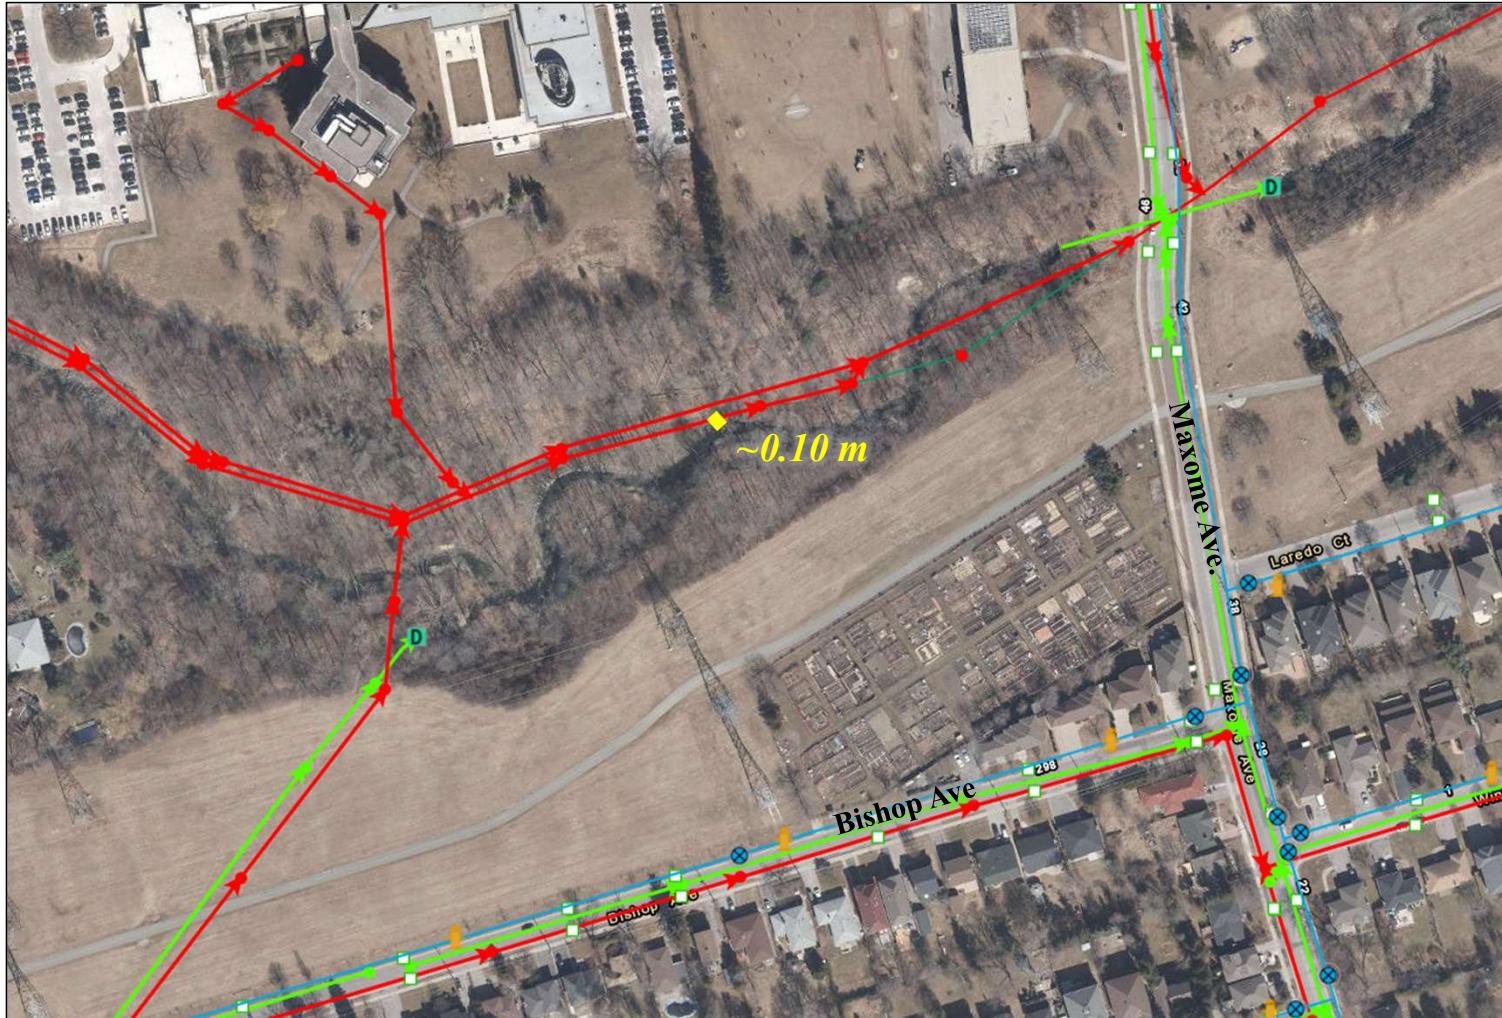
Sanitary Sewer Lateral Risk #12

Horizontal Offset: 0.10 m

$R_c / w = 2.88$

Area of active bank erosion and channel widening

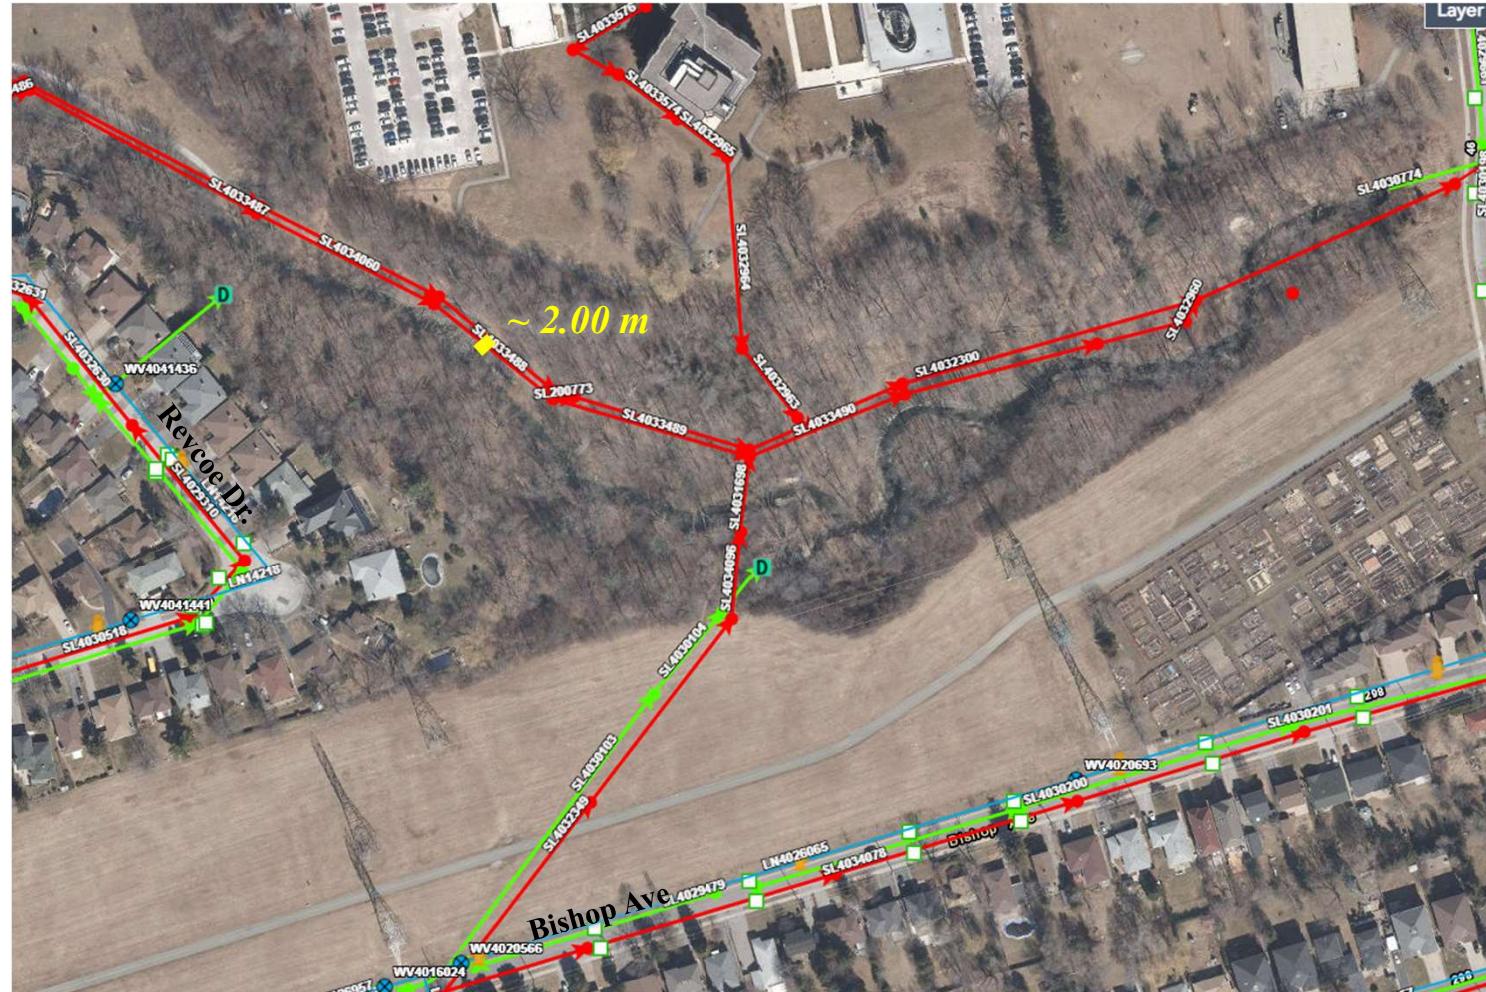
Sanitary Sewer Lateral Risk #14

Horizontal Offset: 2.00 m

$R_c / w = 2.13$

Sewer parallel to Newtonbrook Creek with failed gabion baskets. The emptied baskets have some rip rap protection, basket wire has rusted through.

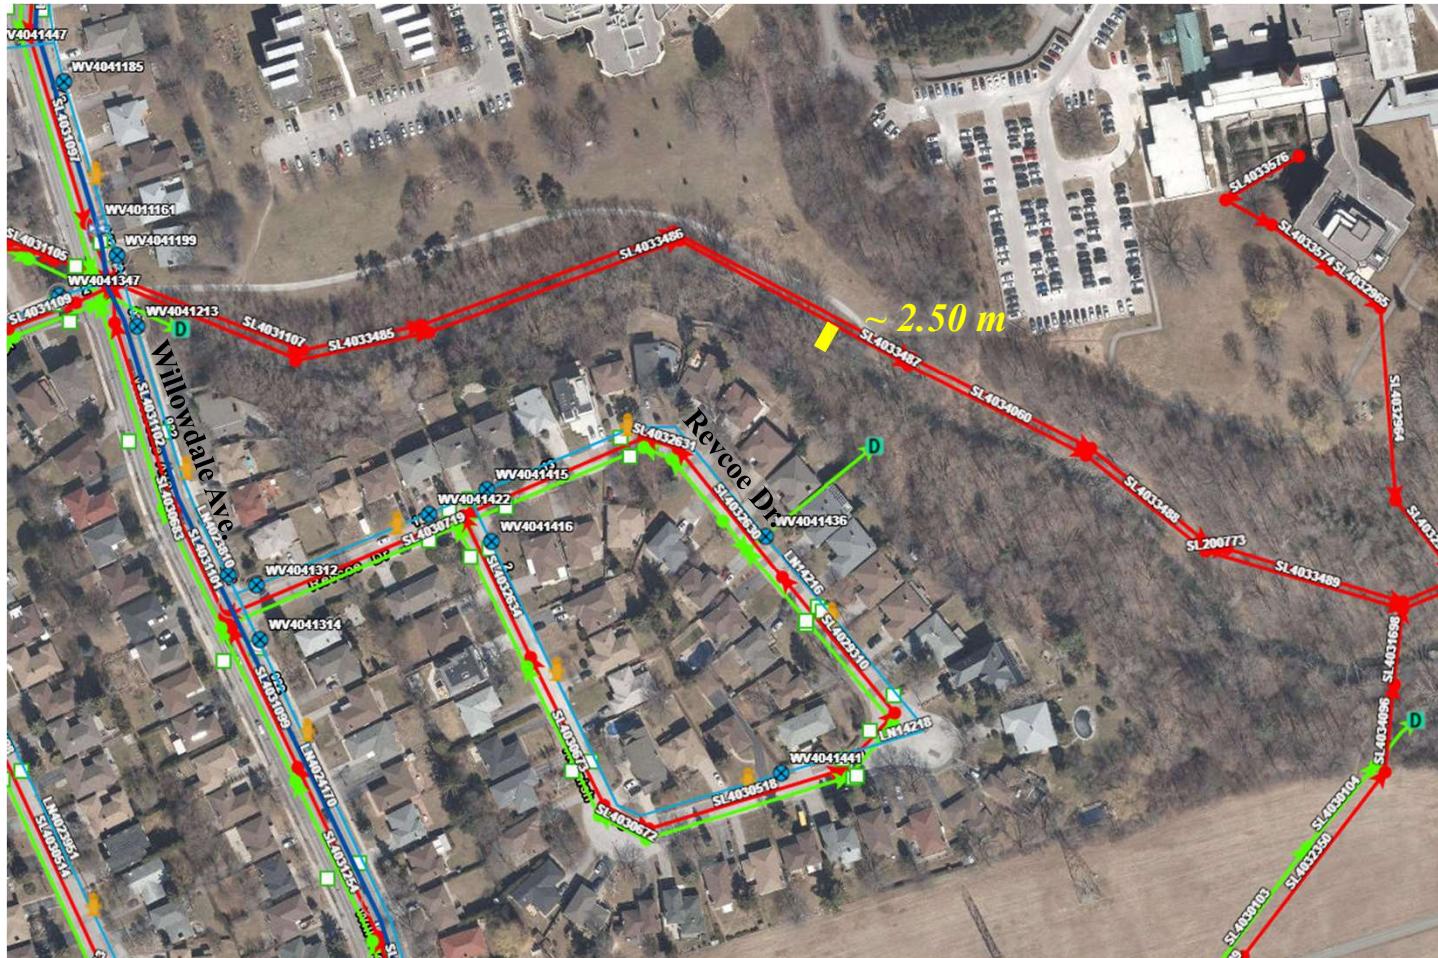
Sanitary Sewer Lateral Risk #15

Horizontal Offset: 2.50 m

$$R_c / w = 13.05$$

Sewer parallel to Newtonbrook Creek with failed gabion baskets. The emptied baskets have some rip rap protection, basket wire has rusted through.

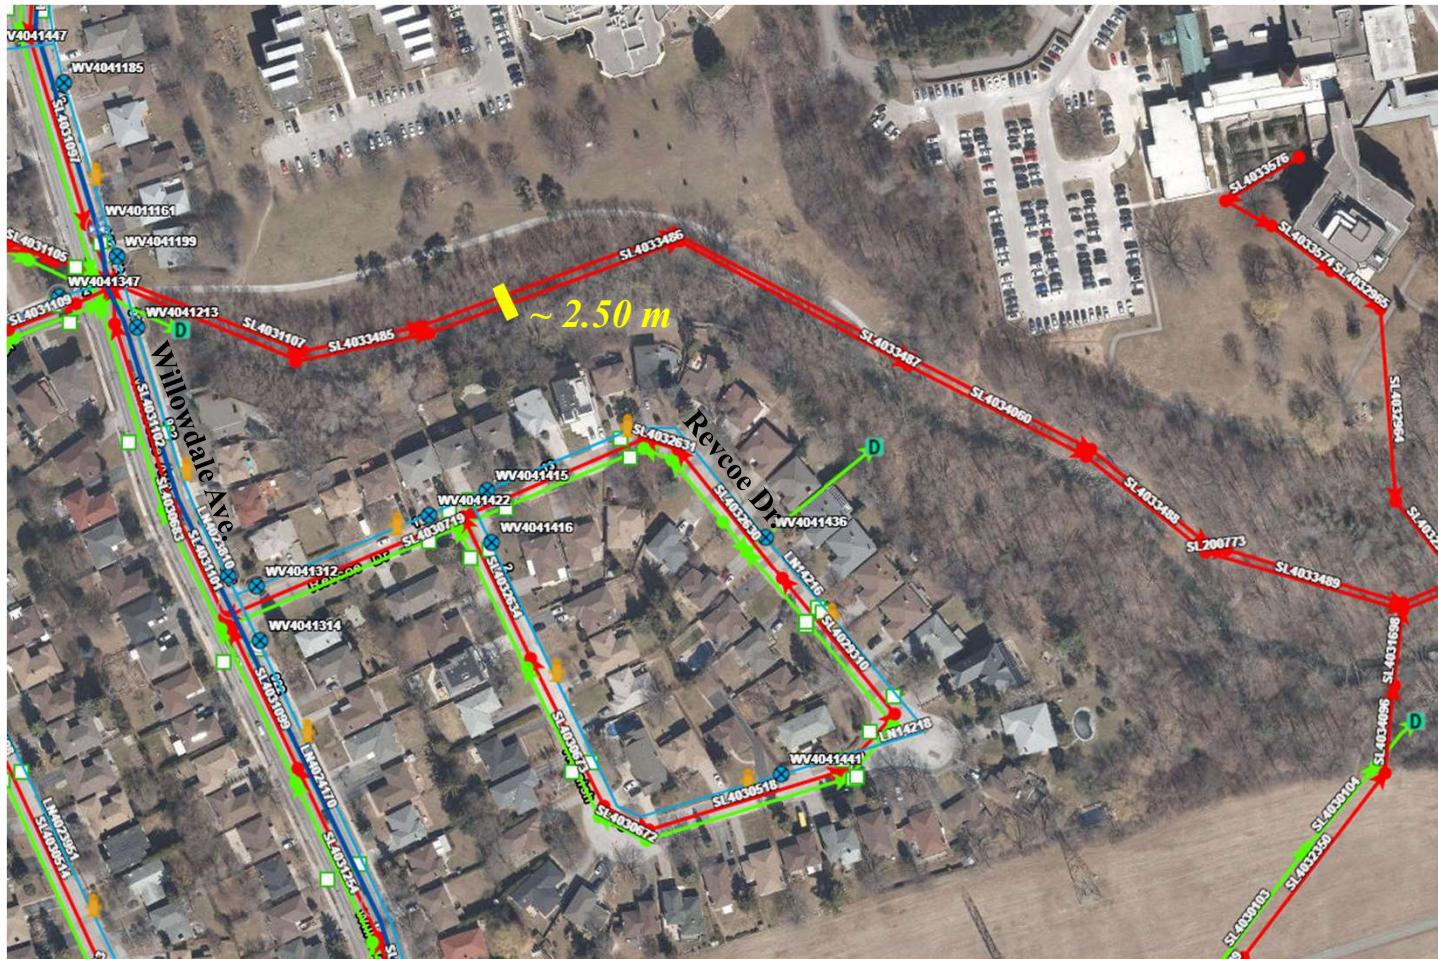
Sanitary Sewer Lateral Risk #16

Horizontal Offset: 2.50 m

$$R_c/w = 13.05$$

Bank Protection Works: Rip Rap

Sewer parallel to Newtonbrook Creek. While offset is minimal, asset has ~ 0.7 m of cover and degradation rate controls TTC
