Appendix J

Summary Sheets for Sanitary Sewer Lateral Risk Sites

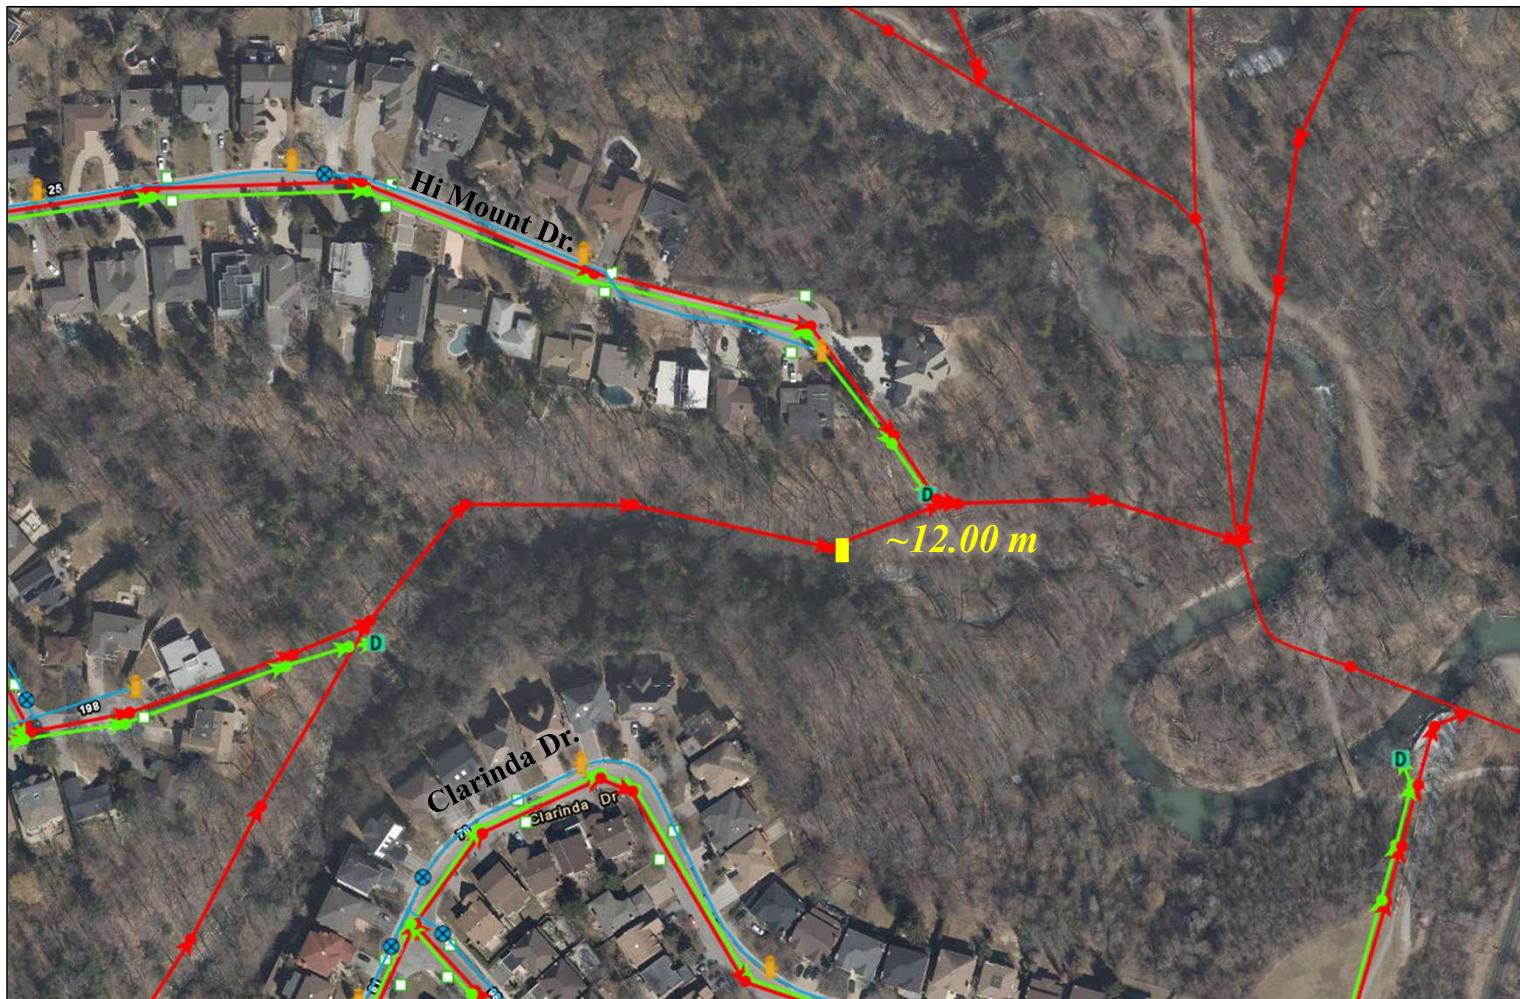
Sanitary Sewer Lateral Risk #17

Horizontal Offset: 12.00 m
Radius of Curvature (R_c): 13.64
Width (w): 2.74 m
 $R_c / w = 4.98$
Bank Protection Works: None
Condition of Bank Protection Works: N/A

Entire valley corridor is area of active bank and slope erosion.

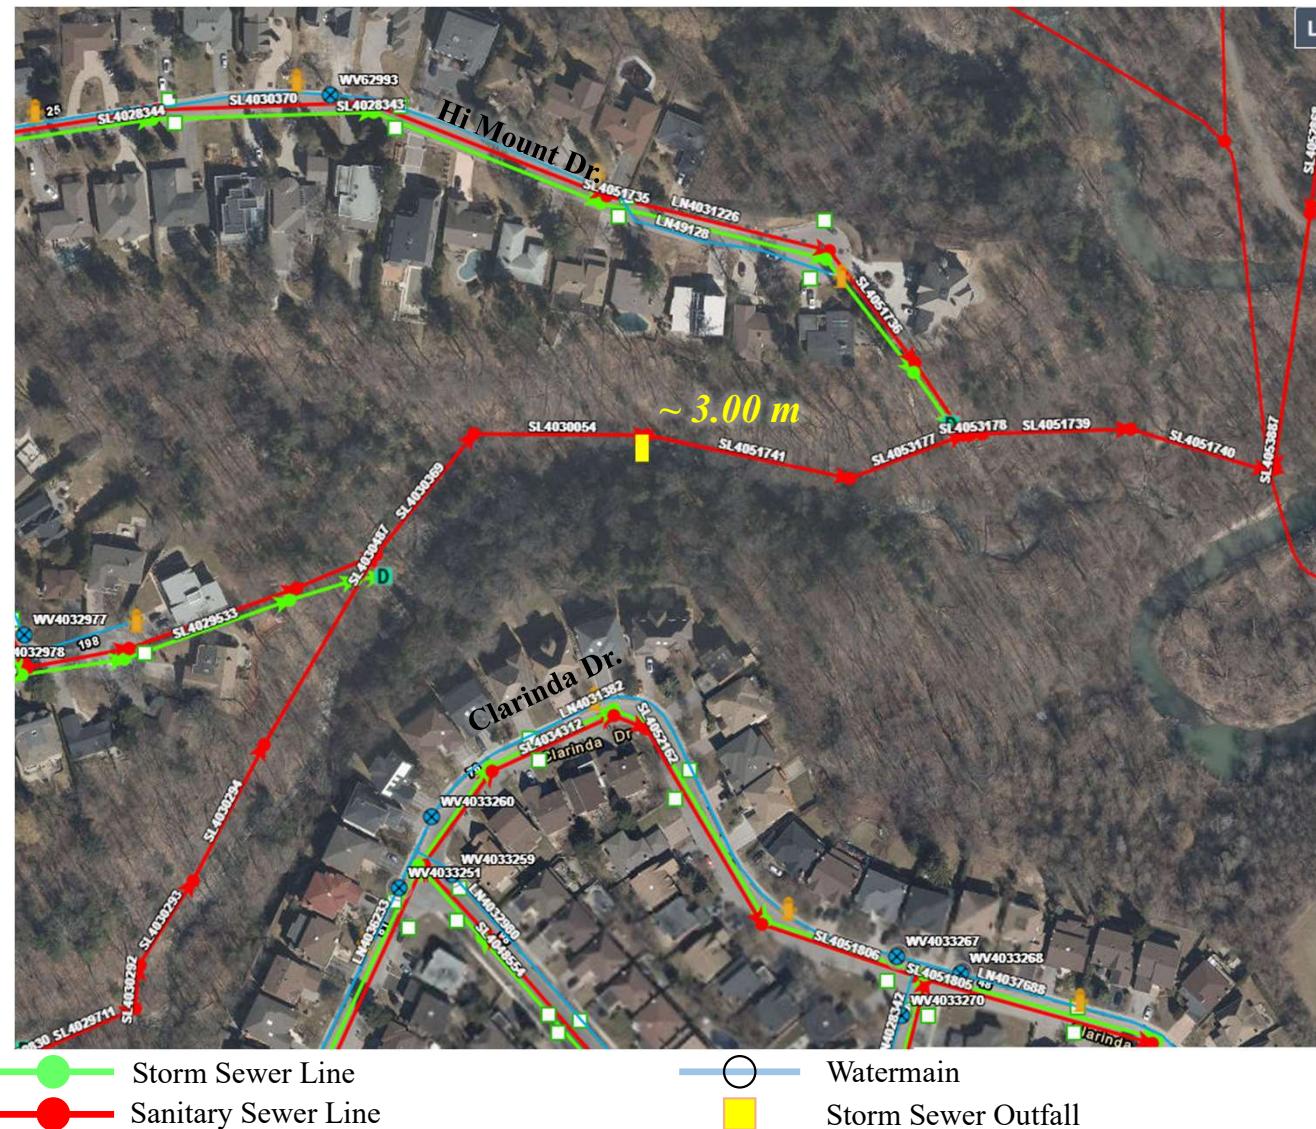
Sanitary Sewer Lateral Risk #18

Horizontal Offset: 3.00 m

$$R_c/w = 7.38$$

Sewer parallel to Blue Ridge Creek with Armourstone and boulder bank protection.

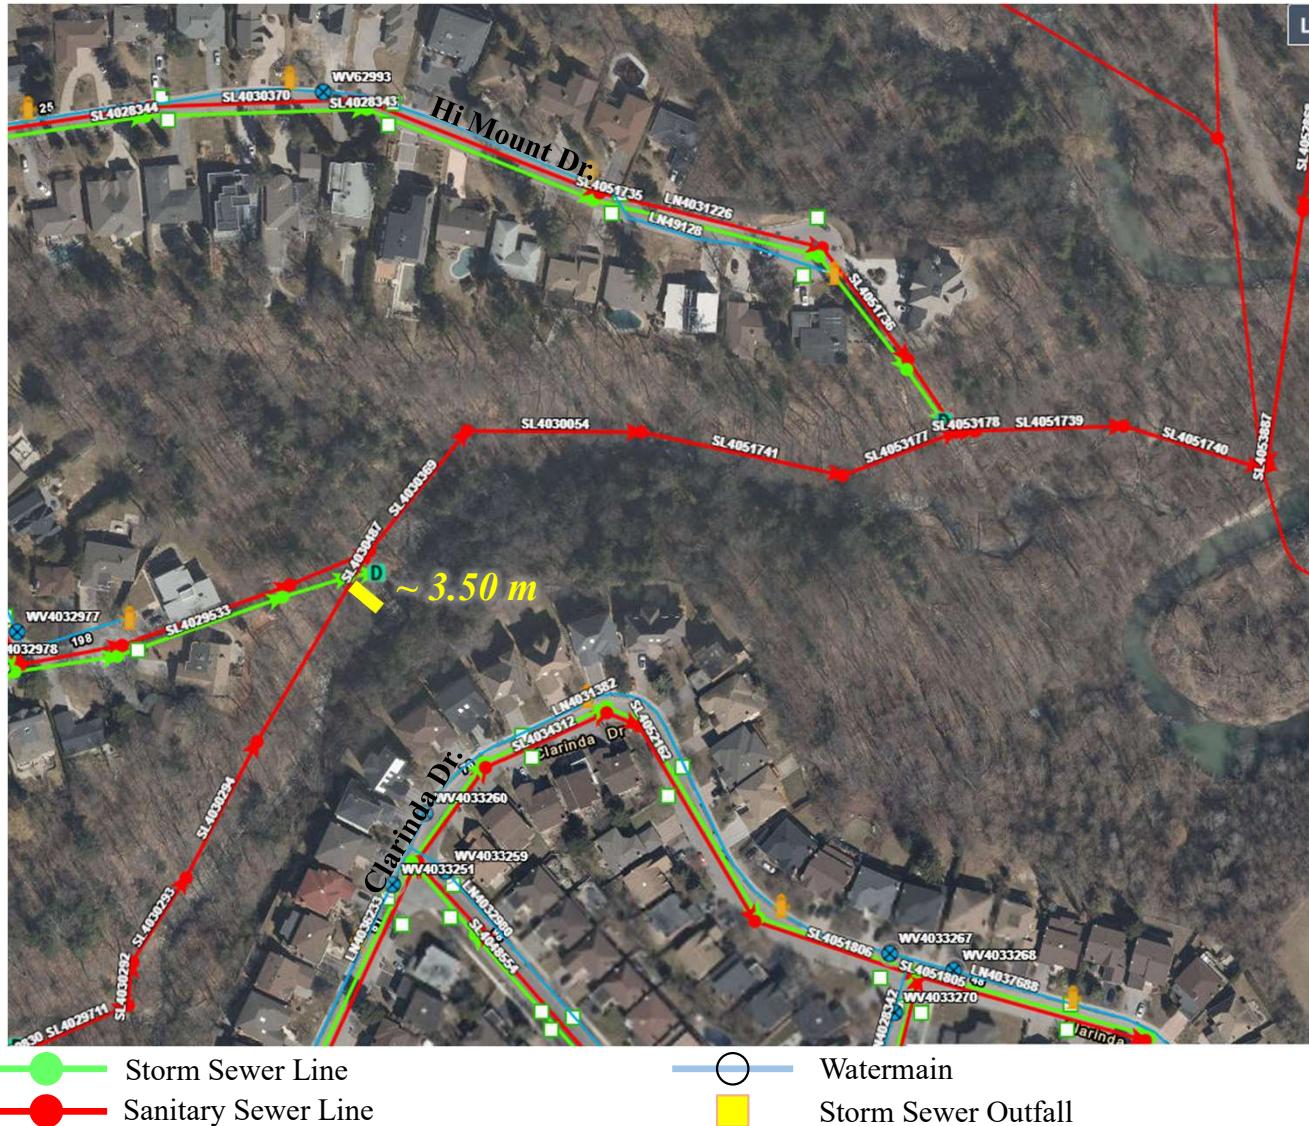
Sanitary Sewer Lateral Risk #19

Horizontal Offset: 3.50 m

$R_c / w = 13.01$

Sewer parallel to Blue Ridge Creek. The closest point of contact is at an unarmoured eroding bank.

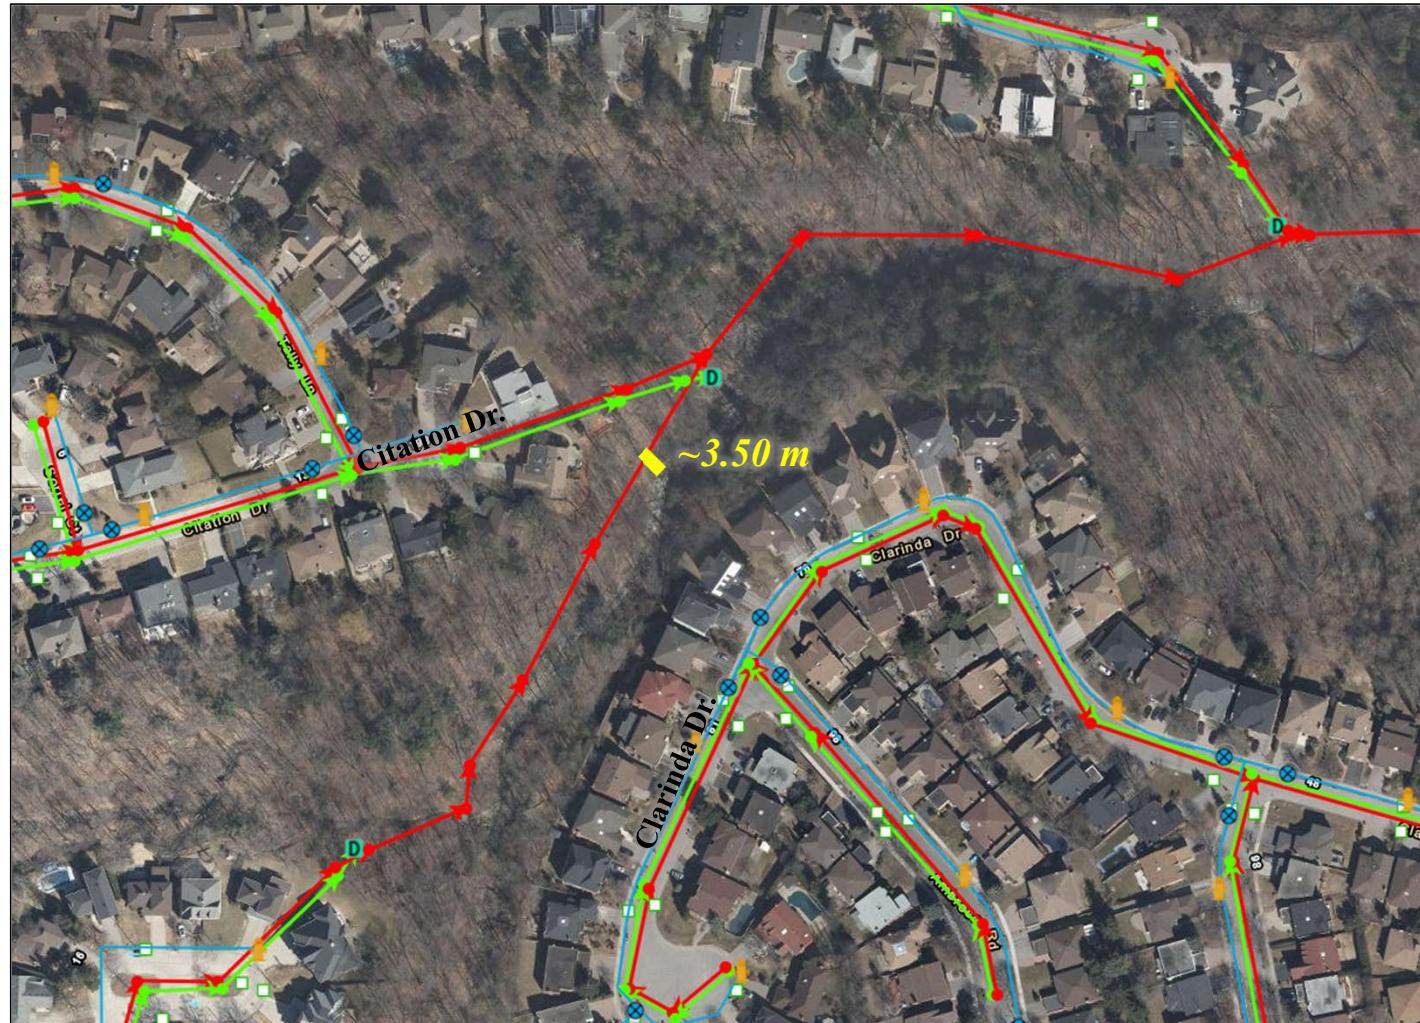
Sanitary Sewer Lateral Risk #20

Horizontal Offset: 3.5 m

$R_c / w = 5.70$

Entire valley corridor is area of active bank and slope erosion.

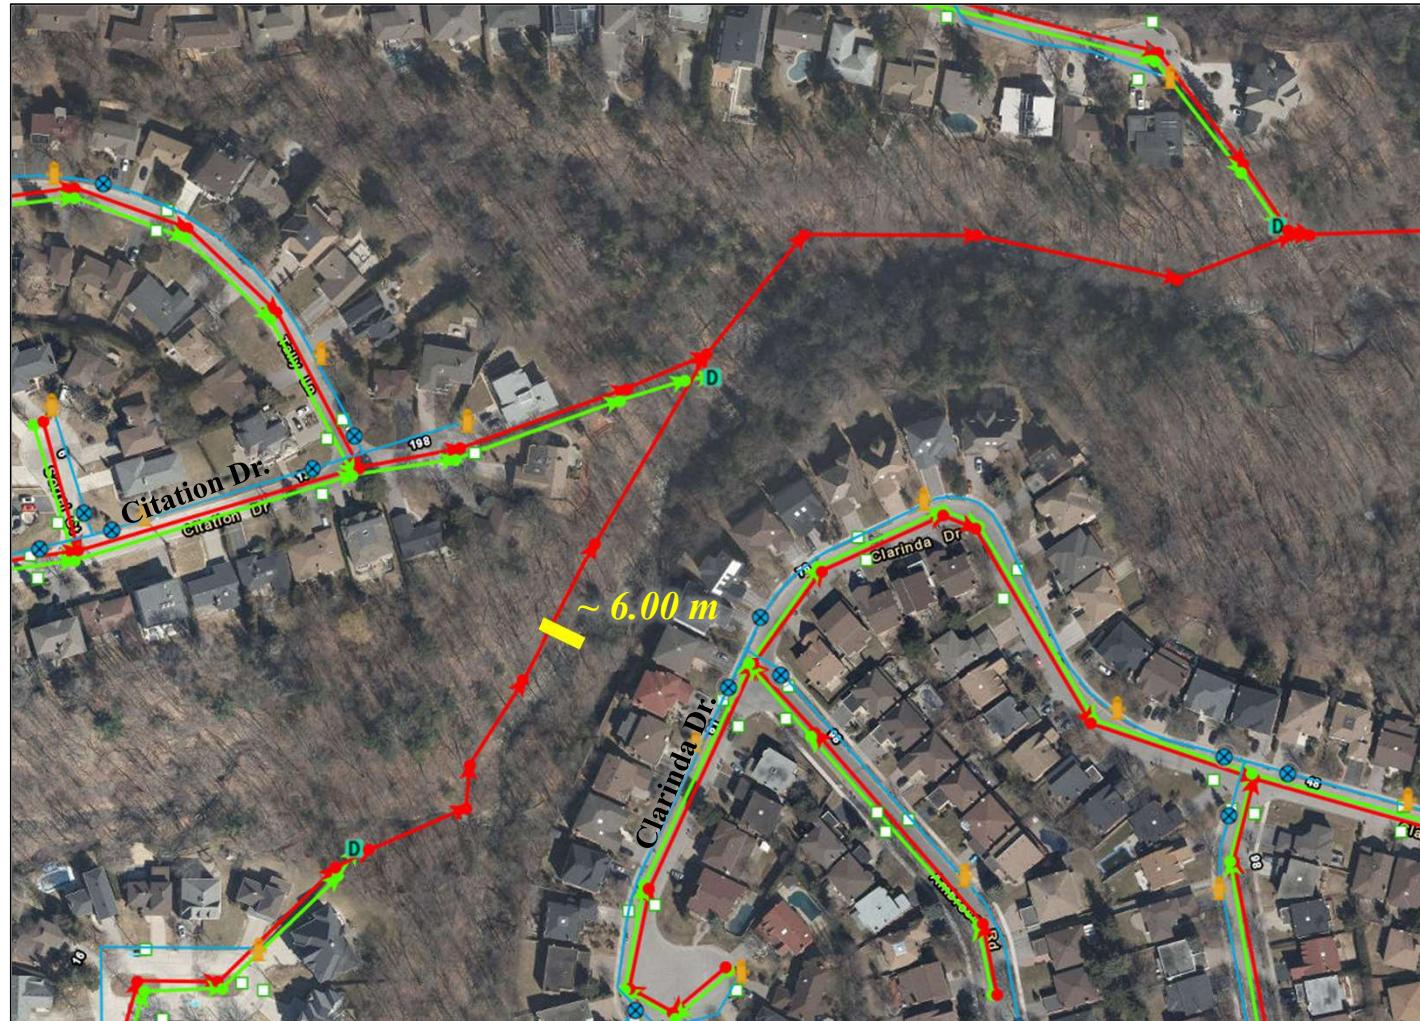
Sanitary Sewer Lateral Risk #21

Horizontal Offset: 6.00 m

$R_c / w = 5.37$

Sewer parallel to Blue Ridge Creek with Armourstone bank protection.

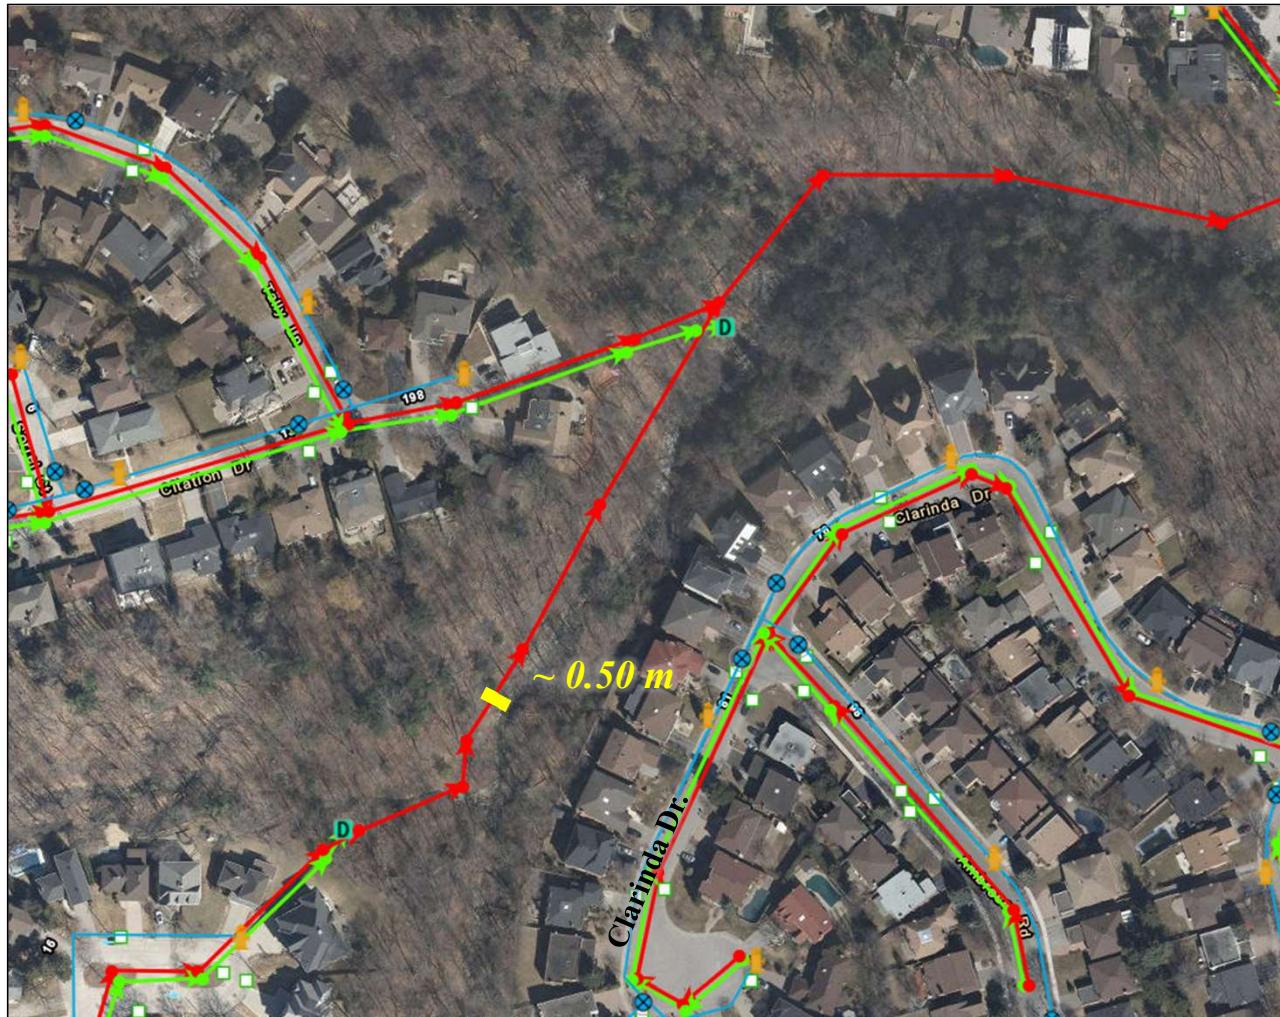
Sanitary Sewer Lateral Risk #22

Horizontal Offset: 0.50 m

$R_c / w = 4.49$

Entire valley corridor is area of active bank and slope erosion.
