4.13 Priority Site #11: Exposed Sanitary Sewer Crossing Upstream of Blessed Trinity Parish

4.14 Priority Site #12: Failed Storm Sewer Outfall at Hi Mount Drive

4.15 Priority Site #13: Failed Storm Sewer Outfall at Citation Drive

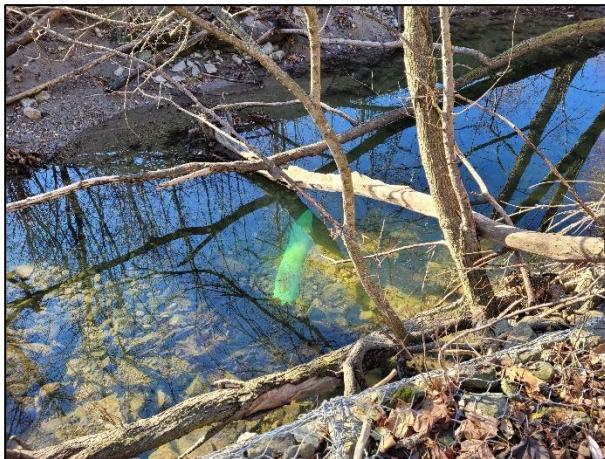
Priority Site #11 is located in Reach N3 of Newtonbrook Creek, approximately 210 metres downstream of the Maxome Culvert Crossing, and 50 metres upstream of a Pedestrian Bridge. Scouring along the creek bed has partially exposed a 250 mm diameter PVC sanitary sewer (Figure 4-61) that crosses the creek before feeding into the 675 mm sanitary trunk sewer that runs through the lower reaches of Newtonbrook Creek. The exposed portion of the sewer is not encased in concrete and is therefore directly vulnerable to damage from exposure to hydrodynamic forces.

Figure 4-61: Exposed Sewer in Channel Bed Without Visible Encasement

- Where feasible, lower and regrade channel banks to restore floodplain connectivity.
- Provide a minimum of 1.0 metres of cover overtop of the exposed sanitary sewer crossing.

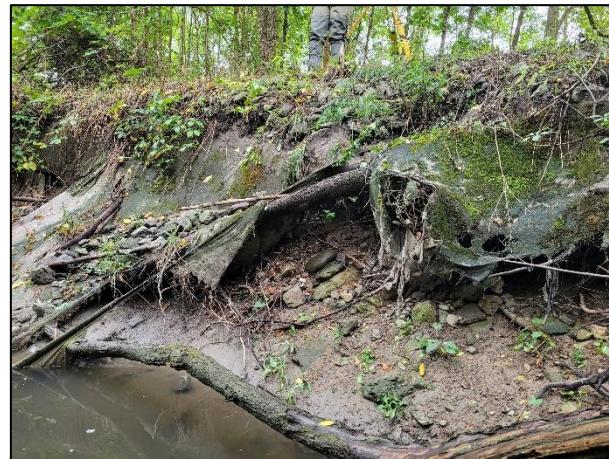
Evidence of channel widening and lateral bank erosion is evident at this location, in addition to the aforementioned scouring, with a loose piece of geotextile fabric visible in an unprotected eroded bank (Figure 4-62). The opposite bank is protected by a gabion basket retaining wall found to be in fair condition, with a few baskets starting to fail due to undermining and failure of the wire mesh. Immediately downstream of the crossing, a 675 mm diameter storm sewer outfall discharges to Newtonbrook Creek. The storm sewer outfall is setback a few meters from the main channel, with an engineered outfall channel that is integrated into a gabion retaining wall (Figure 4-63). Unique to this priority site is the fact that the site is situated within a hydro corridor and that three (3) oil & gas pipelines owned by Sun Canadian, Trans-Northern and Imperial Oil cross the creek within a 20-metre buffer of the sanitary sewer crossing. Field investigations indicate that none of the three pipelines are exposed, however the depth of cover over each pipeline remains uncertain. Upstream and downstream channel conditions indicate that the vertical and lateral erosion observed at this priority site is not localized, but is occurring consistently at a reach scale (Figure 4-64).

Figure 4-62: Bank Subject to Erosion with Degraded Geotextile Fabric

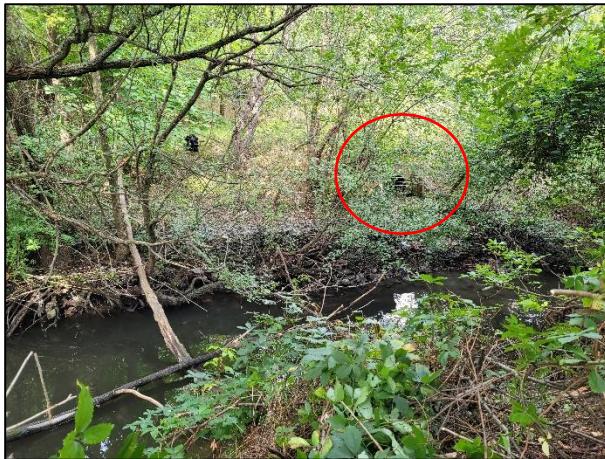
Figure 4-63: Gabion Basket Bank with Storm Outfall Circled in Red

- Rehabilitate the existing storm sewer outfall as required (Priority Site #64 - OF4950913010) and integrate the outfall into the proposed armourstone retaining wall.

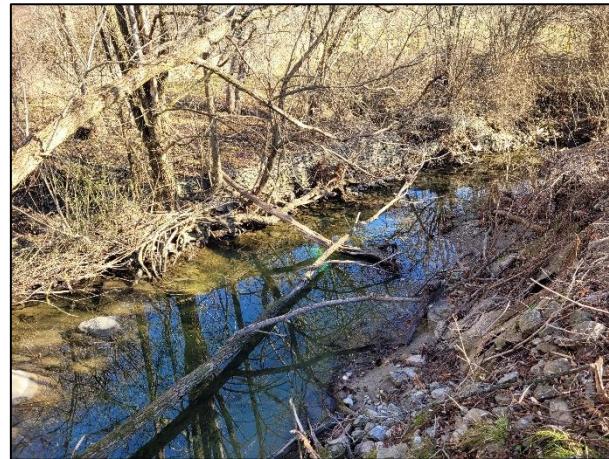
Figure 4-64: Channel Conditions in Close Proximity to Exposed Sewer

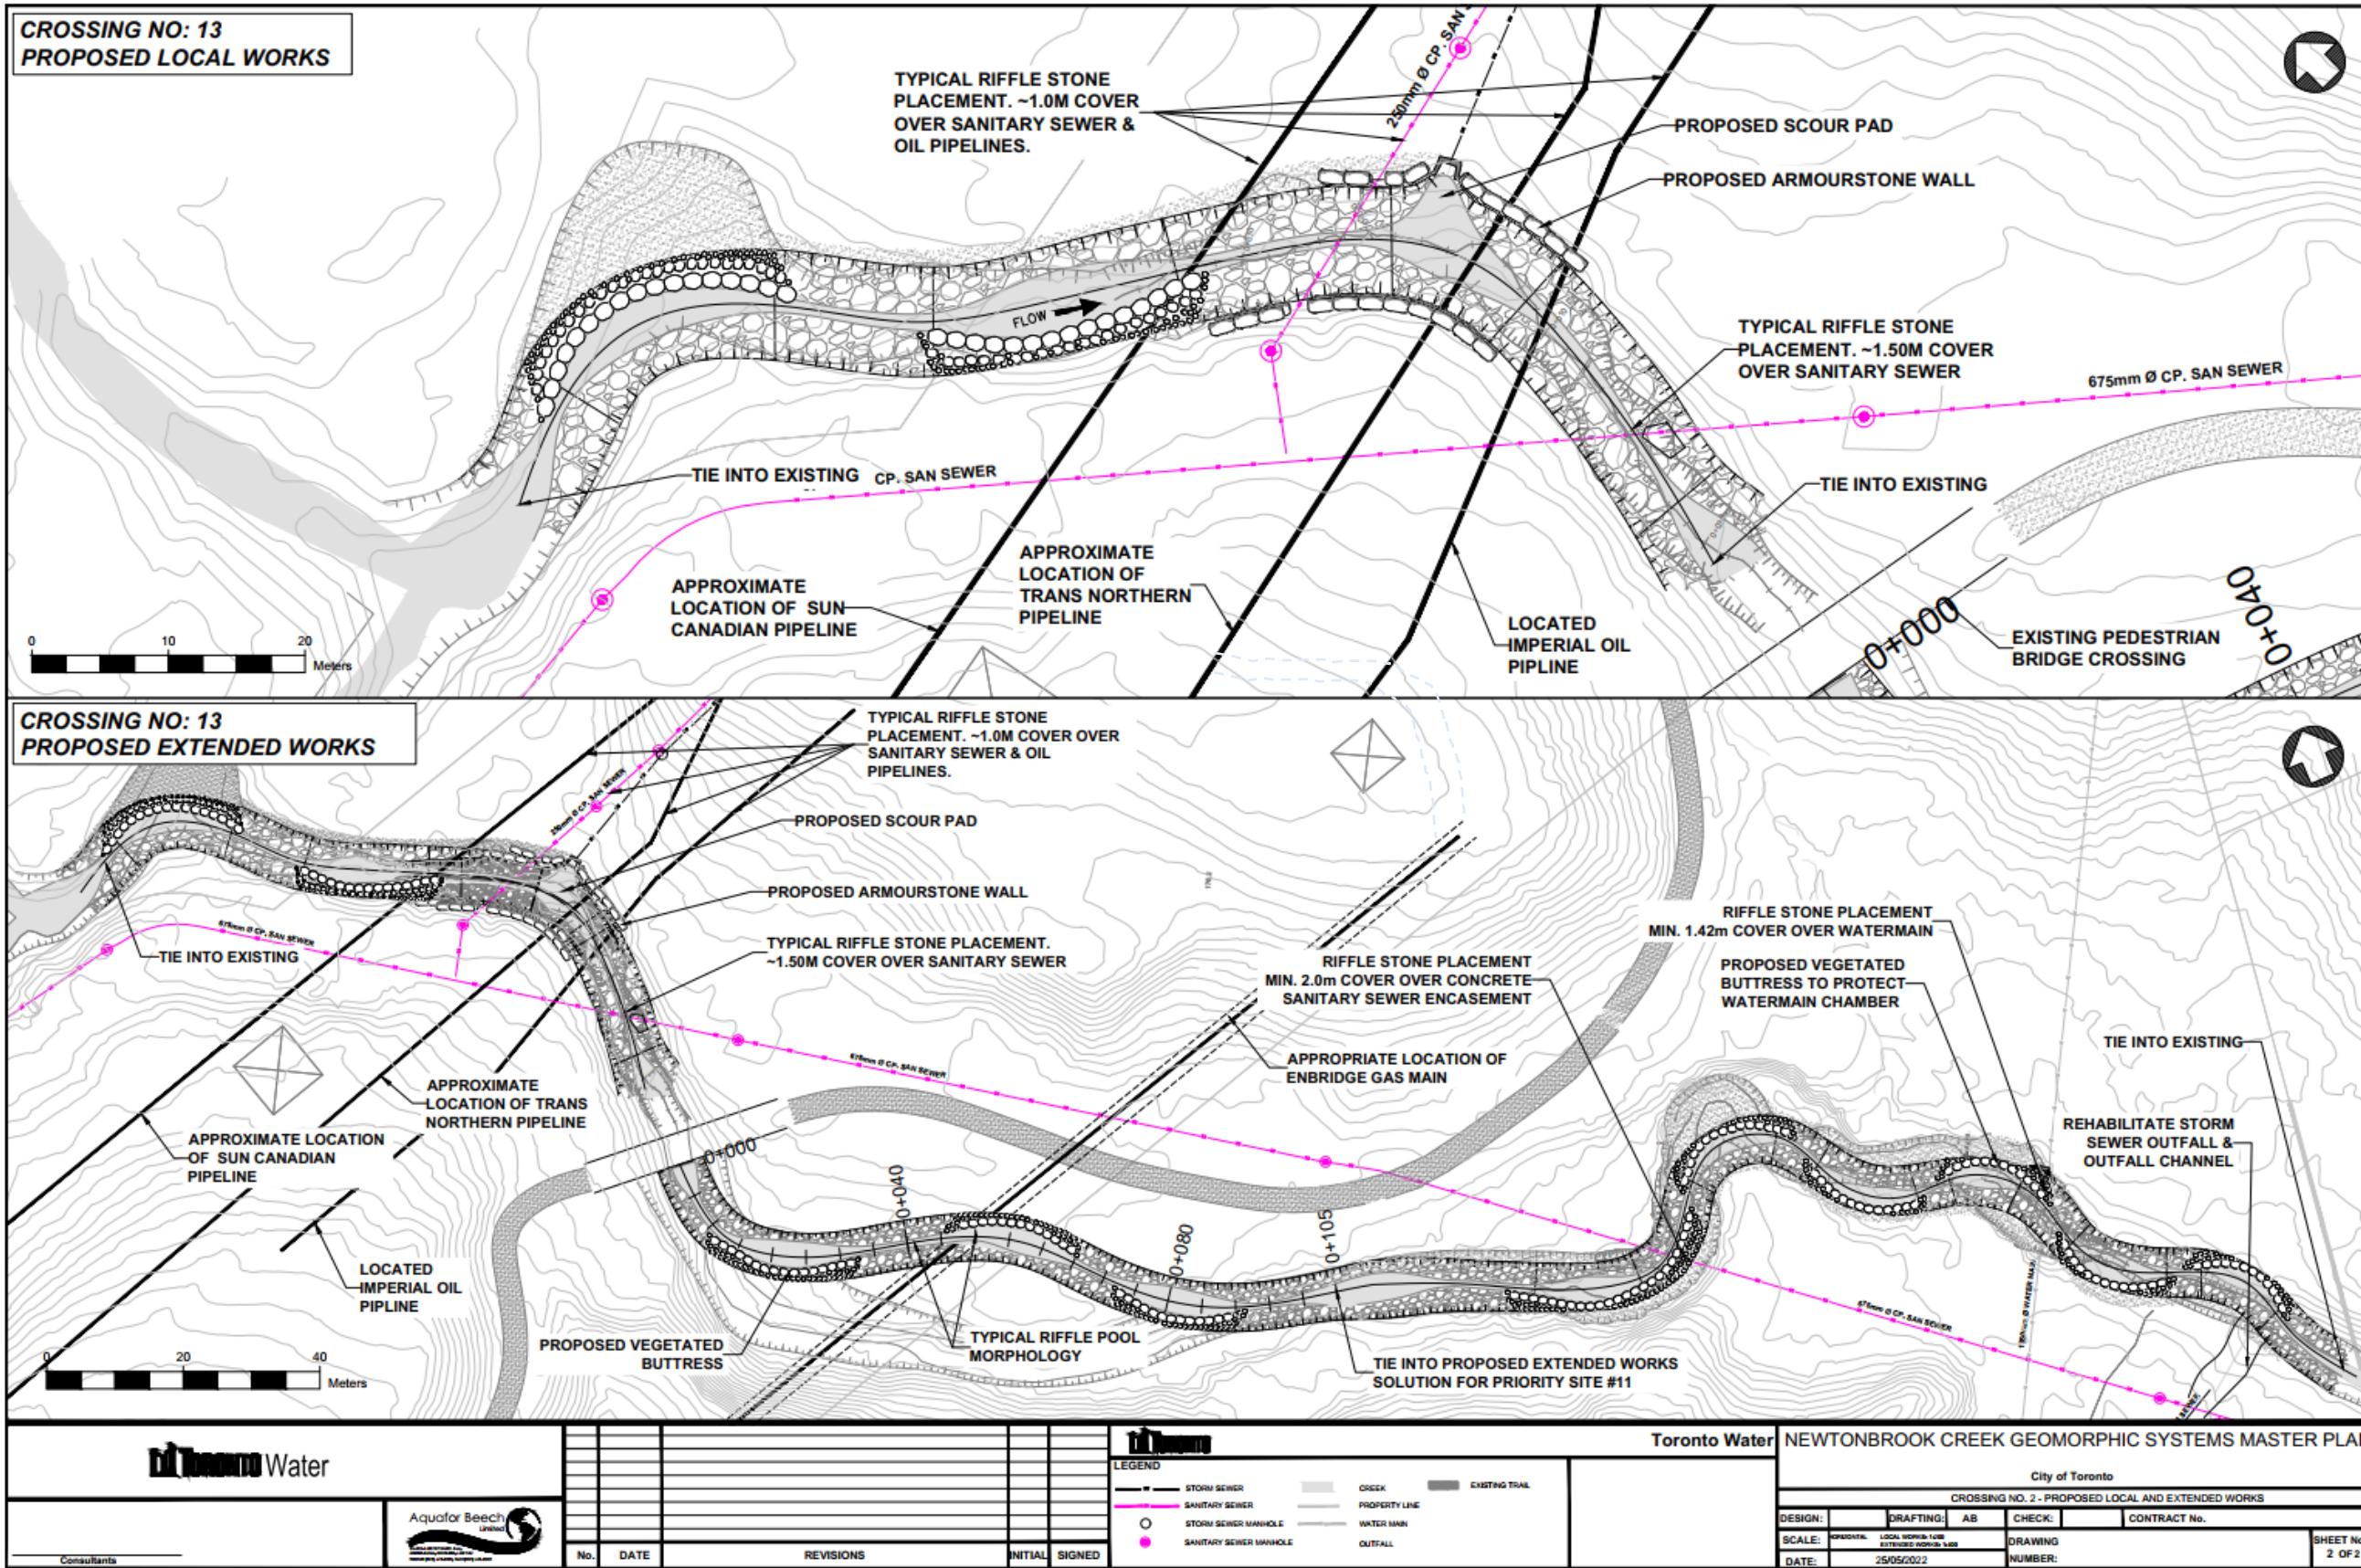
Figure 4-66: Preliminary Design Concepts Alternative 2 & 3 – Priority Site #11

Alternative 2: Local Works – Apply natural channel design works for approximately 120 metres of channel length including riffle-pool morphology and bioengineered bank treatments (vegetated buttresses). The proposed works will tie-into existing conditions upstream where Newtonbrook Creek confluences with a major storm sewer outfall channel. The downstream tie-in point will be situated immediately upstream of the downstream pedestrian bridge crossing. Adjustments to the longitudinal profile, planimetric alignment and typical channel dimensions will look to stabilize the creek from a geomorphic perspective. The proposed solution will establish 1.0 metres depth of cover over the sanitary sewer crossing, and will have the added benefit of also increasing the depth of the cover over sanitary sewer crossing #12, located downstream of this priority site, from an estimated 1.19 metres to 1.50 metres. Depth of cover over each of three (3) oil and gas pipelines will also be increased by a minimum of 1.0 m. Vegetated buttresses will be placed along the outside of each meander bend for erosion protection, with any erosion scars filled in using approved materials. The slopes behind the channel works will be regraded to tie-into existing conditions and will be stabilized through the application of coir matting and restoration plantings. A new armourstone retaining wall will be constructed along both channel banks to mitigate lateral erosion risks to sanitary sewer infrastructure and the three (3) oil pipelines. The existing storm sewer will be also retained and integrated into the Armourstone retaining wall, with an engineered scour pool.

Alternative 3: Sub-Reach-Based Works – Apply natural channel design works for approximately 435 metres of channel length. Accumulated debris, including failed erosion control works, will be removed with riffle-pool morphology established through the placement of engineered substrate. Adjustments to the longitudinal profile, planimetric alignment and typical channel dimensions will look to stabilize the creek from a geomorphic perspective. The slopes behind the channel works will be regraded to tie-into existing conditions and stabilized.

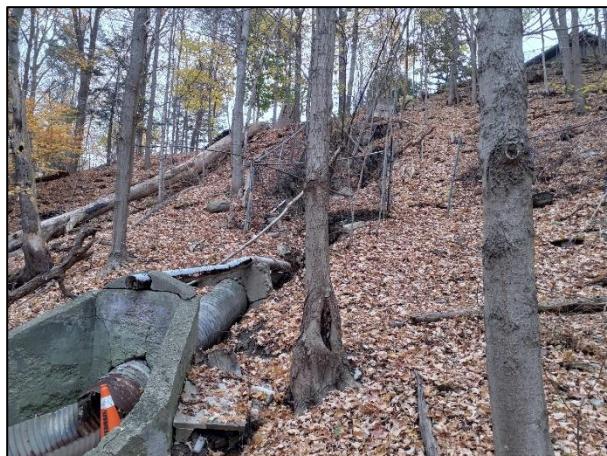
A combination of degrading pipe infrastructure, overland flow erosion, and unstable slope conditions have contributed to the complete failure of this drainage system. A number of gullies/sinkholes have formed along the length of the storm sewer pipe, with the CMP having become visibly detached at a number of locations (**Figure 4-69**). The concrete headwall itself is in poor condition and is showing signs of starting to shift/slump downslope (**Figure 4-70**). In its current state, the drainage system is unable to effectively convey flows from Hi Mount Drive downslope. Continued expansion of the existing erosion gullies and sinkholes is expected if this site is not effectively remediated, creating significant erosion risks to private property. A 300 mm diameter sanitary sewer is also offset around 2.0 metres to the east of the storm sewer, conveying sanitary flows from Hi Mount Drive to the Trunk sewer that runs through the Blue Ridge Creek valley corridor. While currently unexposed, this sewer is also at risk of failure/damage if the erosion gullies along the length of the storm sewer continue to expand and migrate upslope.

Figure 4-67: Storm Outfall Failure in the Slope of the Valley

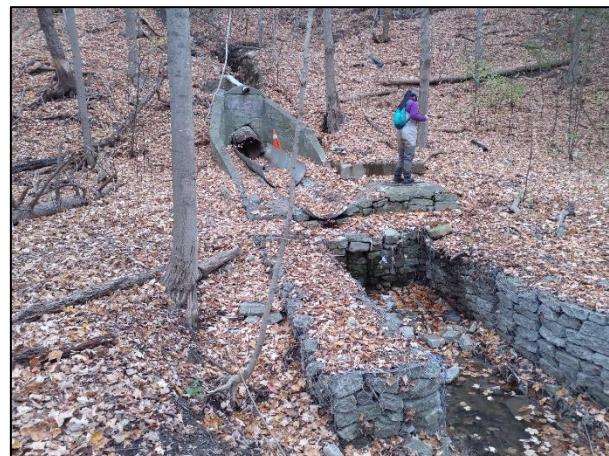
Priority Site #12 is located in Reach BR1 of Blue Ridge Creek, roughly 80-100 metres upstream of the Creek's confluence with the East Don River. A municipal storm sewer, collecting stormwater inflows from Hi Mount Drive and the upstream sewer shed, flows down into the Blue Ridge Valley corridor between the houses at 59 & 55 Hi Mount Drive. The storm sewer is a 600 mm diameter corrugated metal pipe (CMP), that outlets to the creek via a concrete headwall located at the toe of the valley slope (**Figure 4-67**). The headwall structure is setback approximately 35 metres from the main channel, conveying flows to the creek through a steeply graded outfall channel lined with Gabion Baskets and Armourstone blocks (**Figure 4-68**).

Figure 4-68: Degraded Outfall Channel

- Replace the failed outfall structure.
- Construct an engineered scour pool with an armourstone lined outfall channel that transitions into the main branch of Newtonbrook Creek. Give consideration to routing the outfall channel to transition into Newtonbrook Creek at an oblique angle to help mitigate scouring and erosion at the confluence.

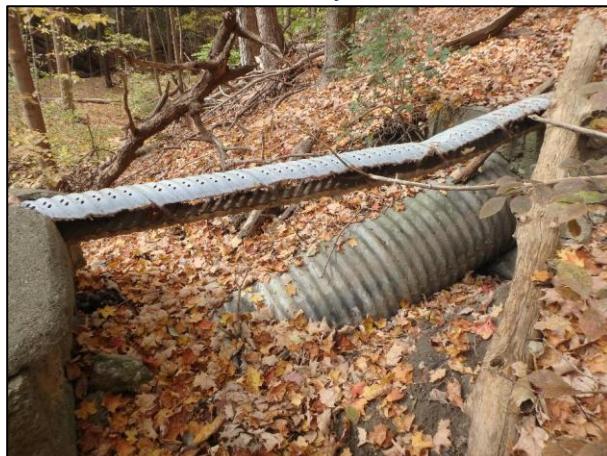
Figure 4-69: Two Failed Pipes Upslope of Headwall

- Repair/Replace approximately 74 metres of failed corrugated metal storm sewer pipe, maintaining the same general pipe alignment in planform. All sewer repair/replacement works must be coordinated with other City departments / basement flooding projects.

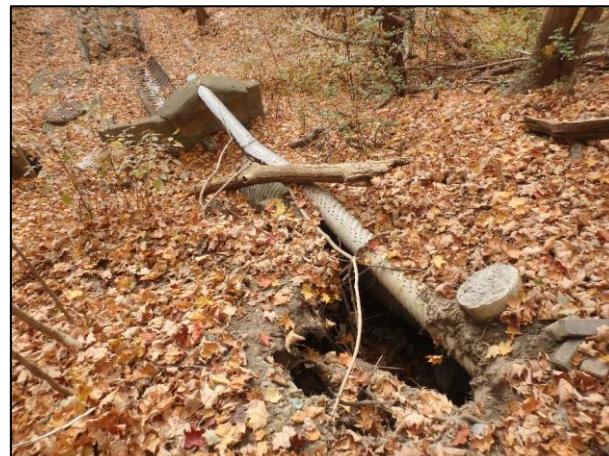
Figure 4-70: Sinkhole Observed Upstream of Headwall Structure

- Restore the failed slope through regrading and infilling of observed sinkholes and gullies with appropriately compacted fill materials. Apply additional slope stabilization measures (i.e., soil anchors, coir logs, etc.) as defined at the detailed design phase.

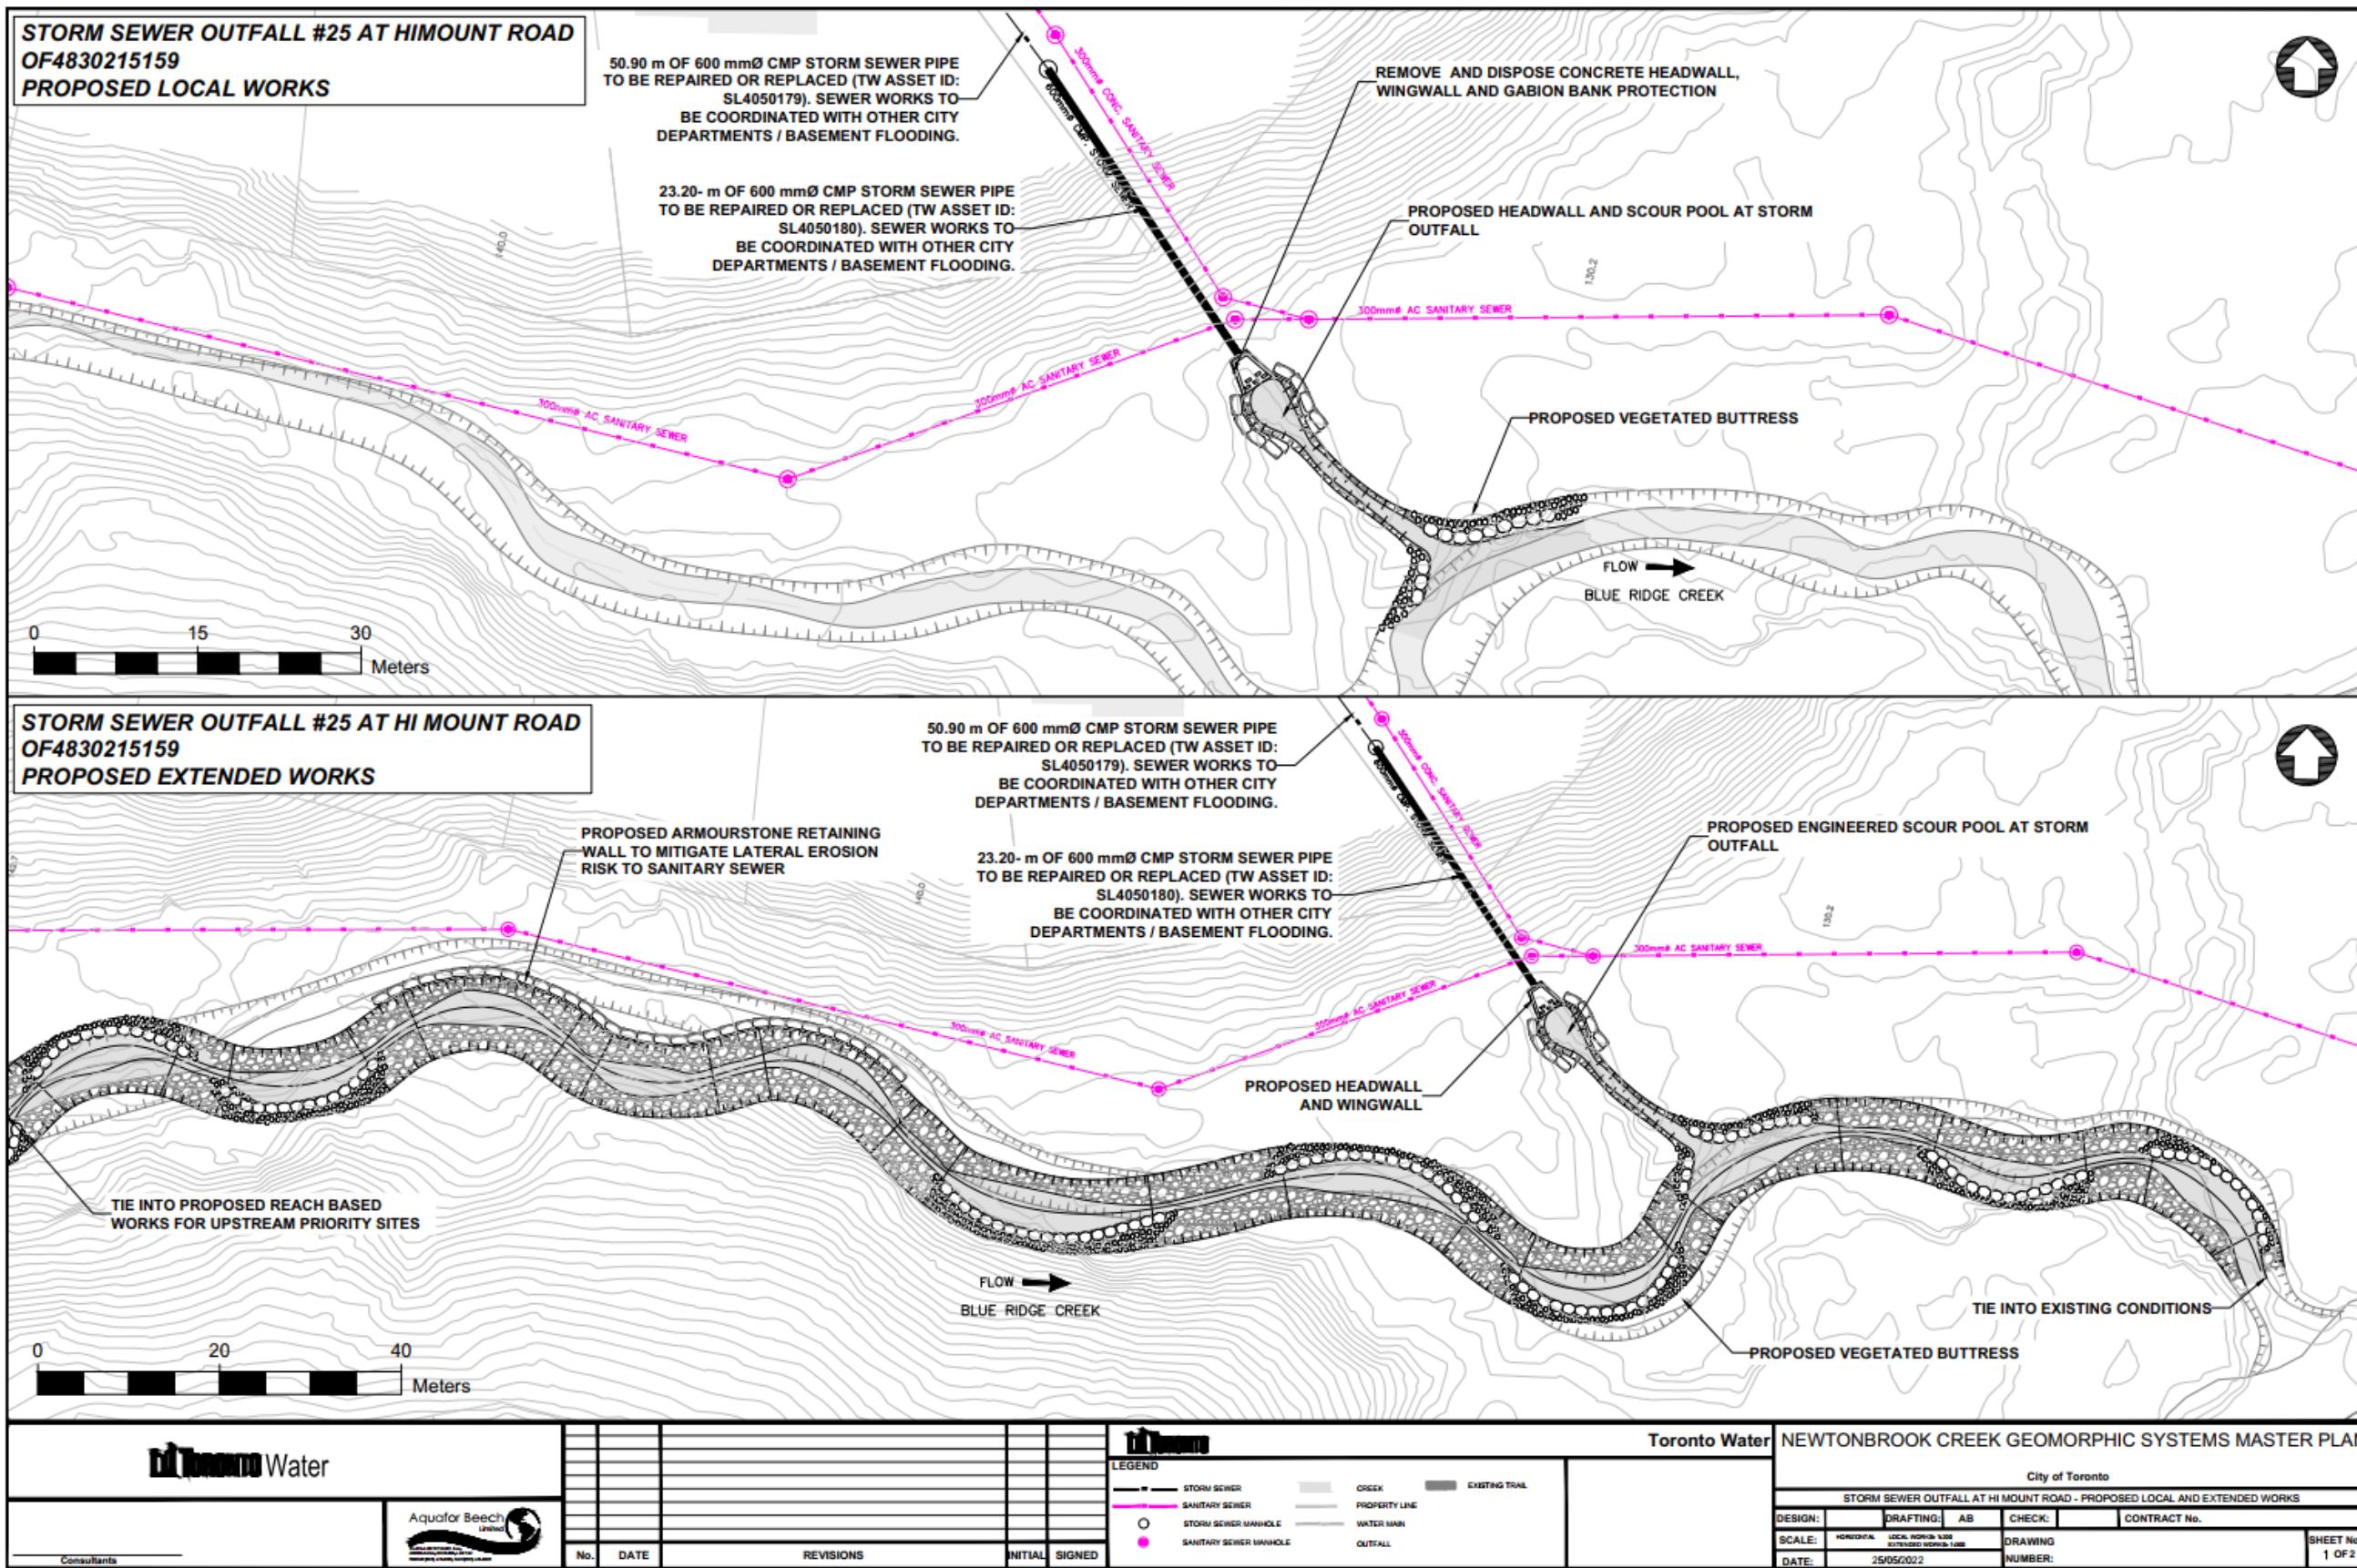
Figure 4-72: Preliminary Design Concepts Alternative 2 & 3 – Priority Site #12

Alternative 2: Local Works – Repair/Replace two (2) segments of failed/damaged storm sewer pipe (total length of approximately 74.10 m), as per the City's recommendation, maintaining the same pipe alignment in planform. Care must be taken to construct the pipes with appropriate bedding and backfill materials, as per City standards, to prevent future failure. All sewer repair/replacement works must also be coordinated with other City departments / basement flooding projects. Erosion sinkholes and gullies along the slope should be infilled with engineered fill and appropriately compacted. The degraded concrete headwall and failing gabion basket protection should be replaced with a new headwall structure discharging to an armourstone lined scour pool. The outfall channel should be re-graded and lined with engineered substrate, tying into the main channel through vegetated buttress lined banks. An easement / permission to enter agreement with 59 Hi Mount Drive will be required to undertake these works.

Alternative 3: Sub-Reach-Based Works – Complete the same local works solution proposed above (Alternative 2), as part of a larger project, intended to apply natural channel works along the lower portion of reach BR1. This will include approximately 275 metres of channel restoration work intended to build the creek back up and stabilize this segment of Blue Ridge creek from a geomorphic perspective. The proposed works will extend from the Creek's confluence with the East Don River, upstream to the confluence with Reach BR2, and will include a combination of riffle-pool morphology coupled with a mixture of engineered bank treatments (vegetated buttresses and armourstone retaining walls).

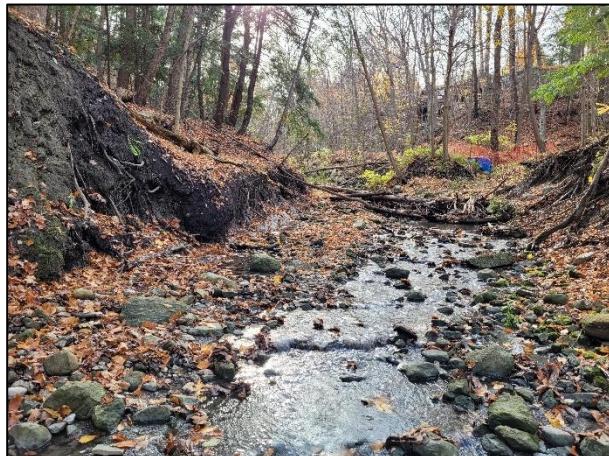
Figure 4-73: Channel Conditions Upstream of Confluence with Tributary BR-2

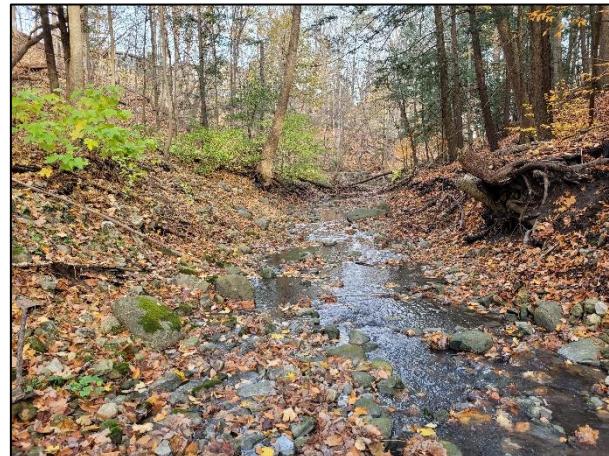
Figure 4-74: Channel Conditions Downstream of Confluence with Tributary BR-2

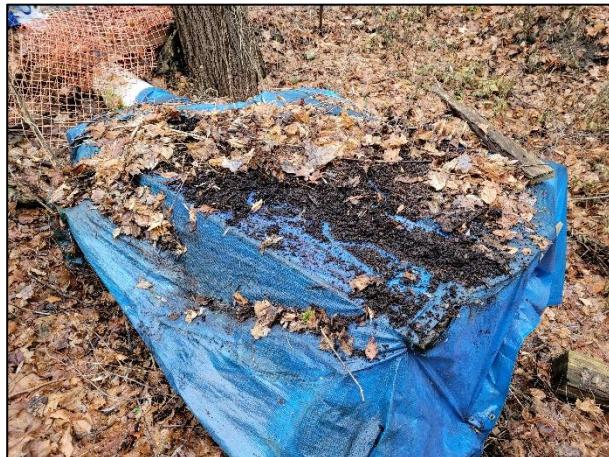
Priority Site #13 is located in Reach BR1 of Blue Ridge Creek, just upstream of the confluence between Reaches BR1 and BR2 (Figure 4-73, Figure 4-74). There is a sanitary sewer crossing of Reach BR2, immediately upstream of the aforementioned confluence. The estimated depth of cover above this crossing is 1.40 m, with a corresponding estimated time to contact of 122 years. The sewer crossing itself is therefore considered a lower priority risk site, ranked as priority site #37 for the purposes of this risk assessment report. However, while the sewer crossing itself is sufficiently protected, the upstream maintenance hole structure is in very poor condition and needs repair. The concrete casing around the maintenance hole has degraded, exposing brick underneath, and creating a fall risk to pedestrians. As the maintenance hole is not functioning safely, a temporary pipe conduit has been installed and a blue tarp covers the maintenance hole (Figure 4-75).

Figure 4-75: Highly Degraded Maintenance Hole Covered By Tarp

- Retrofit/Repair the degraded maintenance hole structure and Replace the failed storm sewer outfall.
- Construct an engineered scour pool with an armourstone lined outfall channel that transitions into the main branch of Blue Ridge Creek. Consider routing the outfall channel to transition into Blue Ridge Creek at an oblique angle to help mitigate scouring and erosion at the confluence.

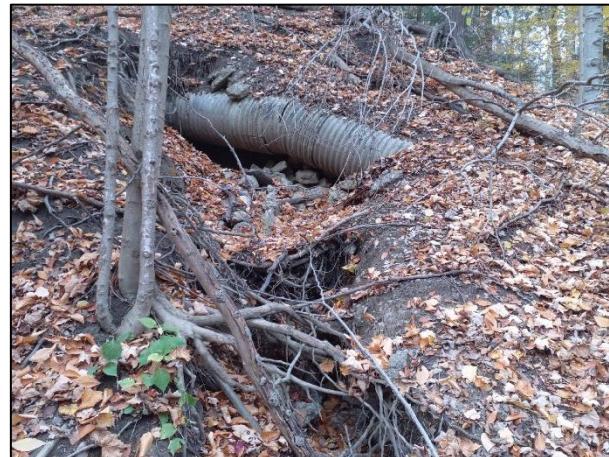
The degraded maintenance hole has two (2) inletting sanitary sewers: a 300 mm diameter sewer that runs through the Blue Ridge Creek Valley corridor and a second 300 mm diameter sewer conveying sanitary flows collected from Citation Drive. This second sanitary sewer runs down a steep valley slope between two private properties at the end of Citation Drive. Running parallel to the sanitary sewer line is a 600 mm diameter Corrugated Metal Pipe storm sewer that was designed to outlet to the creek at the toe of the valley. The downstream segments of the storm sewer pipe and the outfall structure itself have failed, leading to the formation of large erosion gullies along the valley slope. Segments of detached corrugated metal pipes are also visible upslope (Figure 4-76).

Figure 4-76: Detached Pipe Upstream of Storm Outfall, Located Adjacent to Degraded Maintenance Hole

- Repair/Replace approximately 97.30 metres of failed corrugated metal storm sewer pipe, maintaining the same general pipe alignment in planform. All sewer repair/replacement works must be coordinated with other City departments / basement flooding projects.

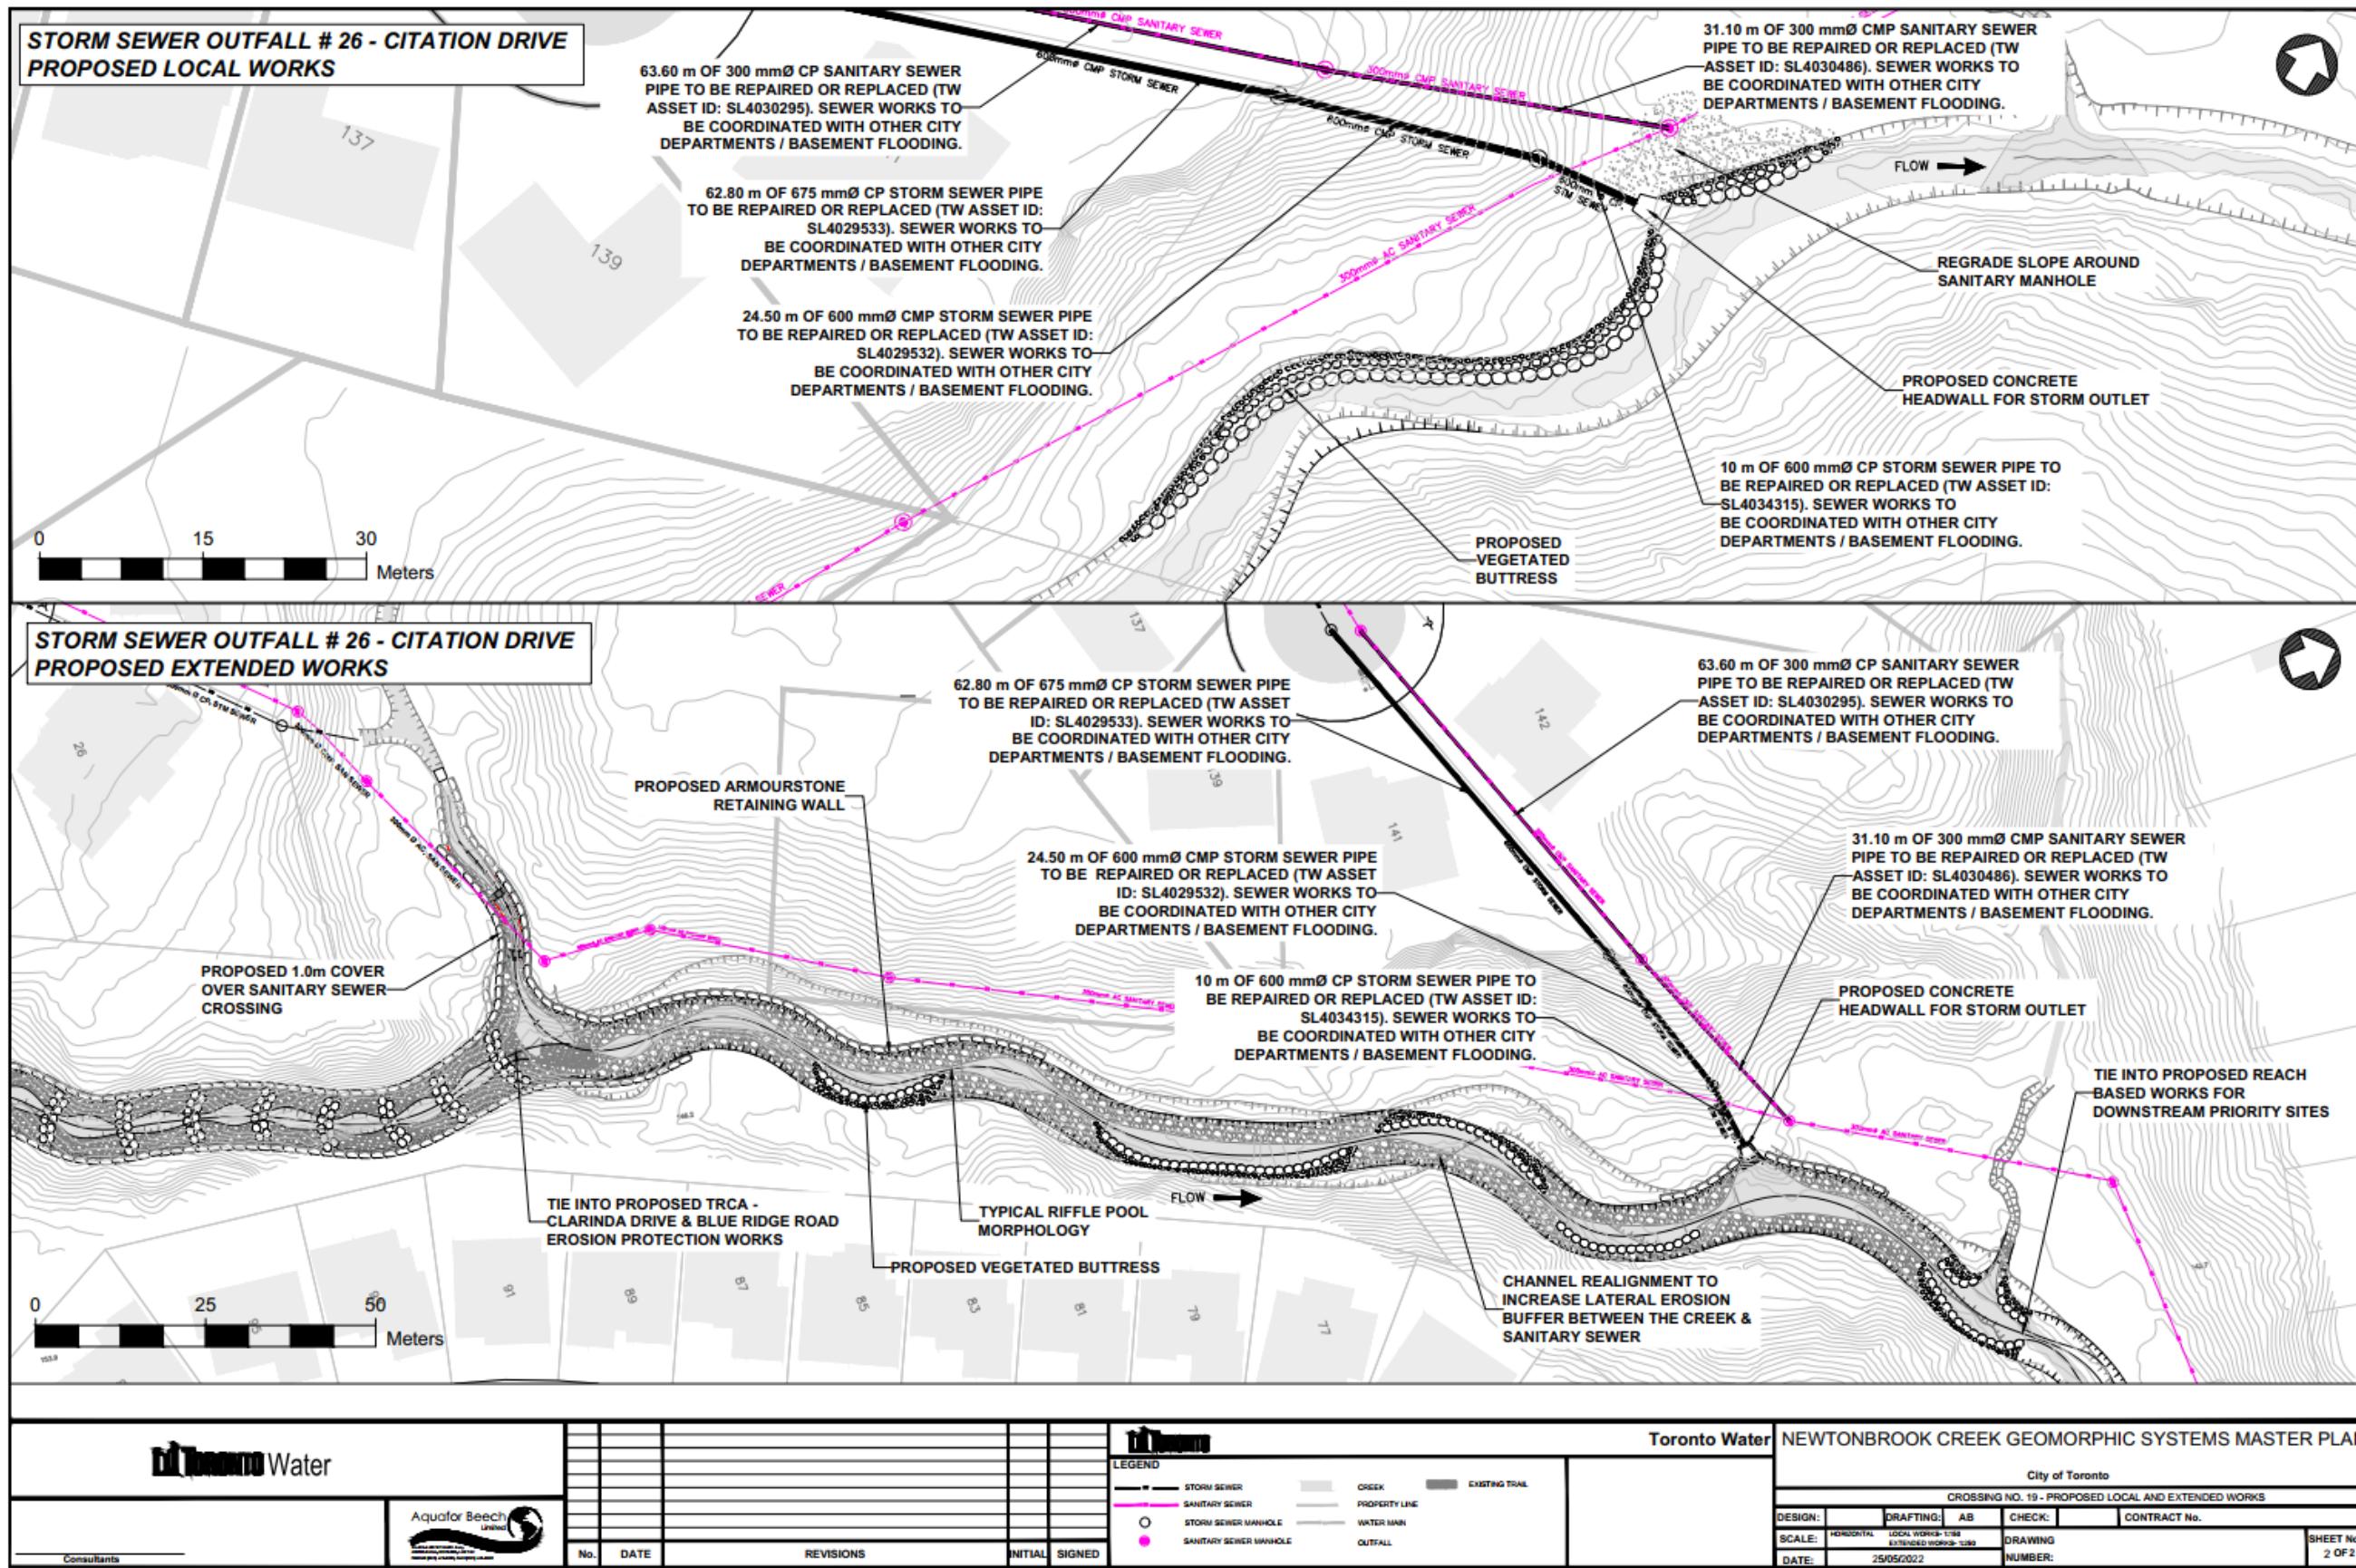
Figure 4-78: Existing Conditions - Priority Site #13

Alternative 2: Local Works – Remove three (3) segments of failed/damaged storm sewer pipe (total length of approximately 97.30 m), and two (2) segments of sanitary sewer pipe (total length of approximately 94.7 m) as per the City's recommendation, and replace with a new set of concrete pipes maintaining the same pipe alignment in planform. Care must be taken to construct the pipes with appropriate bedding and backfill materials to prevent future failure. Erosion sinkholes and gullies along the slope should be infilled with engineered fill and appropriately compacted. A new concrete headwall structure is to be constructed and integrated into a vegetated buttress designed to mitigate lateral erosion risks to Toronto Water infrastructure. The degraded maintenance hole structure will be repaired, with the eroded slope around the maintenance hole regraded and filled in using approved materials. An easement / permission to enter agreement with 141 & 142 Citation Drive may be required to undertake these works.

Alternative 3: Sub-Reach-Based Works – Complete the same local works solution proposed above (Alternative 2), as part of a larger project, intended to apply natural channel works along the upper portion of reach BR1. This will include approximately 300 metres of channel restoration work intended to build the creek back up and stabilize this segment of Blue Ridge creek from a geomorphic perspective. The proposed works will extend from the confluence of Reaches BR1 and BR2 to just upstream of the confluence between Reaches BR3 and BR1. The restoration works will include a combination of riffle-pool morphology coupled with a mixture of engineered bank treatments. These works will have the added benefit of addressing priority sites #14, #15, #21, #29, and #36, and are intended to tie-into a second sub-reach-based works alternative designed to address priority sites #12, #23 & #40 by restoring the remaining downstream portion of Reach BR-1. Preliminary concept drawings illustrating Alternative 2 and Alternative 3 are provided in **Figure 4-78**.
