#### **4.20 Priority Site #18 – Lateral Risk to Sanitary Sewer Upstream of Forest Grove Drive**

#### **4.21 Priority Site #19 – Lateral Risk to Sanitary Sewer at Finchgate Court**

#### **4.22 Priority Site #20 – Lateral Risk to Sanitary Sewer at Brucedale Crescent**

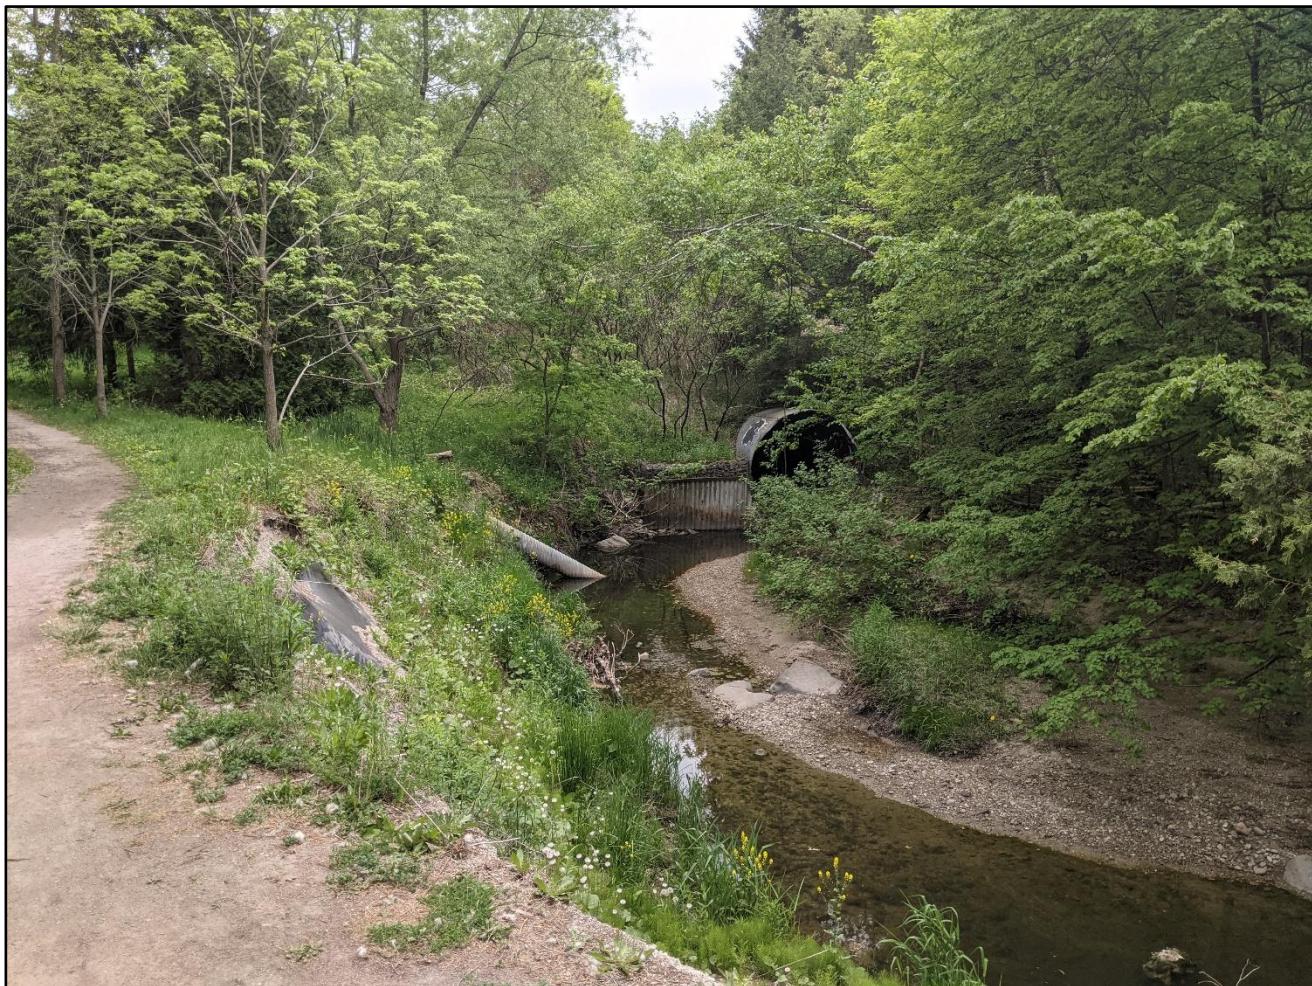
The estimated depth of lateral cover between the sewer and the edge of the channel is approximately 6.00 metres with a projected time to contact of 23.42 years. Given that this priority site is located on the outside edge of a very tight meander bend, there is significant potential for exacerbated rates of localized erosion, thereby increasing the overall lateral risk to both the sanitary trunk sewer and the multi-use trail. It is strongly recommended that at minimum, localized engineered bank works be implemented to provide erosion control protection. A photo illustrating the site-specific channel conditions and actively eroding bank encroaching into the multi-use trail is presented in **Figure 4-94**.

**Figure 4-94: Degraded Channel Conditions at Priority Site #18. The Actively Eroding Bank has Created a Lateral Risk to a 675 mm Diameter Sanitary Sewer**

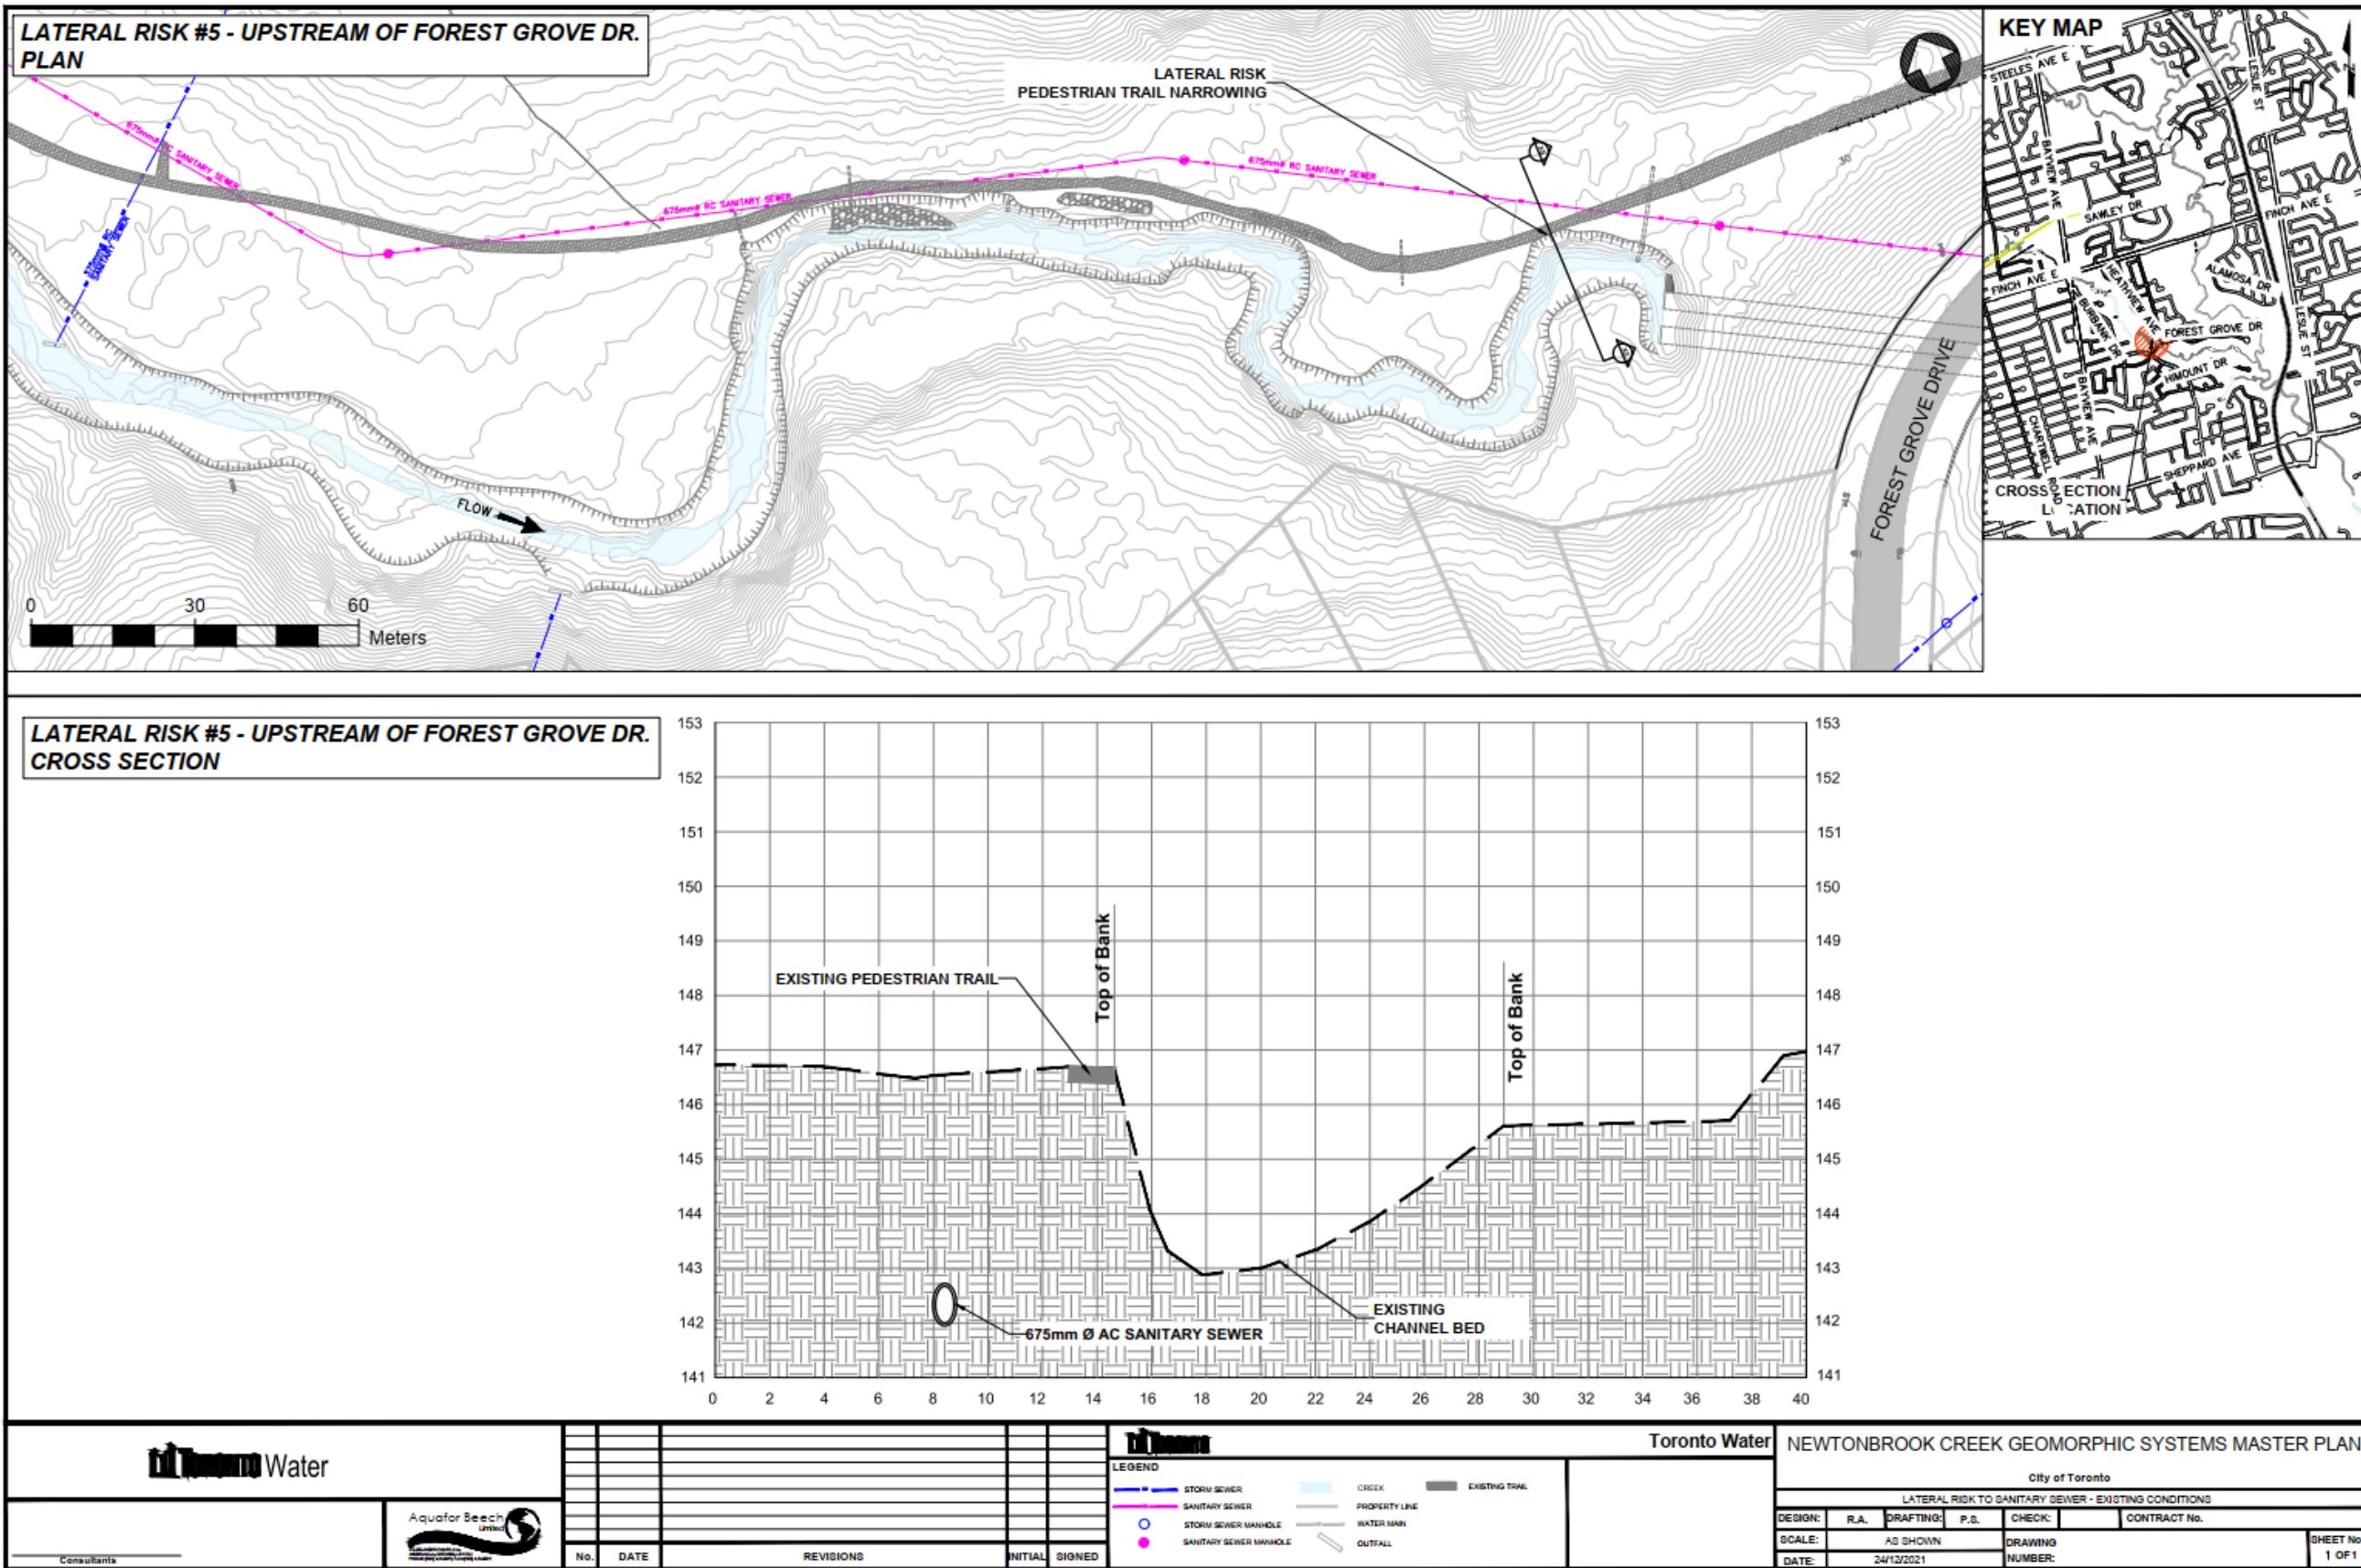
Figure 4-95: Existing Conditions – Priority Site #18

Parameter	Sanitary Trunk Sewer
Toronto Water Asset ID	SL4034031
Year of Construction	1960
Diameter	675
Lateral Depth of Cover	6.00 m
Estimated Time to Contact	23.42 years
Condition of Bank Protection Works	N/A – No Bank Protection Works Present

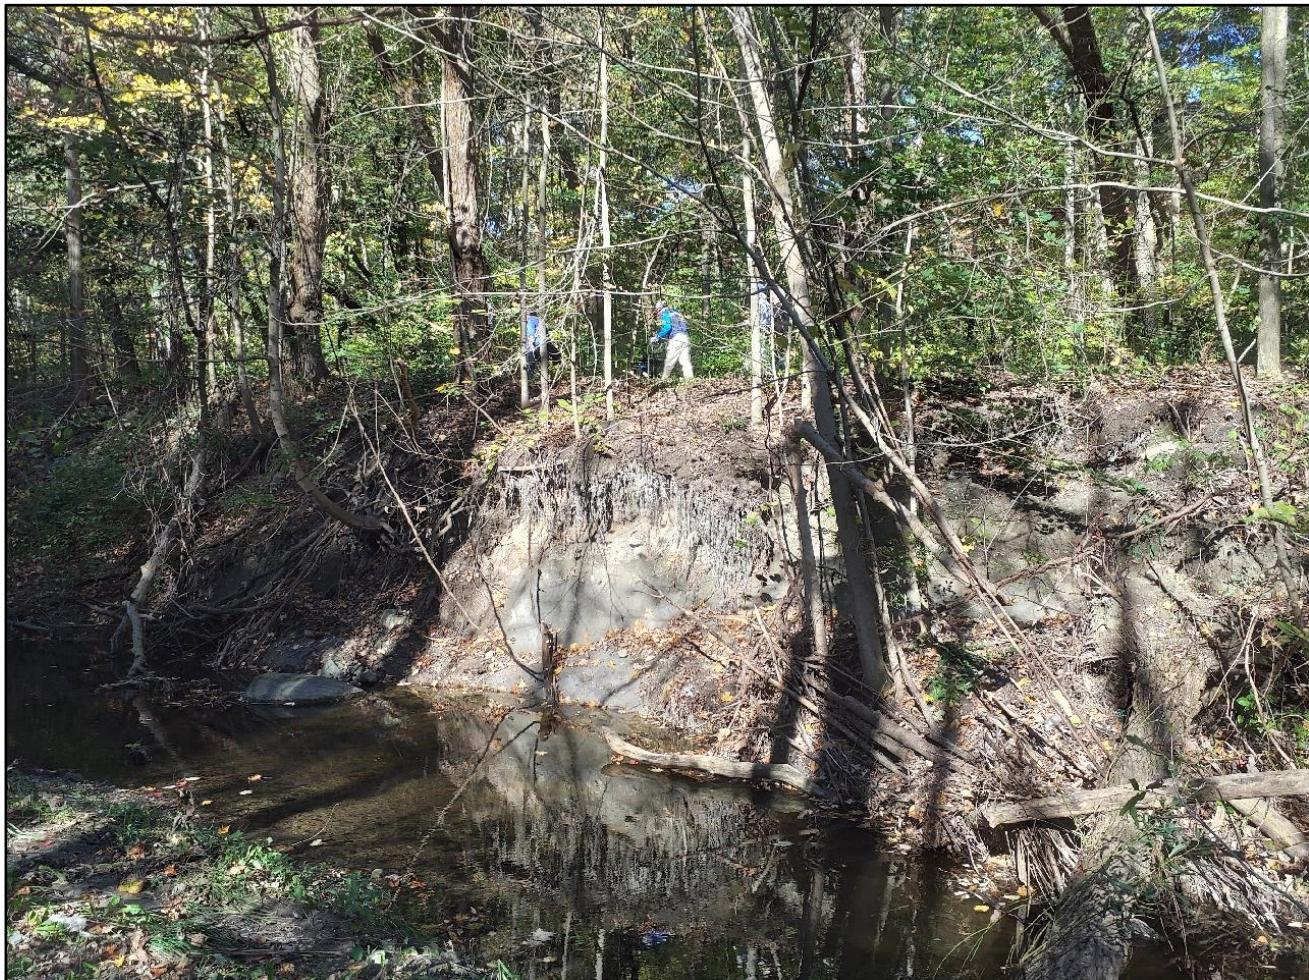
Priority Site #19 is located in Reach N2 of Newtonbrook Creek, approximately 530 metres downstream of the Finch and Bayview intersection. Erosion of the channel along the outside edge of a long meander bend has created a lateral erosion risk to the 675 mm diameter sanitary trunk sewer that runs through the Newtonbrook Creek valley corridor. The estimated depth of lateral cover between the sewer and the edge of the channel is 0.75 m, with an estimated time to contact of approximately three (3) years.

The eroding bank is unprotected and is composed of highly erodible materials further exacerbating the risk to the sanitary sewer infrastructure. A multi-use trail runs through the valley corridor at this location following a similar alignment to the sanitary sewer. There is an opportunity to concurrently address lateral erosion risks to both the trail system and sanitary sewer infrastructure through the implementation of channel restoration works along this portion of Reach N2. A photo illustrating the site-specific channel conditions and actively eroding bank encroaching into the multi-use trail is presented in **Figure 4-97**.

**Figure 4-97: Degraded Channel Conditions at Priority Site #19. The Actively Eroding Bank has Created a Lateral Risk to a 675 mm diameter Sanitary Sewer**

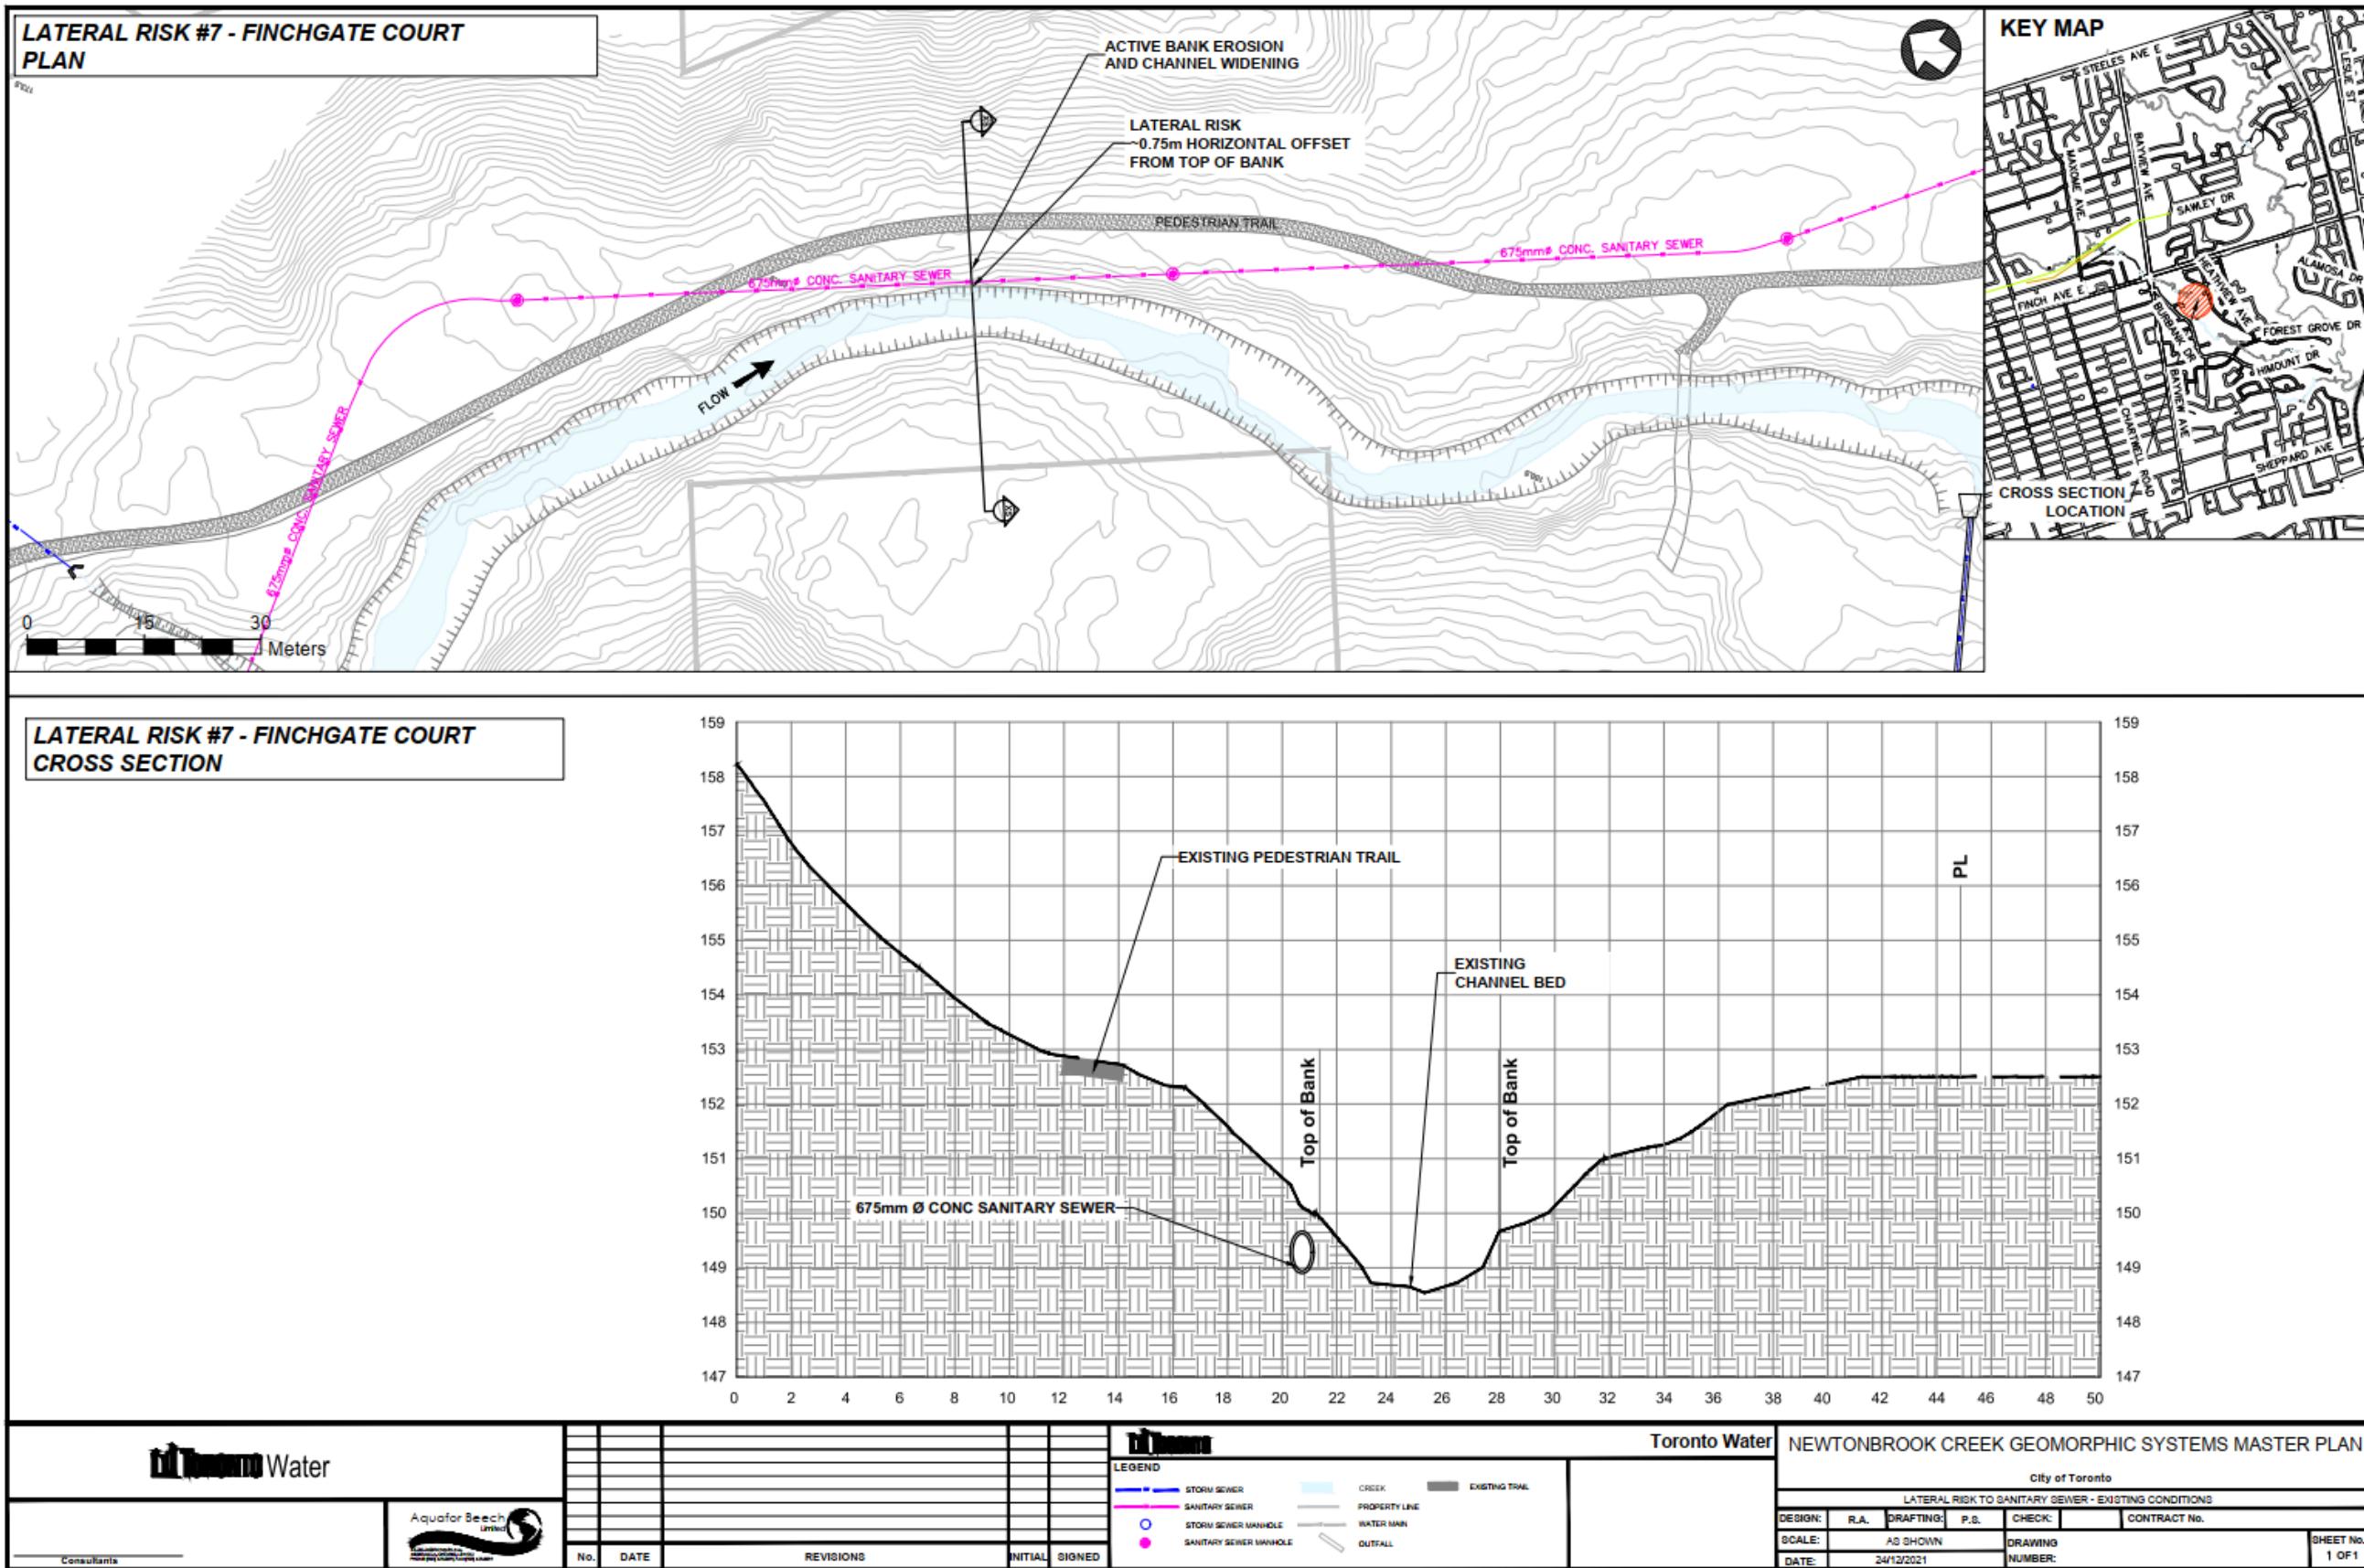
**Figure 4-98: Existing Conditions – Priority Site #19**

Parameter	Sanitary Trunk Sewer
Toronto Water Asset ID	SL4032401
Year of Construction	1960
Diameter	675
Lateral Depth of Cover	0.75 m
Estimated Time to Contact	2.93 years
Condition of Bank Protection Works	N/A – No Bank Protection Works Present

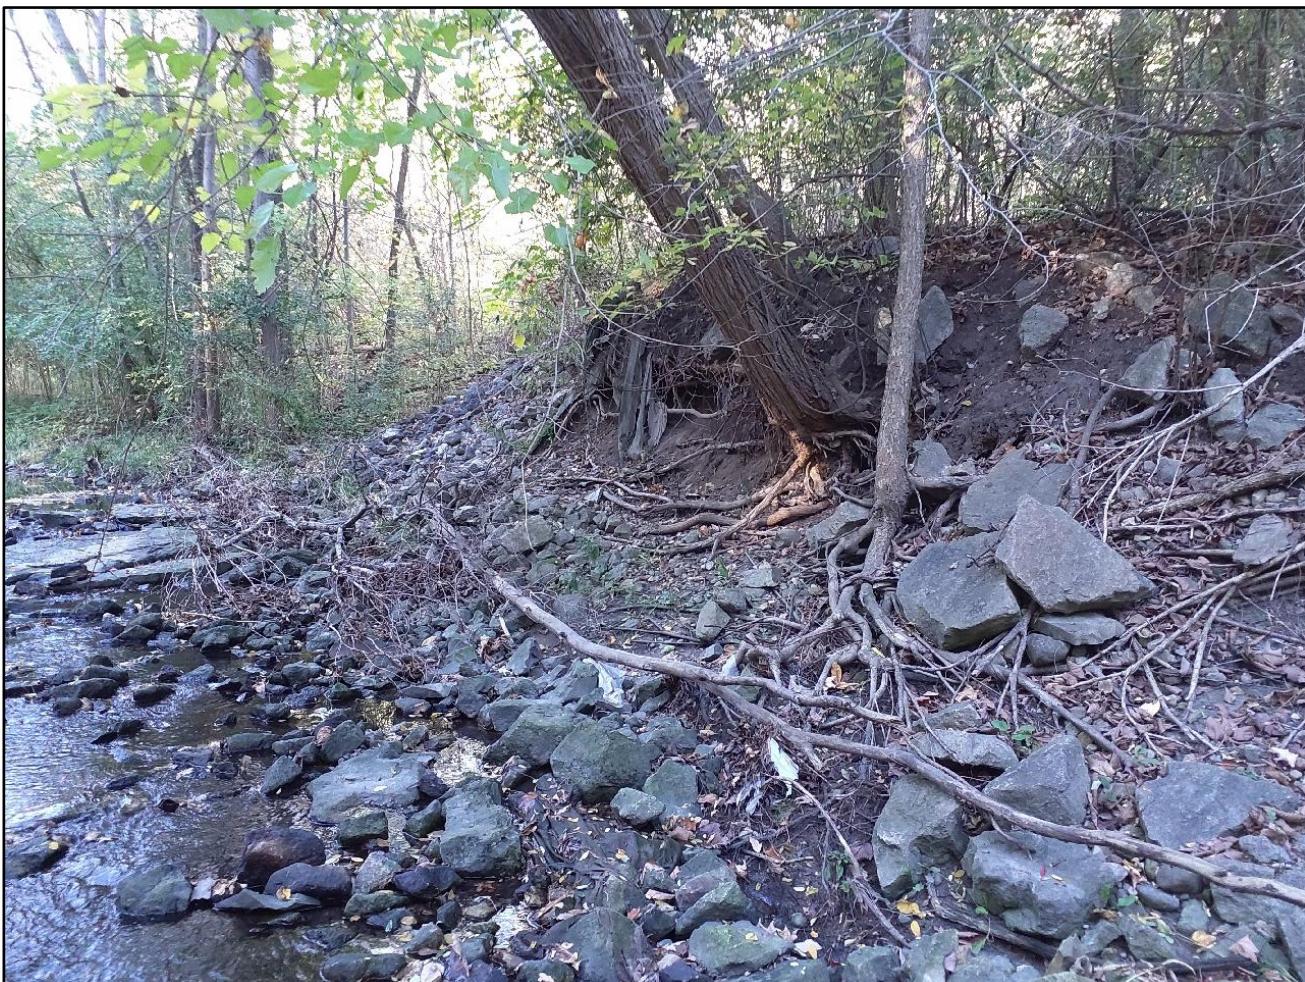
Priority Site #20 is located in Reach N2 of Newtonbrook Creek, between two exposed sanitary sewer crossings (Priority Sites #6 & #7). Widening of the channel has created a lateral erosion risk to the 675 mm diameter sanitary trunk sewer that runs through the Newtonbrook Creek valley corridor. The estimated depth of lateral cover between the sewer and the edge of the channel is 0.25 m. While the depth of lateral cover is minimal, the channel bank is protected by a coating of engineered rip-rap. The rip-rap protection works along the top of the bank have washed out, leaving only the toe of the bank protected. Factoring in the existing rip-rap bank protection, the estimated time to contact is roughly six (6) years. However, it is highly probable that if the rip-rap lining the toe of the bank begins to wash out the bank will begin to erode more rapidly, potentially resulting in the exposure of the sanitary sewer. A photo illustrating the site-specific channel conditions and actively eroding bank encroaching towards the sanitary sewer line is presented in **Figure 4-100**.

**Figure 4-100: Degraded Channel Conditions at Priority Site #20. The Actively Eroding Bank has Created a Lateral Risk to a 675 mm Diameter Sanitary Sewer**

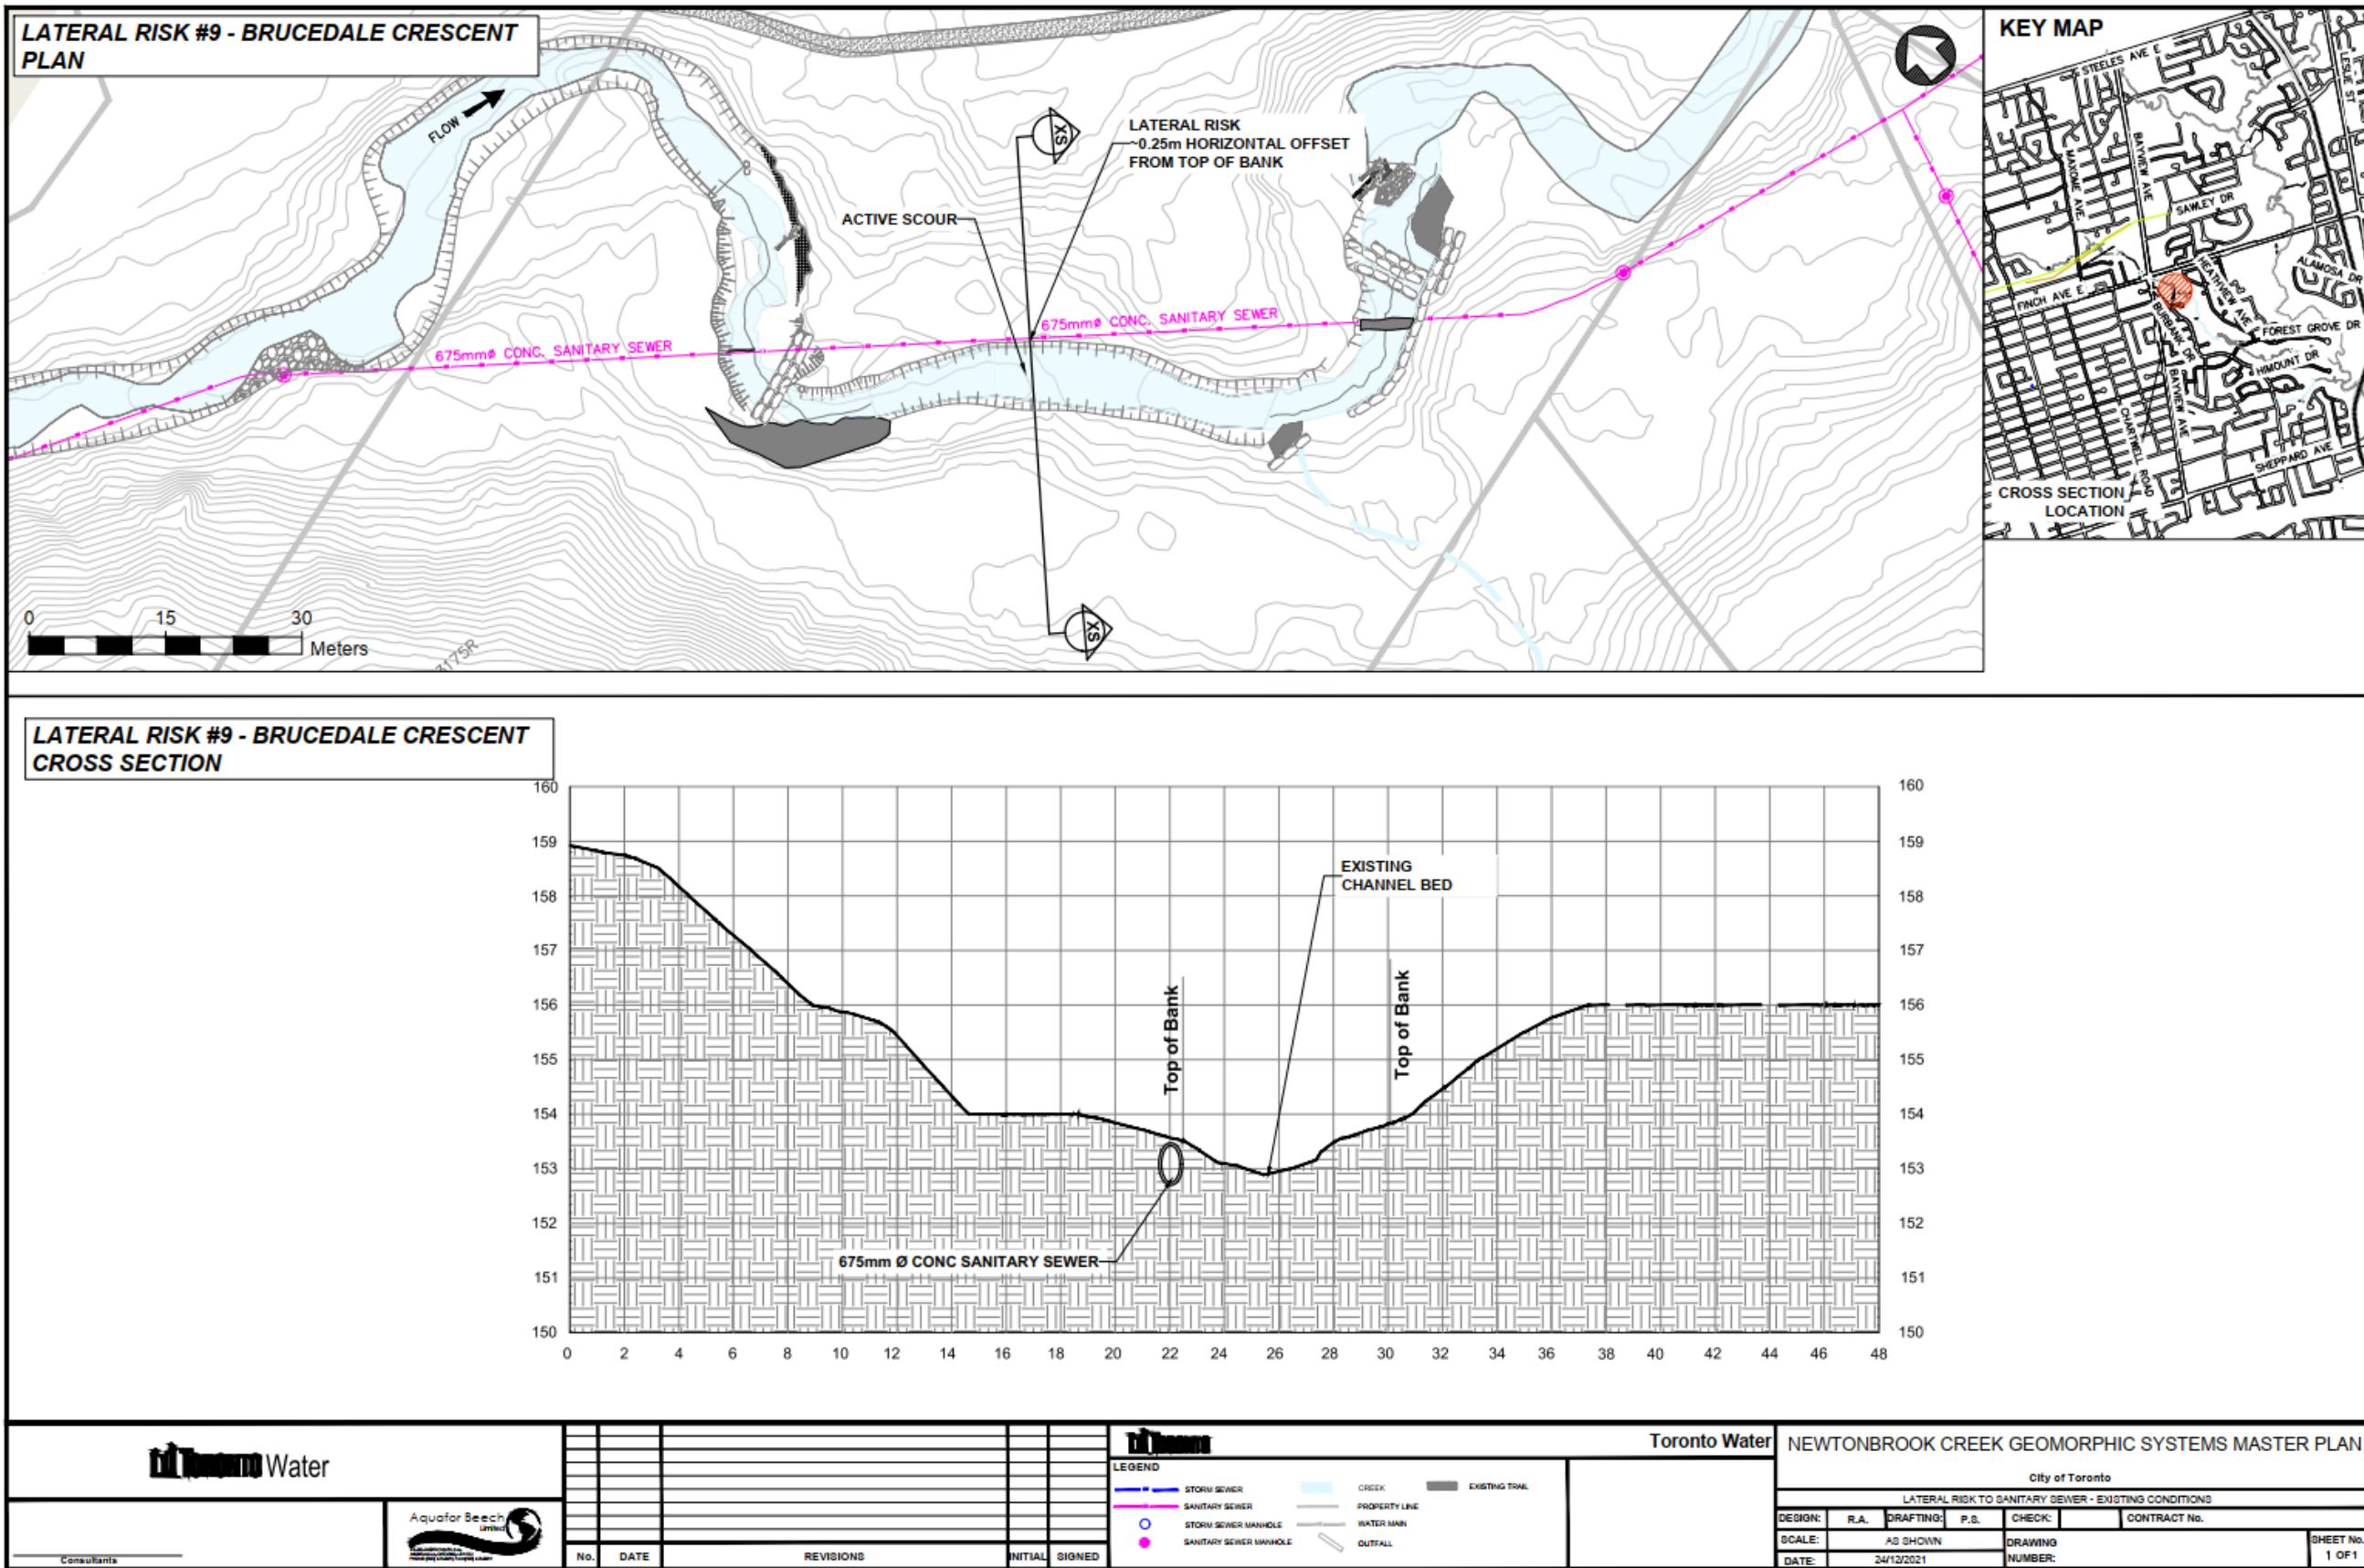
**Figure 4-101: Existing Conditions – Priority Site #20**

Parameter	Sanitary Trunk Sewer
Toronto Water Asset ID	SL4031887
Year of Construction	1960
Diameter	675
Lateral Depth of Cover	0.25 m
Estimated Time to Contact	5.98 years
Condition of Bank Protection Works	Poor – Rip-Rap Protection at Toe of Bank
