4.6 Priority Site #4: Exposed Storm Water Outfall at Canary Crescent

4.7 Priority Site #5: Exposed Sanitary Sewer Crossing at Farmingdale Road

4.8 Priority Site #6: Exposed Sanitary Sewer Crossing upstream of Farmingdale Road

4.9 Priority Site #7: Exposed Sanitary Sewer Crossing Downstream of Finch Avenue and Bayview Avenue

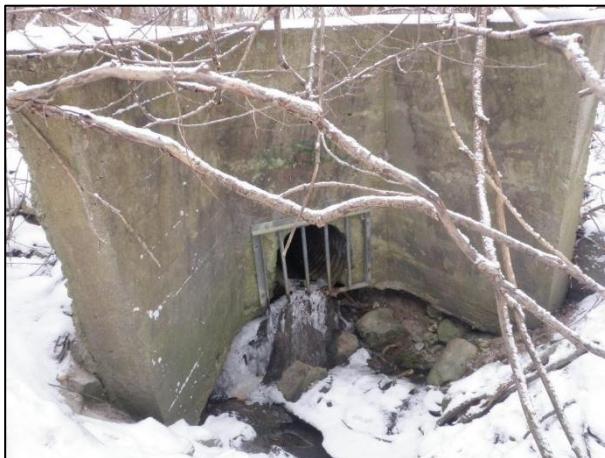
Priority Site #4 is located in Reach N2 of Newtonbrook Creek, east of Burbank Drive at Canary Crescent. A medium sized storm sewer outlets to a rip-rap lined outlet channel through a concrete headwall, set back approximately five (5) meters from the main channel (**Figure 4-19**). A combination of structural degradation of the inletting storm sewer and erosion within the creek corridor has contributed to the failure of this outfall structure.

Figure 4-19: Storm Sewer Outfall Setback Approximately 5 m from Newtonbrook Creek

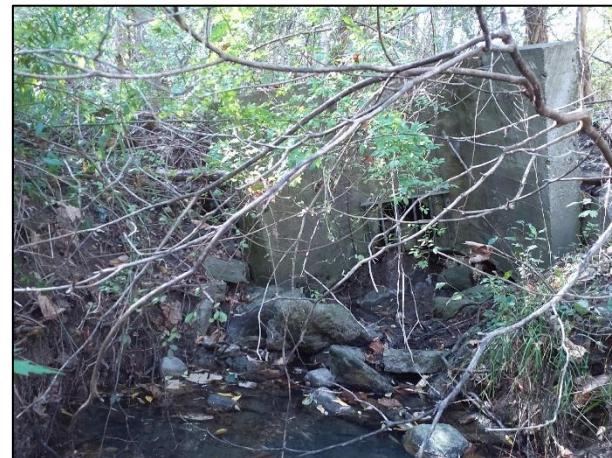
The outlet channel is heavily eroded and down cut, destabilizing the base of the outfall structure and leading to slumping of the concrete headwall (**Figure 4-20**). The headwall has become completely detached from the inletting CMP pipe (**Figure 4-21**). Field assessments and CCTV inspections of the inletting storm sewer pipe also confirm several upstream detachments and obstructions of flow (**Figure 4-22**). Instances of localized erosion and gullying are visible upslope and are expected to worsen if the storm sewer and outfall structure are left in a state of disrepair.

Figure 4-20: Eroded and Down-cut Outfall Channel Contributing to the Slumping of the Upstream Concrete Headwall Structure

Alternative 2: Local Works – Repair/replace two segments of failed/damaged CMP (total length of approximately 92.4 m), as per the City's recommendation, maintaining the same pipe alignment in planform. Care must be taken to construct the pipes with appropriate bedding and backfill materials, as per City standards, to prevent future failure. All sewer repair/replacement works must be coordinated with other City departments / basement flooding projects.

Erosion sinkholes and gullies along the slope should be infilled with engineered fill and appropriately compacted. At the detailed design stage, consideration should also be given to completing a slope stability assessment, with slope stabilization measures (i.e., soil anchors, coir logs, etc.) to be applied as required. The failed concrete headwall should also be replaced with a new equivalent structure, discharging to a newly engineered scour pool and outfall channel.

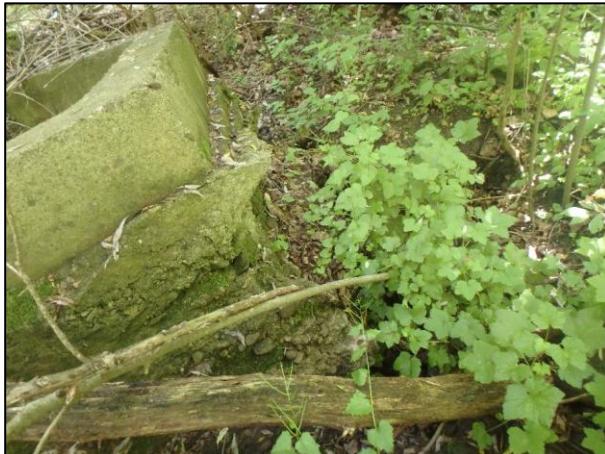
Figure 4-21: Detachment of Headwall From Inlet Pipe

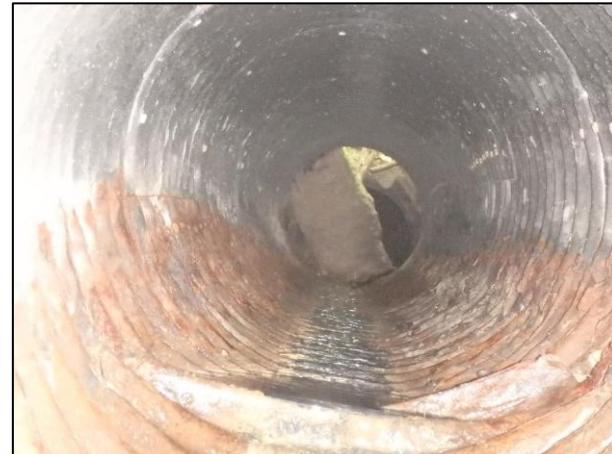
Figure 4-22: Obstructions and Detachments Within Upstream Pipe Segment

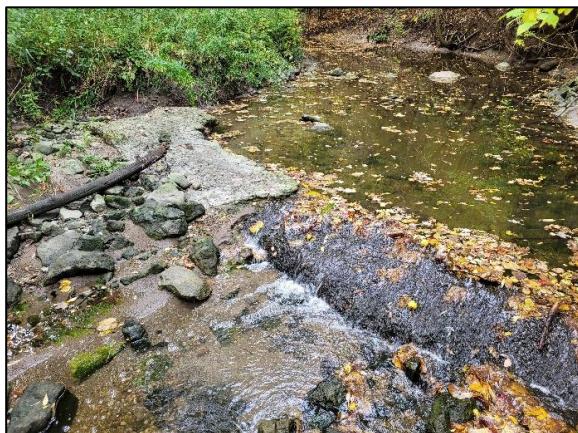
Figure 4-25: Exposed Concrete Encasement Surrounding 675 mm Ø Sanitary Trunk Sewer

- Provide a minimum of 1.0 metres of cover overtop of the exposed 675 mm diameter sanitary sewer crossing.
- Increase the depth of cover overtop of an additional three exposed sanitary sewer crossings (identified as Priority Sites #6, #7 and #9 in the Risk Assessment Report) to a minimum of 1.0 m.

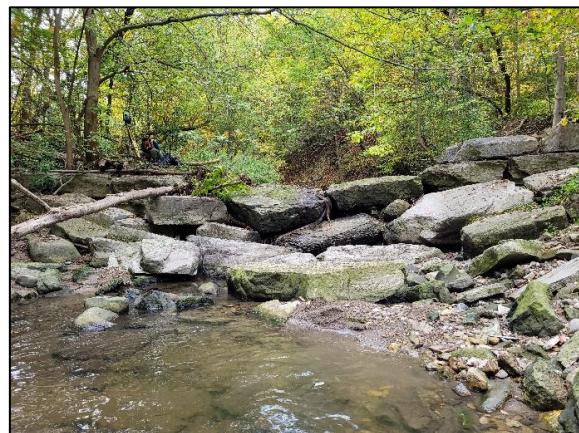
Priority Site #5 is located in Reach N2 of Newtonbrook Creek, approximately 420 metres downstream of the Finch & Bayview crossing. Incision and widening of the channel have exposed the concrete encasement surrounding a 675 mm diameter sanitary Trunk Sewer (Figure 4-25). The concrete encasement, which exhibits signs of degradation due to spalling, is protruding above the bed of the creek creating a slight backwater effect upstream. This exposed sewer crossing is situated just upstream of an armourstone grade control structure that facilitates a near vertical drop of approximately 2.0 metres along the longitudinal profile of the creek. The grade control structure is in a state of poor repair with a number of stones starting to slump and become dislodged (Figure 4-26).

Figure 4-26: Armourstone Grade Control Structure Downstream of Exposed Sanitary Sewer Crossing

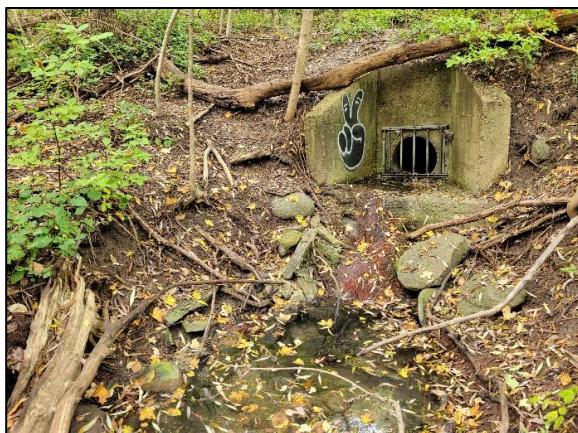
Figure 4-27: Northern Storm Sewer Outfall at Edge of Pedestrian Trail

- Rehabilitation of two storm sewer outfalls and their associated outfall channels (Priority Site #53 - OF4902413782 and Priority Site #65 - OF4907413839).

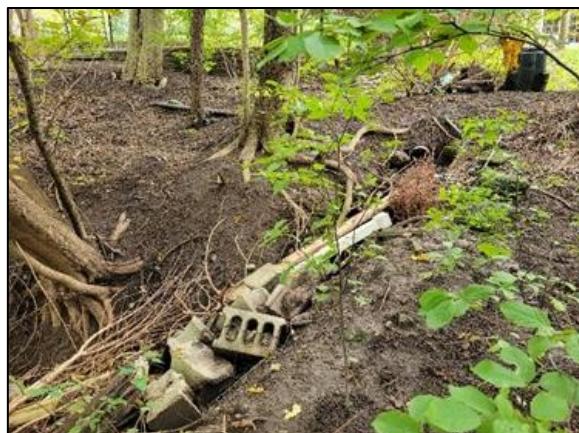
Figure 4-28: Southern Storm Sewer Outfall at Top of Slope and Associated Outfall Channel

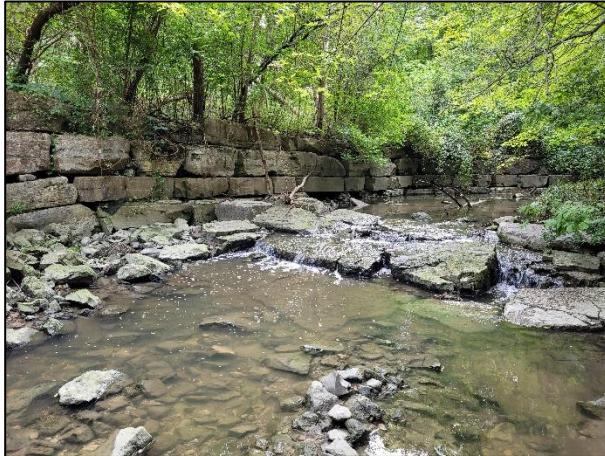
Figure 4-31: Armourstone Grade Control Structure and Armourstone Bank Protection

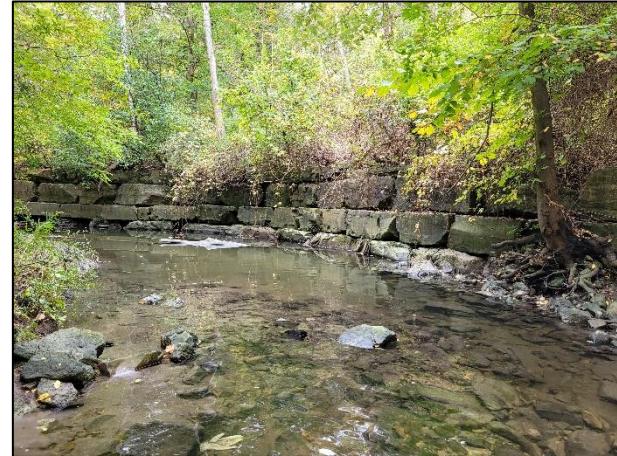
Figure 4-32: Armourstone Bank Protection along Outer Downstream Bank

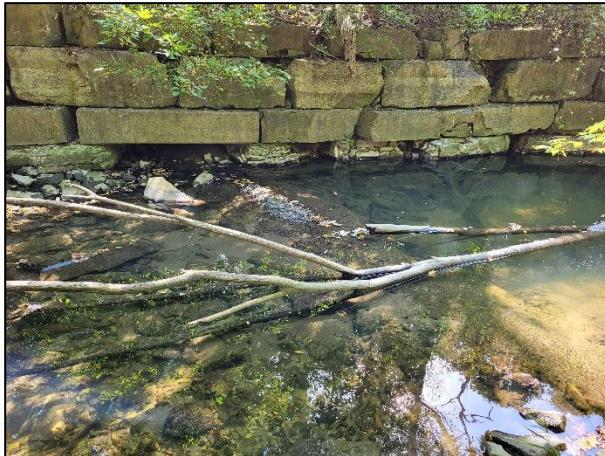
Upstream of the encasement is a large pool with a maximum depth of roughly 1.0 metres (Figure 4-33). This site is setback from the main pedestrian trail and private properties. The exposed encasement here is beginning to undermine due to the continued deepening of the upstream scour pool, with a noticeable gap having formed underneath it. If left unaddressed, the encasement could potentially become undermined and eventually fail. The armourstone wall ends ~8 metres downstream of the encasement (Figure 4-34).

Figure 4-33: Exposed Encasement with Upstream Scour Pool

- Provide a minimum of 1.0 metres of cover overtop of the exposed 675 mm diameter sanitary sewer crossing.
- Increase the depth of cover overtop of an additional three exposed sanitary sewer crossings (Priority Site #5 - SL4031857, Priority Site #6 - SL4031887, Priority Site #7 - SL4031887 and Priority Site #9 - SL4033483) to a minimum of 1.0 m.

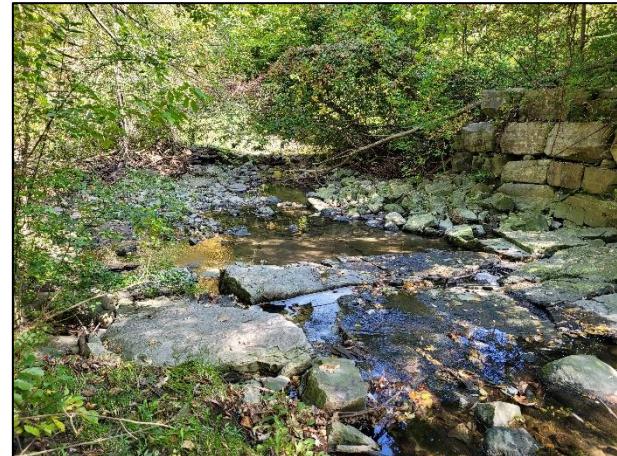
Figure 4-34: Armourstone Bank Protection and Grade Control Downstream of Exposed Encasement

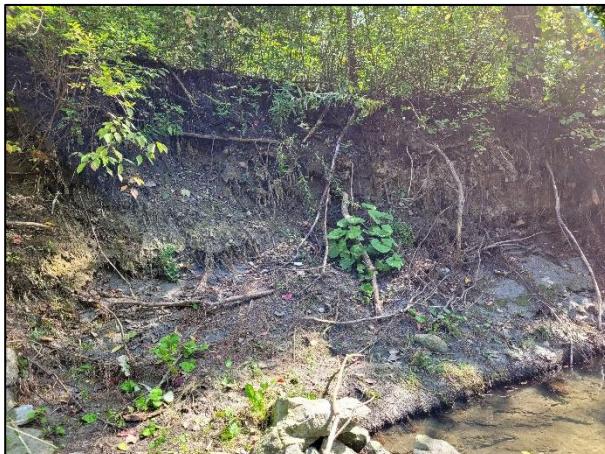
Priority Site #7 is located in Reach N2 of Newtonbrook Creek, roughly 80 metres upstream of Priority Site #6. Similar to Priority Sites #5 and #6, channel incision and widening along Reach N2 has resulted in the exposure of the concrete encasement surrounding the 675 mm diameter sanitary trunk sewer that runs through the Newtonbrook Creek valley corridor. Erosion due to widening is apparent starting well upstream of the encasement where a large erosion scar has formed along the outer bend in the channel (Figure 4-37).

Figure 4-37: Erosion Scar Along Outer Bank Immediately Upstream of Exposed Sewer Encasement

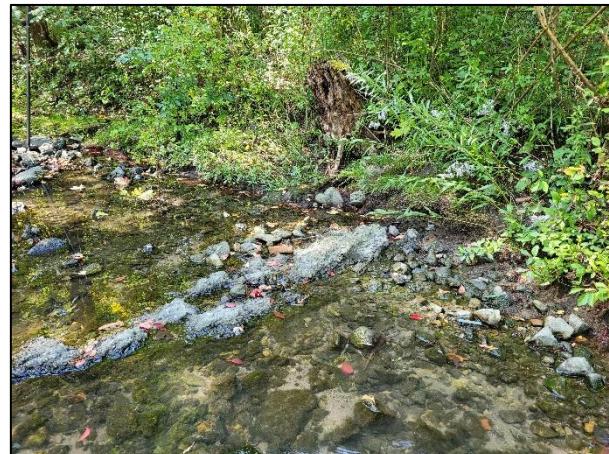
The encasement itself shows signs of significant degradation and spalling (Figure 4-38), that may eventually necessitate emergency repairs. Similar to the downstream sewer crossings identified as priority sites #5 & #6, the exposed sewer is upstream of a multi-tier armourstone grade control structure, which while still intact is in poor condition (Figure 4-39). Some armourstone and riprap bank protection has been implemented along the banks downstream of the exposed encasement (Figure 4-40). This site is not associated with any lateral erosion risks to the pedestrian trail system or private property, however, lateral risk site #9 (priority site #19) is located approximately 35-40 metres downstream of the exposed sewer crossing. As a result of the close of proximity of these risk sites, consideration should be given to addressing multiple priority sites as part of a single restoration project/contract.

Figure 4-38: Exposed Concrete Encasement Exhibiting Degradation and Spalling

- Provide a minimum of 1.0 metres of cover overtop of the exposed 675 mm diameter sanitary sewer crossing.
- Increase the depth of cover overtop of an additional three exposed sanitary sewer crossings (Priority Site #5 - SL4031857, Priority Site #6 - SL4031887, Priority Site #7 - SL4031887 and Priority Site #9 - SL4033483) to a minimum of 1.0 m.

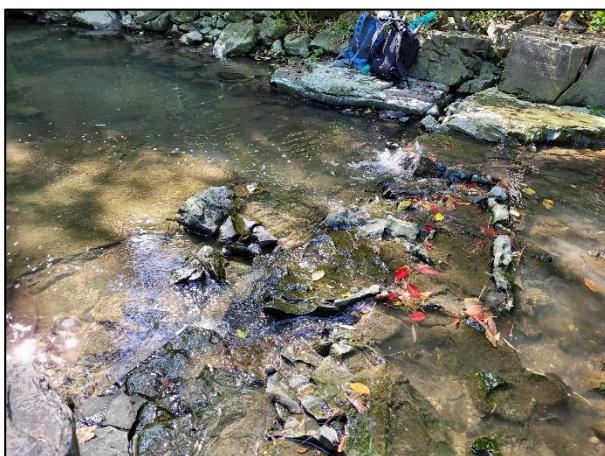
Figure 4-39: Armourstone Grade Control Structure Downstream of the Exposed Encasement

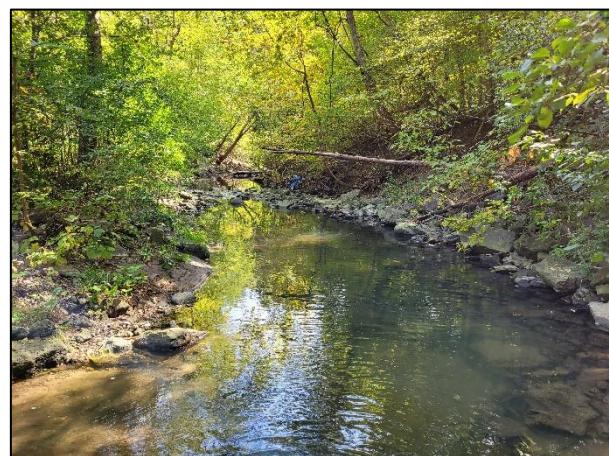
Figure 4-40: Channel Conditions Downstream of the Armourstone Grade Control Structure
