**Application for Encroachment Agreement
267½ Glenholme Avenue (Amended)**

Date:	February 8, 2006
To:	Etobicoke York Community Council
From:	Curtis Sealock, Manager, Municipal Licensing and Standards
Wards:	Ward 17 - Davenport
Reference Number:	ML&S Folder No. 06-139427 RAW

SUMMARY

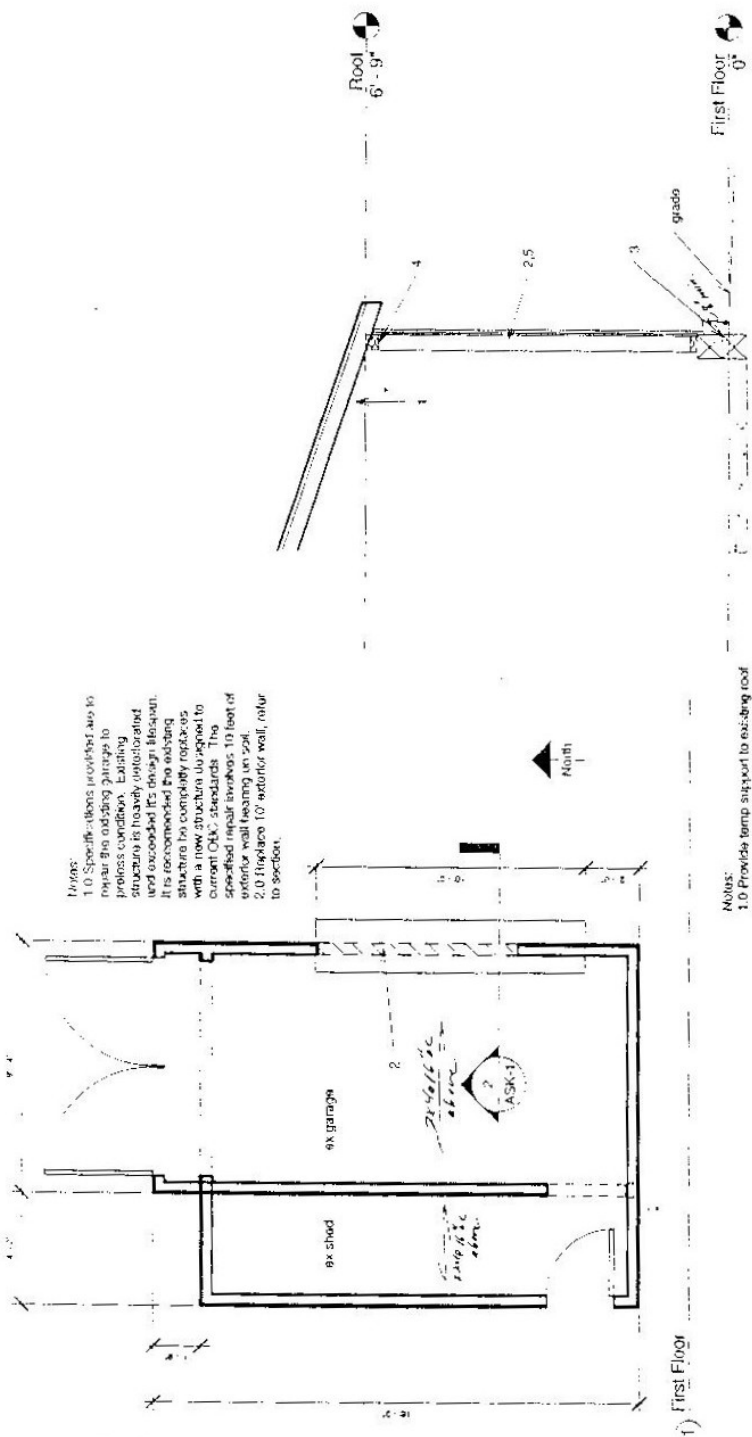
Attachment 4: Garage Detail

Notes:
 1.0 Specifications required are to repair the existing garage to process conditions. Existing structure is heavily deteriorated. It is recommended the existing structure be completely replaced with a new structure to meet current OBC standards. The specified repair involves 10 feet of exterior wall bearing on soil.
 2.0 Replace 10' exterior wall, refer to section.

Notes:
 1.0 Provide ramp support to existing roof frame.
 2.0 Remove 10' of existing 2x4 wall on existing soil, abut to existing floor slab.
 3.0 Install 10' two ply 17' 6x6 timber sill on existing soil, abut to existing floor slab.
 4.0 Insert 2nd ply 2x4 top plate below existing single plate.
 5.0 Repair 2x4 wall @ 16" oc, 1/2" plywood sheathing. Finish with asphalt shingles.

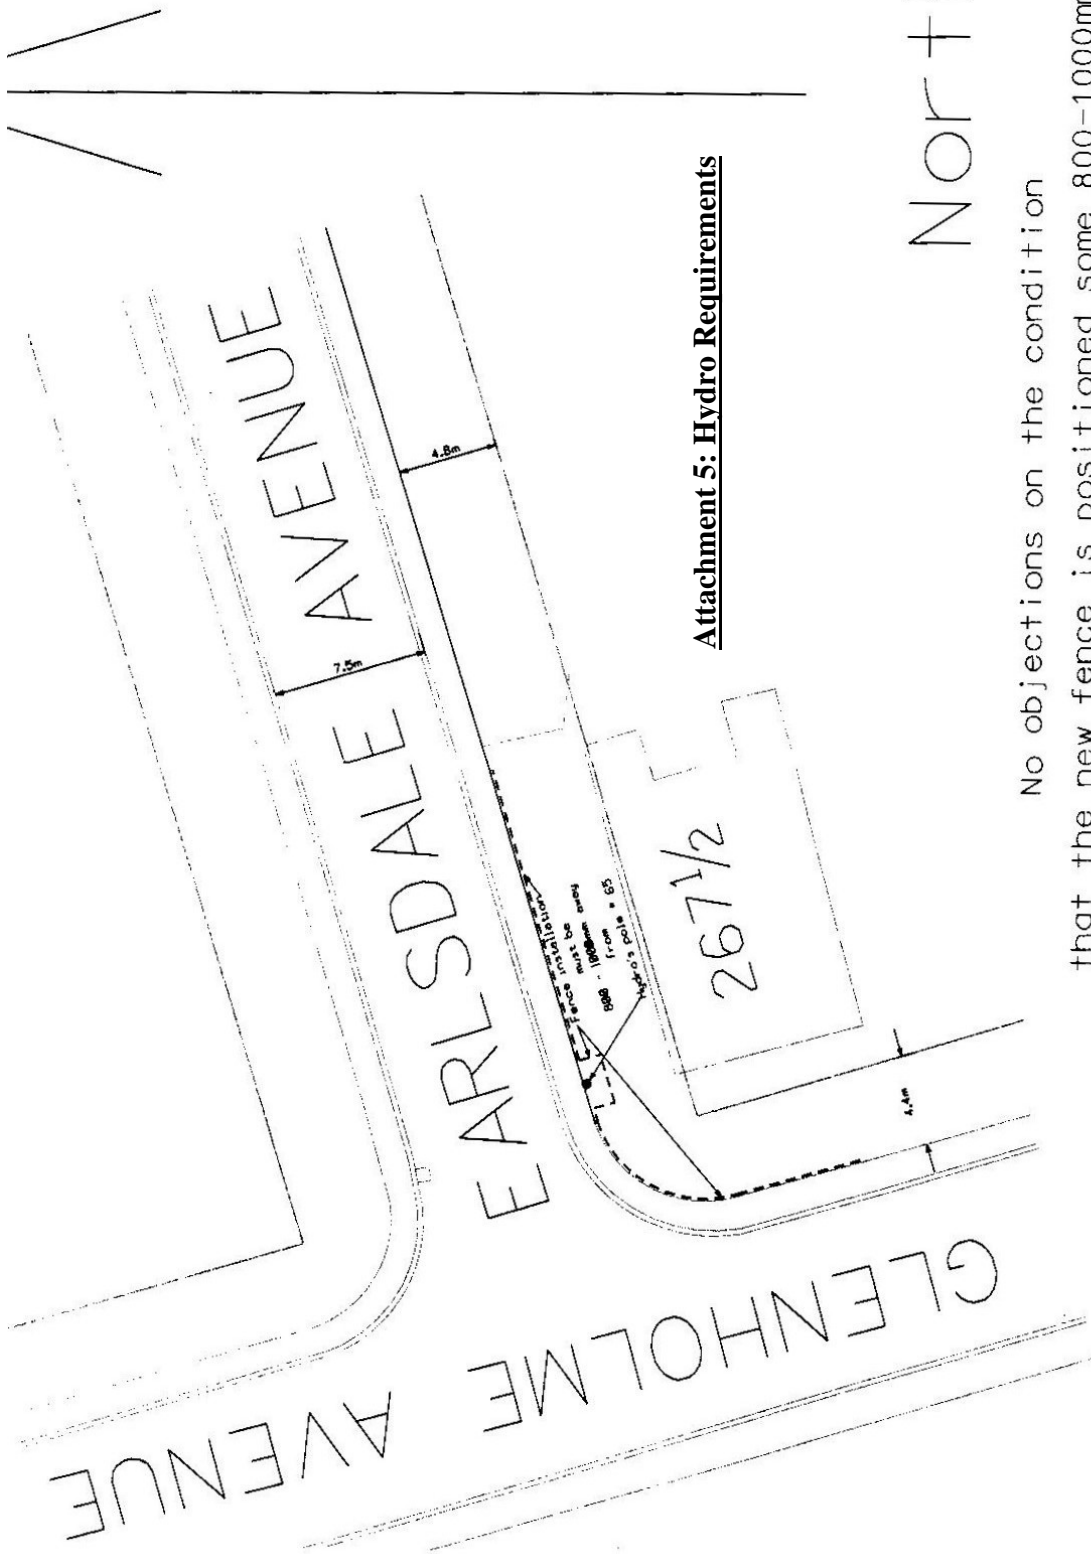
Attachment 5: Hydro Requirements

No objections on the condition that the new fence is positioned some 800-1000mm away from the perimeter of our Hydro pole# 65 !

3. the subject chain link fence to be kept in a state of good repair and maintenance, and, should the fence be replaced in future, it has to be realigned to allow a clearance of 800 mm – 1000 mm from the existing hydro pole on the Earlsdale Avenue road allowance, in compliance with the requirements of Toronto Hydro – Attachments 5 and 8;

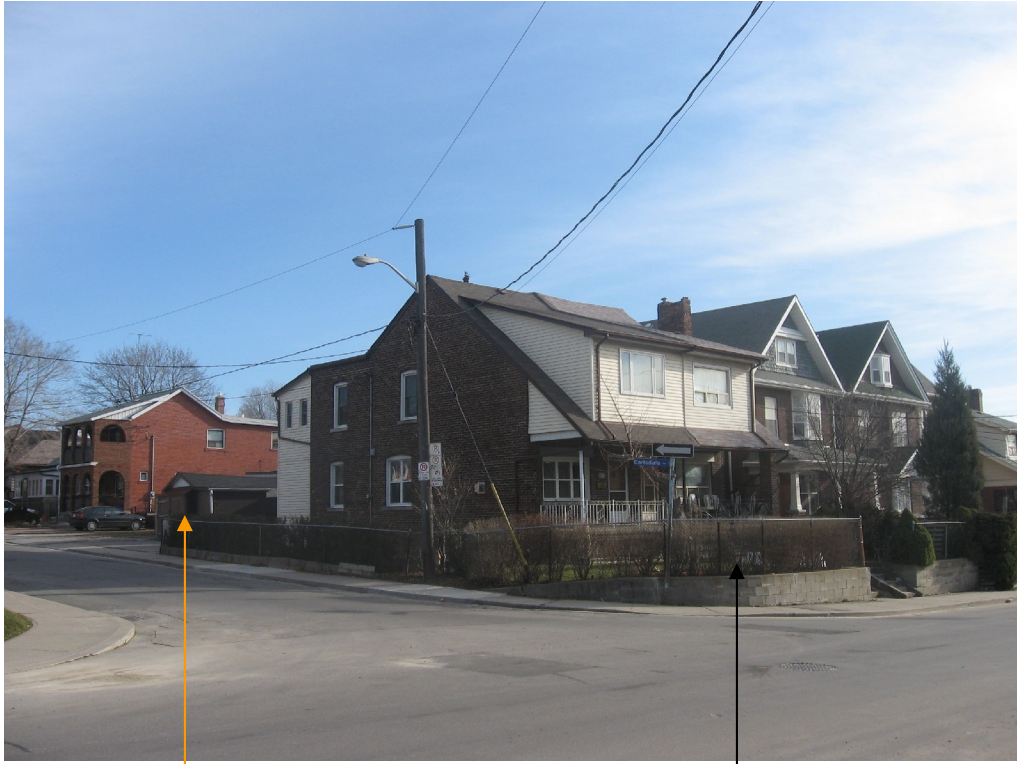
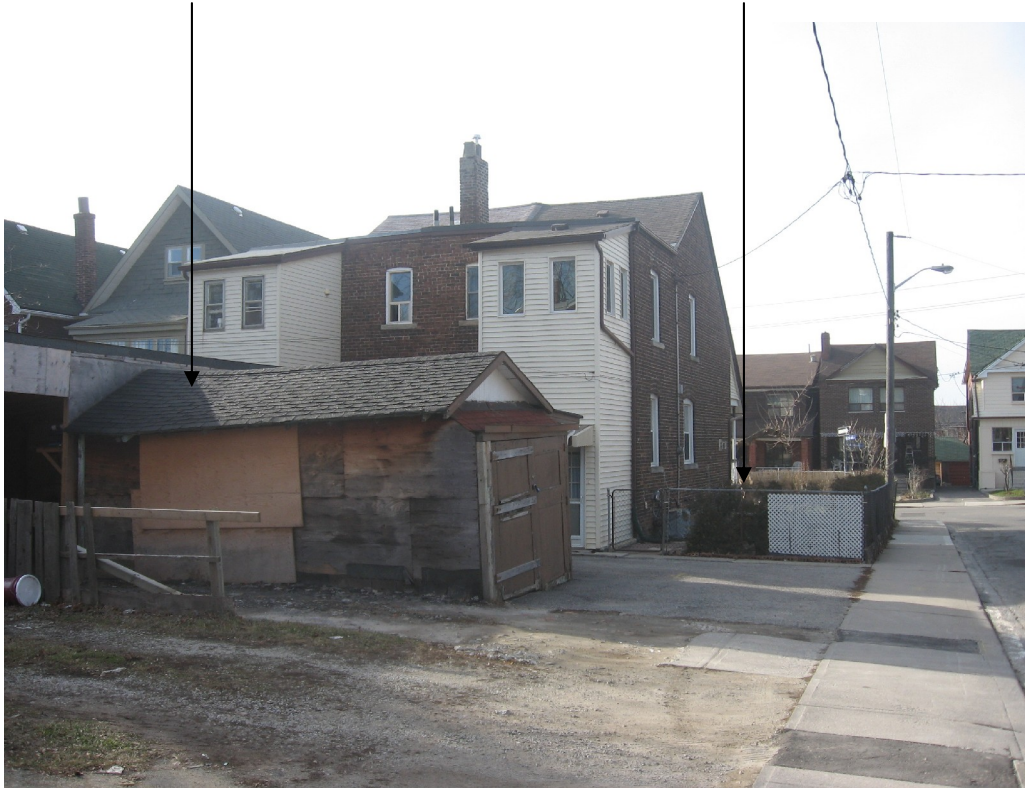
Attachment 6

Garage at Earlsdale Flankage

Chain Link Fence

6. the owner to obtain a construction/streets occupation permit prior to the commencement of any construction;
7. the dilapidated garage to be repaired in accordance with Chapter 629 of the Toronto Municipal Code, Property Standards, and, should the repairs involve any structural alteration, drawings for a Building Permit are to be submitted to Toronto Building for approval – Attachments 4 and 6;

11. the broken driveway to the east side of the driveway to be paved with asphalt or an acceptable hard surface, including crushed limestone or gravel, to avoid water ponding – Attachment 6;

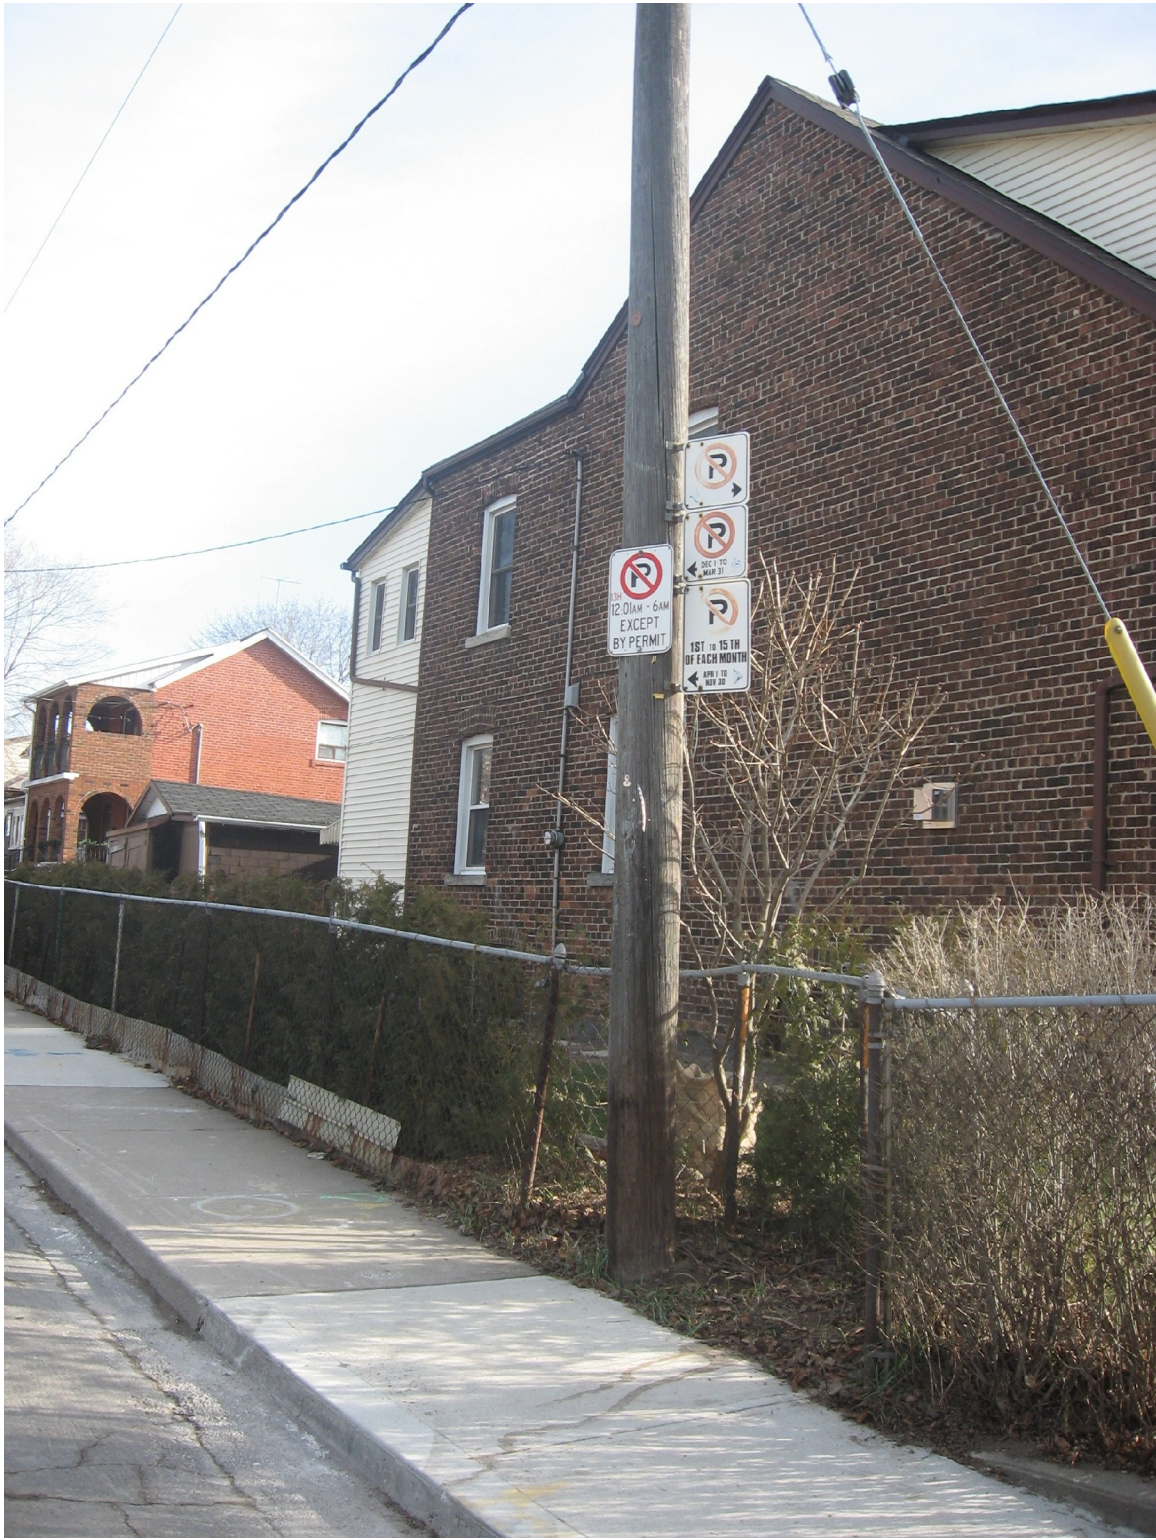
Attachment 8: Existing Hydro Pole and Fence Clearance Required

This application has been circulated for comment to Transportation Services, Urban Forestry Services, Toronto Fire Services and various utility companies, with no negative responses being received, other than the special requirement of Toronto Hydro to maintain the specified clearance of the chain link fence behind the existing hydro pole – Attachments 5 and 8.

9. the tree/shrubs adjacent to the hydro pole to be constantly trimmed and maintained to avoid overgrowth and sight line obstruction to the traffic signs erected thereon – Attachment 8;
