**STAFF REPORT
ACTION REQUIRED**

**Application for Encroachment Agreement
95 Prescott Avenue**

Date:	May 11, 2007
To:	Etobicoke York Community Council
From:	Curtis Sealock, District Manager, Municipal Licensing and Standards
Wards:	Ward 17, Davenport
Reference Number:	Folder Number 07 112149 RAW 00 IR

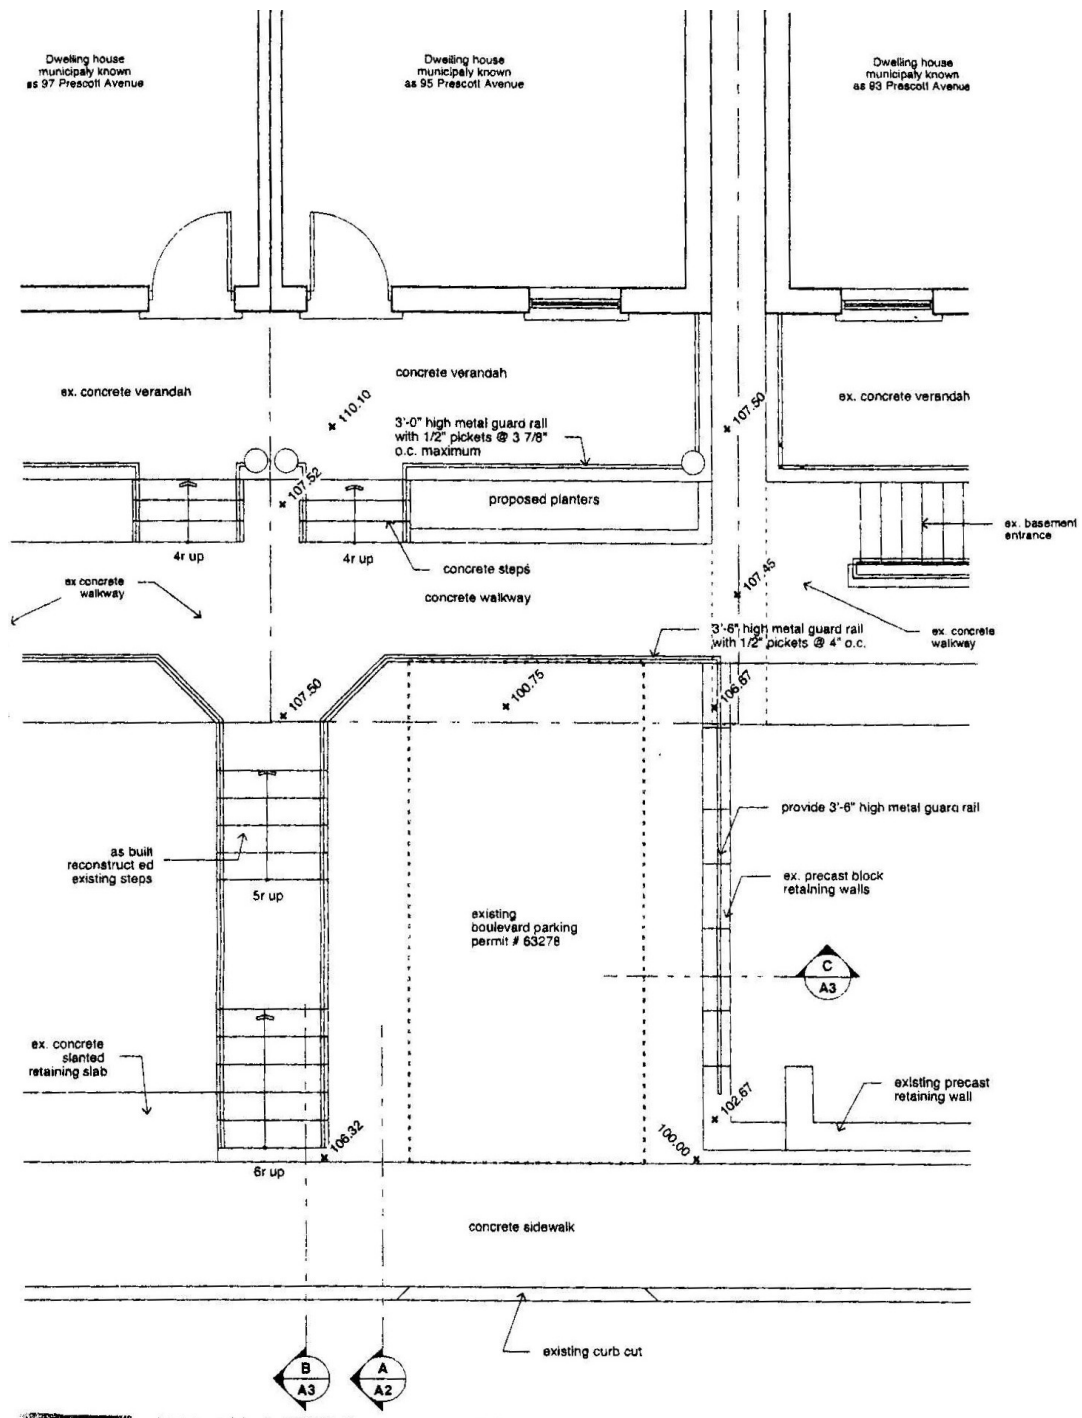
Attachment 3: Plan showing the encroaching Stairs and Retaining Wall

A concrete block retaining wall has been built alongside the south property line to make space for parking of a vehicle which is subject to a Front Yard Parking Permit Number 63278 (Attachments 2 and 3).

4. to install a 1.07 metres high guardrail on top of the subject retaining wall for its entire length where the difference in grade levels on each side of the wall is more than 600 millimetres, to connect to existing the guardrail at the concrete deck to ensure continuity, in accordance with the requirements of the latest edition of the Ontario Building Code (Attachments 3, 4, 6 and 7);

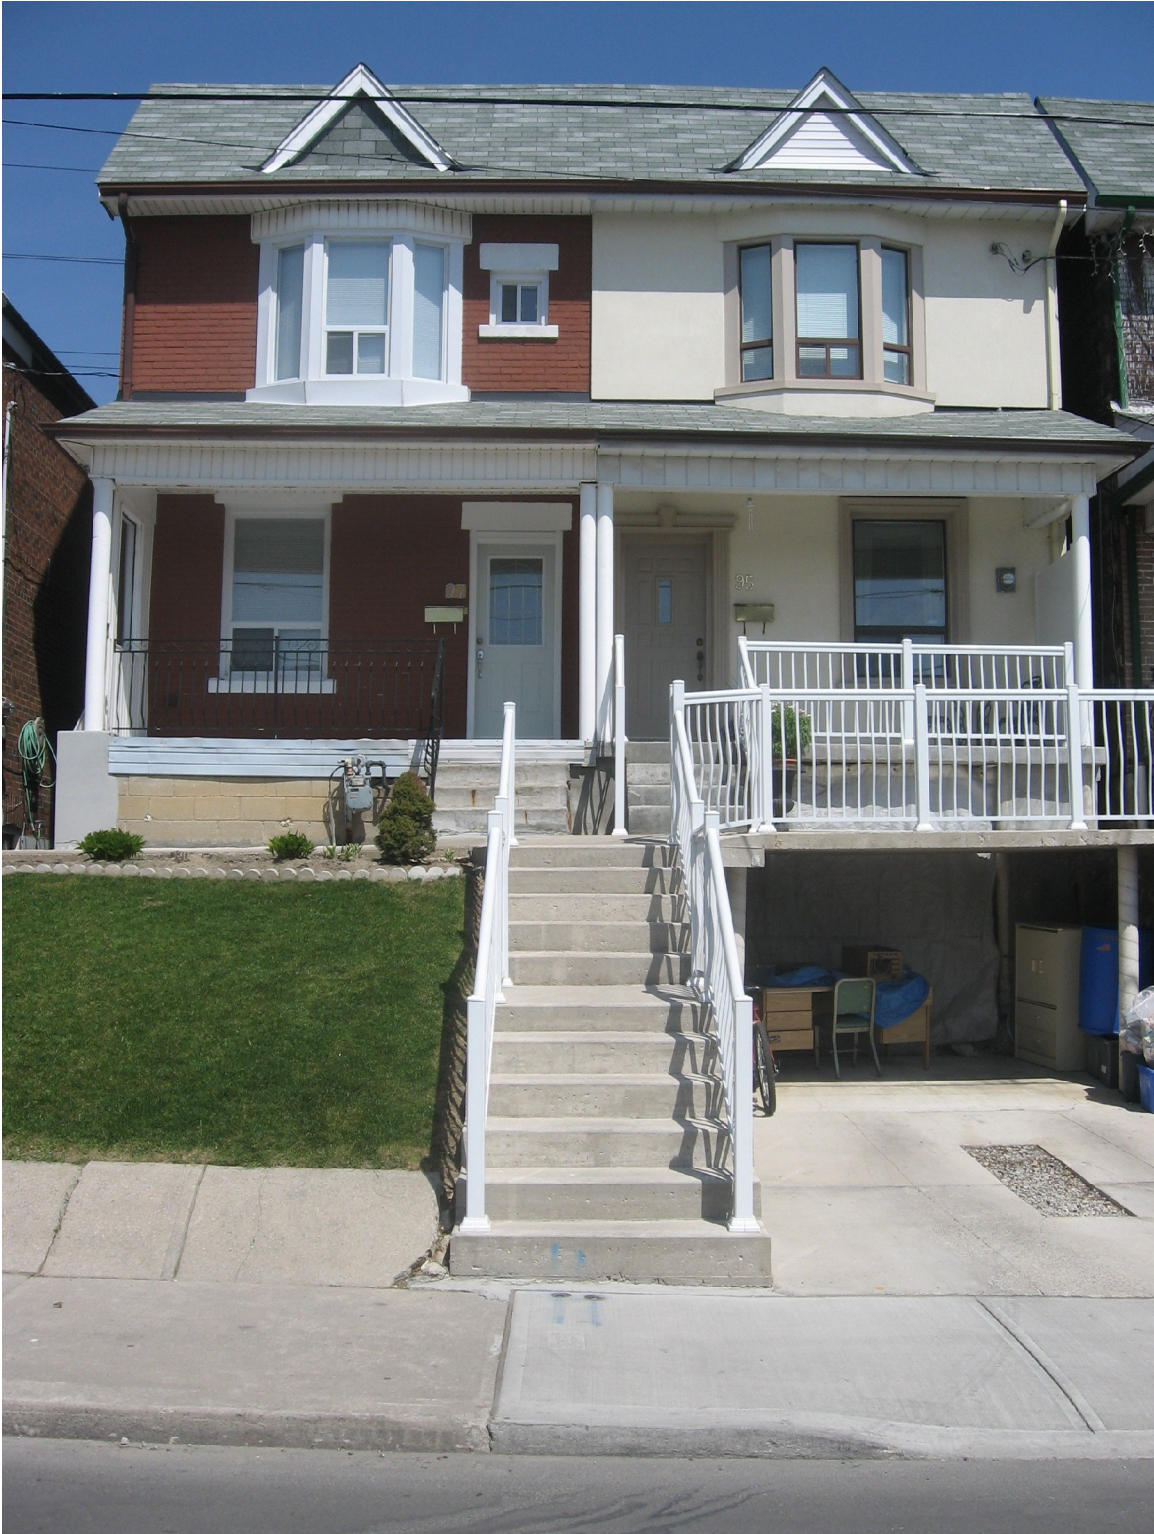
Attachment 5: Photograph of the property showing the encroaching mutual stairs

The properties at 95 and 97 Prescott Avenue consist of a pair of two-storey semi-detached houses with an elevated concrete deck at the front, approximately 2.06 metres above street level. Entrance to the houses is accessible from the street via a flight of 1.50 metres wide mutually shared concrete stairs which is encroaching on the municipal road allowance over a distance of approximately 15.50 metres (Attachments 1 – 6).

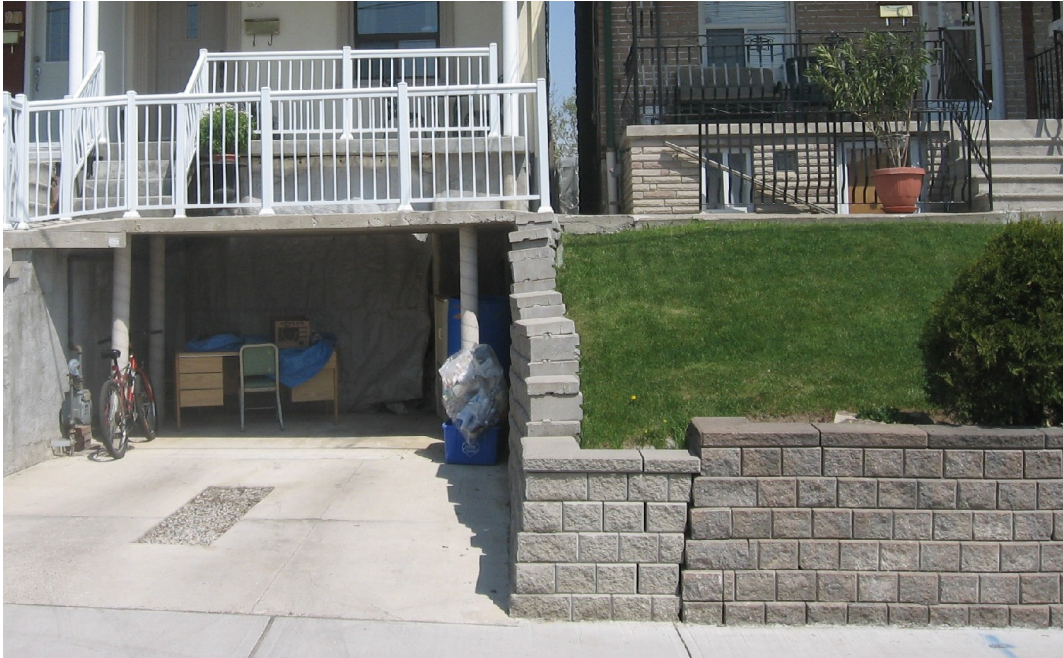
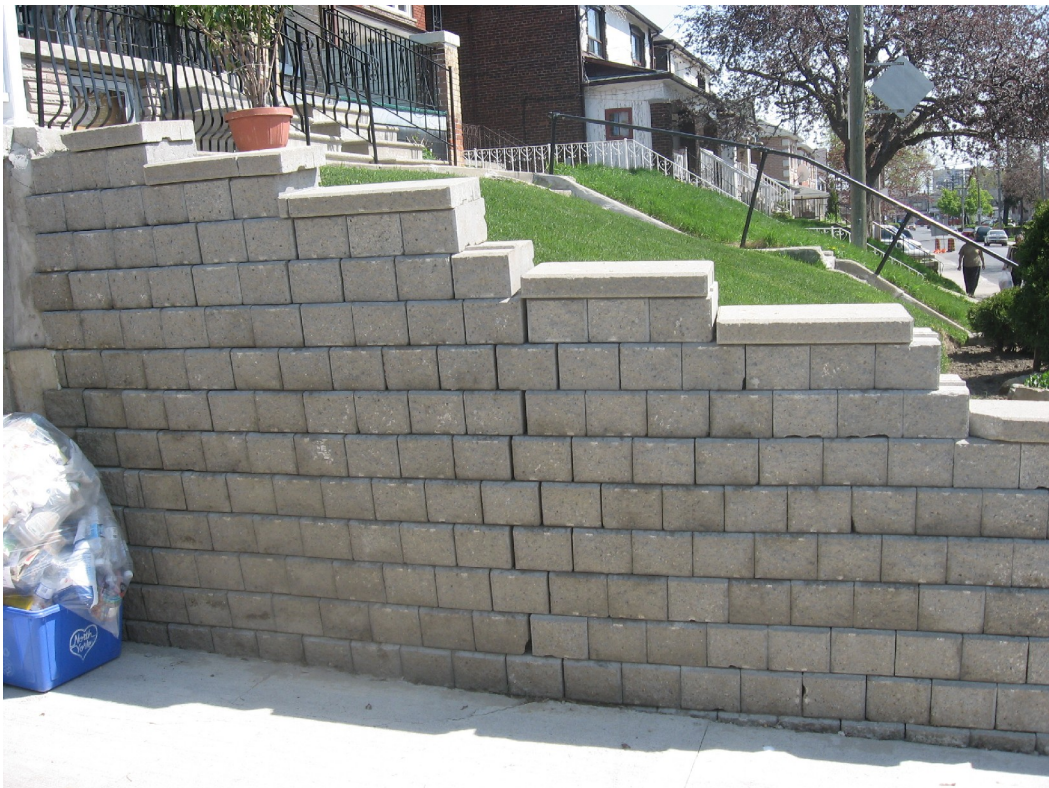
Attachment 7: Close-up photographs of the encroaching retaining wall

Inspection of the subject retaining wall revealed that it appears to be out of plumb and is showing signs of lateral movement. In view of its height, location and proximity to the public sidewalk, it is considered to be a designated structure under the Ontario Building Code and is required to be repaired under a Building Permit and supervised by a Professional Engineer (Attachment 7).

6. to apply for a Building Permit to repair the subject retaining wall under the supervision of a Professional Engineer to ensure it is structurally sound and plumb (Attachment 7);
