STAFF REPORT INFORMATION ONLY

607 Briar Hill Ave – Removal of One Private Tree

Date:	November 5, 2007
To:	North York Community Council
From:	Brenda Librecz, General Manager, Parks, Forestry and Recreation
Wards:	Ward 16 - Eglinton-Lawrence
Reference Number:

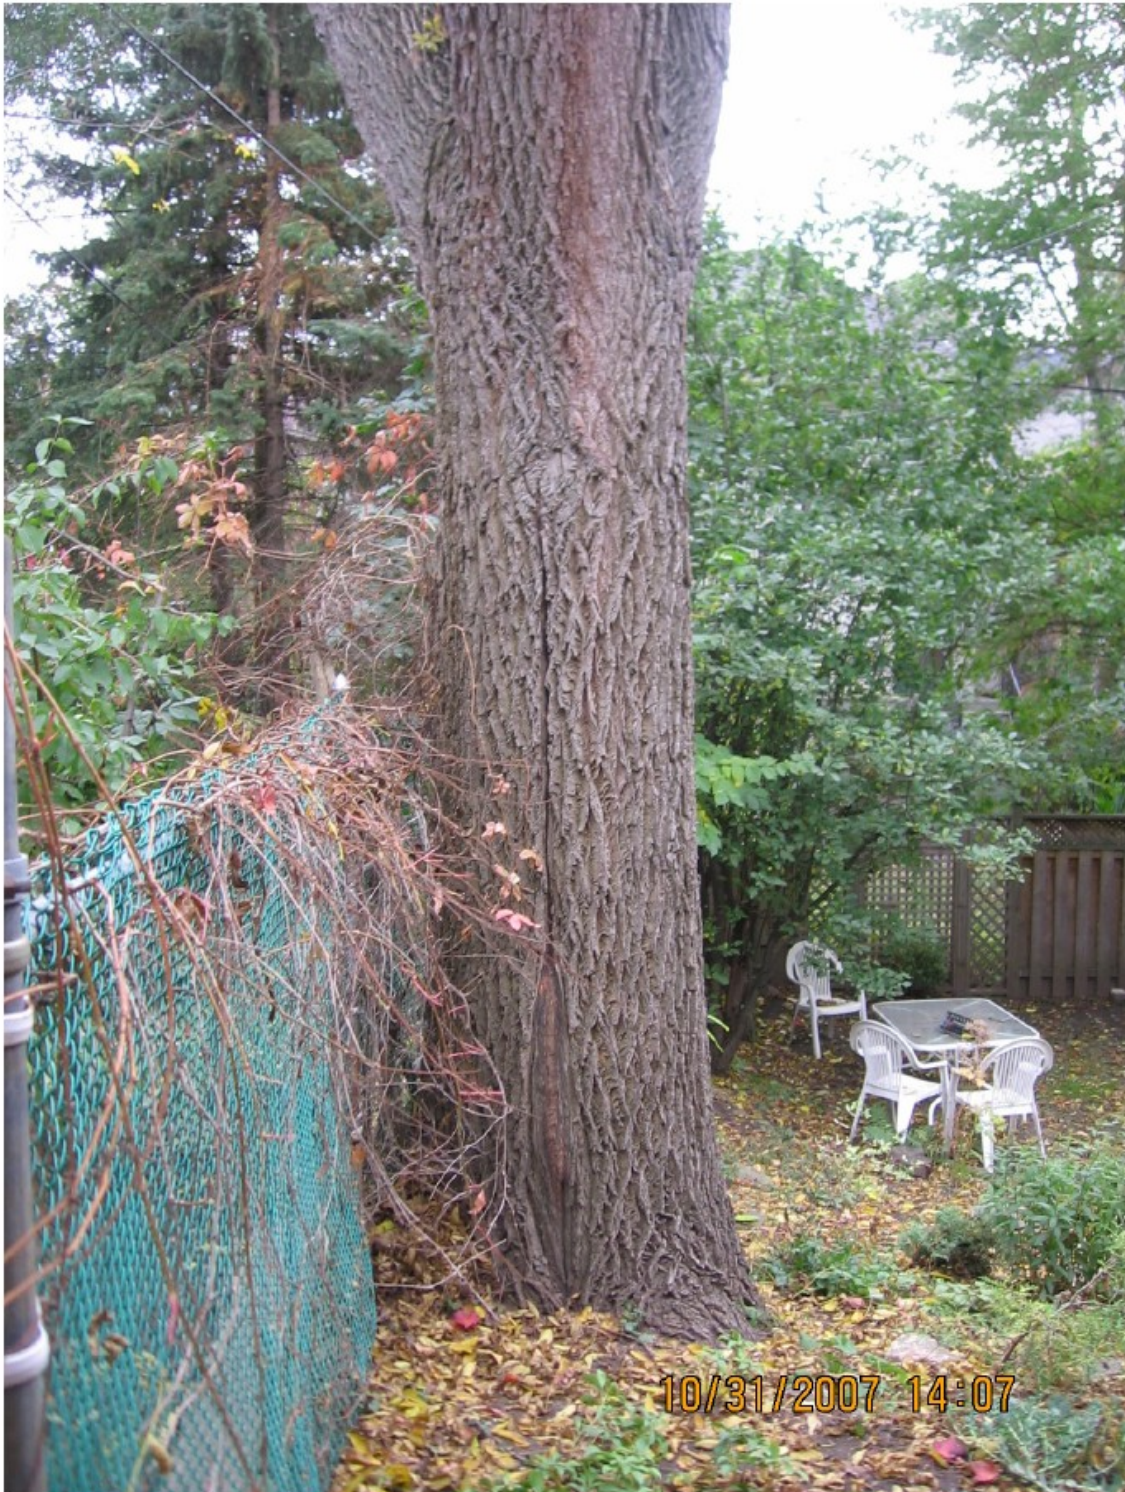
A supplemental report received October 26, 2007 indicates the presence of a structural fault in the tree. A vertical crack in the trees main stem is present on the north side of the tree extending right through the stem to the south side, from 0.5m above grade and running upwards 2.5m. The crack is still active as the development of wound wood can be observed.

The structural integrity of the black walnut tree is compromised as a result of the crack in the main stem and issuing the applicant a permit to remove the tree was the only reasonable option. Urban Forestry issued a permit to allow the removal of the subject tree, conditional on the owner planting replacement trees acceptable to the General Manager of Parks, Forestry and Recreation.

Attachment 1 - View of crack visible in North side of trunk

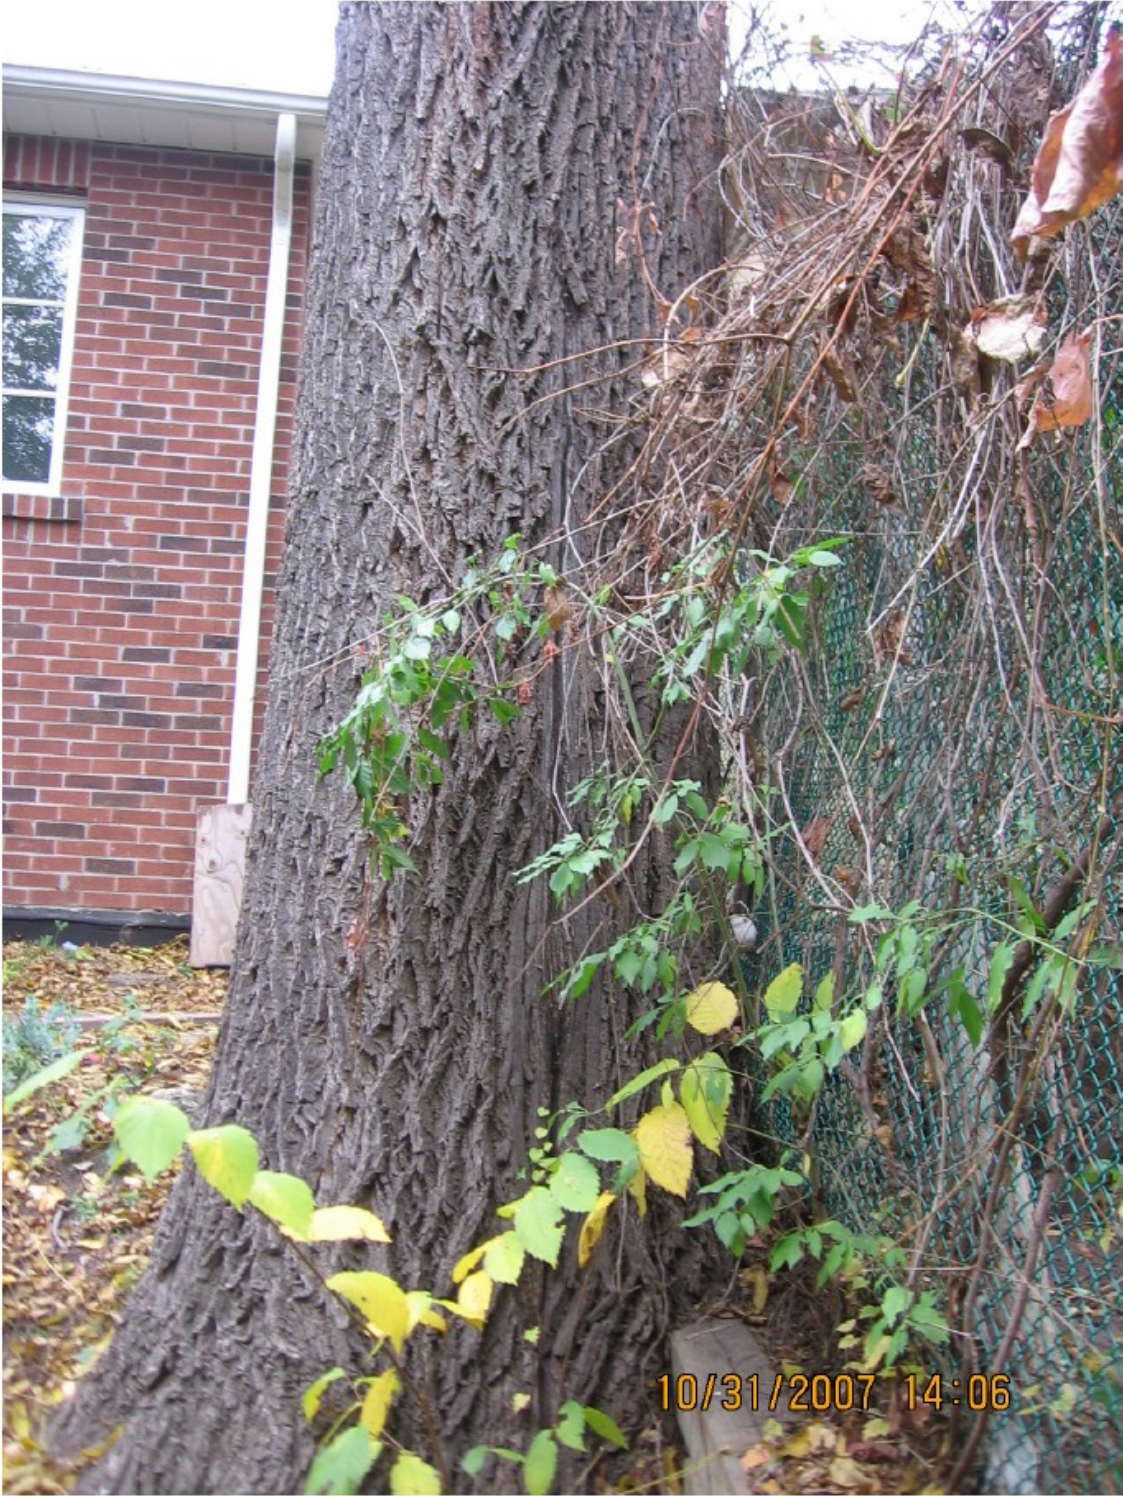
Attachment 1 - View of crack visible in South side of trunk
