**Heritage Impact Statement (Conservation Strategy)
Supplementary Report
The Burano
832 Bay Street
Toronto, Ontario**

PREPARED FOR:
Bay Grosvenor Developments Limited

PREPARED BY:
E.R.A. Architects Inc.
10 St. Mary Street, Suite 801
Toronto, Ontario
M4Y 1P9

ISSUED:
March 14, 2008

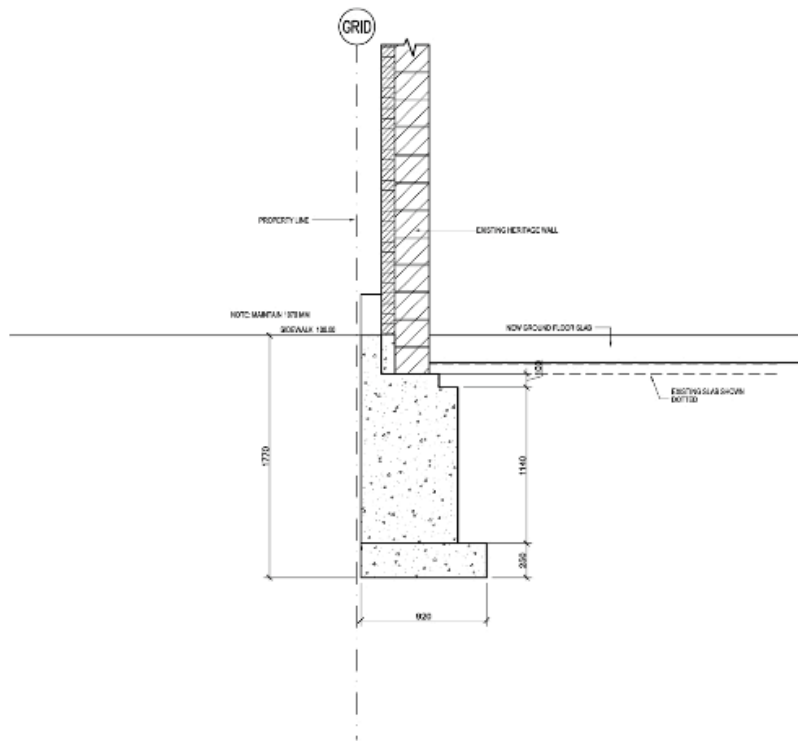
Fig 1. Existing footing condition at heritage wall

The walls of the heritage facades are carried on conventional concrete spread footings that bear on these unconsolidated glacial soils. See Fig.1 for the configuration. There is a very great risk of subsidence in these soils when the new foundation walls for the basement parking garage are excavated. If the facades were kept in place, the excavation would necessarily be very close, approximately 0.5 metres away, because the narrowness of the site requires that the new foundation walls be constructed as close as possible to the lot line to maximize parking space.

It is the opinion of the project geotechnical engineers, McClymont and Rak, Engineers, that the risk of subsidence of the soils beneath the façade foundations is very high, leading to local loss of support and settlement and cracking of the heritage masonry and the concrete support frame. Please see the engineer's letter in Appendix 6.3.

- The revised strategy therefore proposes that the designated facades would be measured, dismantled, salvaged, stored and reconstructed on the new concrete building structure once it is constructed
- The new basement garage foundations walls are to be formed by the slurry wall technique, but the logic would be no different if they were to be done in the more-conventional augured caisson wall technique

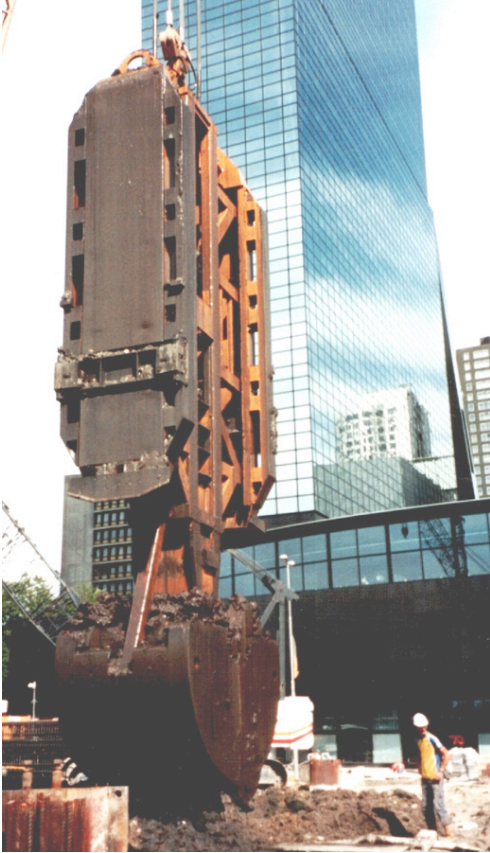
Fig. 2 Clamshell excavator for the foundation walls

The basement foundation walls are very deep at 22 m (75 ft.) and therefore 600 mm wide for structural strength. That means that large amounts of material will be removed by every pass of the clamshell excavator, which only increases the risk of subsidence.

The clamshell excavator is operated by a crane and suspended on a steel cable. It is laterally restrained, but operating within 500 mm (20") of the heritage wall any small movement of such a large piece of equipment due to wind or operator error could cause disproportional damage to the masonry through collision.
