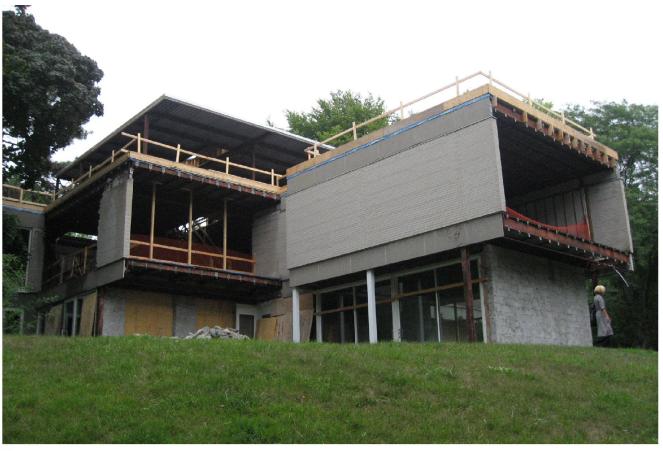
Figure 4a: VIEW OF RAVINE SIDE: photo taken in Fall 2007

Present state of house - after work was halted

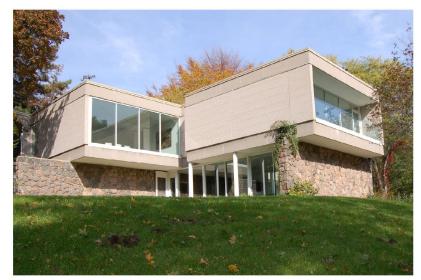
Figure 4b: VIEW OF RAVINE SIDE: photo taken prior to most recent renovation (Fall 2006)

- Horizontal banding at fascia
- Large surfaces of material.
- Large surfaces of glass
- Controlled views at upper floor towards ravine
- Controlled views at lower floor

perpendicular to ravine
