**Heritage Impact Statement (Conservation Strategy)  
Supplementary Report  
The Burano  
832 Bay Street  
Toronto, Ontario**

PREPARED FOR:  
Bay Grosvenor Developments Limited

PREPARED BY:  
E.R.A. Architects Inc.  
10 St. Mary Street, Suite 801  
Toronto, Ontario  
M4Y 1P9

ISSUED:  
March 14, 2008

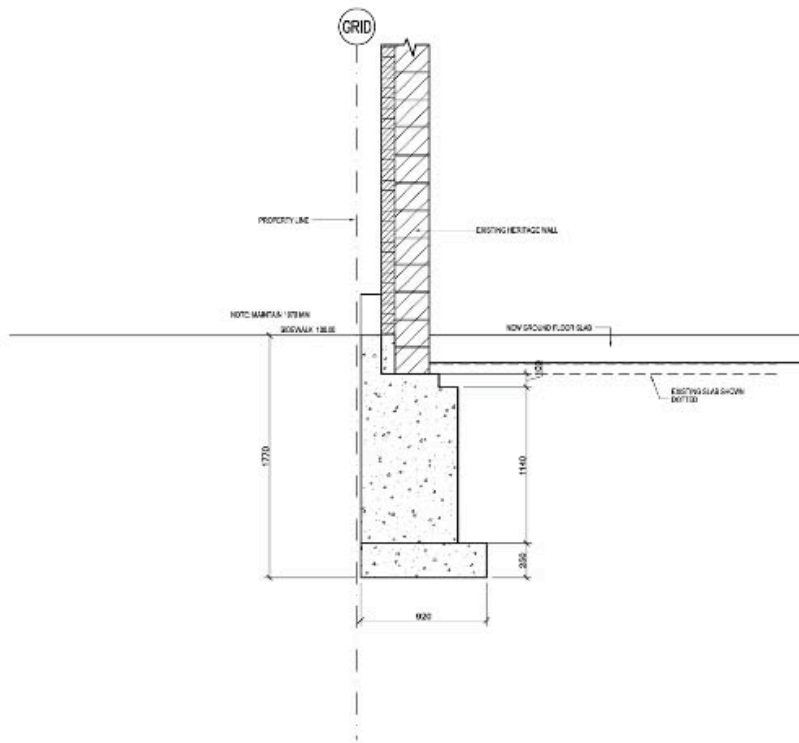
The walls of the heritage facades are carried on conventional concrete spread footings that bear on these unconsolidated glacial soils. See Fig.1 for the configuration. There is a very great risk of subsidence in these soils when the new foundation walls for the basement parking garage are excavated. If the facades were kept in place, the excavation would necessarily be very close, approximately 0.5 metres away, because the narrowness of the site requires that the new foundation walls be constructed as close as possible to the lot line to maximize parking space.

It is the opinion of the project geotechnical engineers, McClymont and Rak, Engineers, that the risk of subsidence of the soils beneath the façade foundations is very high, leading to local loss of support and settlement and cracking of the heritage masonry and the concrete support frame. Please see the engineer's letter in Appendix 6.3.

Fig 1. Existing footing condition at heritage wall

To safeguard the east and south elevations, including the angled main entrance elevation at the corner of Bay and Grenville Streets, of the building described in the Reasons for Designation, we recommend the following procedures for their conservation by dismantling and rebuilding:

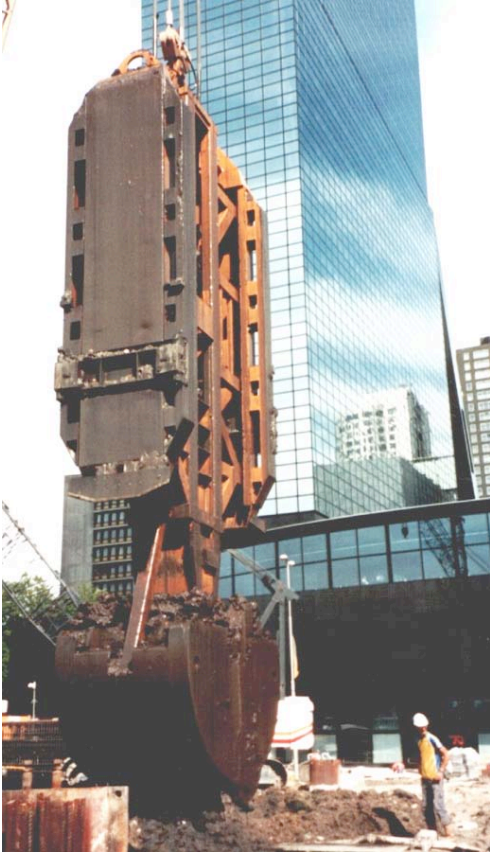
Fig. 2 Clamshell excavator for the foundation walls

The clamshell excavator is operated by a crane and suspended on a steel cable. It is laterally restrained, but operating within 500 mm (20") of the heritage wall any small movement of such a large piece of equipment due to wind or operator error could cause disproportional damage to the masonry through collision.

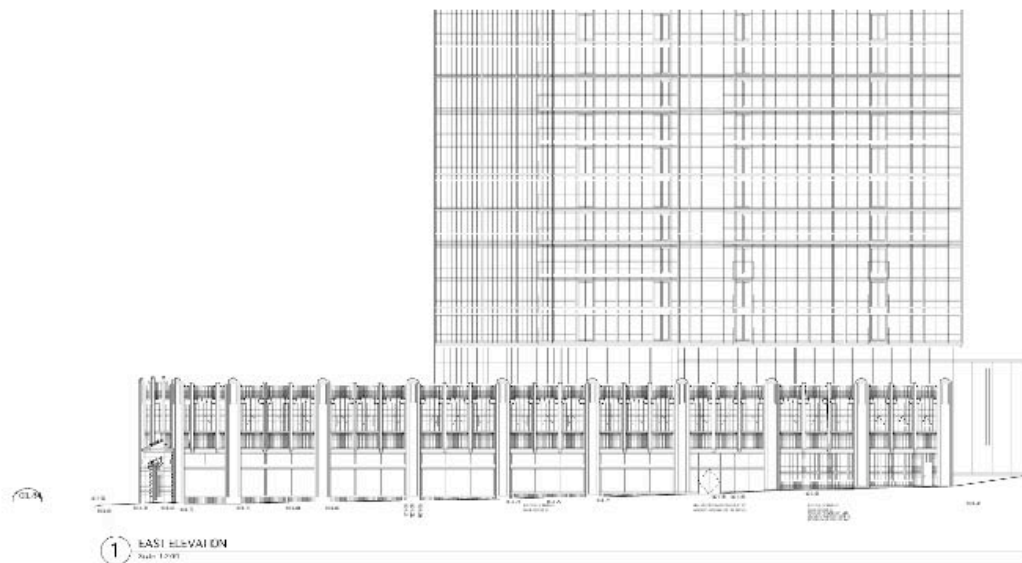
Fig. 4: East elevation of the existing building as reconstructed

15. To suit the new ground floor uses it is proposed that the pattern of storefront windows will be maintained, the service bay entrance will be altered to match the typical storefront and the north vehicle entrance will be made to match the original bay adjacent to provide windows for a new retail space.
16. The third bay from the north on Bay Street becomes the main entrance to the residential condominium and is aligned with the tower circulation and elevator core. Heritage elements from this bay will be salvaged to alter the north vehicle entrance bay.
