**Front Yard Parking Appeal**

61 Forest Hill Road

December 23, 2011

**Re: Arborist Report/Tree Preservation Plan on the Effects of Parking Pad Construction upon one Privately-owned Red Oak Tree at the Front of 61 Forest Hill Road, Toronto**

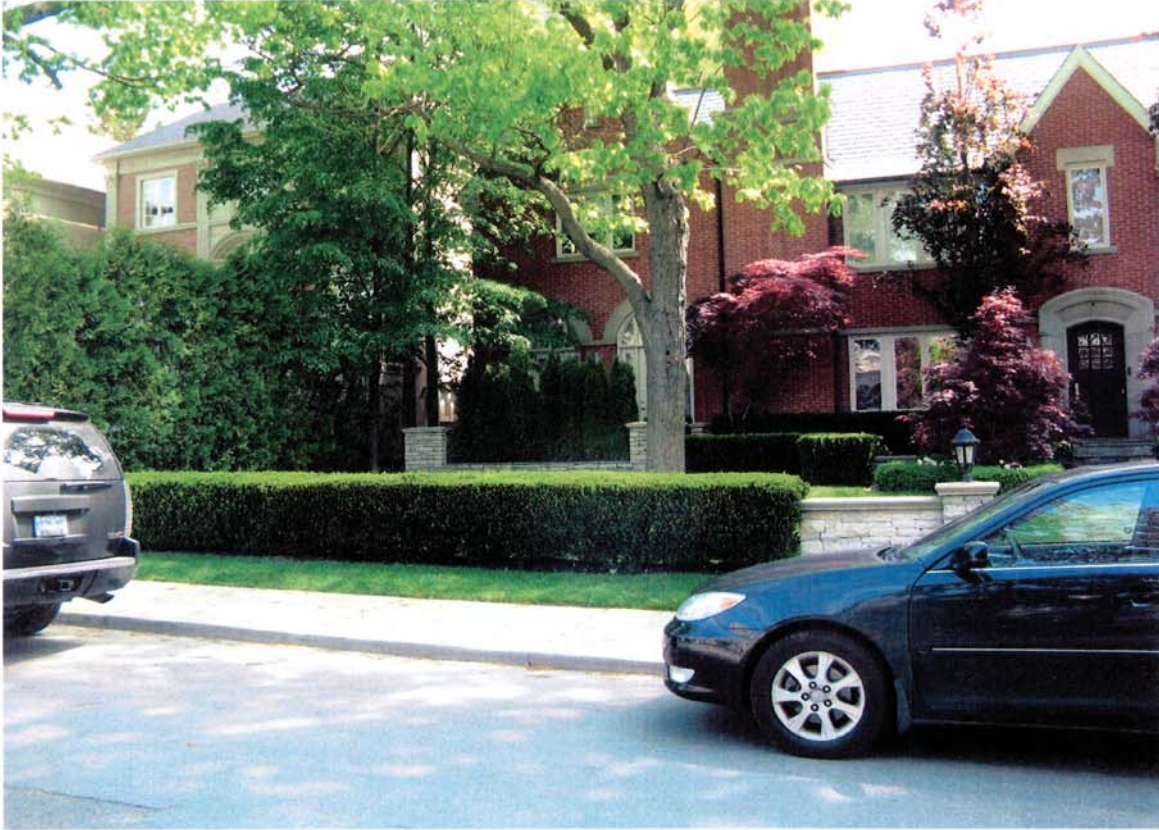
61 Forest Hill Road – May 27, 2011

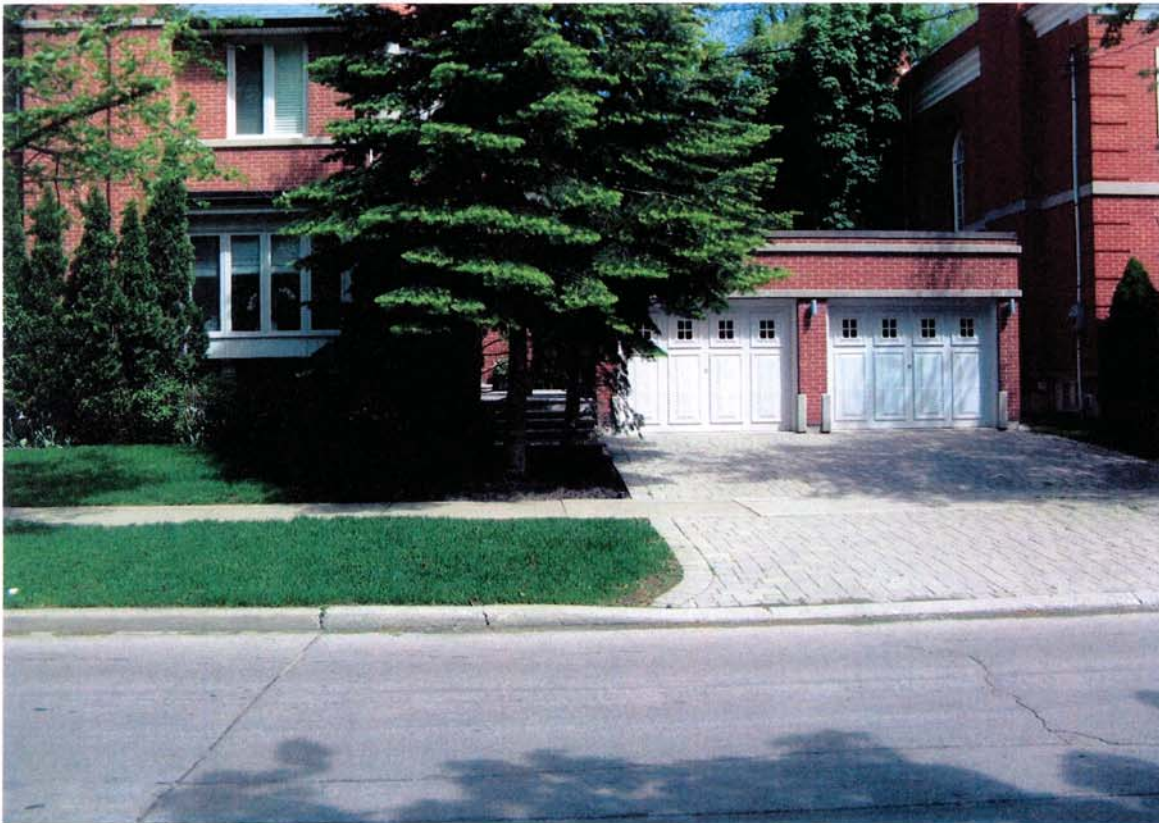
61 Forest Hill Road – Heath Street Flank – May 27, 2011

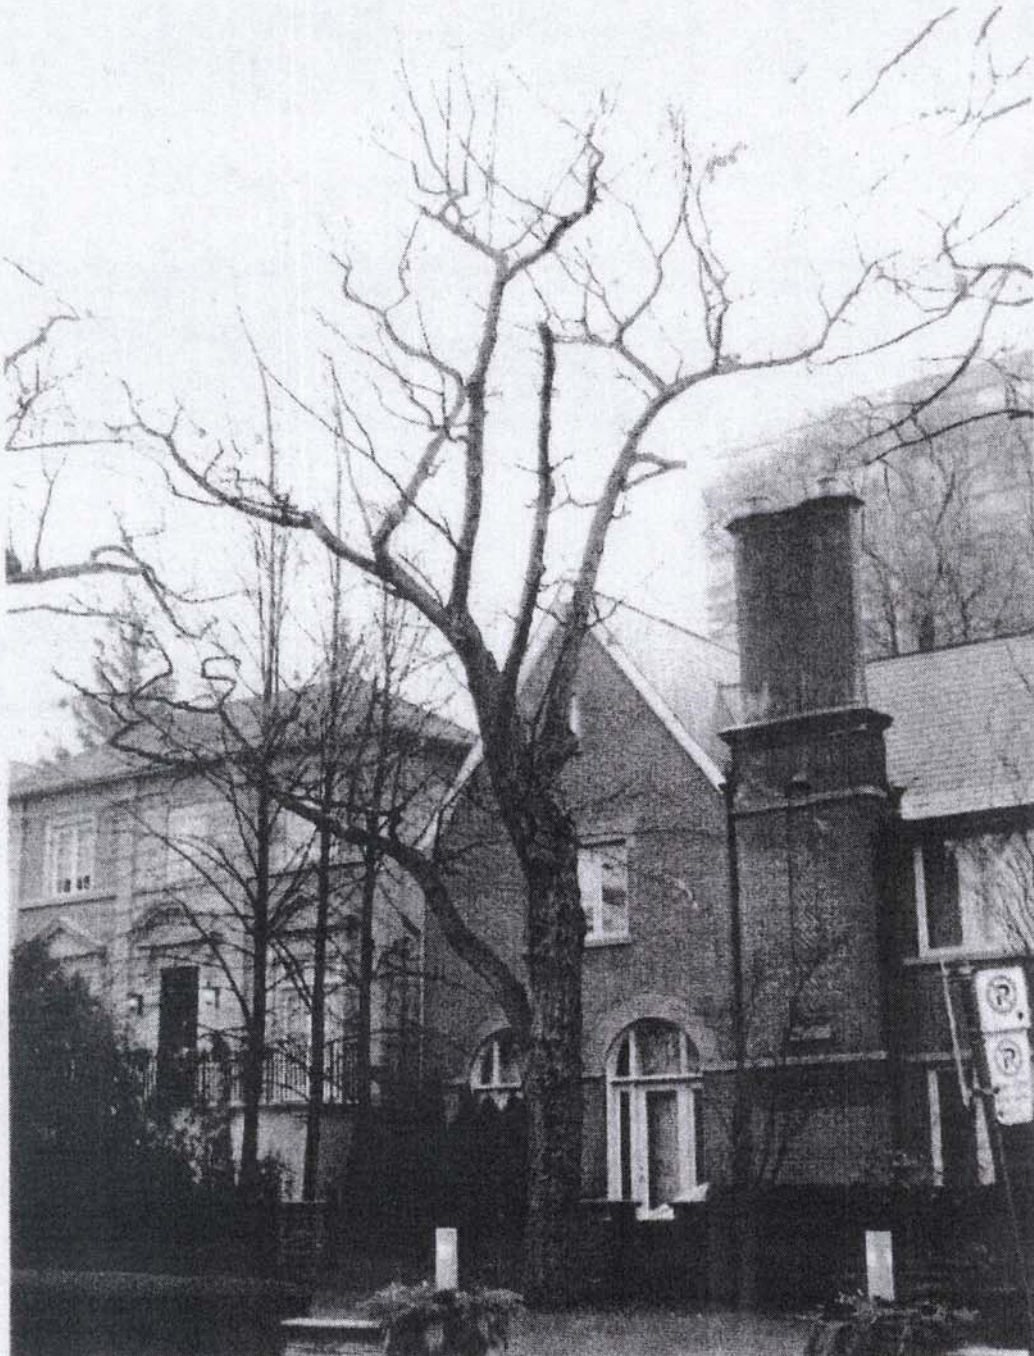
The native red oak appears to be botanically in fair condition and structurally in poor condition exhibiting a number of large cavities on its main stem - including below the main union - and a large, open split on its north leader as the prominent deficiencies observed. Minor defects include a moderate amount of watersprout growth and poor-callus growth development on some pruning cuts. The tree appears to be botanically viable based on its bud development, though its structural integrity is questionable given the extent and size of cavities present and, as such, the oak should be considered a candidate for removal irrespective of the proposed development. However, the Walderman family have expressed their appreciation for the trees environmental and aesthetic attributes and wish to preserve the oak in conjunction with the construction of an entrance driveway and two-car parking pad proposed within its 4.2m Tree Protection Zone (TPZ).

Photograph showing the full crown of the subject 68 cm dbh red oak (*Quercus rubra*) tree.

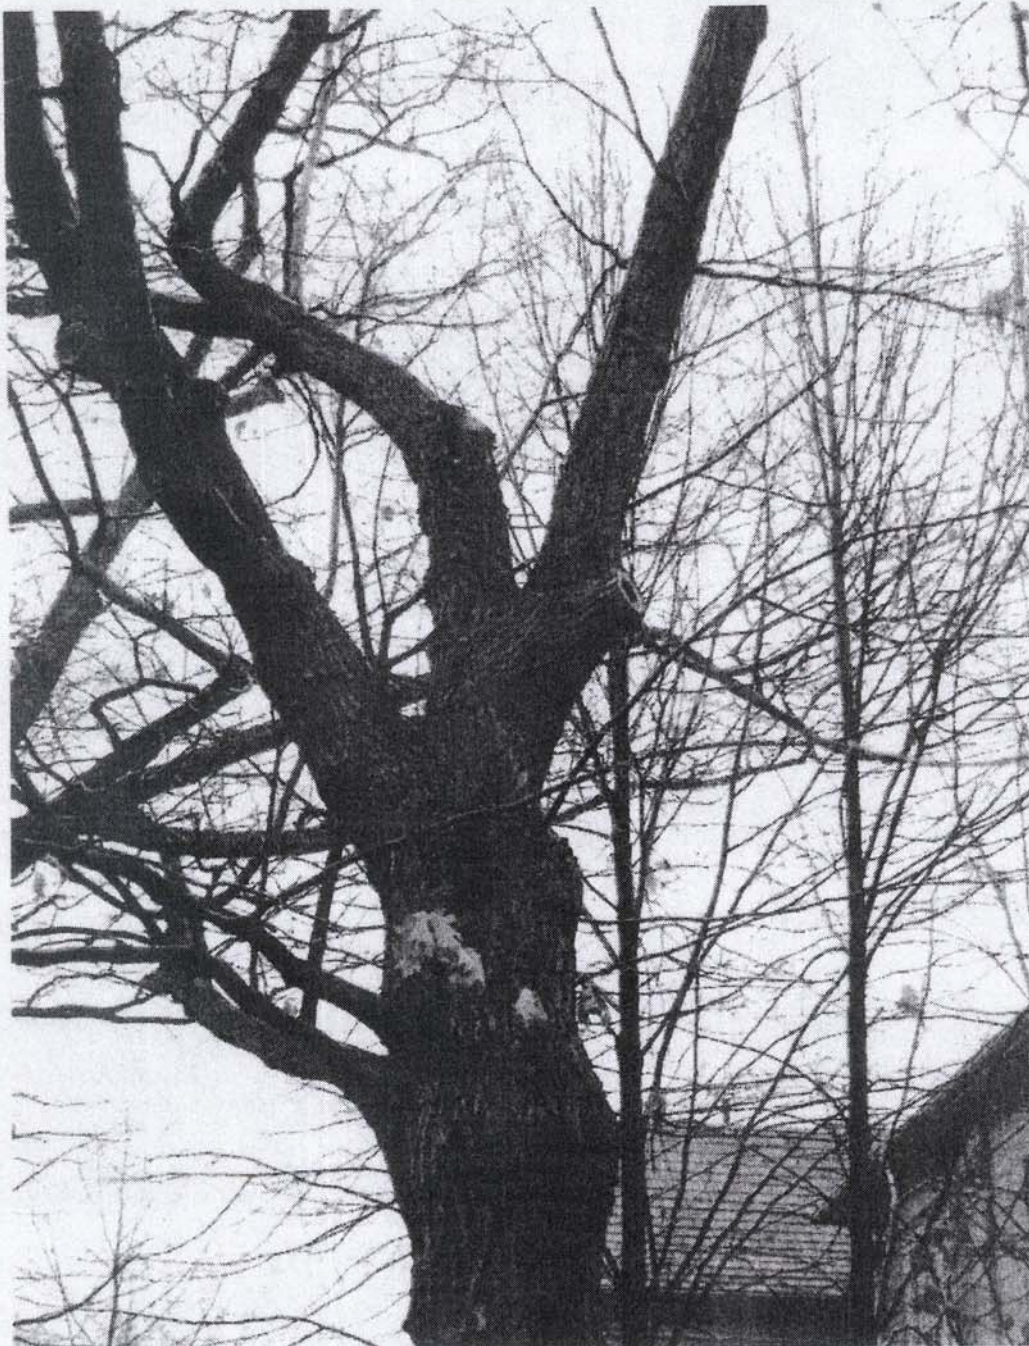
Photograph showing a number of open cavities and an upper branch split on the south face of the subject red oak.

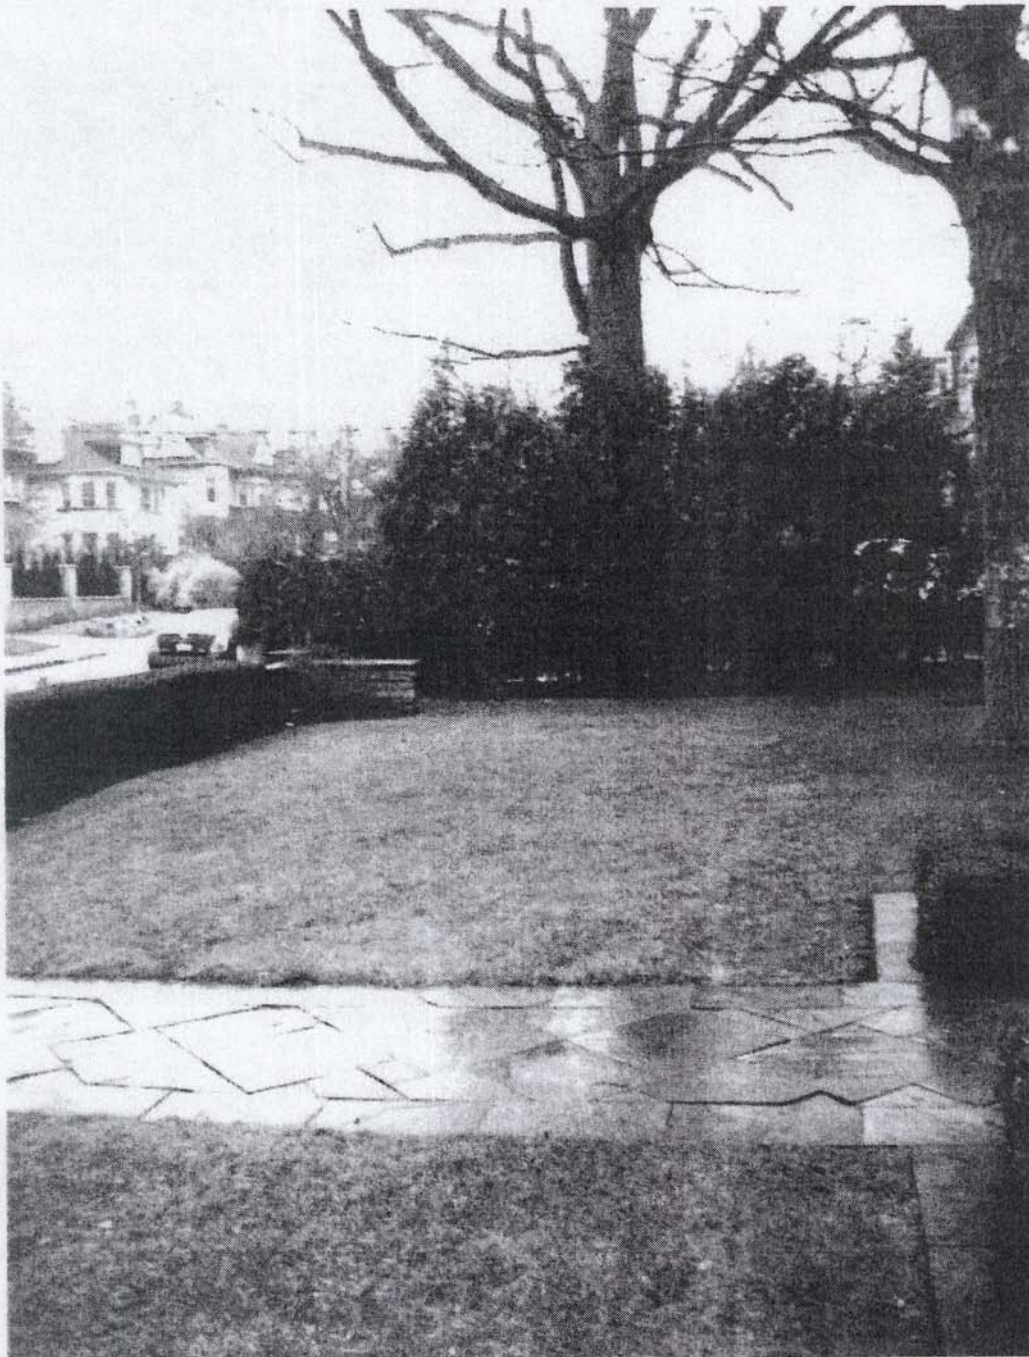
Proposed locations for protection barriers on the west side of the tree do not comply with the minimum 4.2m Tree Protection Zone (TPZ) required under By-Law specifications due to the location of the proposed parking pad approximately 1.5m from the tree base. As such, a permit to injure this tree will be required, including a \$300.00 non-refundable application fee, due to construction activity encroachment within the trees TPZ.

Photograph showing the subject red oak (far right), the area of the proposed parking pad (centre) and new driveway entrance (left), and the location for tree protection fencing (along the north edge of the flagstone walkway, extending northward toward the cedars).

along the determined line of excavation required to construct the eastern edge of the parking pad, extending north to south where within the trees 4.2m TPZ, in advance of site construction activity; prune exposed roots; install the driveway pavers overlain on a sand base to promote water infiltration and to not alter soil acidity; ensure all construction materials/equipment and supplies are stored outside of the trees TPZ and the 6.0m TPZ of a nearby 96 cm dbh red oak on the south side of the walkway, as shown on attached photos; and ensure all tree protection fencing remains in effective condition for the duration of all site construction activity.

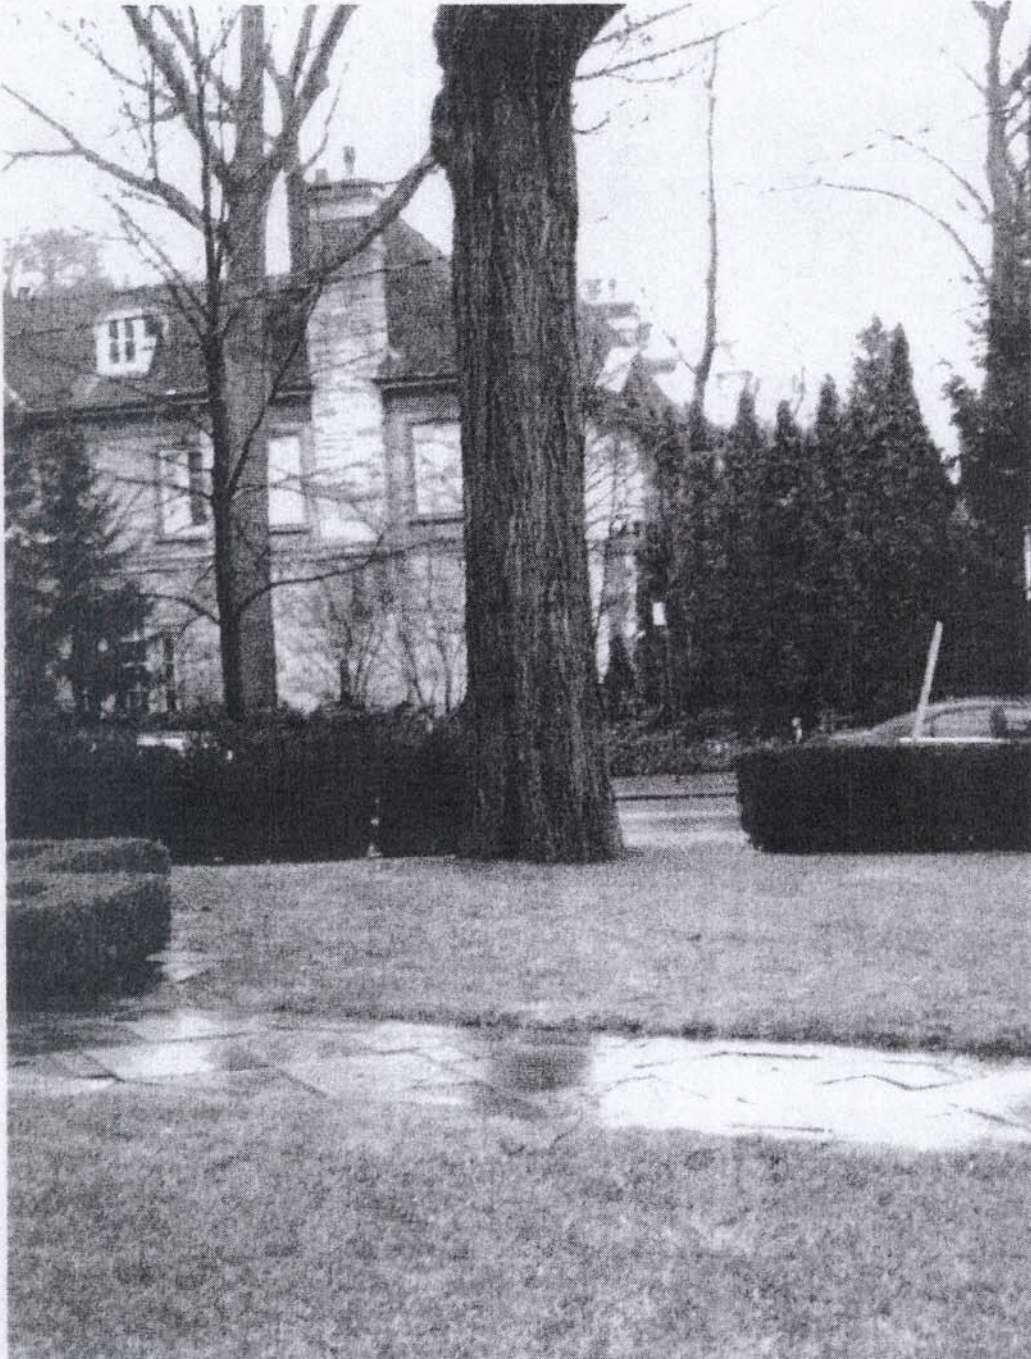
**Photograph showing the 96 cm dbh red oak, in good health, located on the south side of the flagstone walkway that will require protection of its 6m TPZ.**

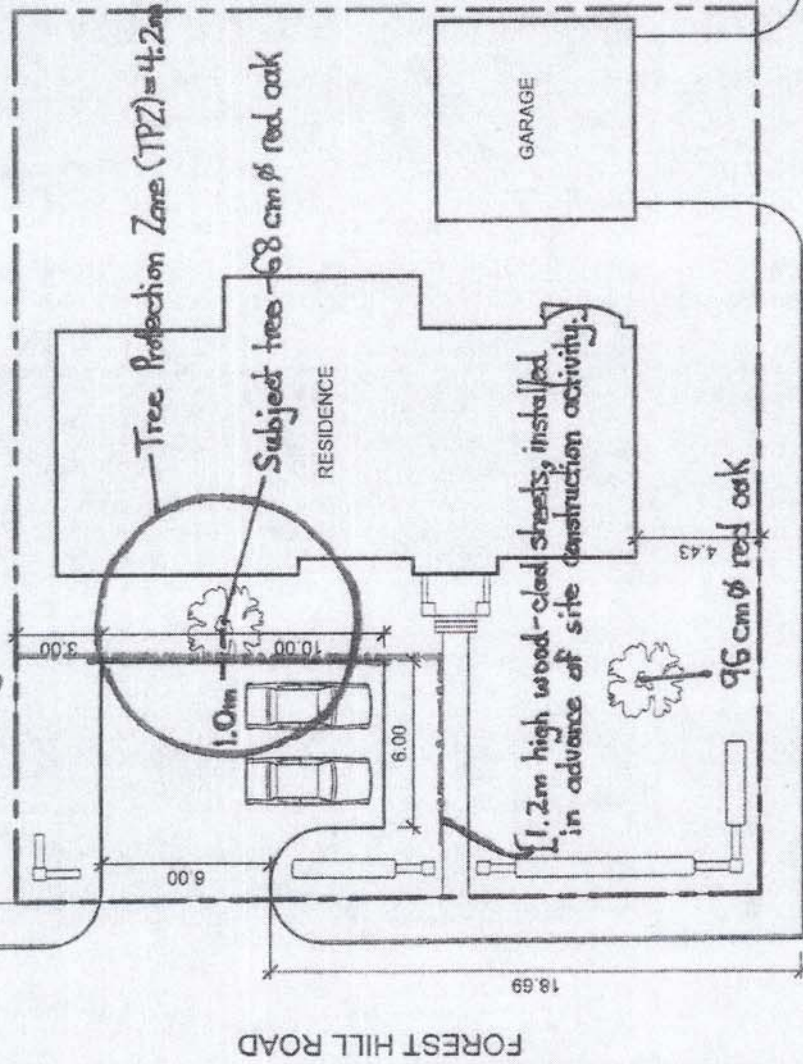
FIGURE 1: Tree Preservation Plan - 61 Forest Hill Road, Toronto  
Prepared by Al Miley & Associates on December 23, 2011.

Adverse construction effects upon this tree are anticipated to be significant in nature given the oaks close proximity to the east edge of the proposed parking pad. Potential injury is to be limited to the oaks westernmost transport and feeder root network during shallow soil excavation work necessary to facilitate installation of the proposed interlocking pavers within its TPZ. Mitigating measures to be implemented include: conduct a general crown pruning by a professional tree care company to remove deadwood and to prune back only those branches necessary to reduce crown weight; install support cables in the crown to provide structural stability to its leaders; probe open cavities to determine the extent of holding wood during an aerial inspection of the crown; install 1.2m (4') high wood-clad sheets at locations 1.0m west of the tree base, extending north to south from the cedar grouping in the north to the north edge of the flagstone walkway to the south, in advance of any site construction activity, as shown on Figure 1; undertake hydro-vacuum operations by a professional company at operational pressures not exceeding 20 psi

— Areas of hydro-vacuum operations, along East edge of proposed parking pad, in advance of construction activity.
