Demolition of a Designated Heritage Property – 3 Chedington Place

Date:	May 10, 2013
To:	Toronto Preservation Board North York Community Council
From:	Director, Urban Design, City Planning Division
Wards:	Ward 25 – Don Valley West
Reference Number:	P:\2013\Cluster B\PLN\HPS\NYCC\June 18 2013\nyHPS19

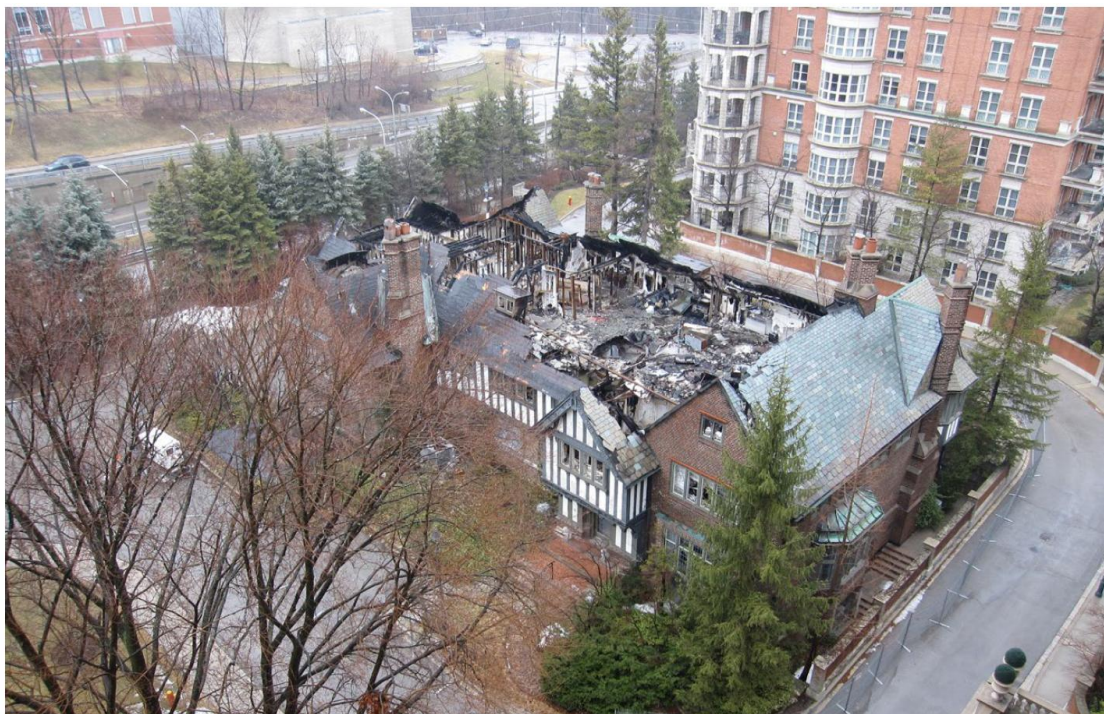
After Fire

Heritage Preservation Services visited the property on November 3, 2009, and found extensive damage to the roof and third floor of the building, approximately 75% of the leaded glass windows destroyed, and some of the masonry charred. At this time HPS noted that the building appeared to be repairable but that engineering reports were required for short-term stabilization and long-term repair.

On November 29, 2012, NAL prepared a second condition assessment of the heritage property which was submitted as part of the demolition application from E.R.A. Architects Inc. (“E.R.A”). The assessment evaluated the extent of structural remedial work completed, the condition of the remaining structure, and the feasibility of salvaging the remaining structural elements for residential use. The condition assessment found that the foundation requires complete reconstruction, and that virtually all interior finishes have been destroyed, and exterior walls require complete reconstruction of the interior walls to provide lateral stability. Furthermore, a new roof structure is required with larger span trusses and design to meet current building code. The condition assessment concluded that restoration and rehabilitation is not a viable option due to the amount and degree of intervention required to repair and restore the building.
