**STAFF REPORT
ACTION REQUIRED**

2 Waterbury Drive– Application to Remove a Private Tree

Date:	October 22, 2015
To:	Etobicoke York Community Council
From:	Jason Doyle, Director, Urban Forestry, Parks, Forestry and Recreation
Wards:	Ward 4 – Etobicoke Centre
Reference Number:	P:\2015\Cluster A\PFR\EY10-111015-AFS#22025

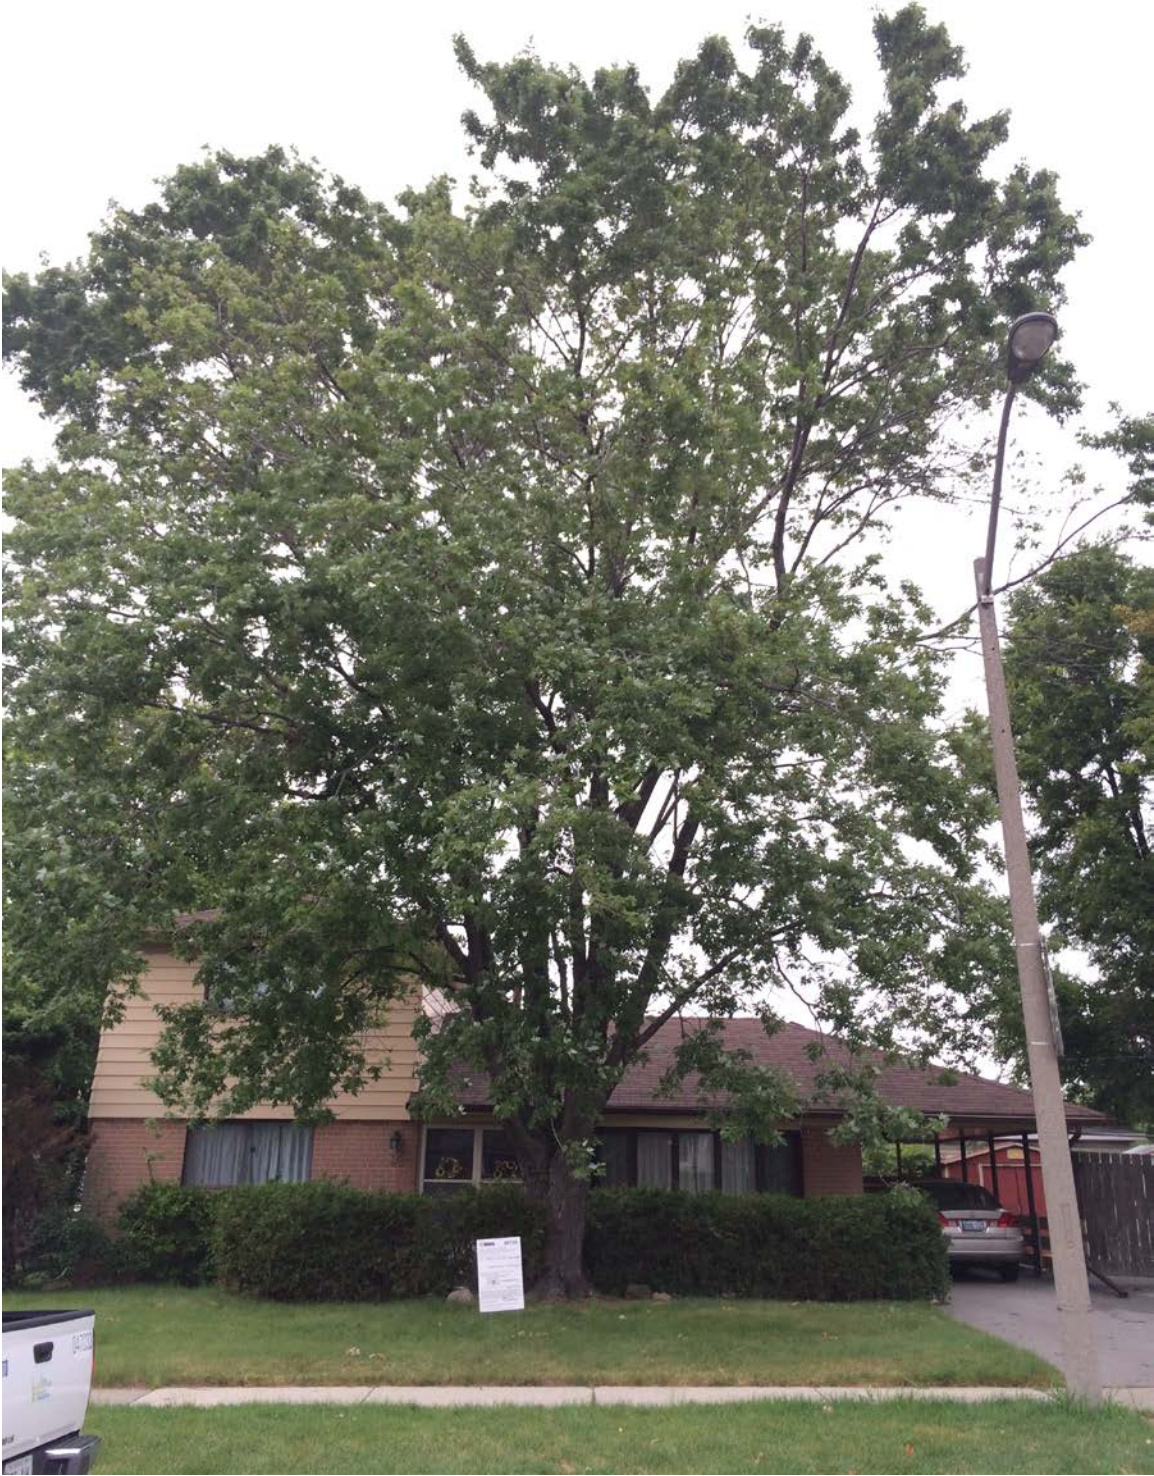
Attachment 1 – Photograph of the 85.5 cm diameter silver maple tree at the front of 2 Waterbury Drive

Urban Forestry staff inspected the tree and determined that it is healthy and maintainable. No evidence was observed nor was evidence provided that the tree is causing or is likely to cause damage to any load-bearing structures, including the foundation of the adjacent home. The tree is situated 2.2 m away from the house. Tree roots are not physically capable of exerting the physical force to crack concrete or asphalt. Tree roots are however, capable of growing into any available cracks that offer water and air. A tree cannot damage a properly-constructed foundation.

This silver maple tree at 2 Waterbury Drive is a valuable part of the urban forest. With proper care and maintenance this tree has the potential to provide the property owner and the surrounding community with benefits for many more years. Urban Forestry, therefore, does not support removal of this tree.

1. City Council deny the request for a permit to remove one (1) privately-owned tree located at 2 Waterbury Drive.
