## STAFF REPORT ACTION REQUIRED

### 74 Garfield Avenue – Application to Remove a Private Tree

<b>Date:</b>	March 12, 2015
<b>To:</b>	Toronto and East York Community Council
<b>From:</b>	Jason Doyle, Director, Urban Forestry, Parks, Forestry and Recreation
<b>Wards:</b>	Ward 27 – Toronto Centre -Rosedale
<b>Reference Number:</b>	P:\2015\Cluster A\PFR\TE05-041415-AFS#20916

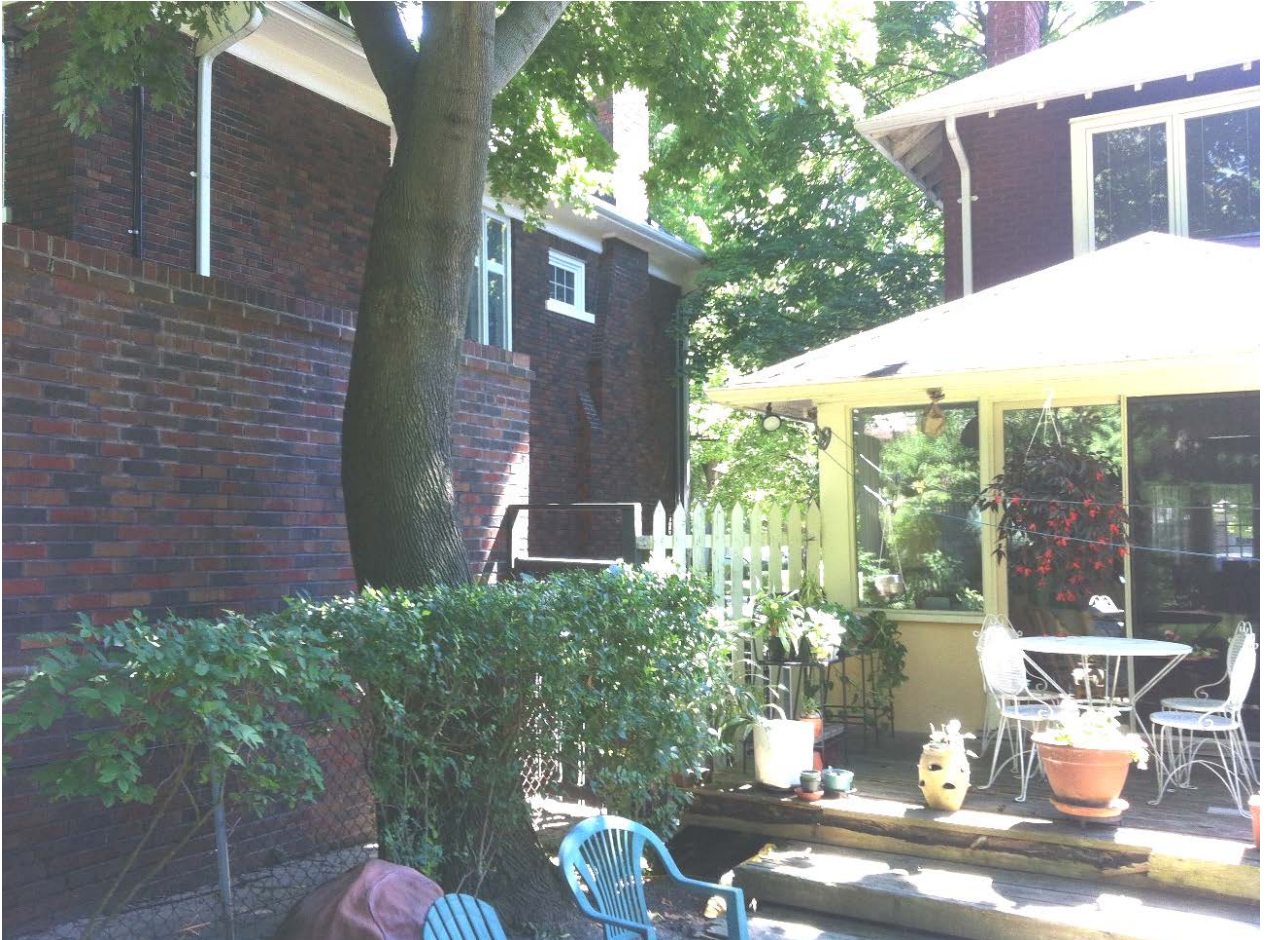
56 cm diameter Norway maple – Rear of 74 Garfield Avenue

Urban Forestry staff inspected the tree and confirmed that the tree is healthy and appears structurally sound. The tree was found to be a medium to large specimen in good health, with a generally balanced crown and full canopy. The lower stem is not entirely upright/vertical, but the weight of the tree is generally well distributed above the base of the stem and root plate. The main branches show none of the signs or symptoms typically associated with weak or failure-prone trees. The "crack" on the main leader, identified in the Arborist Report, does not appear to penetrate beyond the bark. As Norway maples mature their bark typically develops shallow cracks and fissures. However, these characteristics do not compromise the health or structural stability of the tree.

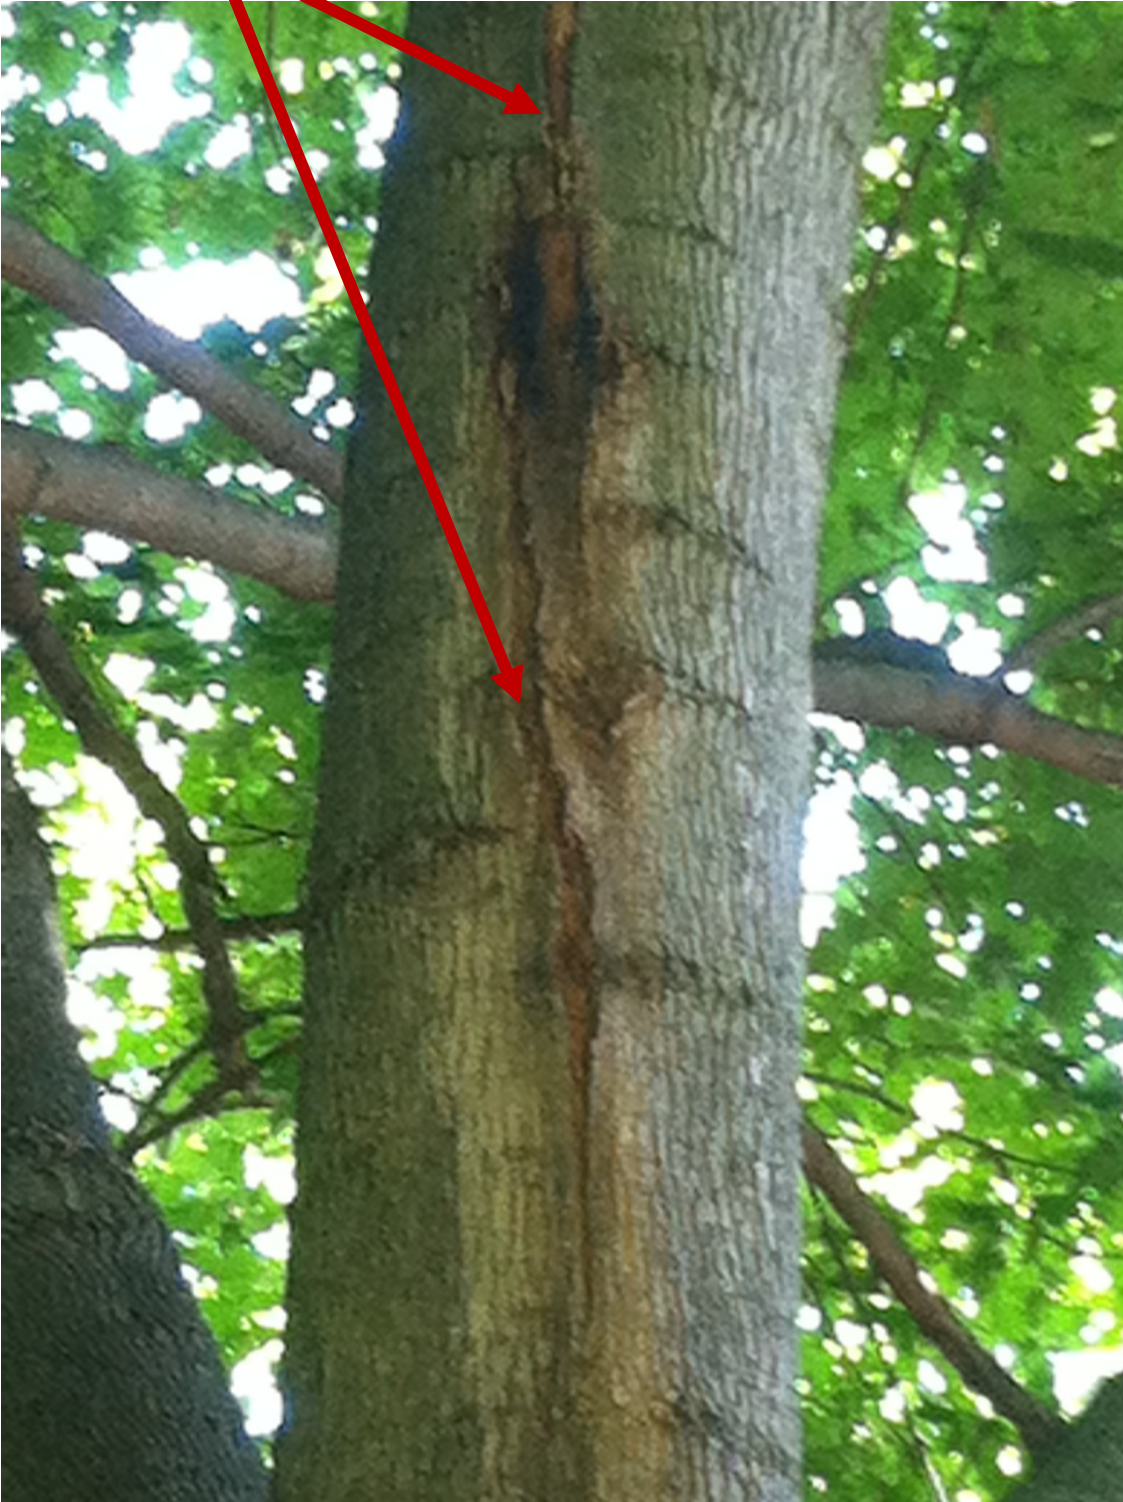
This report addresses removal of the 56 cm diameter Norway maple located in the rear yard of the property, for which an appeal was received. The reason for requesting removal of the 56 cm diameter Norway maple is that the property owner is concerned that the tree is too close to the house, and feels that the roots may enter into the basement of the house. However, no evidence was submitted to substantiate these concerns. The Arborist Report notes "cracks forming on the base of the main leader which could be torsional cracks or verticillium wilt". Later in the report, the arborist adds, "the cracks may manifest into a weak point within the tree".

Superficial cracks in 56 cm diameter Norway maple at 74 Garfield Avenue
