**Re: 100 Simcoe Street, Inclusion on the City of Toronto's Heritage Register - Item No. PB20.2**

# ANNOTATED PHOTOGRAPHS

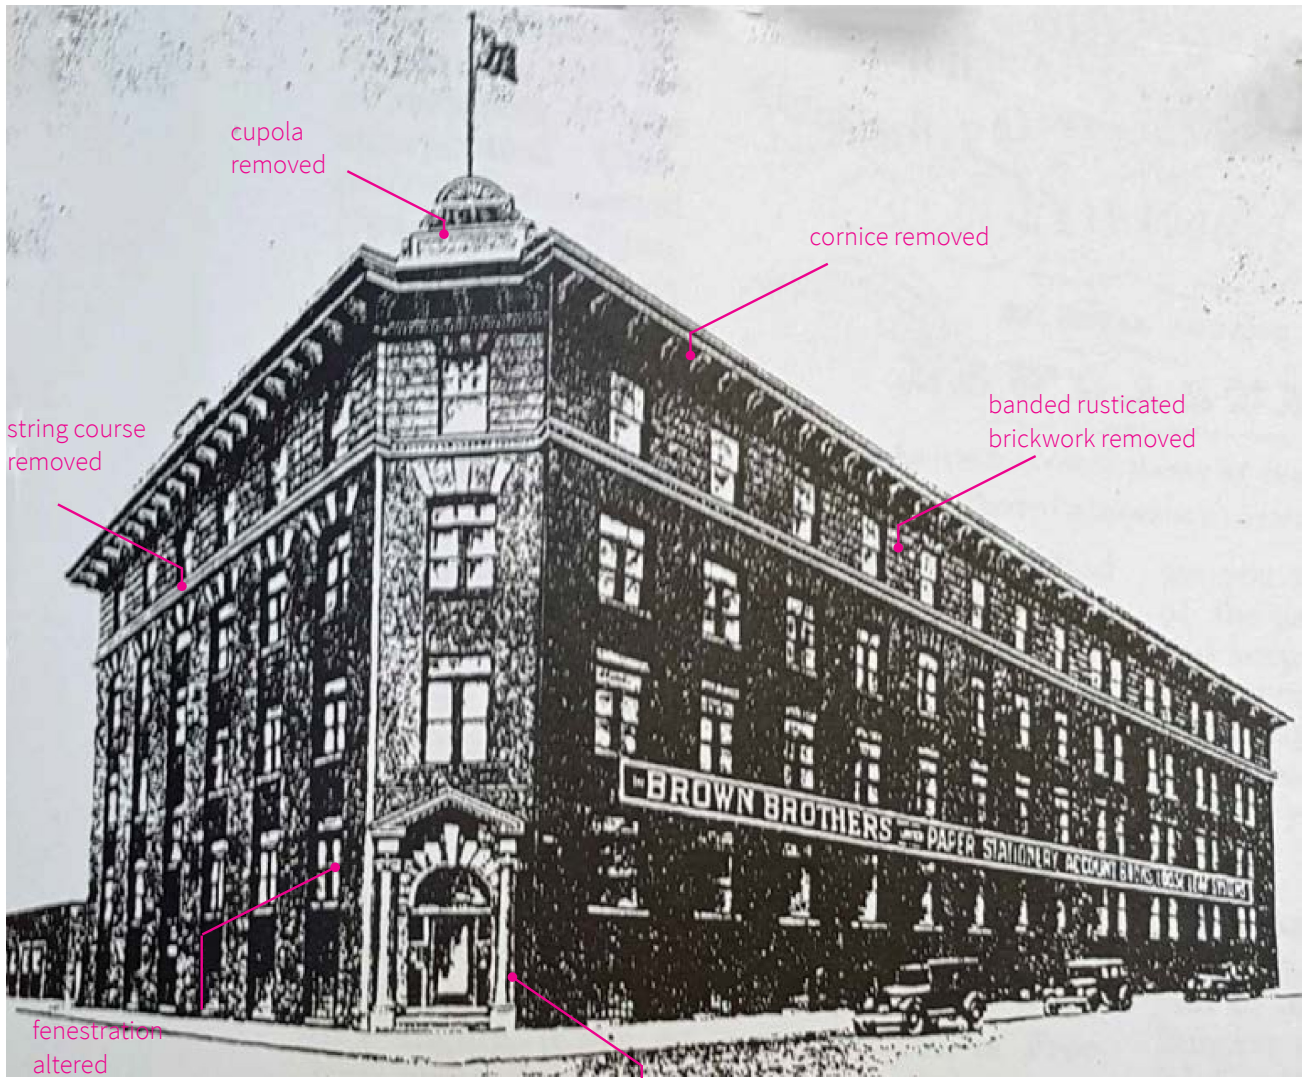
1936

cupola removed

cornice removed

string course removed

banded rusticated brickwork removed

fenestration altered

cut stone door surround removed

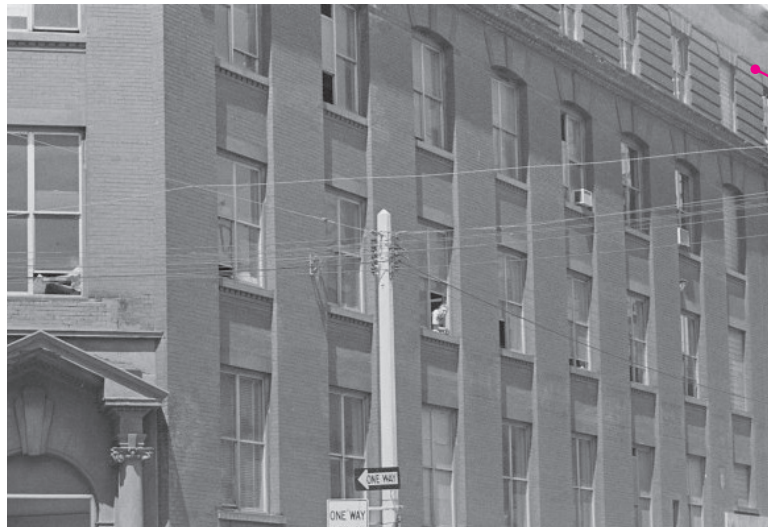
1973

Historic photographs show the fourth storey windows originally had decorative brick jack arches, not stone lintels.

East elevation detail (1975) showing 4th storey windows originally had brick jack arches, not stone lintels
