**RE: Toronto Preservation Board Meeting of June 22, 2017**  
**- Item No. PB24.1**  
**- Designation of the King-Spadina Heritage Conservation District**  
**under Part V of the Ontario Heritage Act**  
**- Notice of Objection filed on behalf of Sun Life Assurance Company of Canada**  
**re: 100 Simcoe Street and 211 Adelaide Street West**

**Re: 100 Simcoe Street, Inclusion on the City of Toronto's Heritage Register - Item No. PB20.2**

# ANNOTATED PHOTOGRAPHS

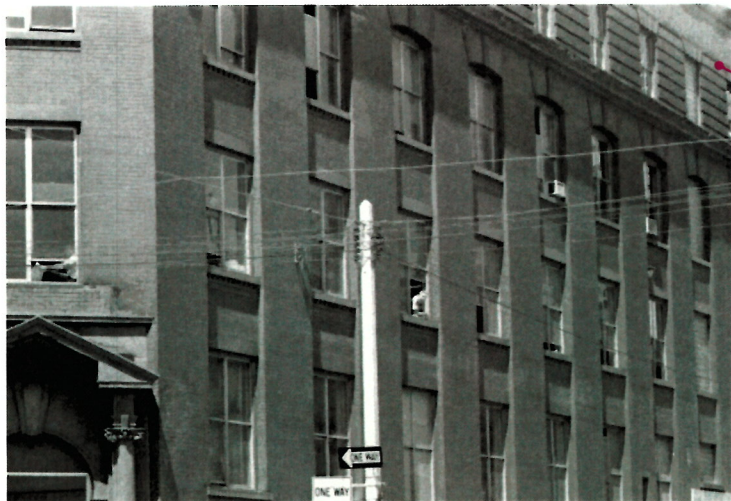
1973

Historic photographs show the fourth storey windows originally had decorative brick jack arches, not stone lintels.

East elevation detail (1975) showing 4th storey windows originally had brick jack arches, not stone lintels

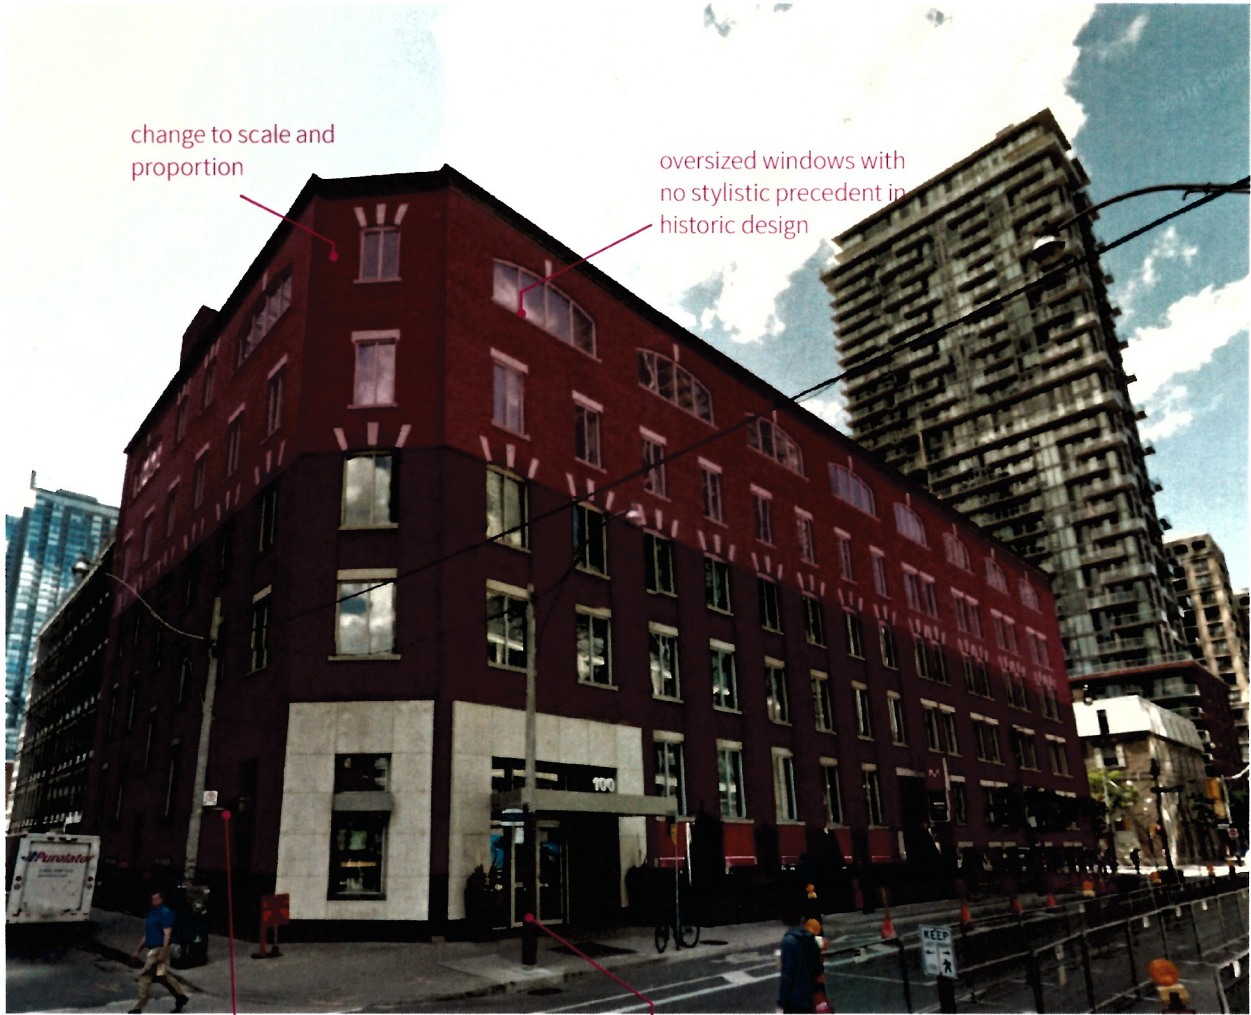
2016

Today the entrance is through an unsympathetic modern opening on the east elevation and the building is no longer oriented to the corner.

The scale, form and massing of the building have all been altered. The original four-storey design was modified to five storeys, which has resulted in completely different proportions from those that were intended by the original designers.

The embellished string course distinguishing the upper storey, the banded rustication accentuating the upper storey, the prominent cornice with dentil course, and the cupola have all been removed. The new window openings on the fifth storey are entirely modern and their wide proportions have no stylistic precedent on the building, nor in Edwardian Classicist design.

change to scale and proportion

oversized windows with no stylistic precedent in historic design

building orientation changed; entrance added

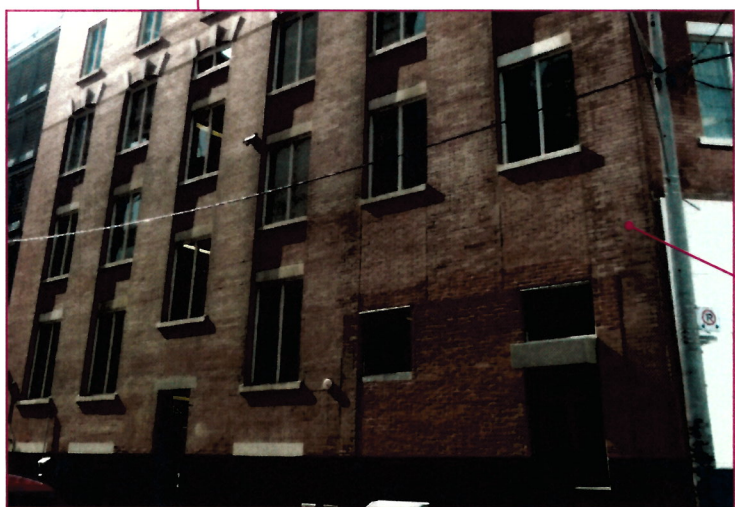
2016

The fenestration on the south elevation has been substantially modified. The placement, size, and proportion of the first floor openings in the two easternmost bays are completely changed, compromising the rhythm of the original elevation. Moreover, the modern replacement windows have steel lintels and concrete sills.

South elevation detail showing fenestration pattern and rhythm compromised
