Application to Remove Two Private Trees – 56 Roxborough Street West

Date: September 27, 2017

From: Jason Doyle, Director, Urban Forestry, Parks, Forestry and Recreation

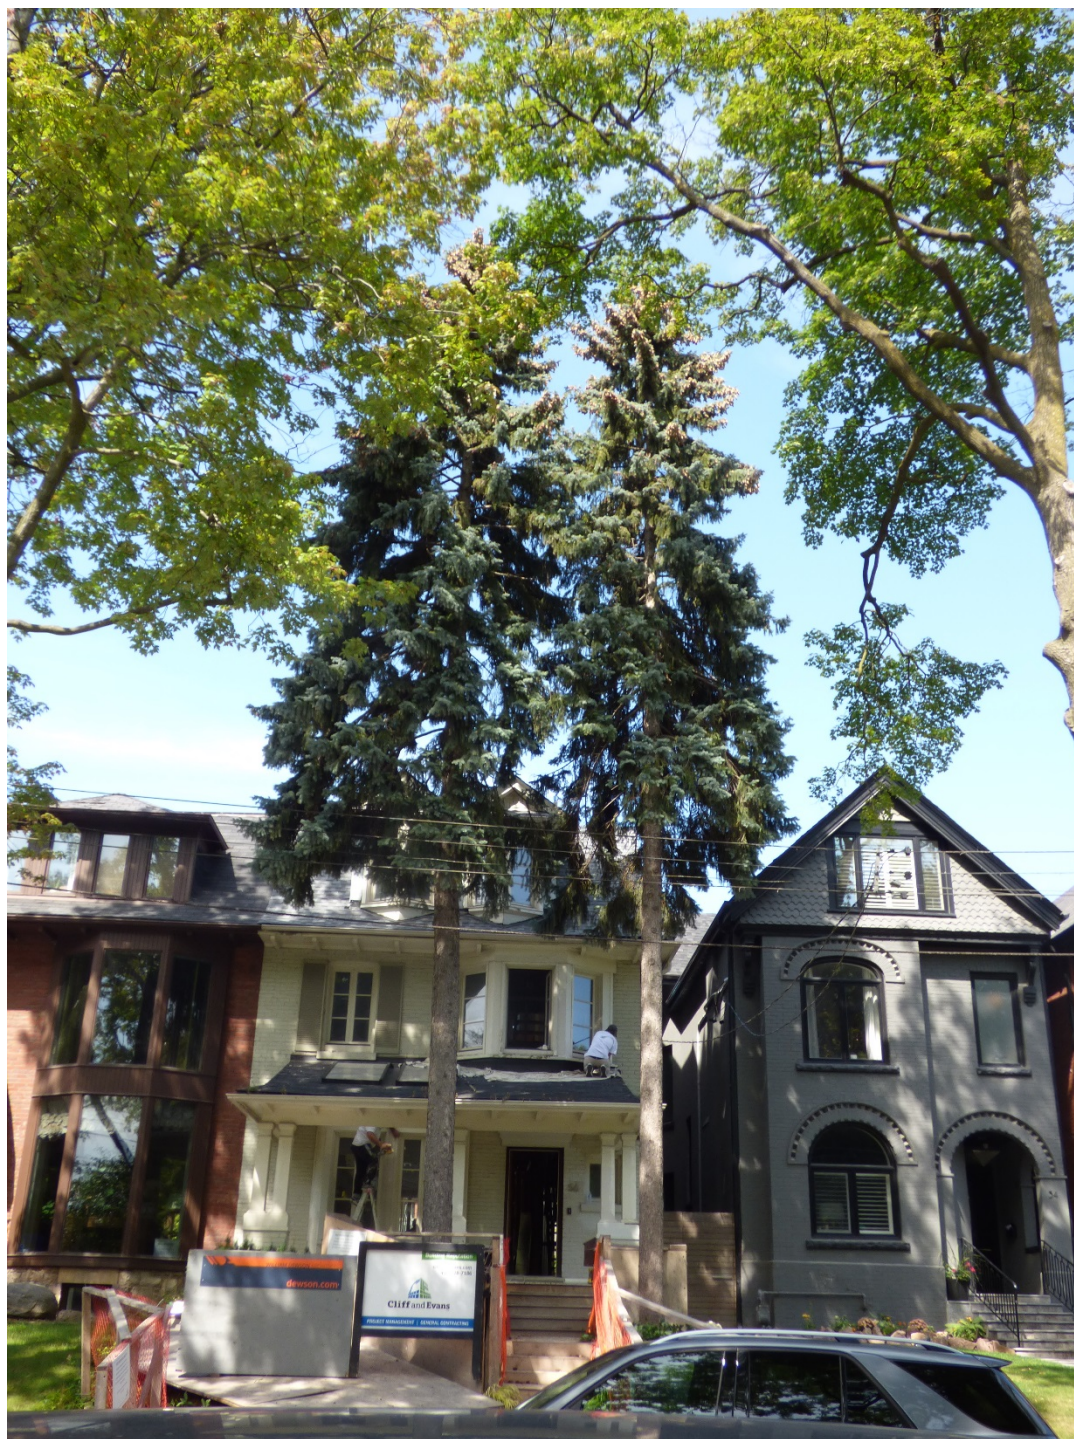
Attachment 1 - Photograph of the two Colorado spruce trees measuring 36 cm and 33 cm in diameter.

Urban Forestry staff inspected the trees and at the time of inspection determined that, while the canopy of the trees has been raised over the years, they were healthy and maintainable both botanically and structurally.

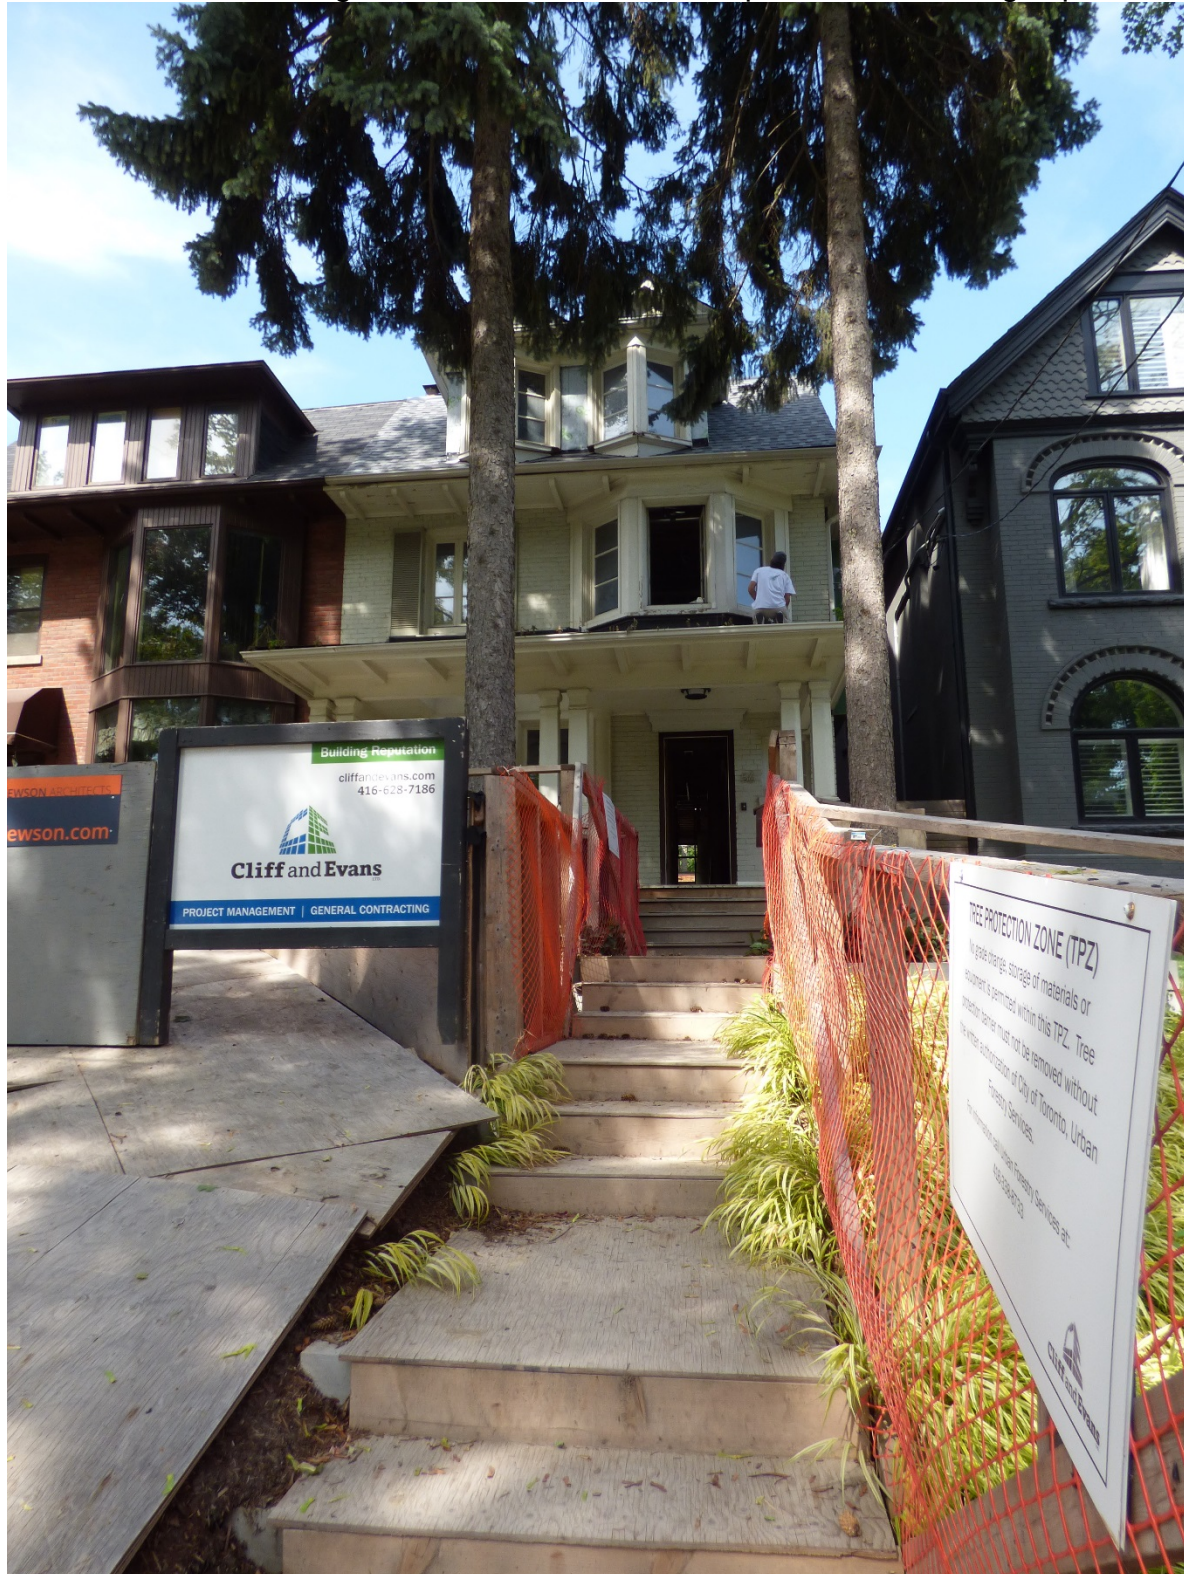
At the time of processing the application, these trees were being protected throughout a major home renovation following a tree protection plan that was permitted by Urban Forestry. New front stairs were installed on piers in order to avoid excavation within the minimum tree protection zones and a combination of horizontal and vertical hoarding was installed throughout the entire front yard, in order to protect the trees from any damage or compaction from construction. These protective measures were in place at the time of inspection.

Attachment 4 - Photograph of the two Colorado spruce trees measuring 36 cm and 33 cm in diameter, showing vertical and horizontal tree protection hoarding in place.
