- **Agenda Item TE26.14 – “Designation of the King-Spadina Heritage Conservation District under Part V of the Ontario Heritage Act”**
- **Notice of Objection filed on behalf of Sun Life Assurance Company of Canada re: 100 Simcoe Street and 211 Adelaide Street West *et. al.***

Re: 100 Simcoe Street, Inclusion on the City of Toronto's Heritage Register - Item No. TE22.18

Re: 100 Simcoe Street, Inclusion on the City of Toronto's Heritage Register - Item No. PB20.2

ANNOTATED PHOTOGRAPHS

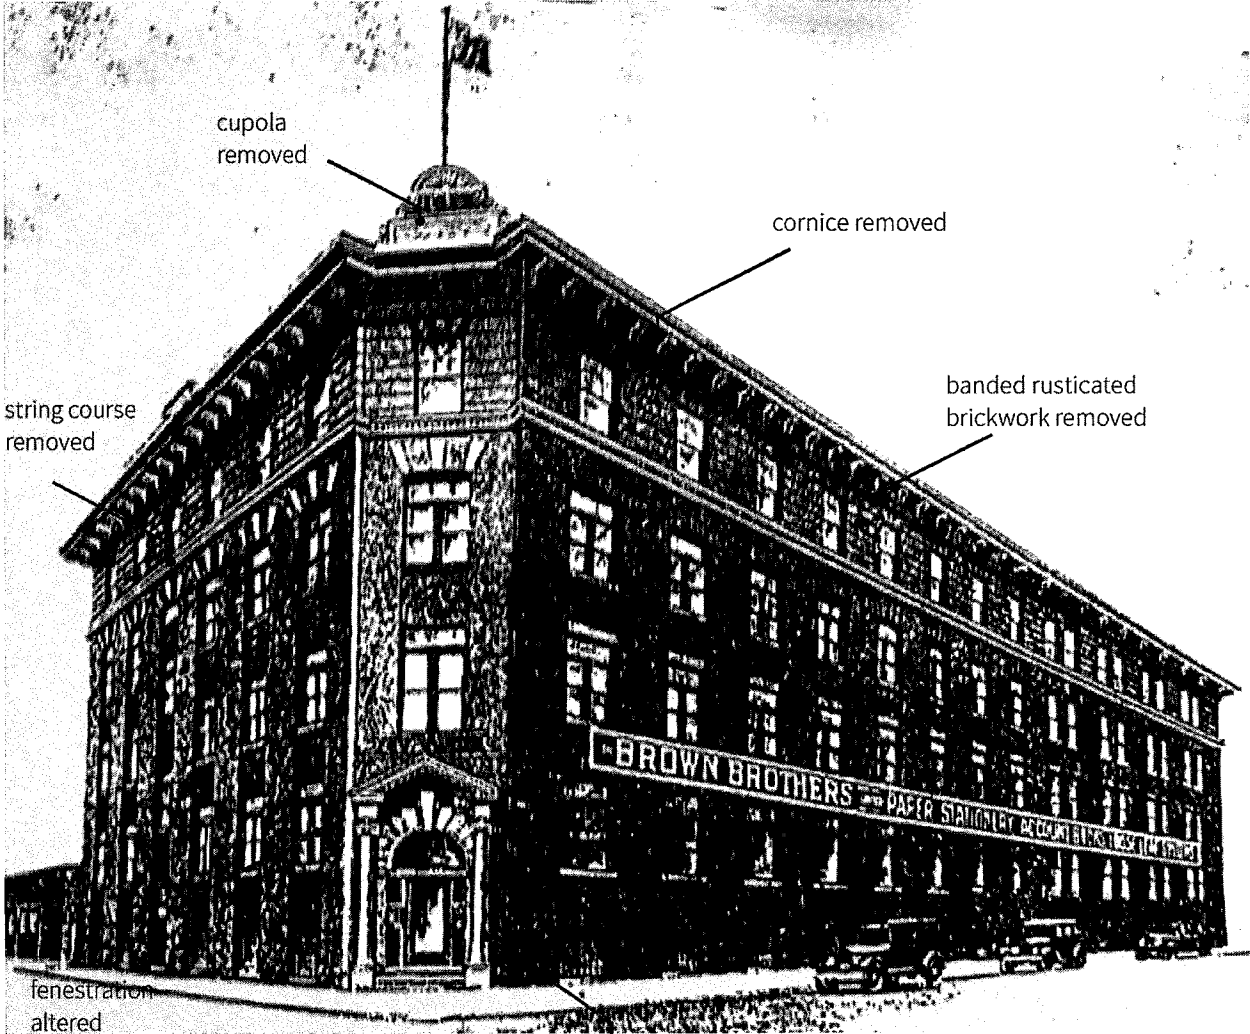
1936

fenestration altered

cupola removed

cornice removed

banded rusticated brickwork removed

cut stone door surround removed

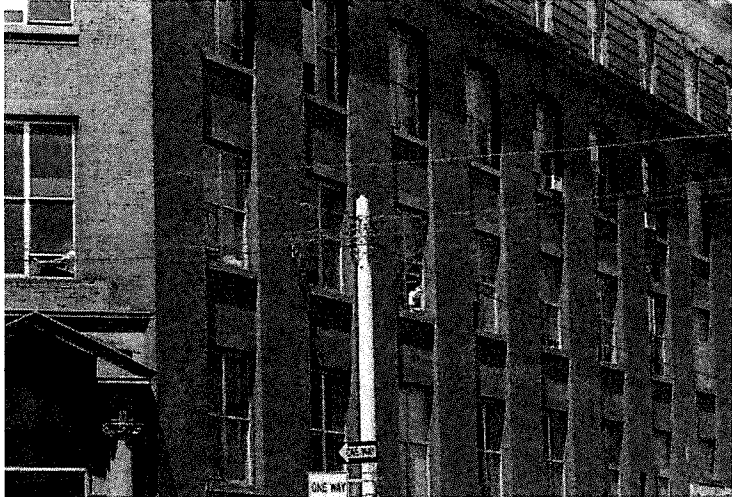
Historic photographs show the fourth storey windows originally had decorative brick jack arches, not stone lintels.

East elevation detail (1975) showing 4th storey windows originally had brick jack arches, not stone lintels

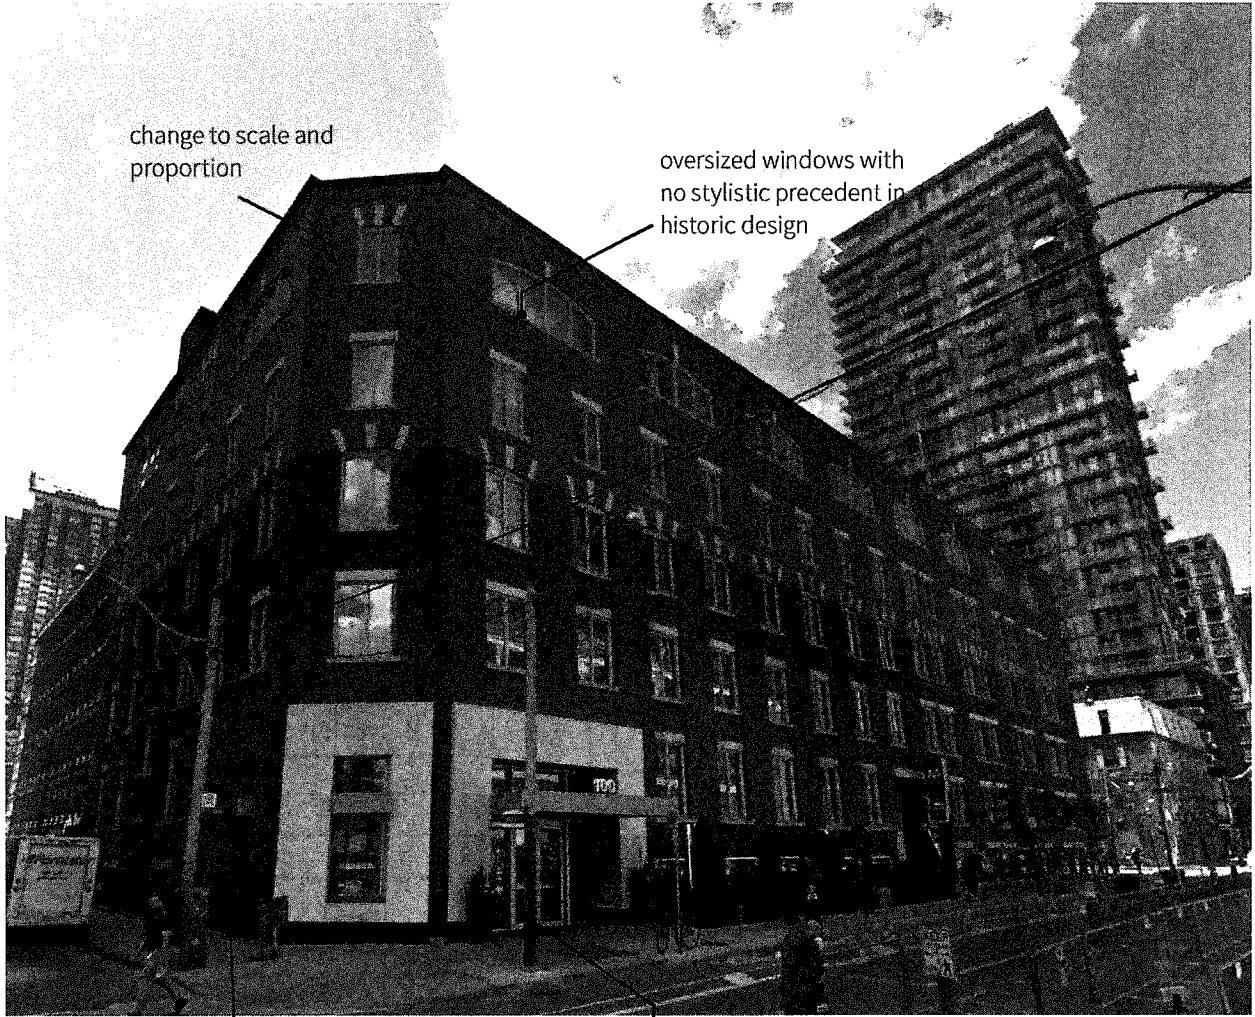
2016

The scale, form and massing of the building have all been altered. The original four-storey design was modified to five storeys, which has resulted in completely different proportions from those that were intended by the original designers.

The embellished string course distinguishing the upper storey, the banded rustication accentuating the upper storey, the prominent cornice with dentil course, and the cupola have all been removed. The new window openings on the fifth storey are entirely modern and their wide proportions have no stylistic precedent on the building, nor in Edwardian Classicist design.

As mentioned, the additional storey changes the building’s scale and proportions. It also necessitated removal of the string course and the banded rustication on the upper storeys which served to horizontally unify the architecturally distinct north and south sections. While the addition uses complementary materials, it is not in the spirit of the architectural composition of the original designers. The oversized windows have no stylistic precedent on the building and are alien to Edwardian Classicism.

change to scale and proportion

oversized windows with no stylistic precedent in historic design

building orientation changed; entrance added

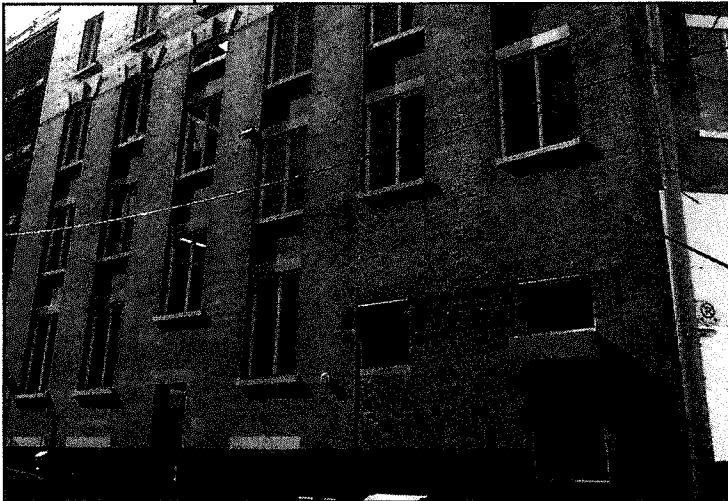
The fenestration on the south elevation has been substantially modified. The placement, size, and proportion of the first floor openings in the two easternmost bays are completely changed, compromising the rhythm of the original elevation. Moreover, the modern replacement windows have steel lintels and concrete sills.

South elevation detail showing fenestration pattern and rhythm compromised
