Traffic Safety Review - Broadview Avenue at Erindale Avenue, Broadview Avenue at Danforth Avenue and Broadview Transit Station

Date: August 24, 2020
To: Toronto and East York Community Council
From: Acting Director, Traffic Management, Transportation Services
Wards: Ward 14, Toronto - Danforth

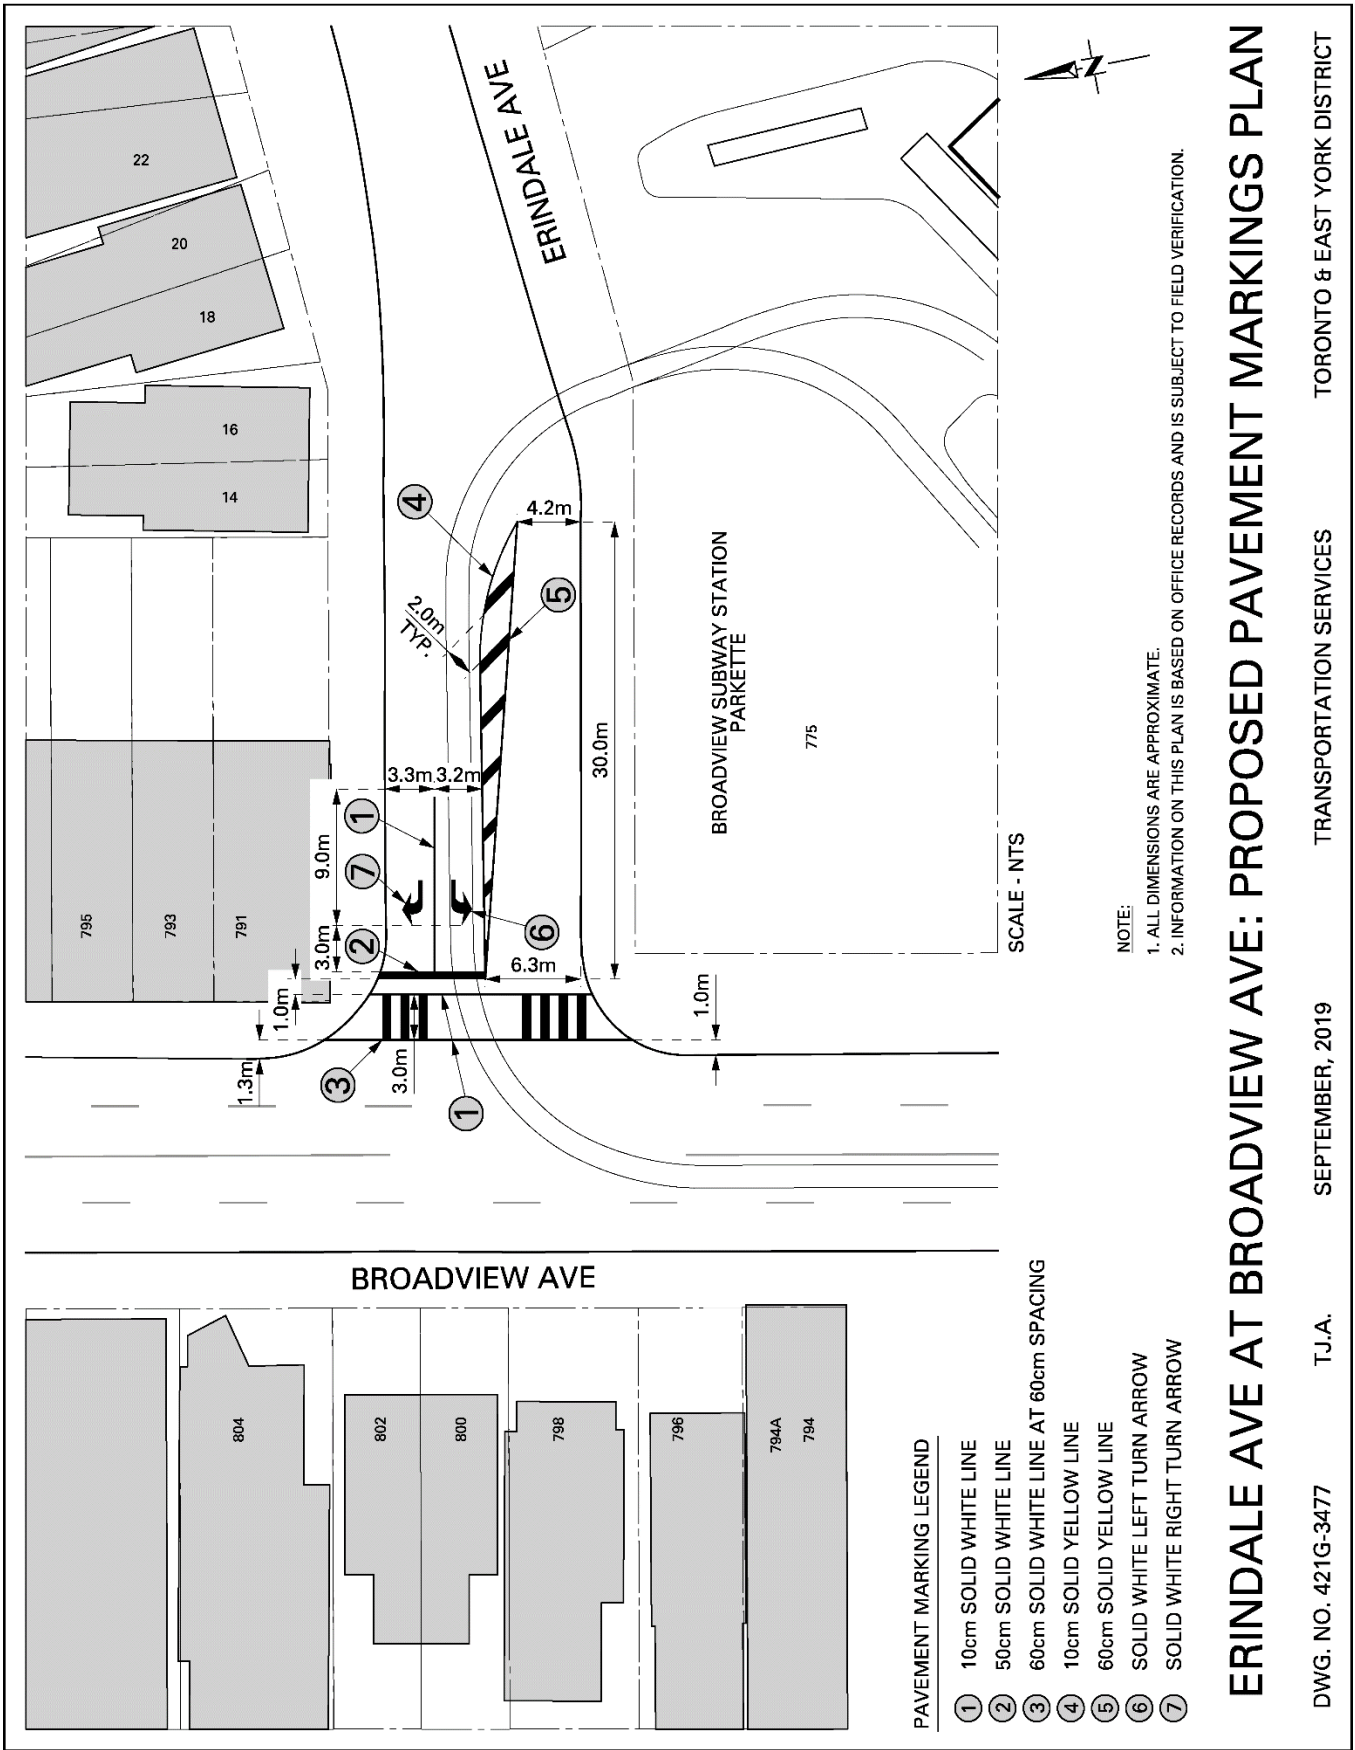
1. Drawing No. 421G-3477, dated September 2019

A review of the existing pavement markings for the east approach of Broadview Avenue and Erindale Avenue, identified the following deficiencies:

- The eastbound lane was noted to be wider than the westbound lane,
- The westbound left and right turn lanes were not delineated, and
- The absence of directional lane markings near the streetcar tracks to provide a safe buffer between the TTC's new low floor light rail vehicles (LFLRV) and opposing traffic.

The revised pavement marking plan includes the reallocation of lane widths at the east approach of the intersection to provide for the designation of a westbound left and westbound right turning lanes. Additionally, the installation of a hatched median between opposing traffic will provide clear separation between eastbound traffic and the rear tail swing of a TTC LFLRV. Attachment 1 illustrates the proposed pavement marking plan of the lane designation.
