RE: Toronto and East York Community Council Meeting of December 2, 2020
- Item TE21.15
- Intention to Designate under Part IV, Section 29 of the *Ontario Heritage Act*
- 100 Simcoe Street
- Letter of Objection

Re: 100 Simcoe Street, Inclusion on the City of Toronto's Heritage Register - Item No. TE22.18

Re: 100 Simcoe Street, Inclusion on the City of Toronto's Heritage Register - Item No. PB20.2

ANNOTATED PHOTOGRAPHS

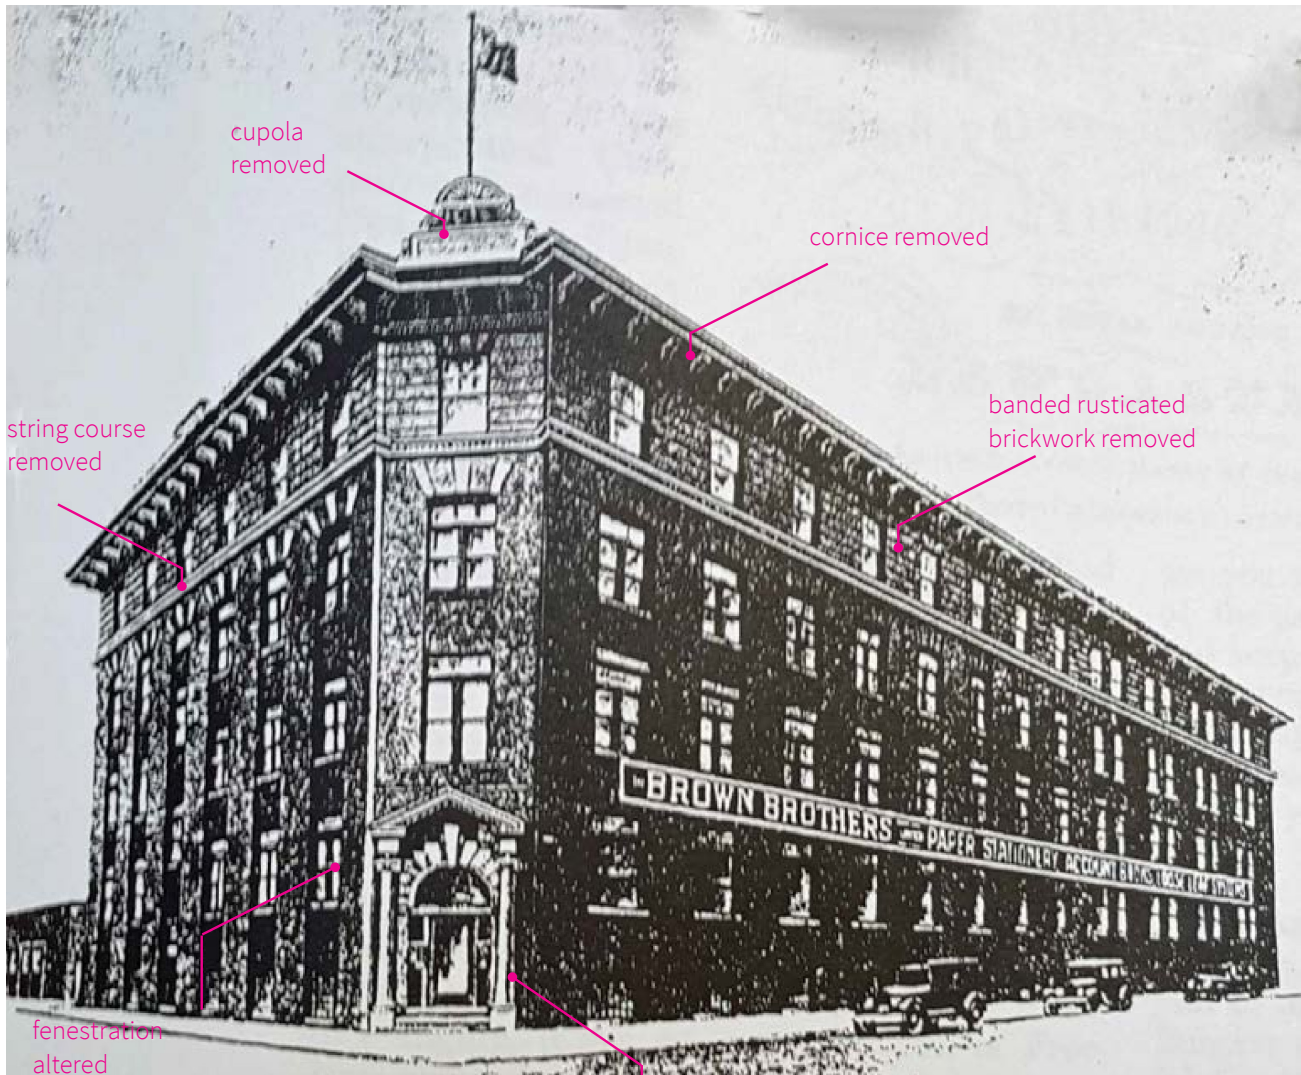
1936

The orientation of the building has been modified from its original design. Historically the building was oriented to the corner of Simcoe and Pearl Streets, visually emphasized by an elaborate cut stone doorcase, emphatic break in the cornice line and decorative cupola (all demolished).

The embellished string course distinguishing the upper storey, the banded rustication accentuating the upper storey, the prominent cornice with dentil course, and the cupola have all been removed. The new window openings on the fifth storey are entirely modern and their wide proportions have no stylistic precedent on the building, nor in Edwardian Classicist design.

The roofline has been altered. The original roof was historically topped by an ornamental cupola which crowned the architectural composition, now removed. The flat roofline should not be considered a heritage attribute because it has no heritage value in its own right and has compromised the integrity of the well-designed and highly ornamental original roof.

cupola removed

cornice removed

string course removed

banded rusticated brickwork removed

fenestration altered

cut stone door surround removed

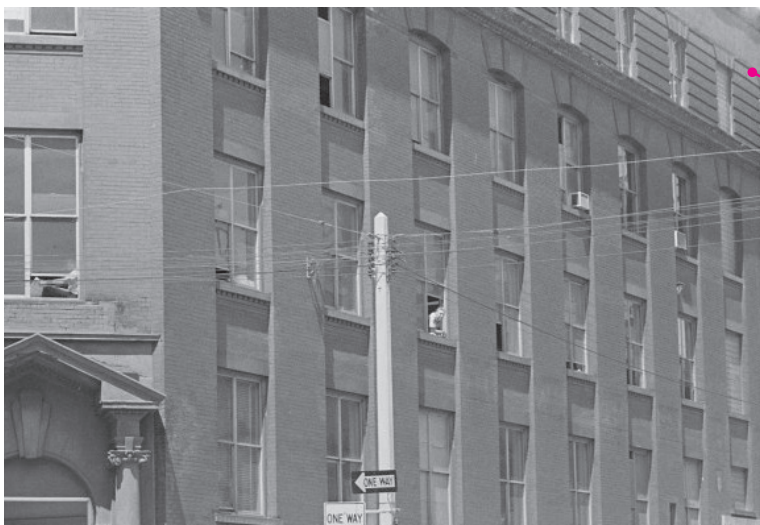
1973

Historic photographs show the fourth storey windows originally had decorative brick jack arches, not stone lintels.

East elevation detail (1975) showing 4th storey windows originally had brick jack arches, not stone lintels

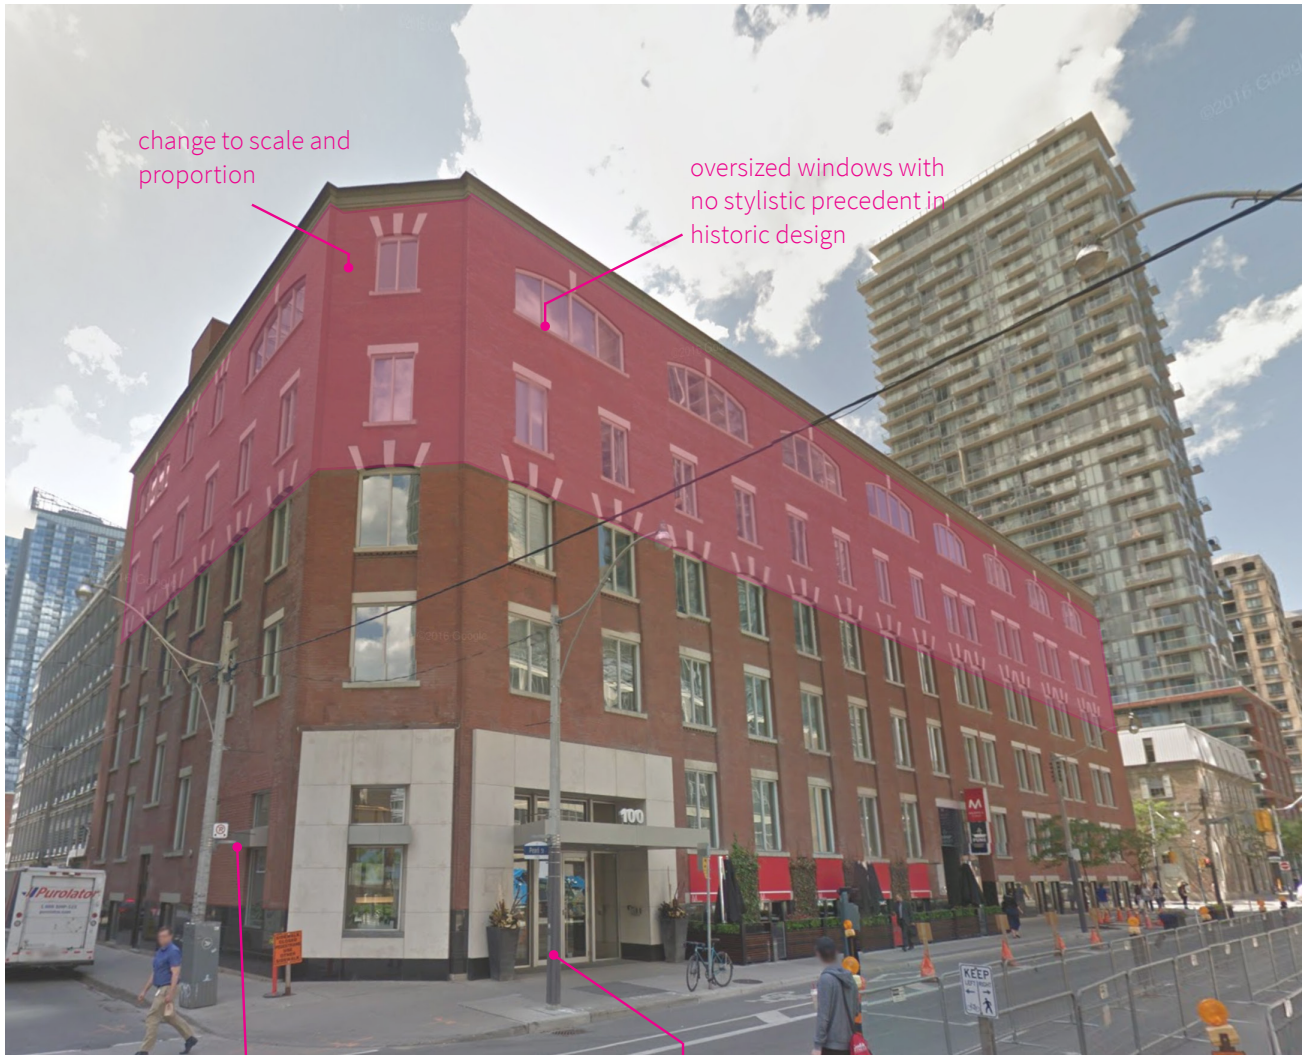
2016

Today the entrance is through an unsympathetic modern opening on the east elevation and the building is no longer oriented to the corner.

The scale, form and massing of the building have all been altered. The original four-storey design was modified to five storeys, which has resulted in completely different proportions from those that were intended by the original designers.

As mentioned, the additional storey changes the building’s scale and proportions. It also necessitated removal of the string course and the banded rustication on the upper storeys which served to horizontally unify the architecturally distinct north and south sections. While the addition uses complementary materials, it is not in the spirit of the architectural composition of the original designers. The oversized windows have no stylistic precedent on the building and are alien to Edwardian Classicism.

change to scale and proportion

oversized windows with no stylistic precedent in historic design

building orientation changed; entrance added

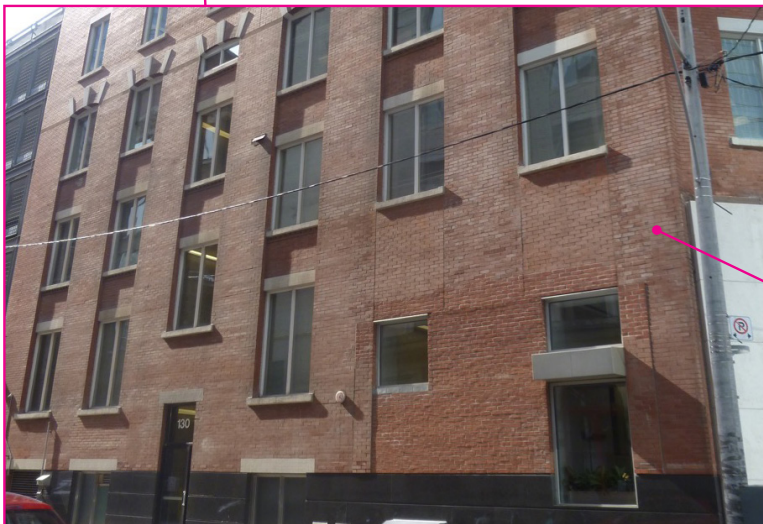
2016

The fenestration on the south elevation has been substantially modified. The placement, size, and proportion of the first floor openings in the two easternmost bays are completely changed, compromising the rhythm of the original elevation. Moreover, the modern replacement windows have steel lintels and concrete sills.

South elevation detail showing fenestration pattern and rhythm compromised
