RECONSTRUCTION PLAN

314 JARVIS STREET

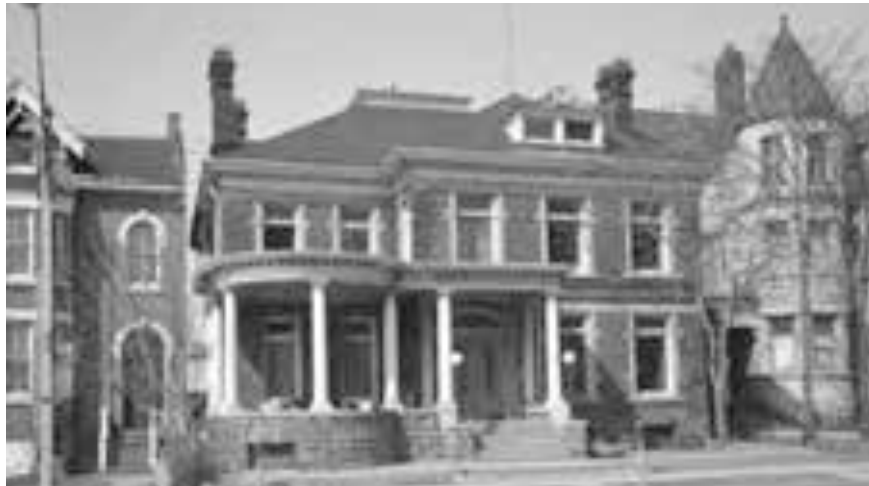
Archival image showing 314 Jarvis c.1970 (Source: Toronto Public Library)

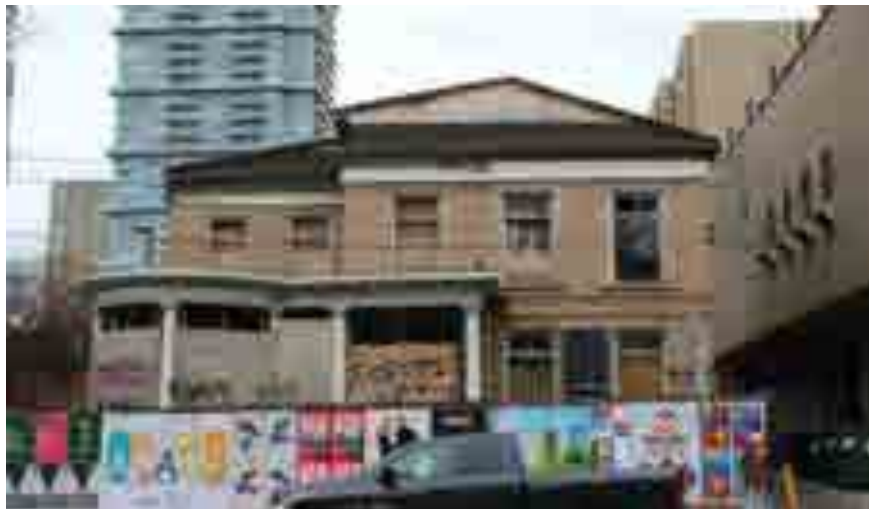
Image showing 314 Jarvis condition after the 2016 fire, the original roof was destroyed during the fire and replaced with a temporary roof structure (Source: GBCA, 2019).

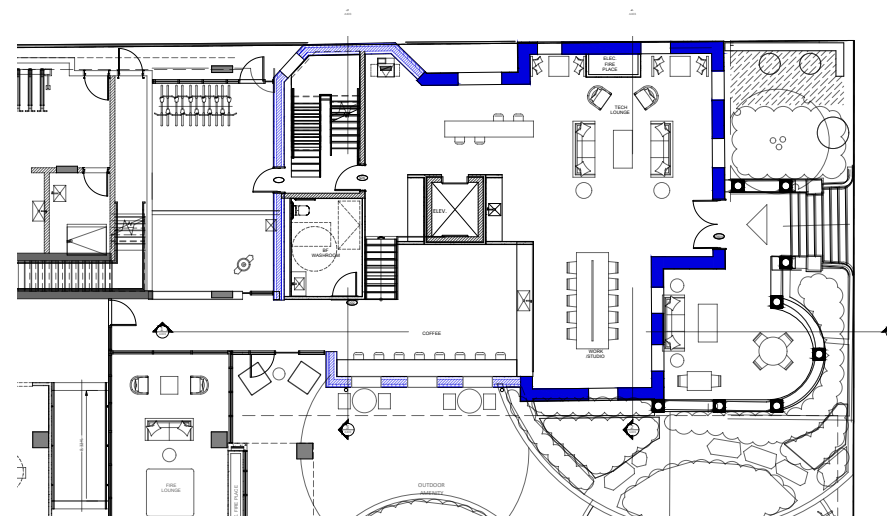
Excerpt of proposed site plan showing the extents of the remaining exterior heritage walls to be conserved (solid blue lines) and perimeter walls to be reconstructed (light blue hatch).

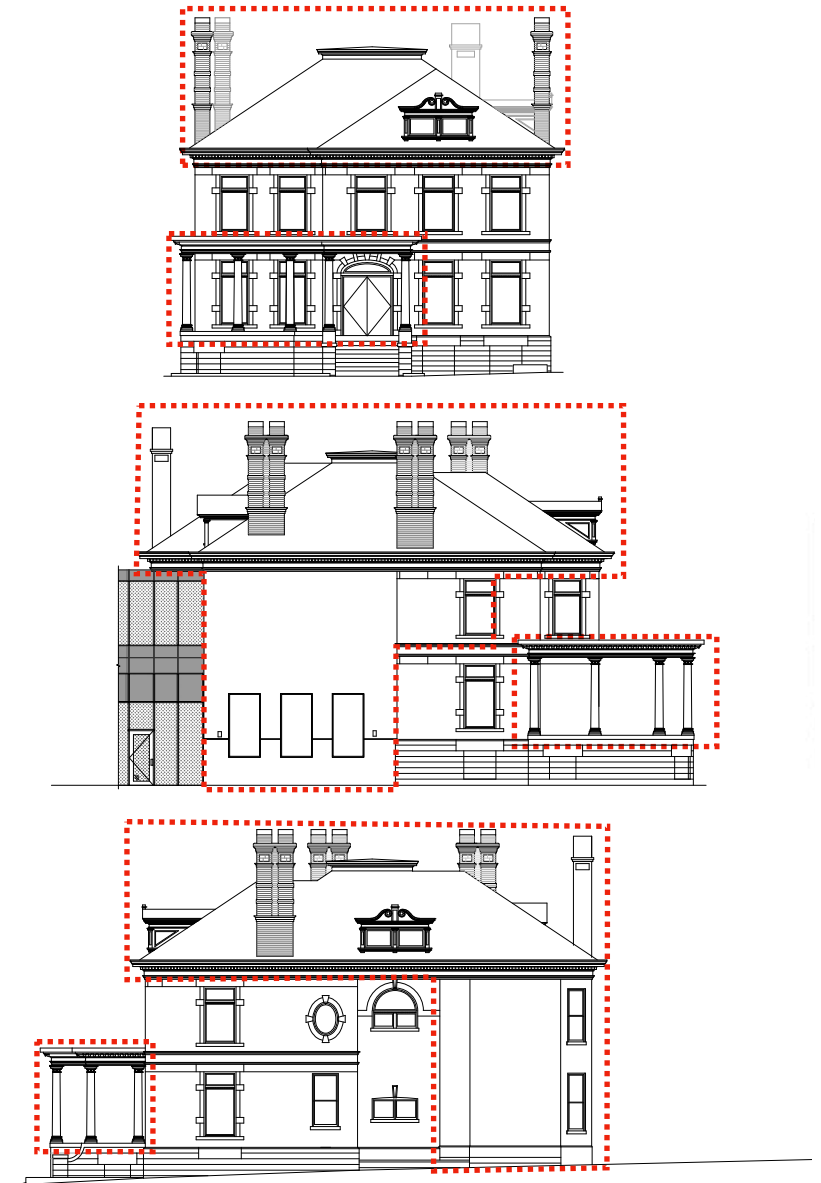
Proposed elevations (314 Jarvis) highlighting the building elements to be reconstructed, to preserve the original form, scale and mass of this designated heritage building (Source: GBCA, 2020).

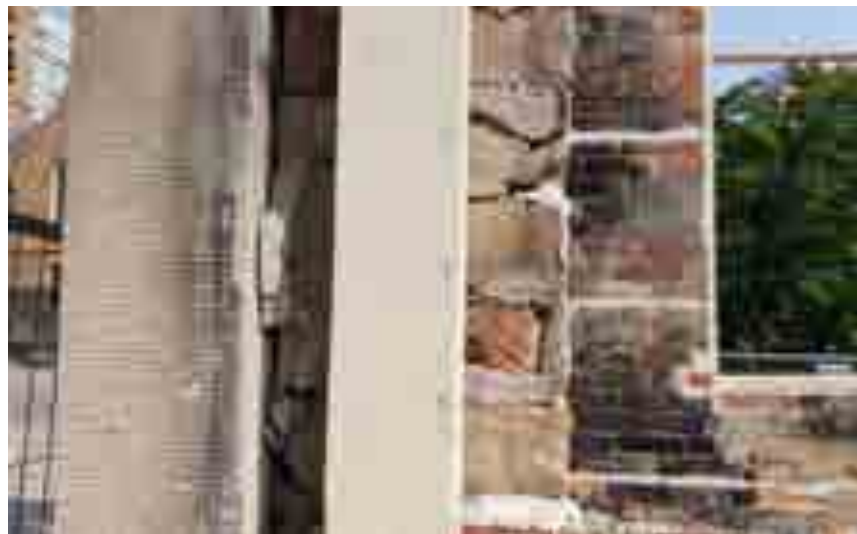
Image showing multi-wythe masonry wall at typical window opening, note staining at stone window surround (Source: GBCA, 2020)

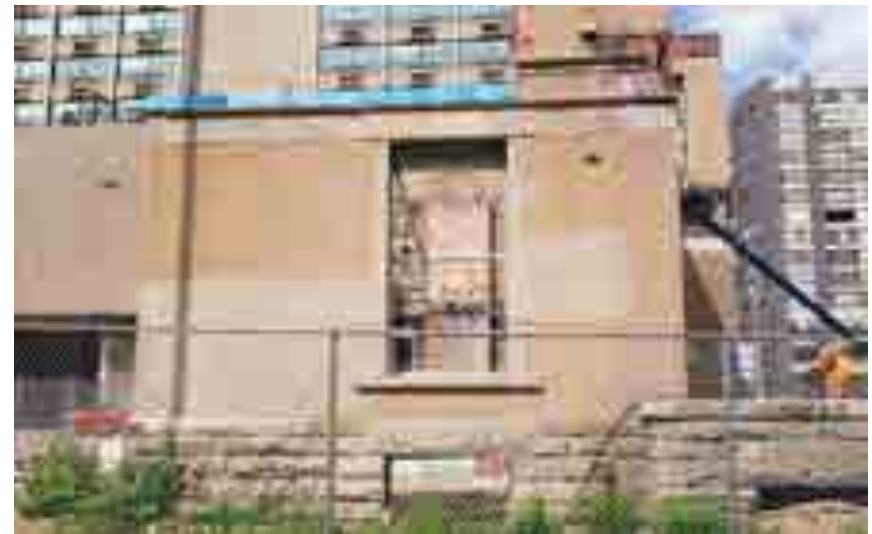
Image showing remaining south wall portion, note deteriorated stucco parging and staining at stone band course (Source: GBCA, 2020)

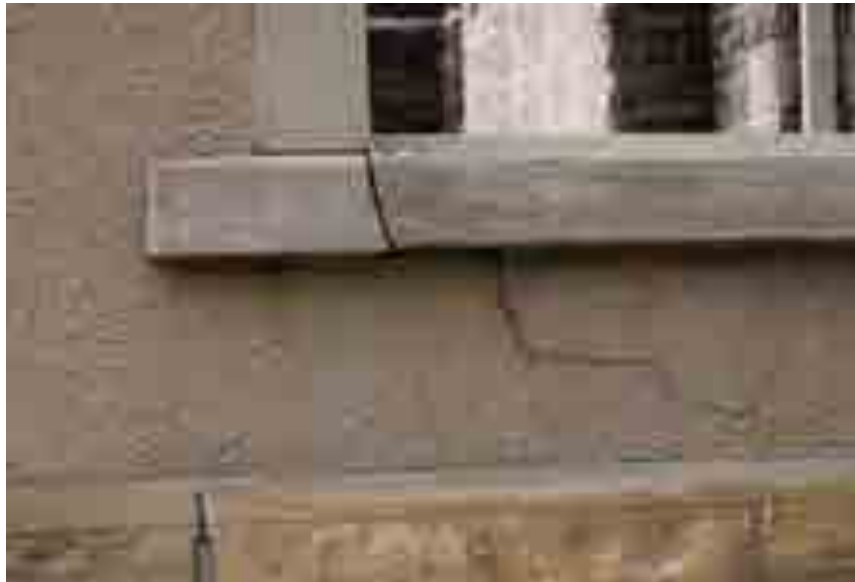
Detail showing cracked and displaced stone sill (Source: GBCA, 2020)

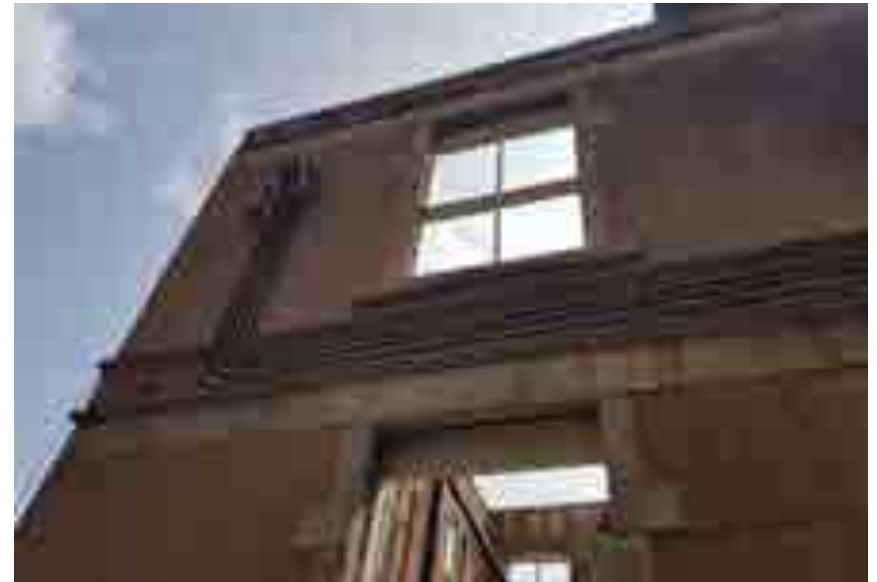
Image showing deteriorated stucco parging, stained stone band and decommissioned electrical conduits to be removed (Source: GBCA)

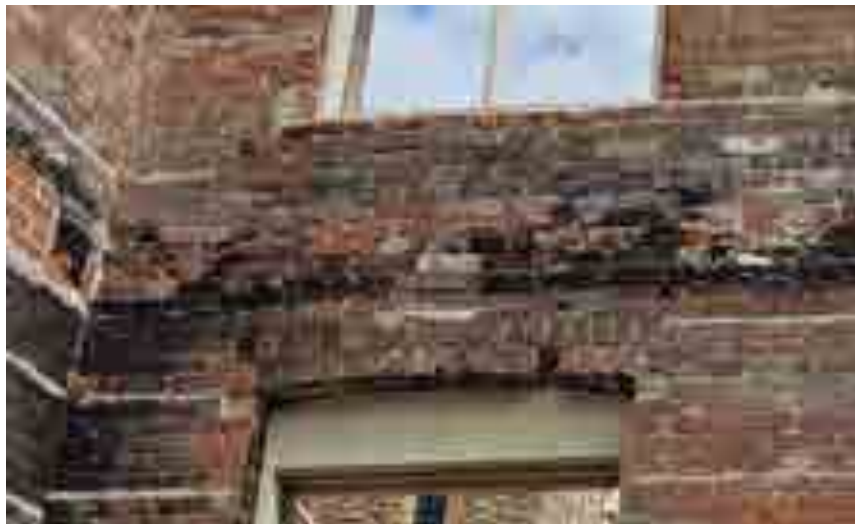
Interior detail showing damaged masonry arch at window opening, note deteriorated mortar joints and brick staining (Source: GBCA, 2020)

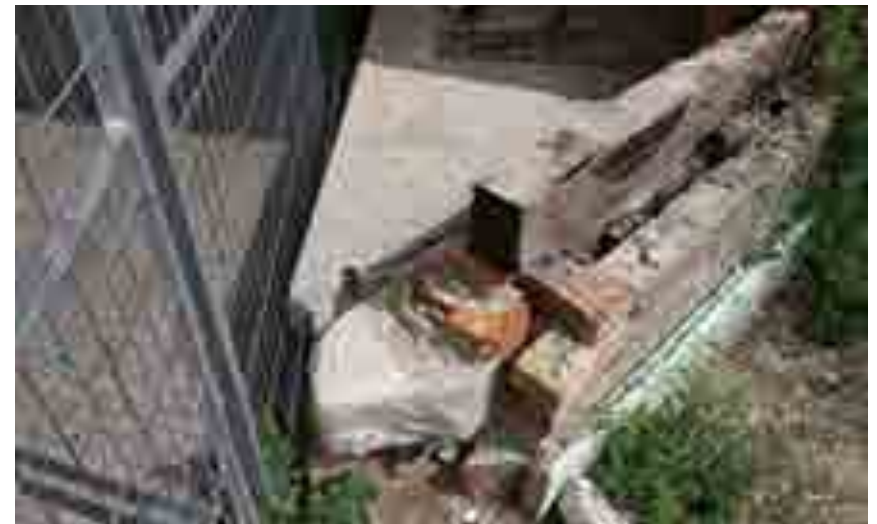
Detail showing northwest foundation wall segment and non-original curb to be removed (Source: GBCA, 2020)

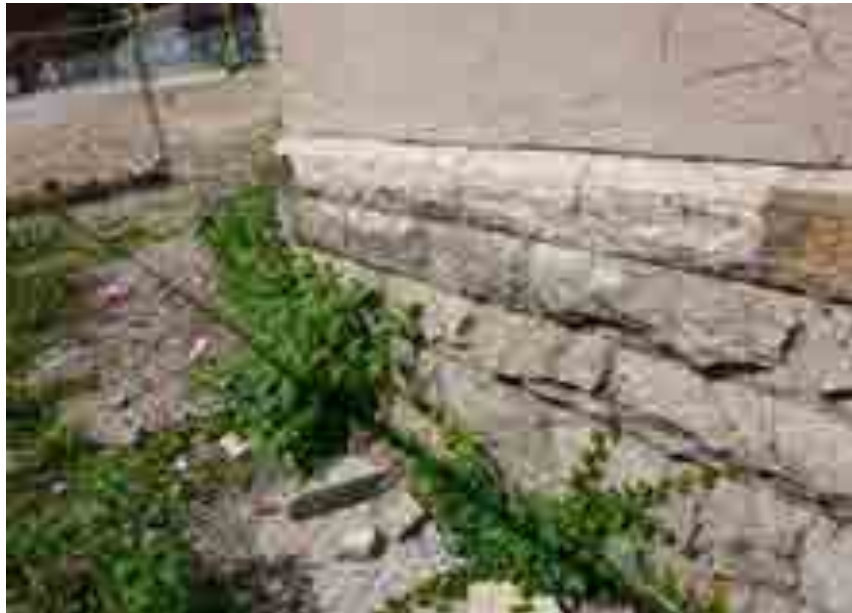
Image showing raised stone foundation with paint staining, biological growth and vines (Source: GBCA)

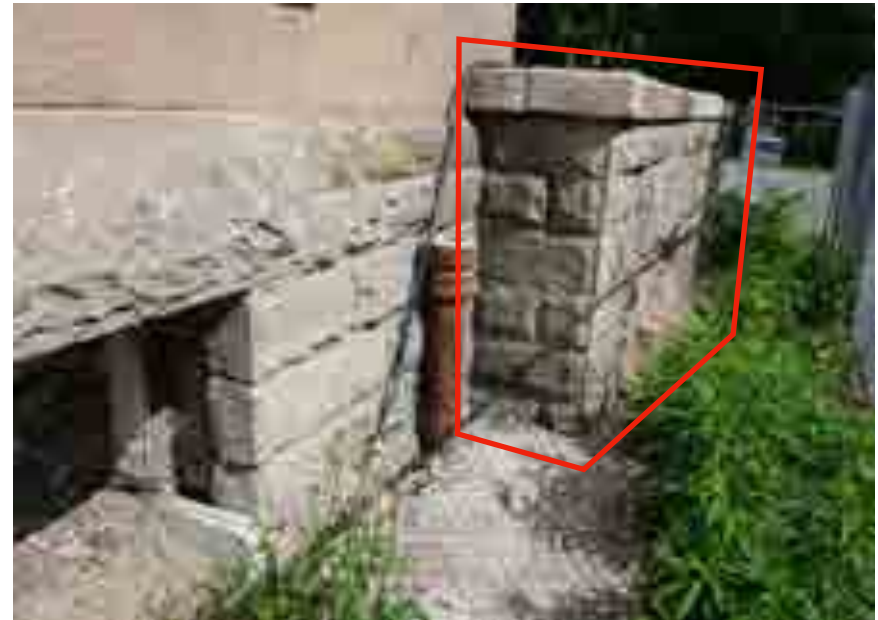
Image showing decommissioned opening to be infilled and efflorescence staining. Red box indicates portion of front porch stone base to be dismantled and reconstructed, refer to section '3.2 Front Porch' below for more information (Source: GBCA)

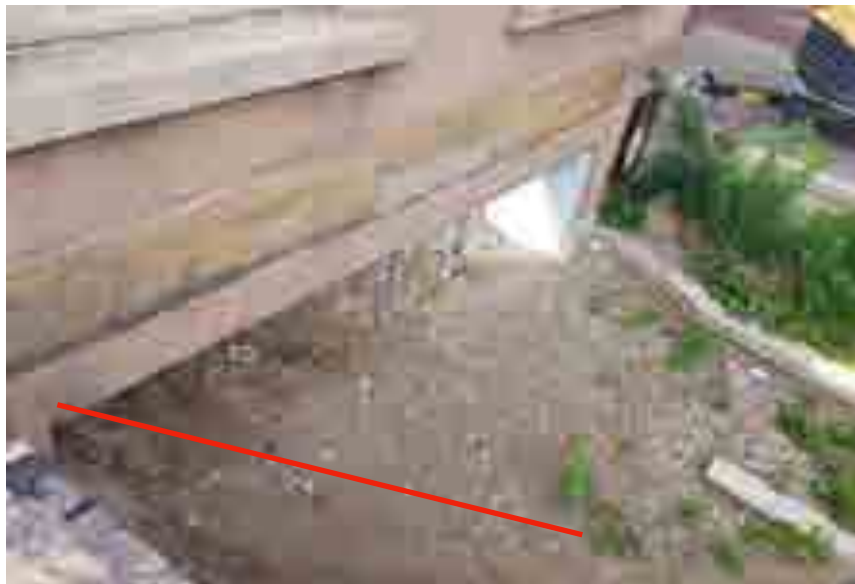
Image showing face lintels at modified basement window, non-original finishes to be removed (see drawings) and decommissioned window (Source: GBCA, 2020)

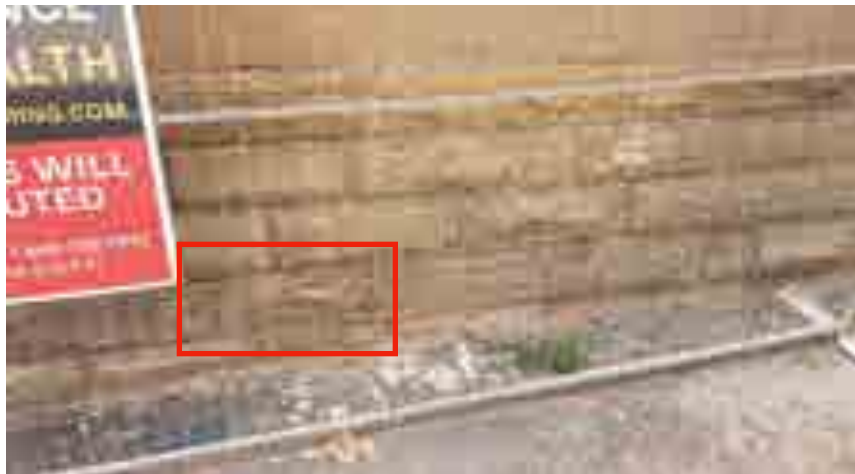
Image showing typical condition along north foundation wall, note deteriorated stones (red box) and efflorescence (Source: GBCA, 2020)

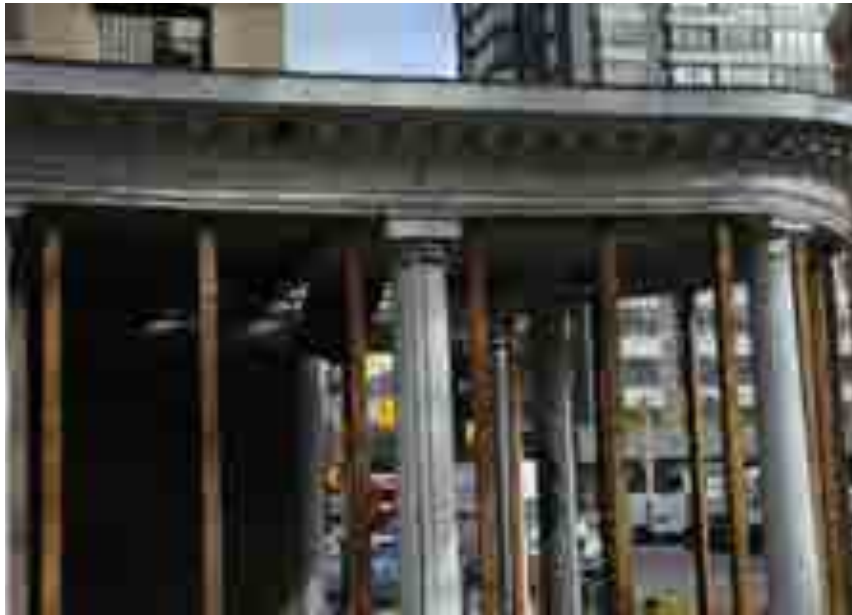
Image showing damaged wood porch after the 2019 fire (Source: GBCA, 2019)

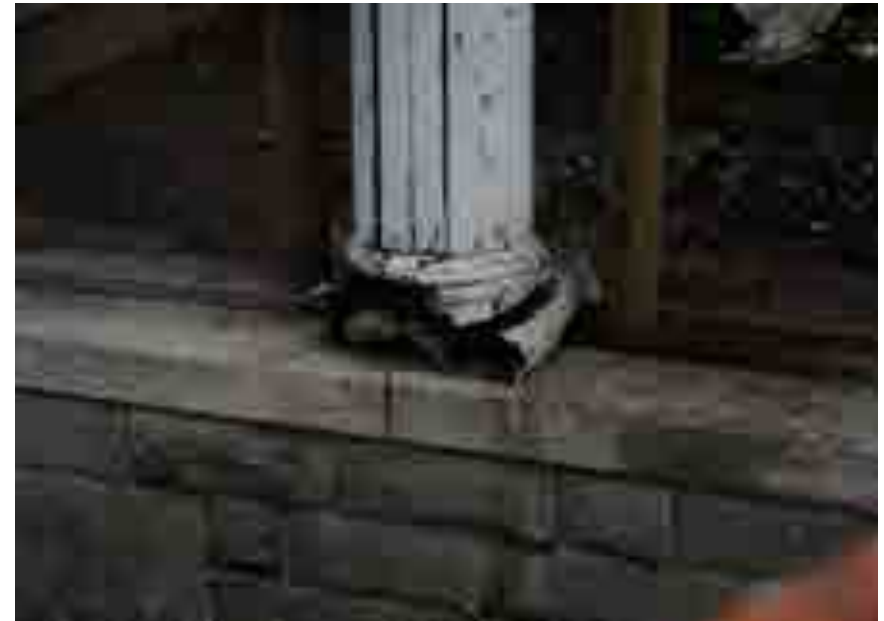
Detail Image showing damaged wood column (Source: GBCA)

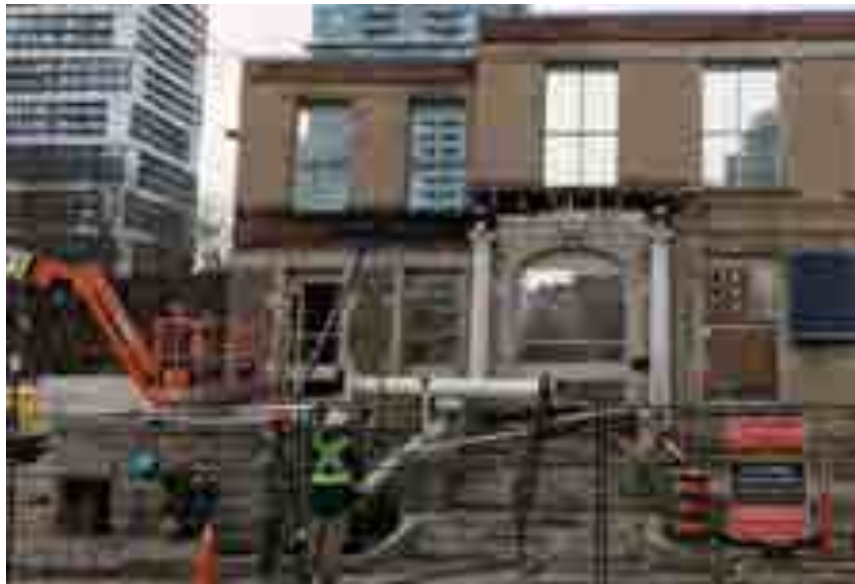
Image showing wood porch removal process (Source: GBCA, 2019)

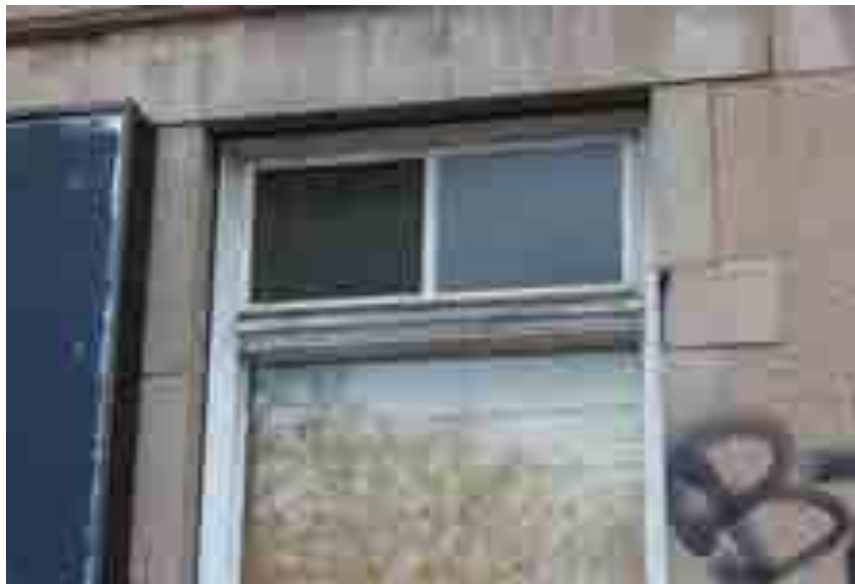
Image of typical east elevation wood window showing condition before 2019 fire (Source: GBCA)

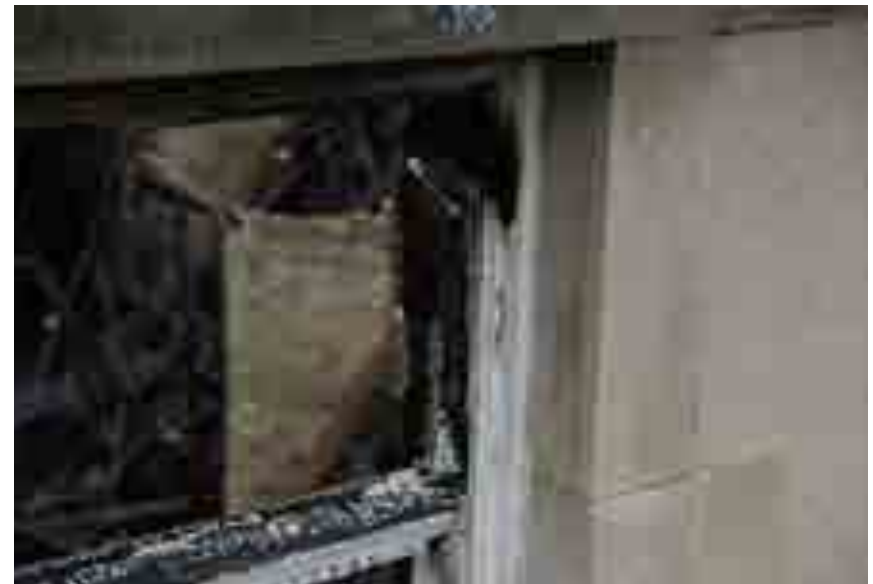
Detail showing destroyed wood window after 2019 fire (Source: GBCA)

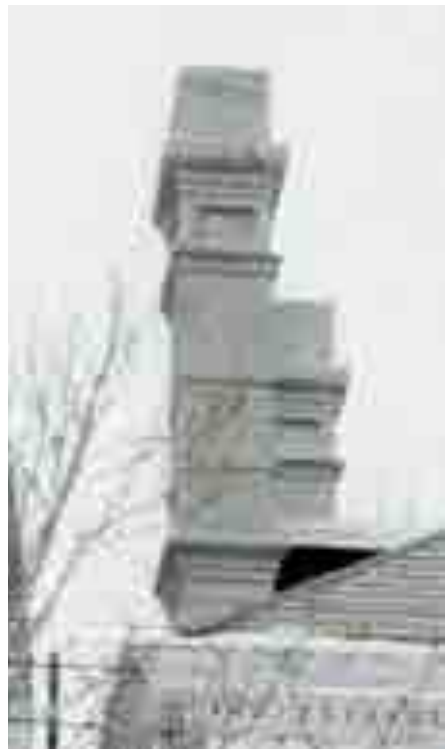
Decorative south masonry chimneys, c.1981 (Source: Toronto Public Library)

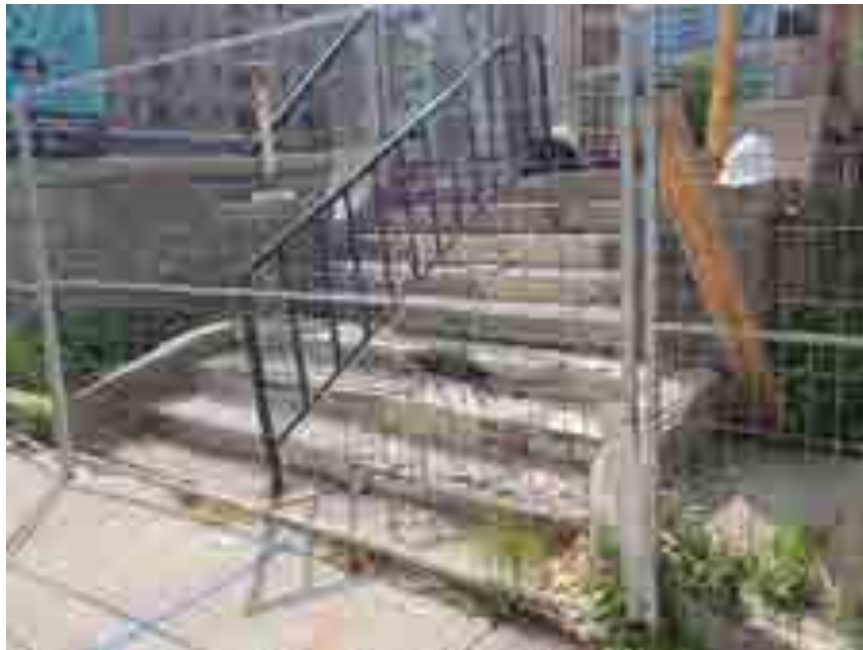
Image showing existing entrance steps condition, note deteriorated surface, exposed rebar, chipped ceramic tile finish and modern central handrail (Source: GBCA, 2020).

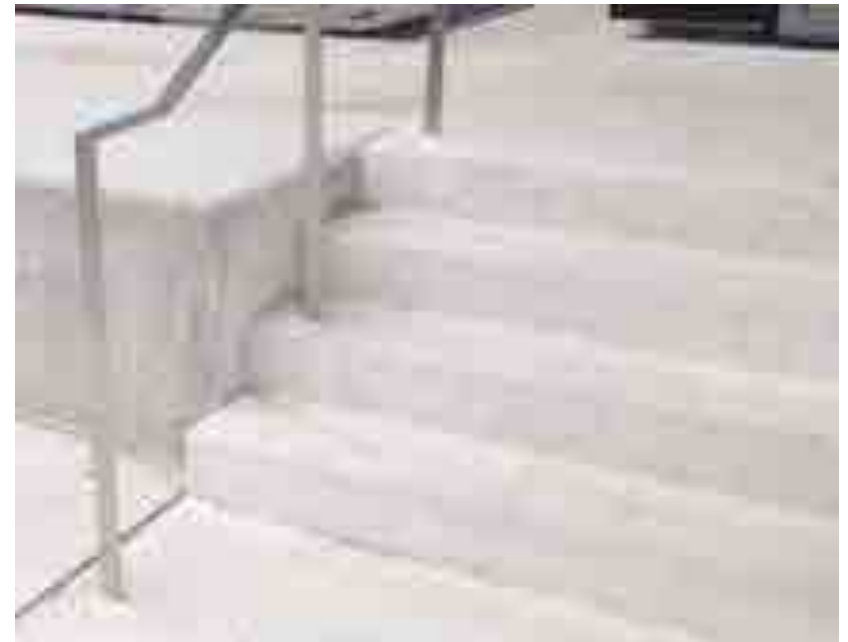
Image showing example of proposed treatment for the front steps at Jarvis Street, the steps material is proposed to be stone or cast stone material with no nosing.

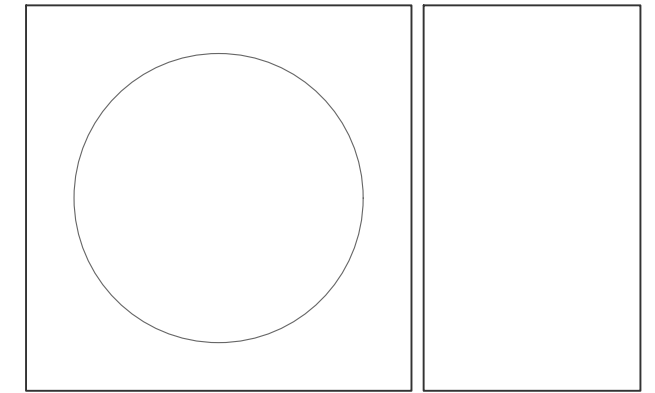
DATE	NO.	DESCRIPTION
2020.11.02	1	ISSUED FOR COORDINATION
2020.12.02	2	ISSUED FOR RECONSTRUCTION PLAN

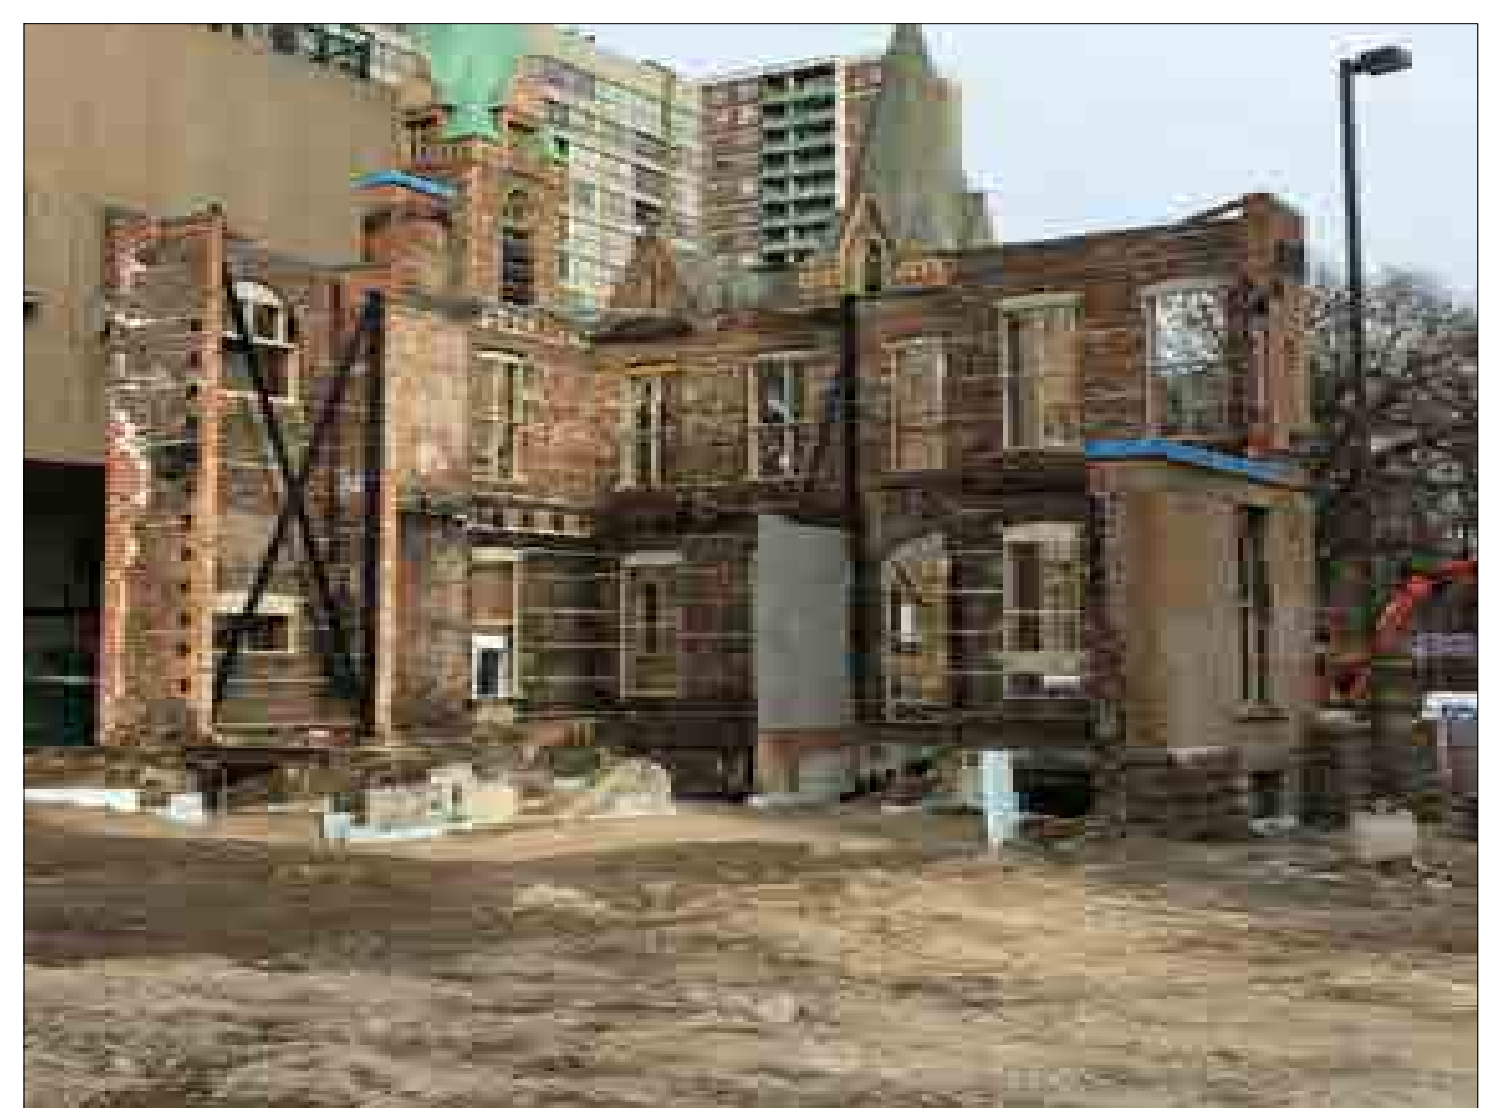
2 CURRENT SITE PHOTOS SHOWING CONDITION AFTER 2019 FIRE
N.T.S.

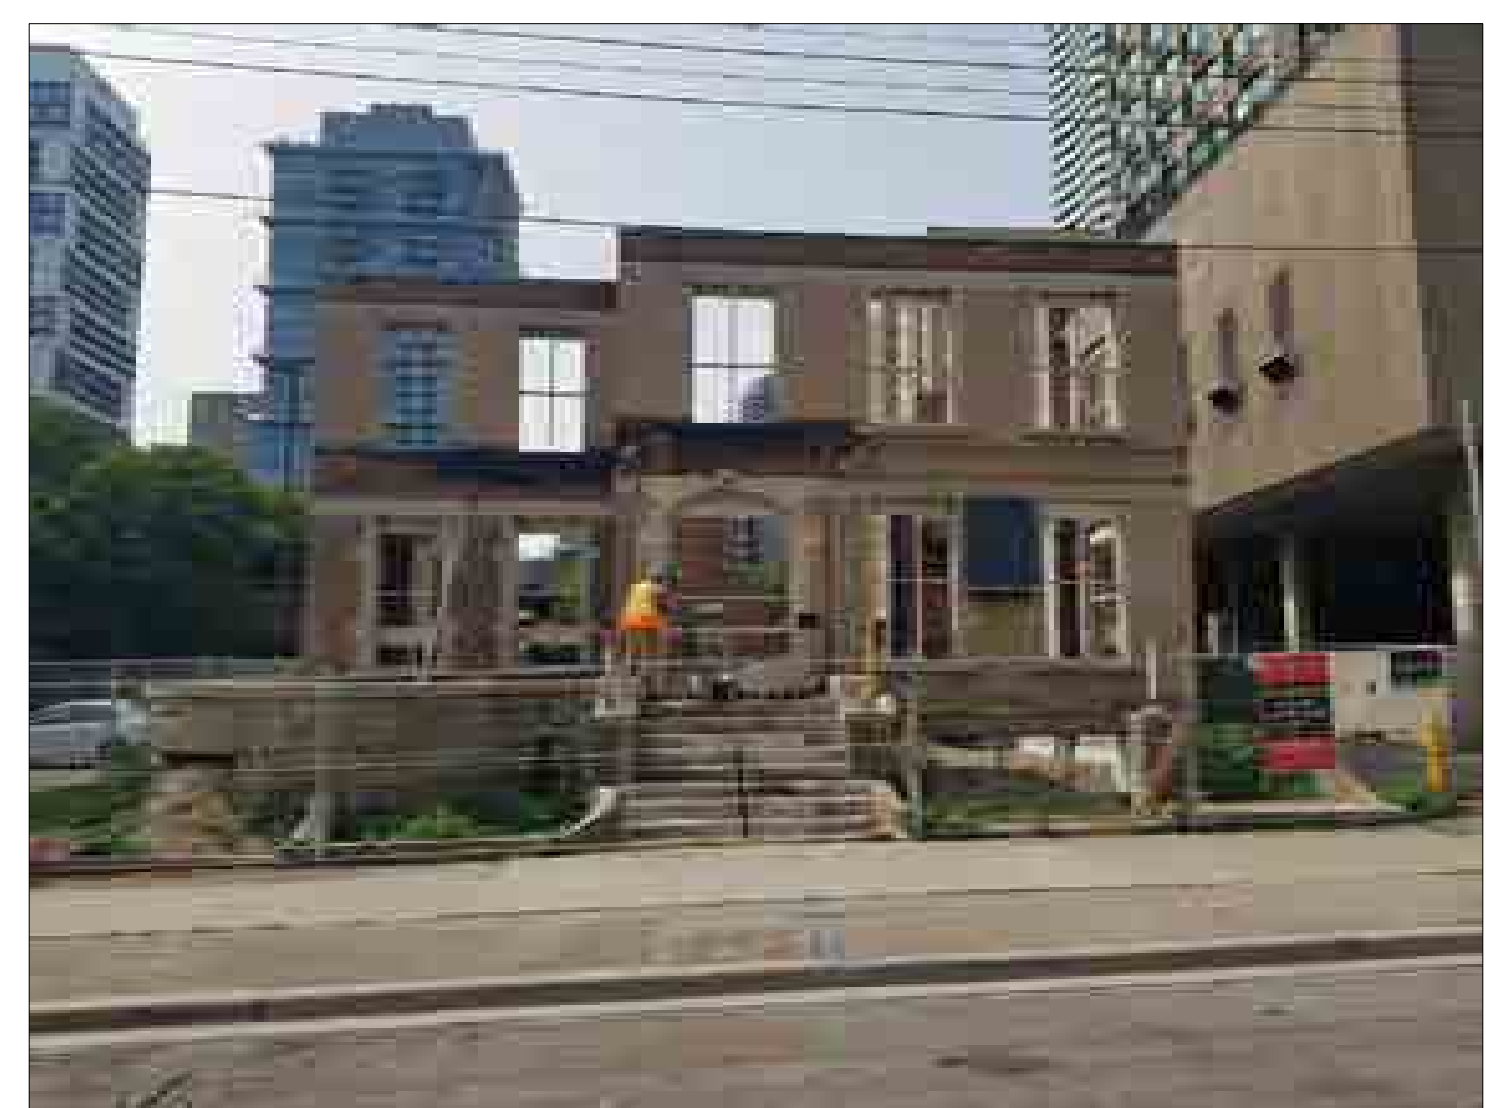
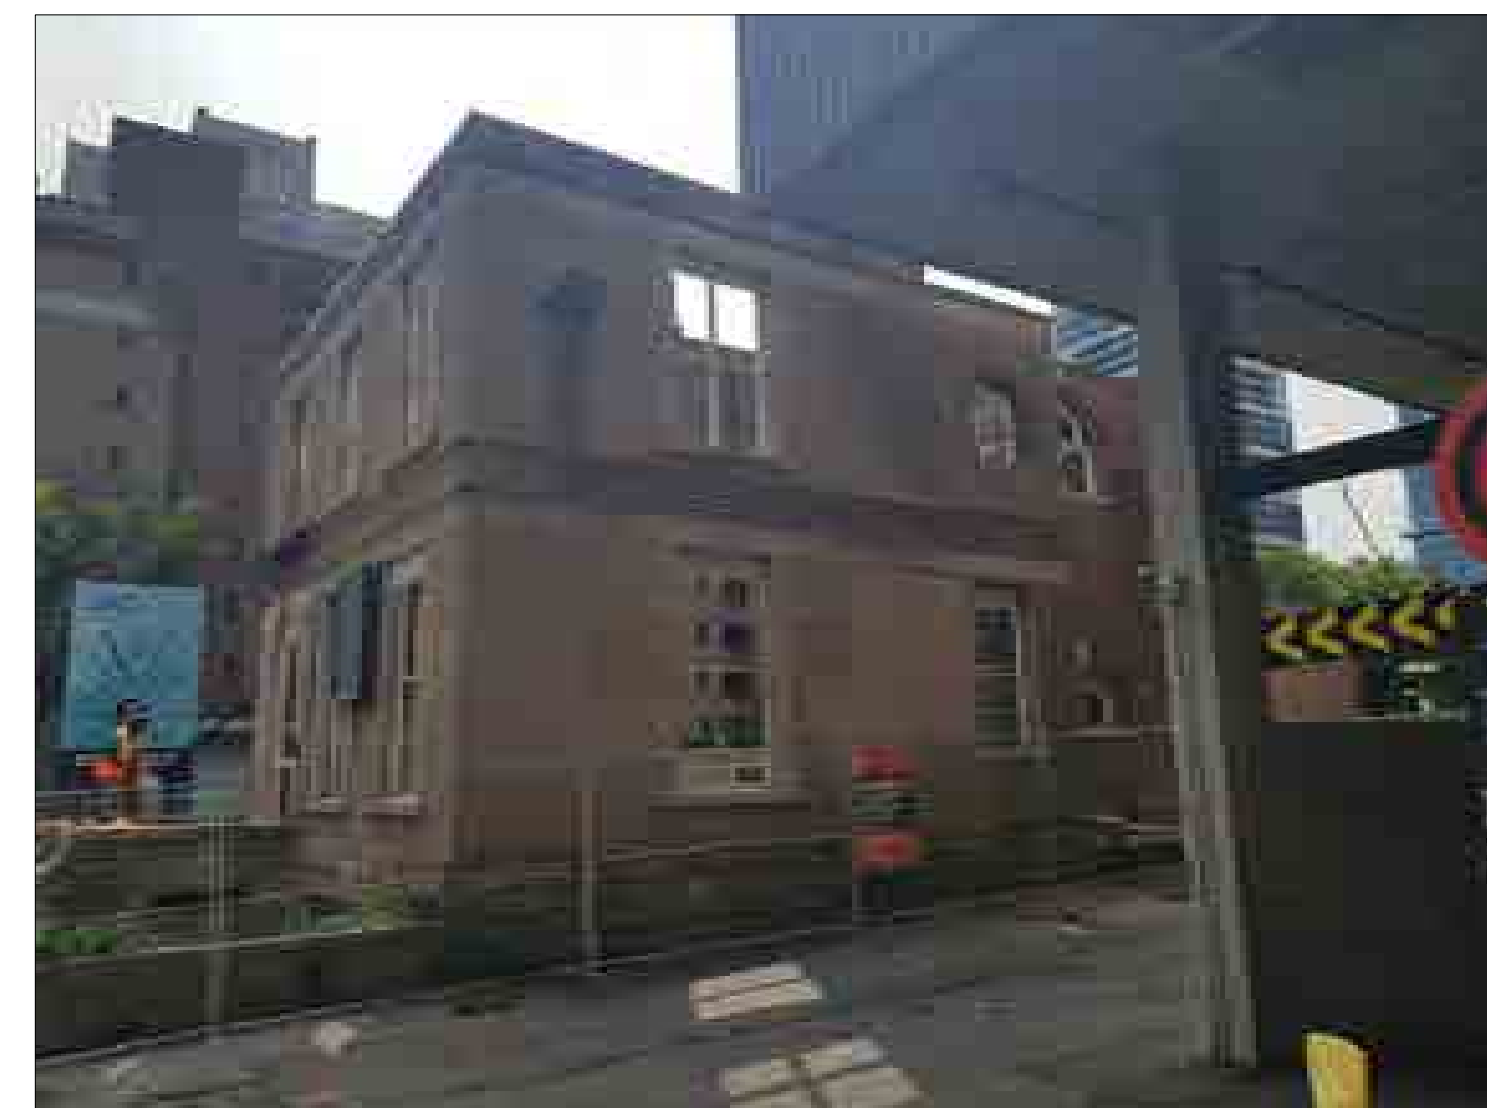
NOT FOR CONSTRUCTION

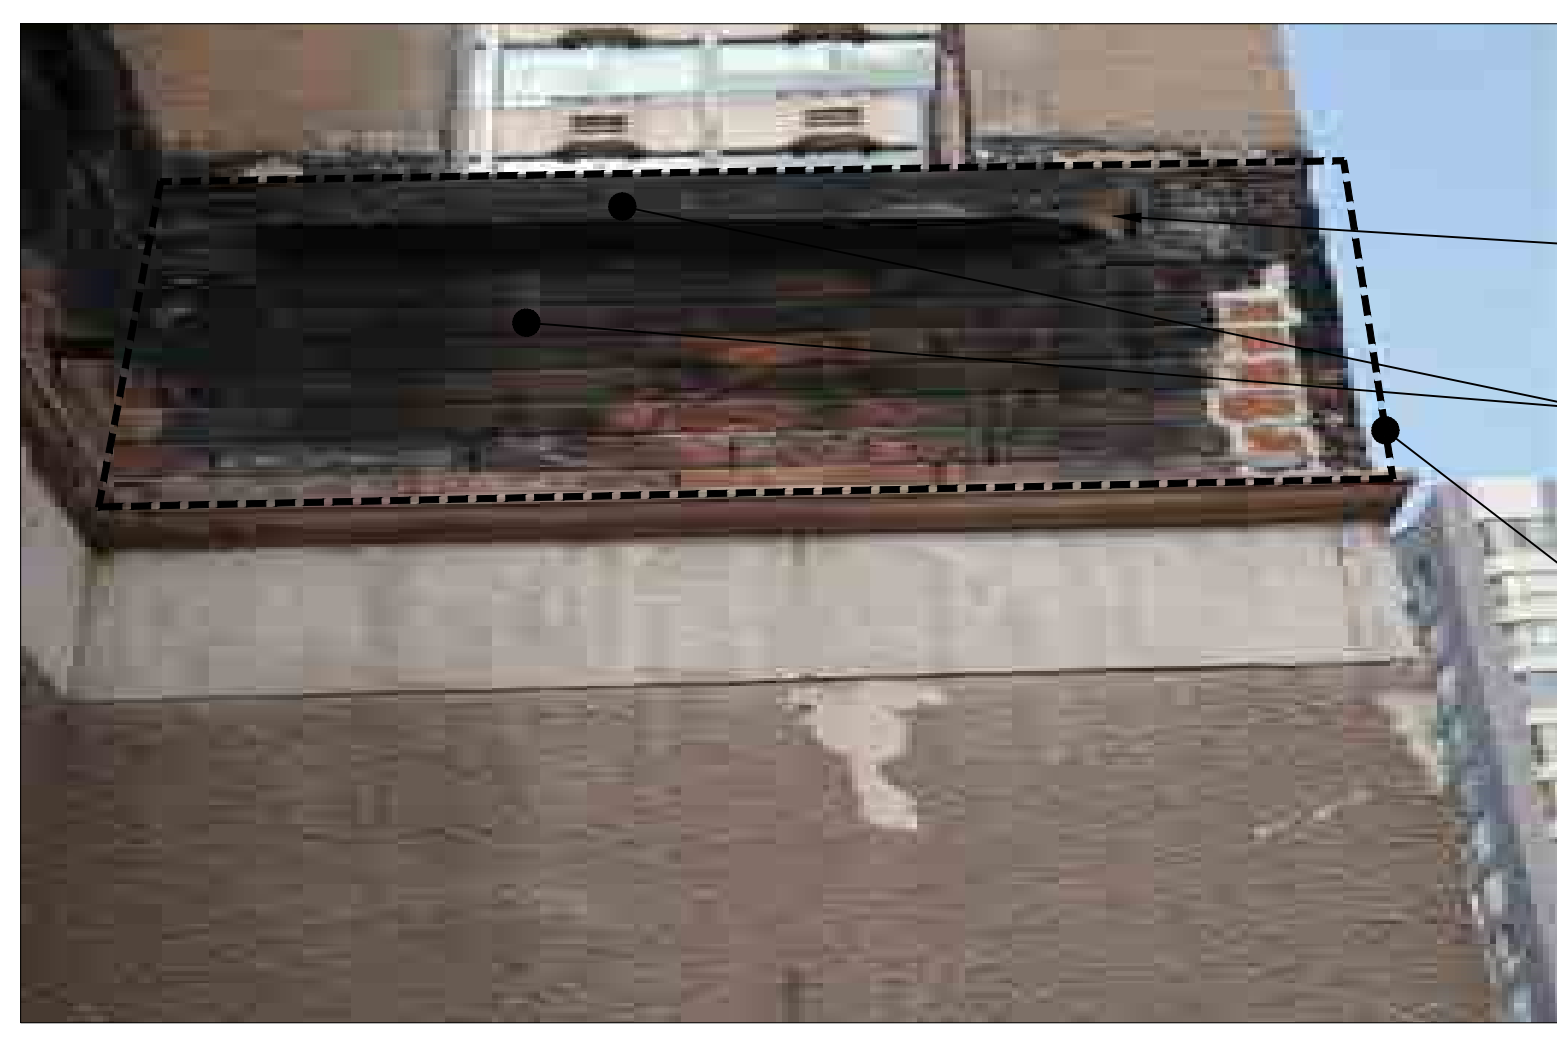
2 SOUTH ELEV. SOILING AND DETERIORATED WINDOW SILL
N.T.S

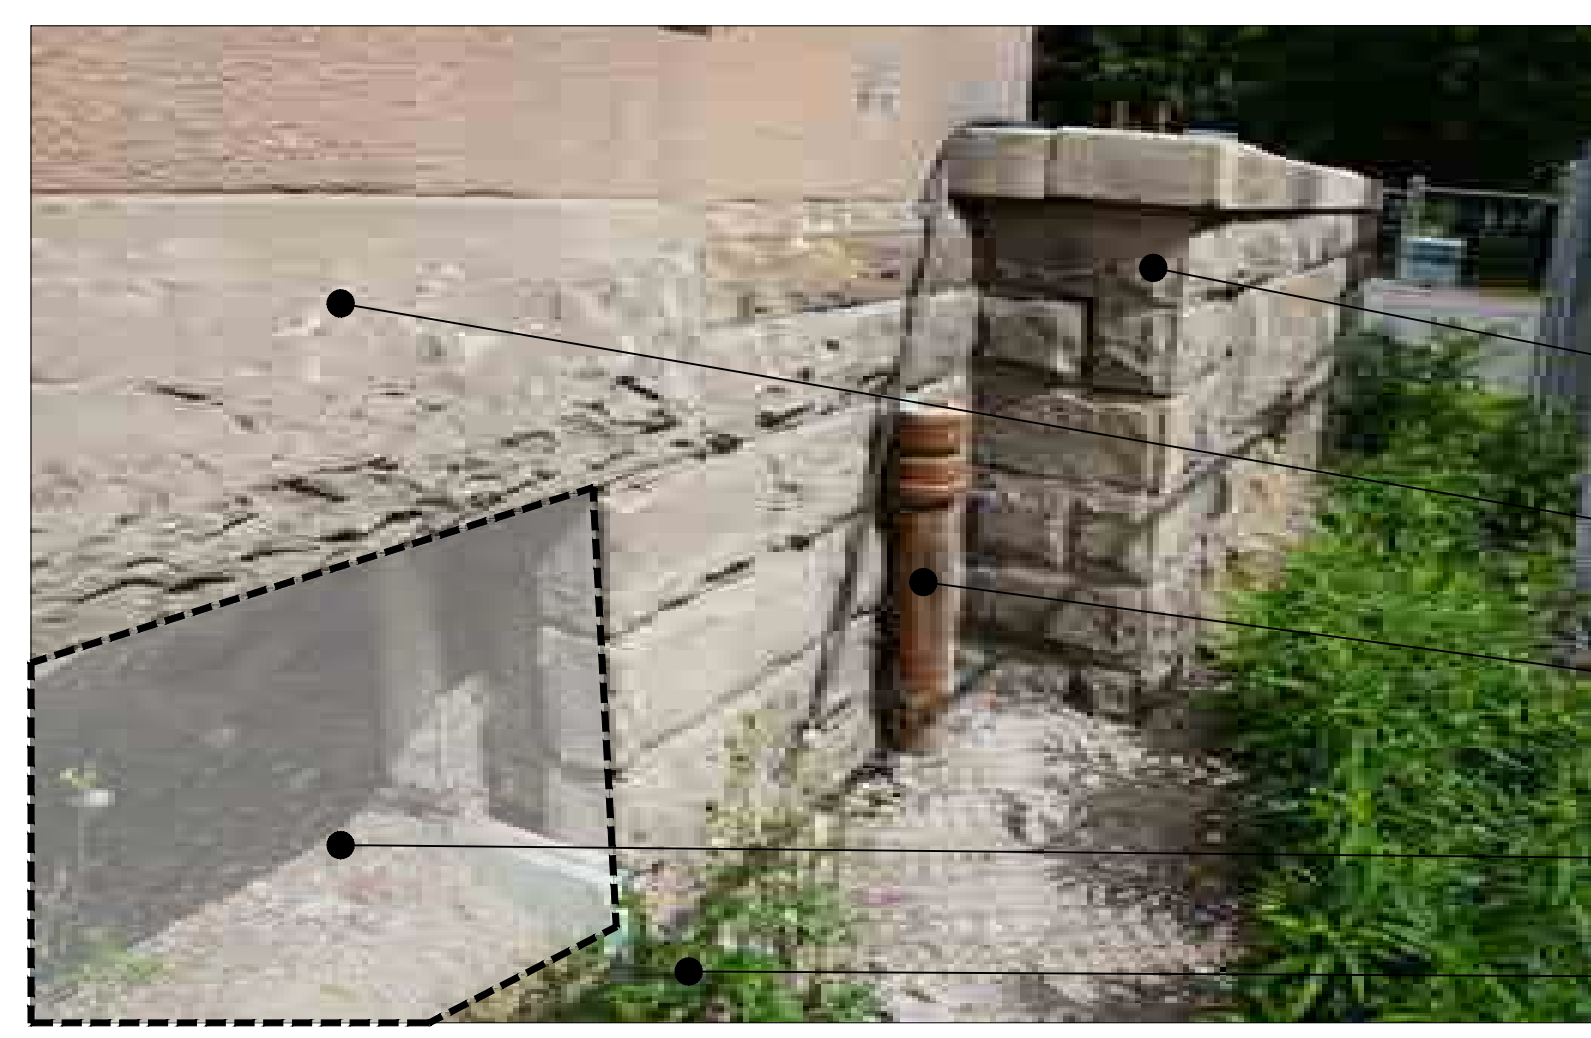
3 SOUTH ELEV. SOILING AND DETERIORATED RUBBLE STONE
N.T.S

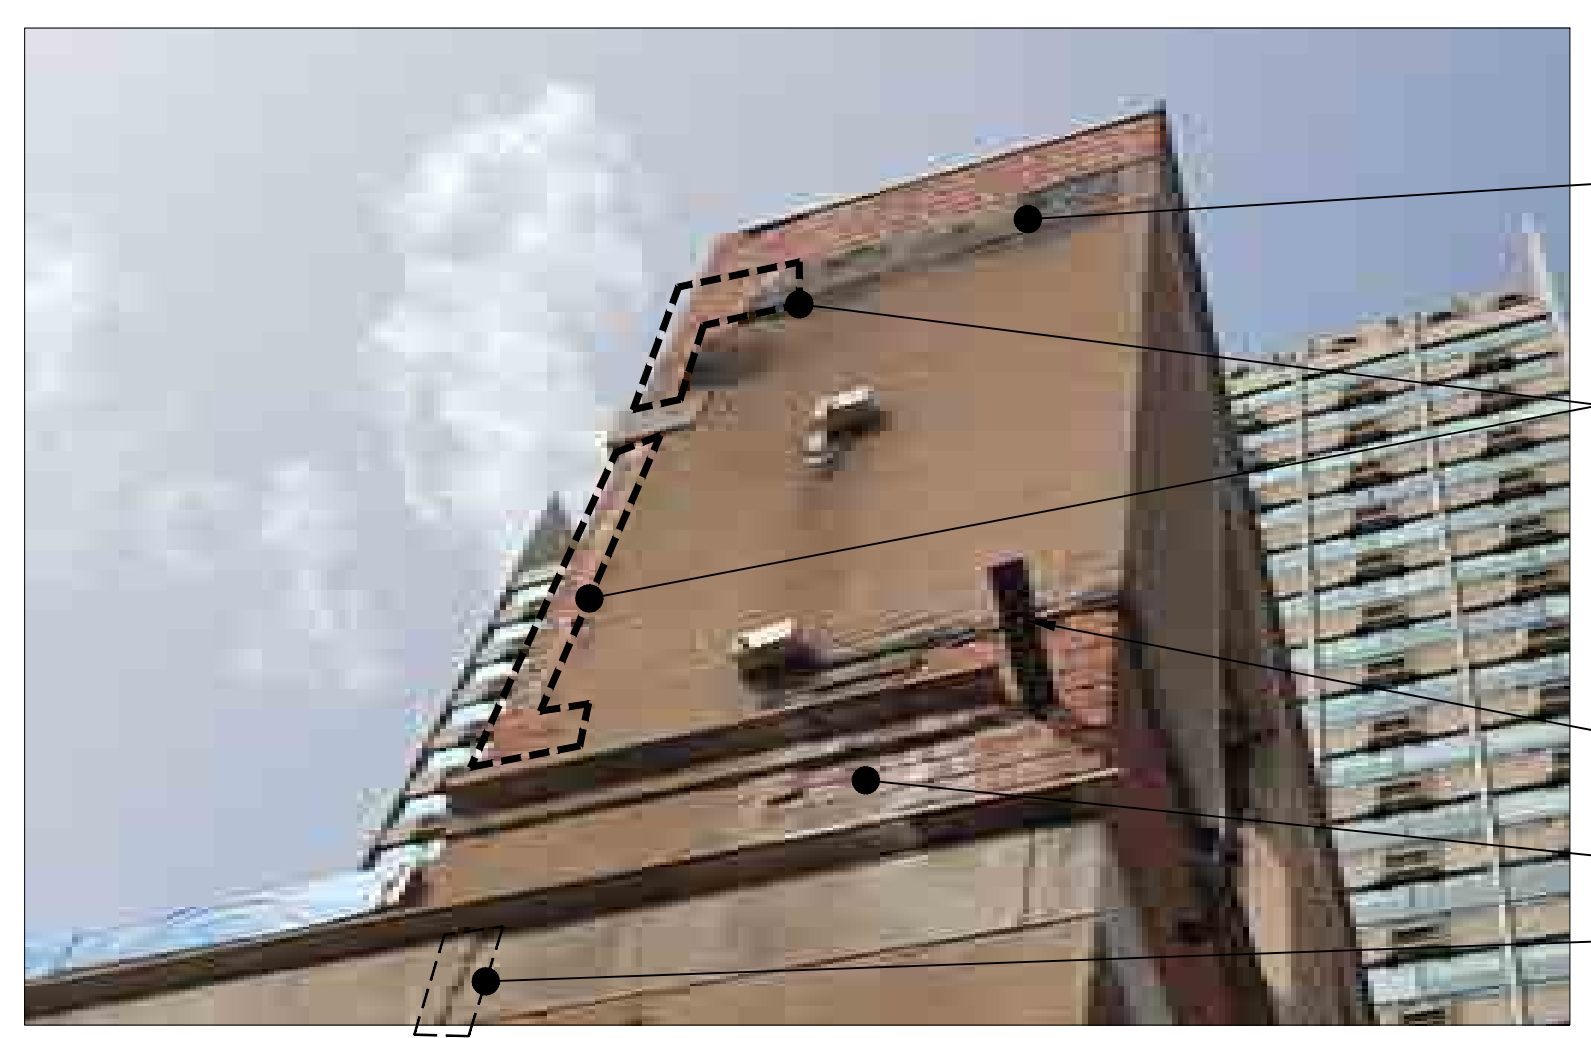
4 SOUTH ELEV. SOILING AND DETERIORATION AT REMAINING WALL
N.T.S
