RECONSTRUCTION PLAN

314 JARVIS STREET

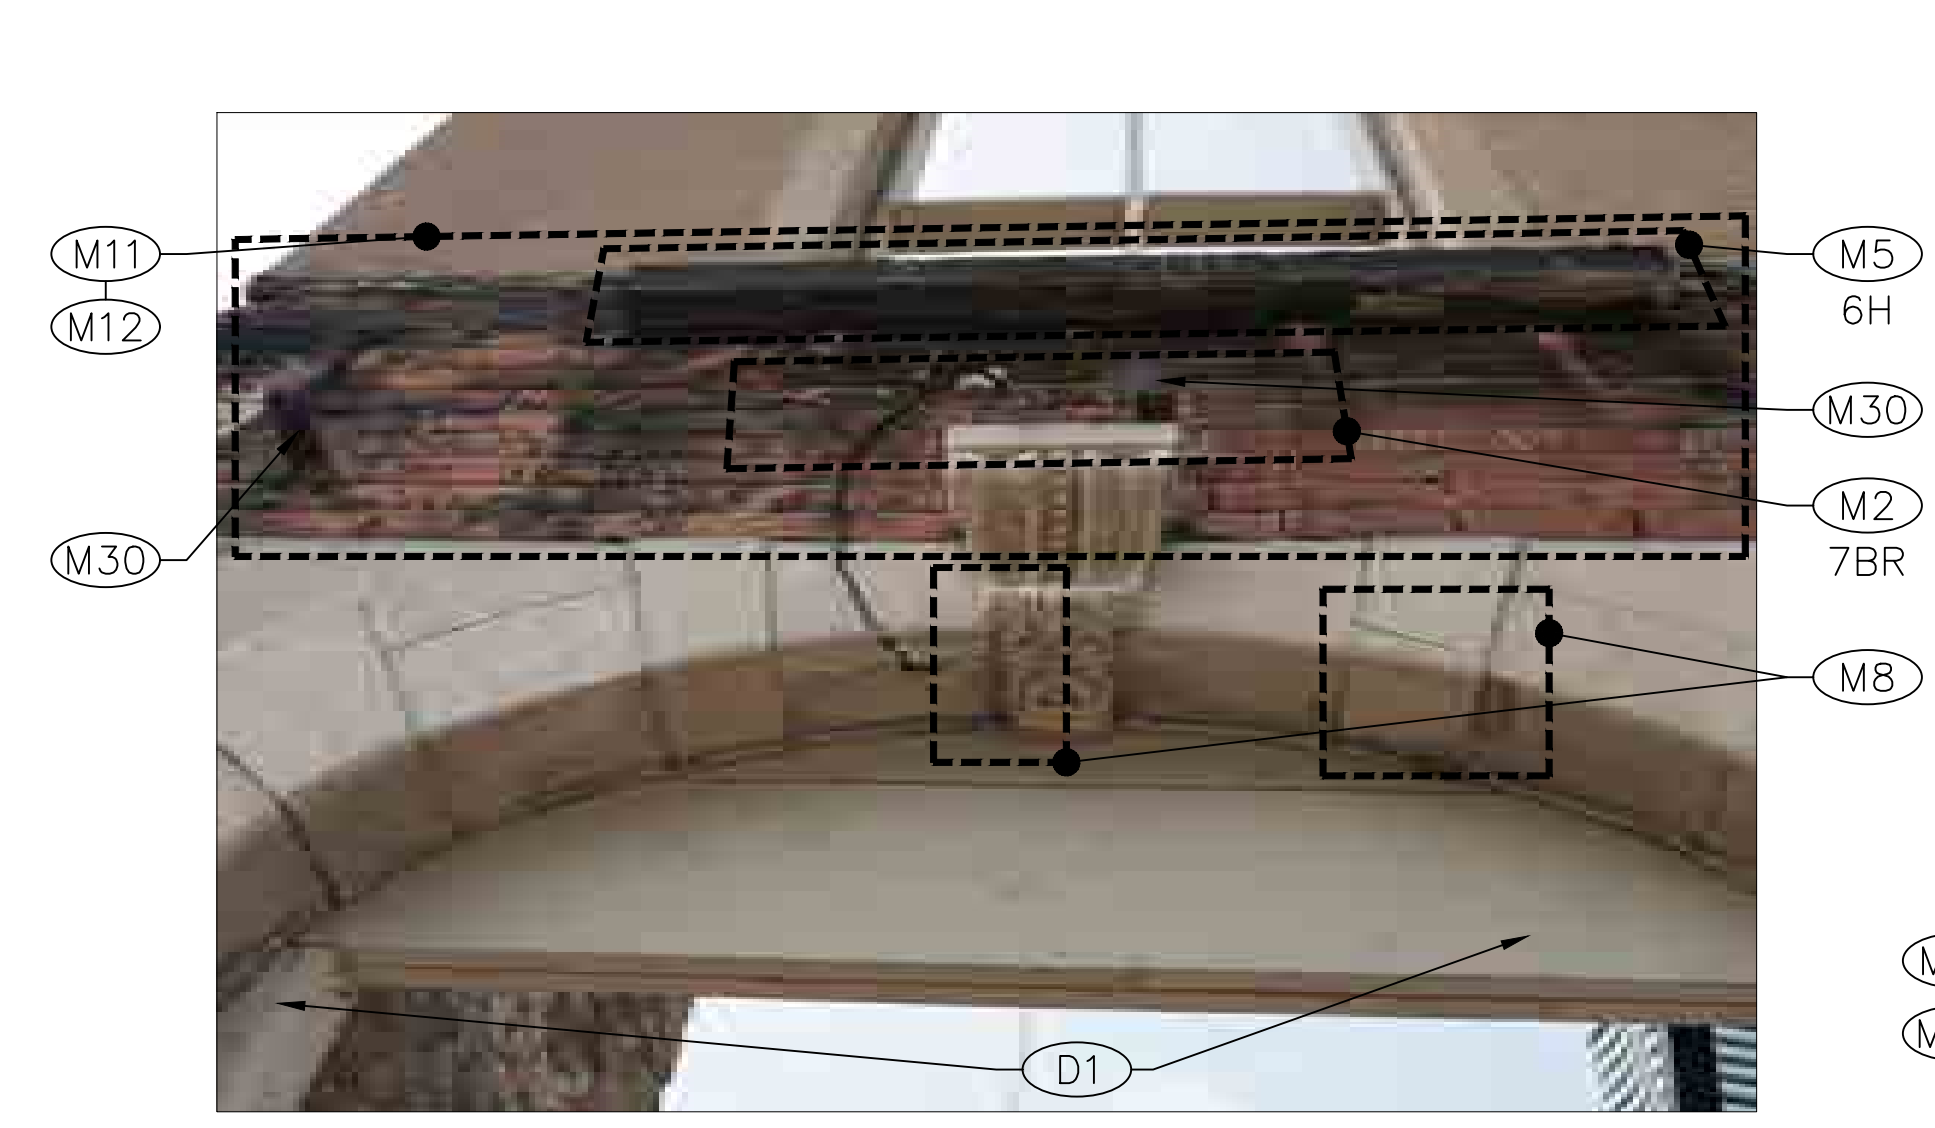
3 EAST ELEV. DETERIORATED MASONRY AT ENTRANCE AREA
N.T.S.

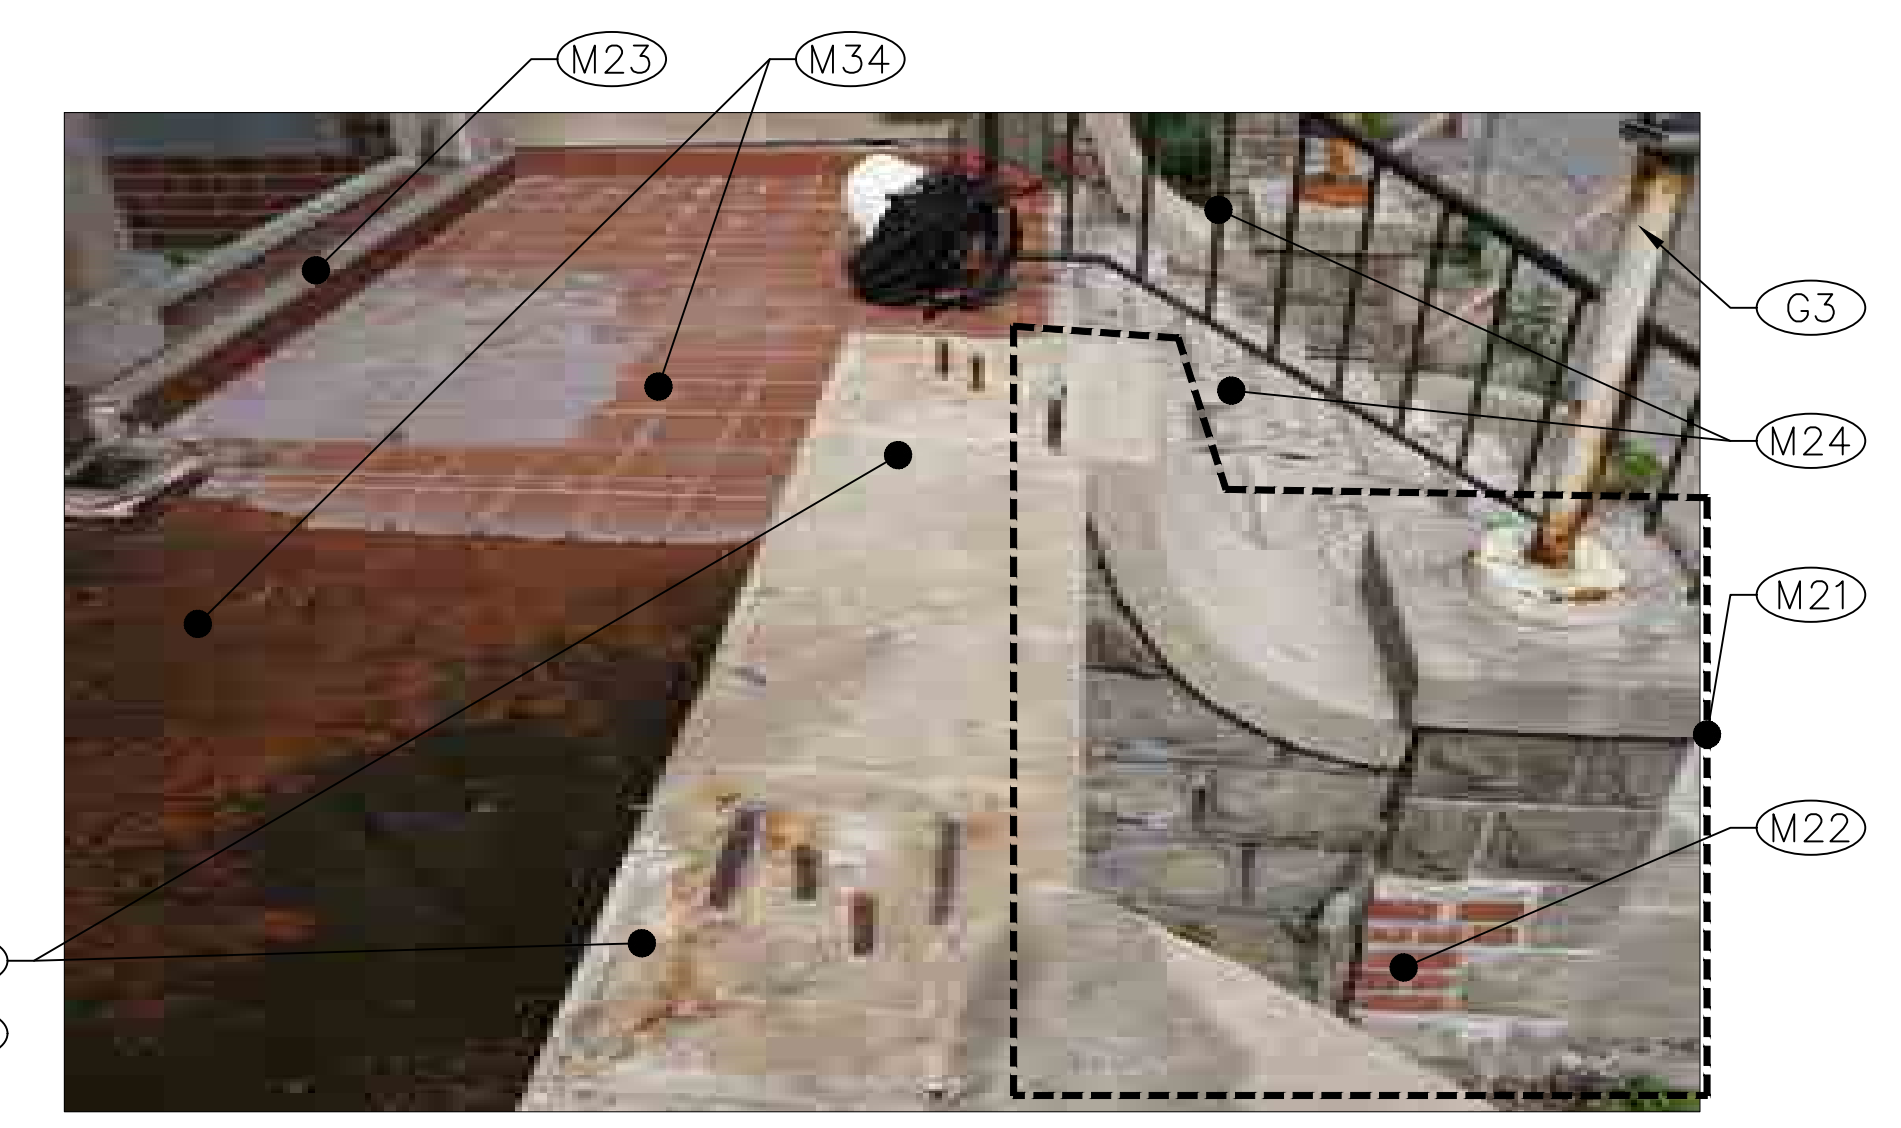
4 EAST ELEV. CURRENT CONDITION AT ENTRANCE PORCH AREA
N.T.S.

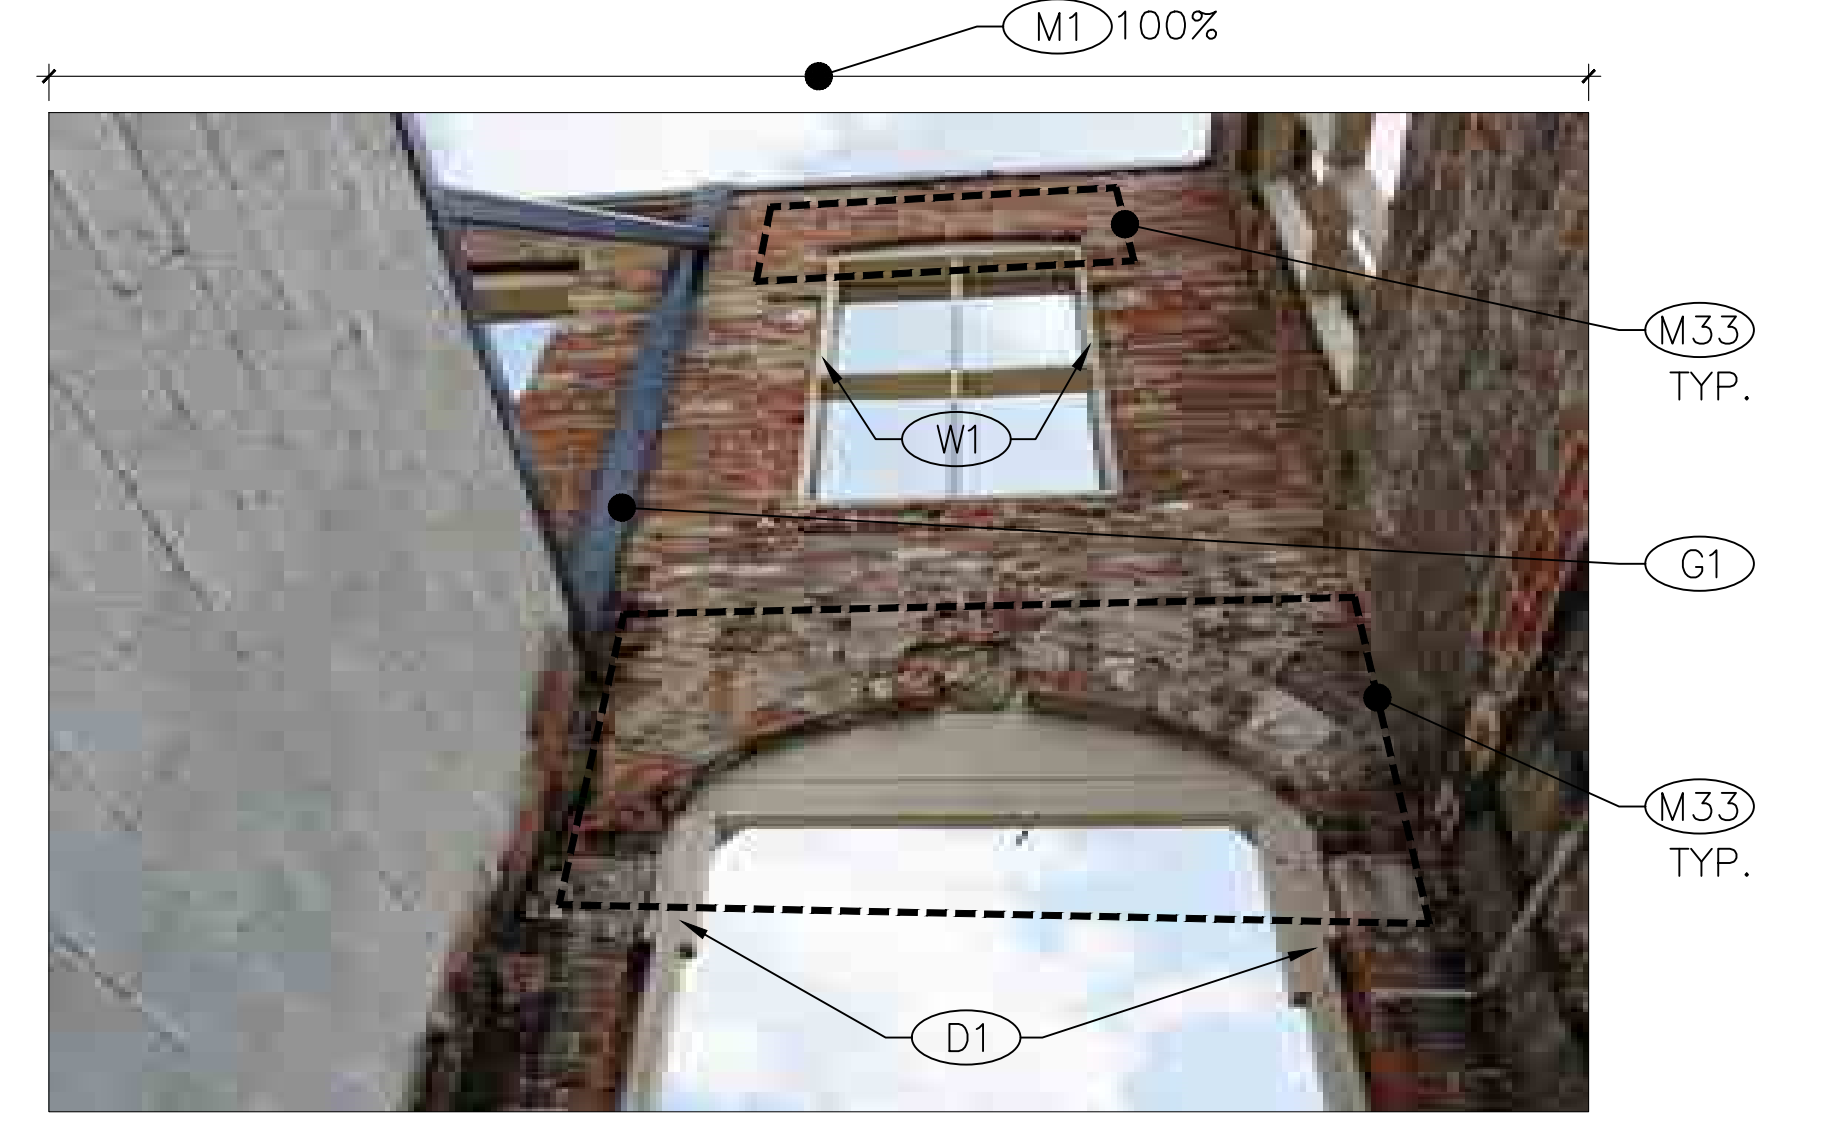
5 EAST ELEV. SHOWING TYPICAL CONDITION AT MASONRY WALL (INTERIOR)
N.T.S.

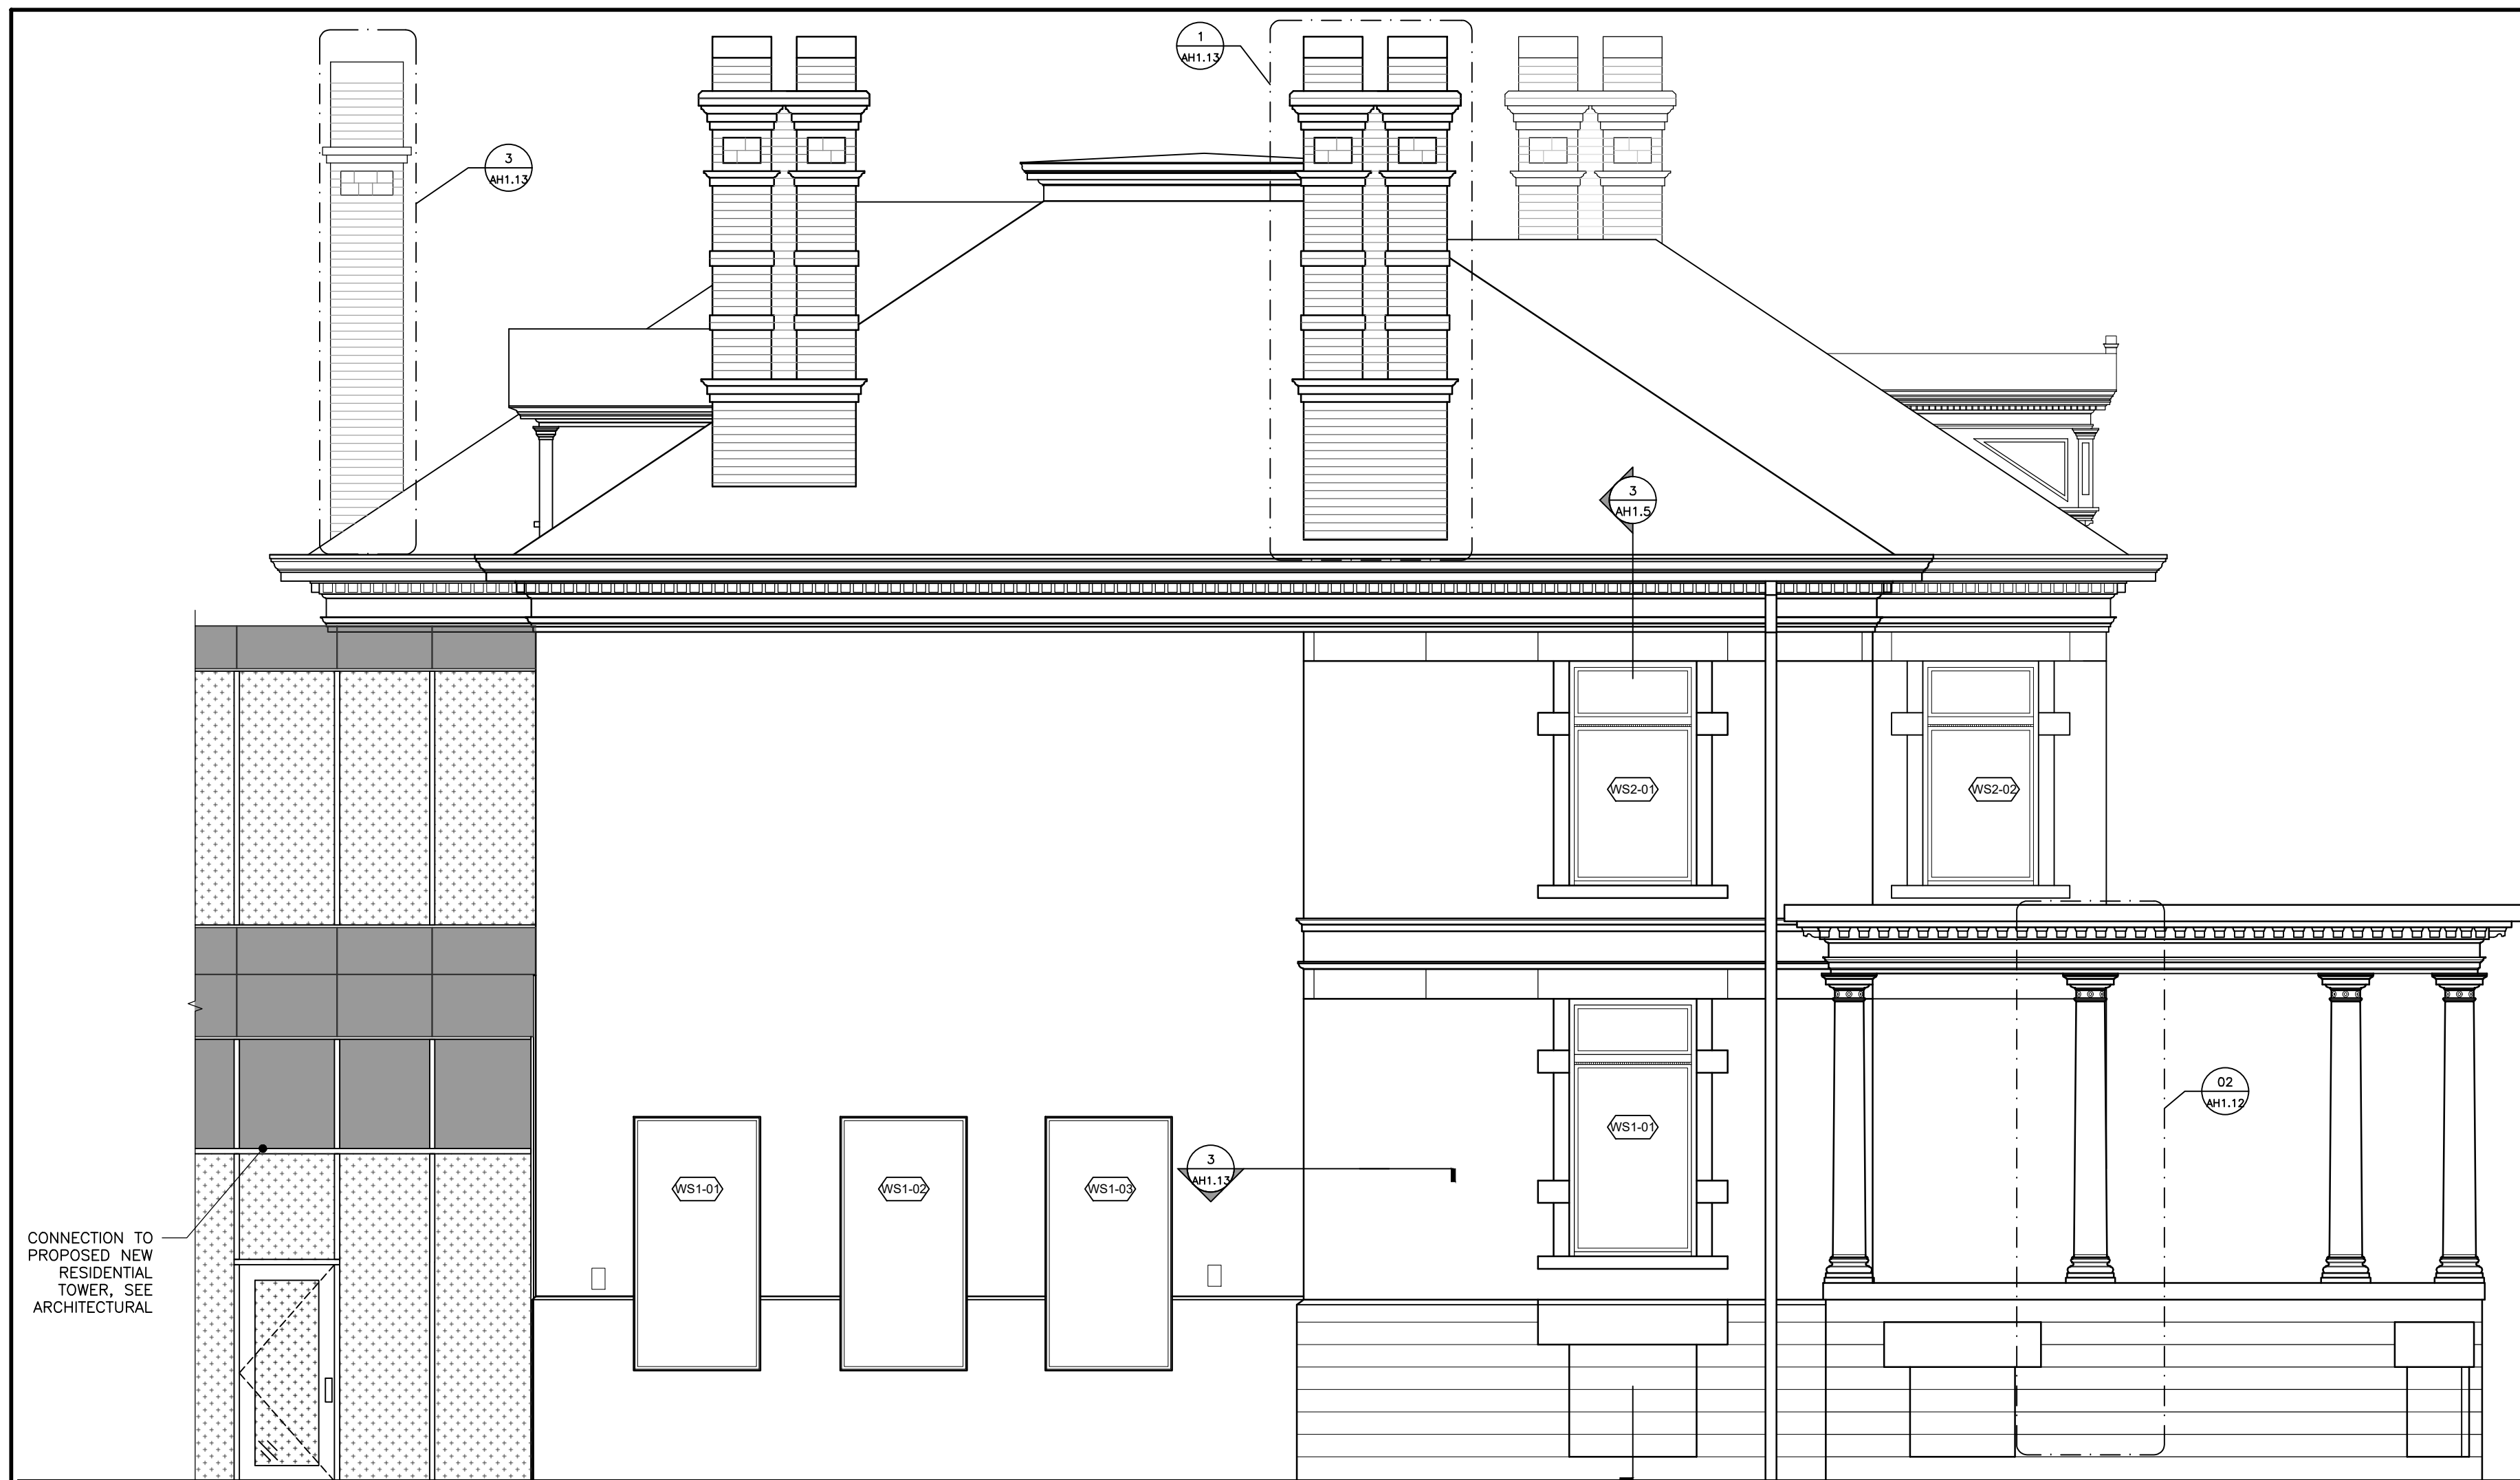
1 SOUTH ELEVATION (314 JARVIS)

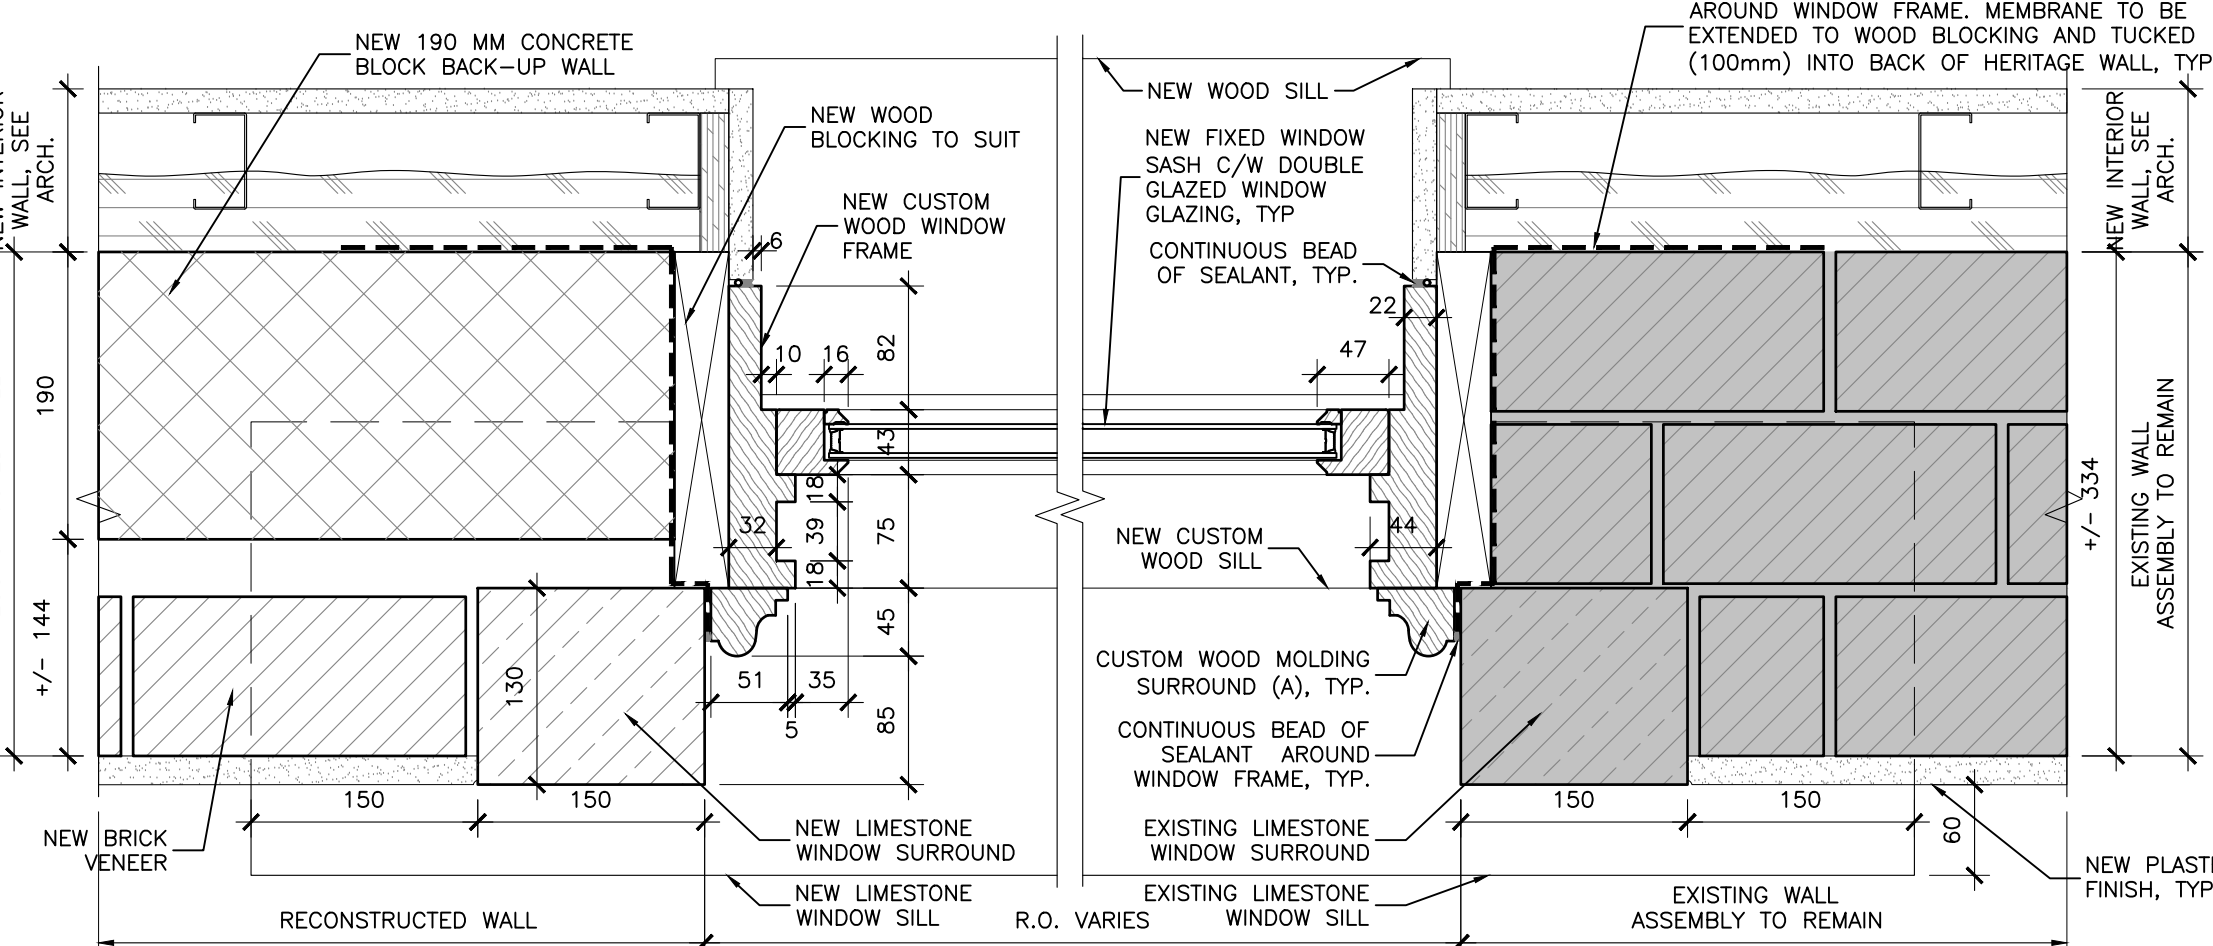
7 NEW WINDOW SECTION - JAMB DETAIL
1:5 (SHOWING RECONSTRUCTED AND EXISTING WALL CONDITIONS)

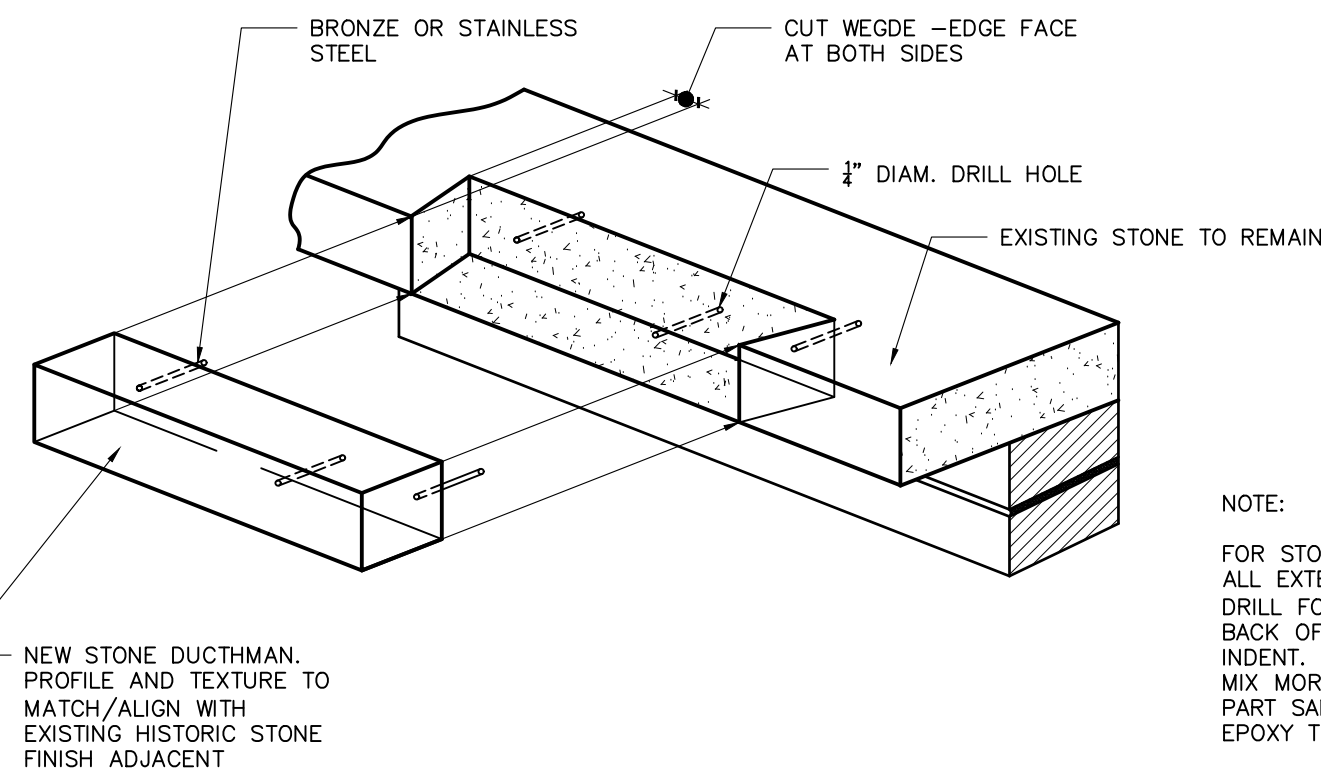
1 TYPICAL REPAIR OF HOLES AT MASONRY

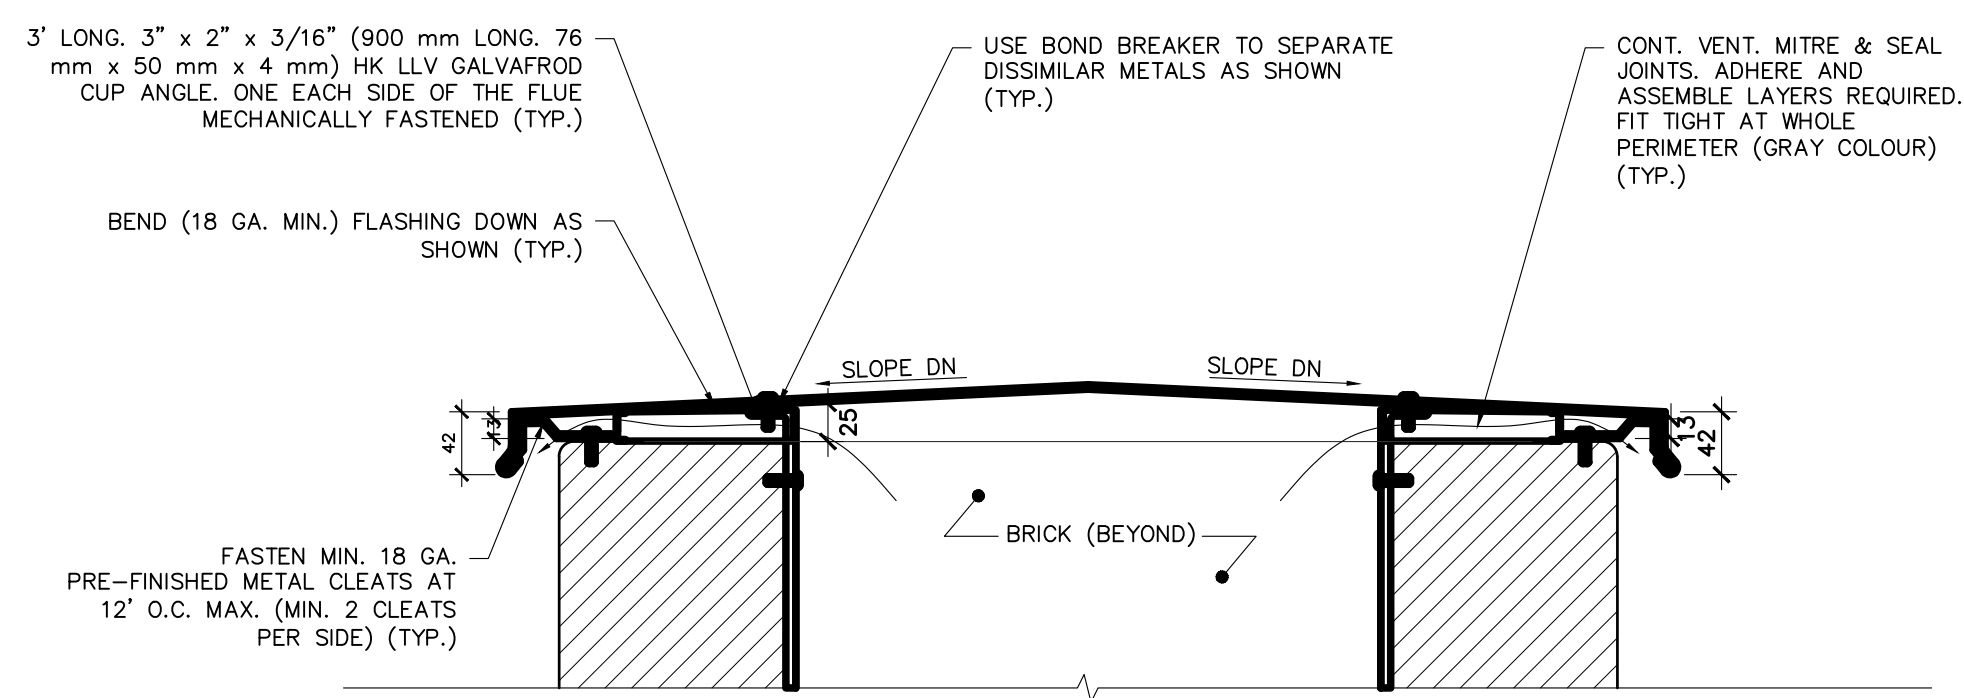
3 TYPICAL CHIMNEY METAL CAP FLASHING DETAIL

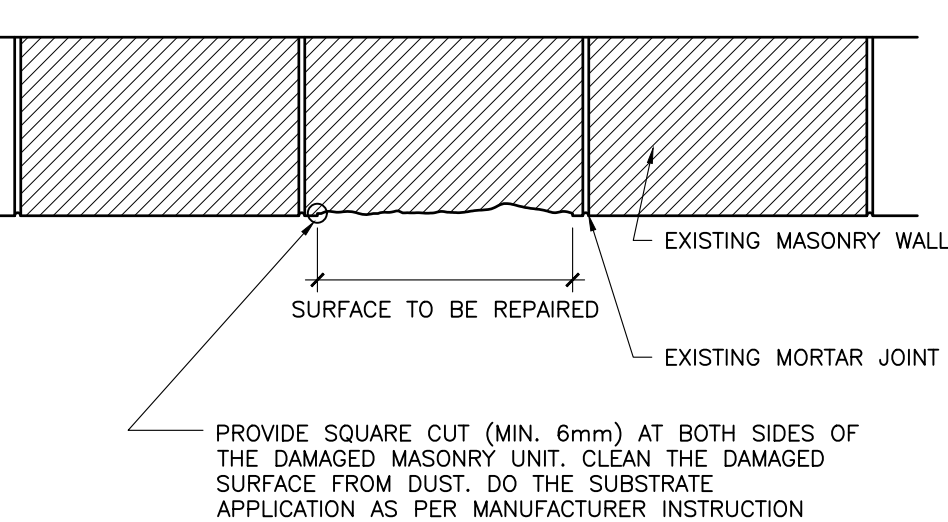
5 TYP. SURFACE REPAIR AT MASONRY

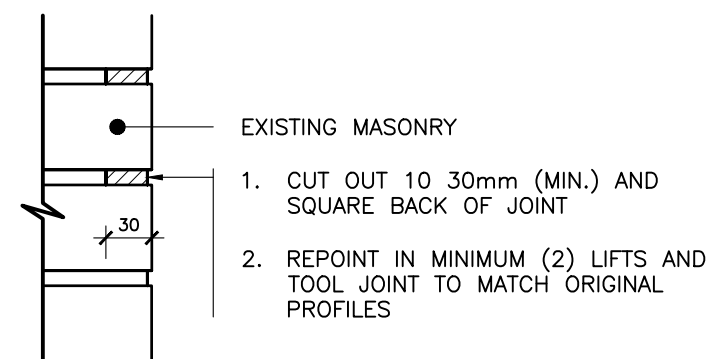
6 TYPICAL REPOINTING DETAIL
