Application to Remove a Private Tree – 149 Blantyre Avenue

Date: April 18, 2024

From: Director, Urban Forestry, Parks, Forestry and Recreation

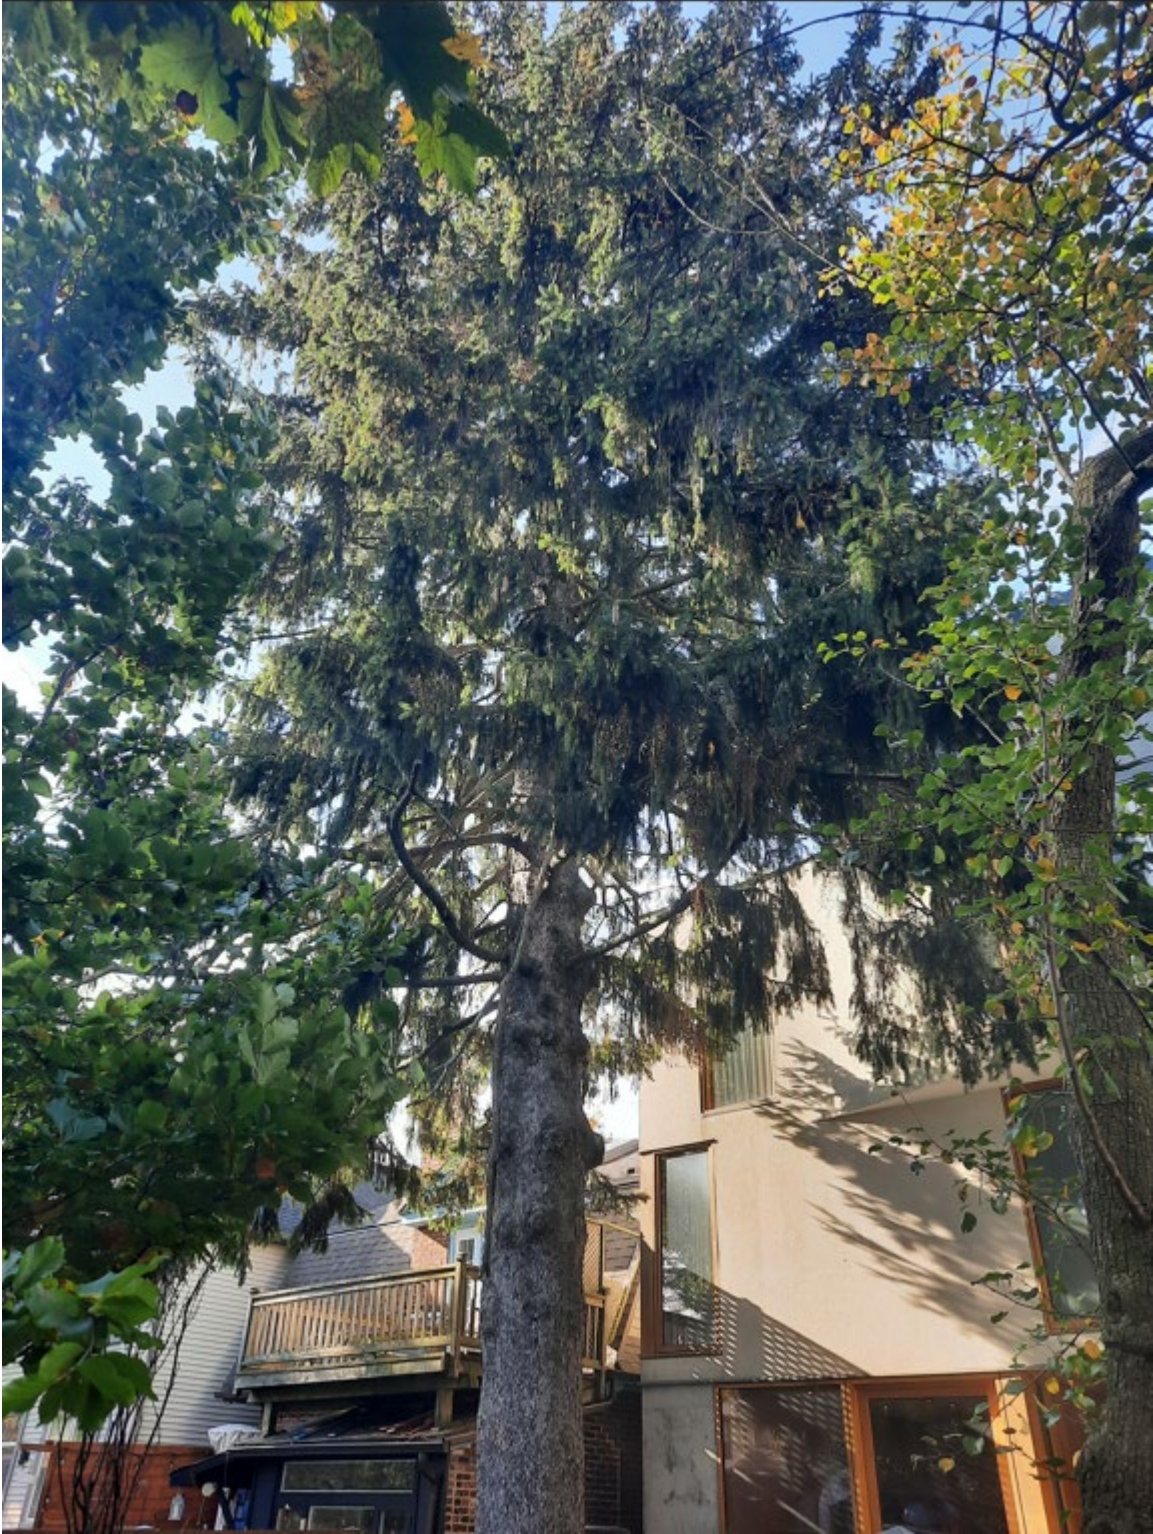
Attachment 1 – Figure 1: Staff photograph of the Norway spruce tree at 149 Blantyre Avenue; October 31, 2023

City staff inspected the tree and at the time of inspection determined that it is healthy and maintainable. Staff noted some minor deadwood and some branches in contact with the building. Only minimal pruning would be required to prevent the branches from touching the house; all the branches below the height of the building do not have to be removed. Preventing branches from touching the building and the presence of dead wood are issues that can be addressed through pruning in accordance with good arboricultural practices and the performance of routine tree maintenance.

As part of the inspection, staff identified that the sap flow observed on the trunk is typical to the species and was not assessed to be a critical defect. Staff also assessed that there are no visible signs of decay to the trunk that would make it more prone to failure. A common indication of potential failure due to strong winds can be a heaving root plate. At the time of inspection staff noted that the root system appears structurally sound without any heaving. The proximity of the building also provides the subject tree with additional shelter from strong winds.

This tree's apparent lean is a phototropic growth pattern that exists because the tree has been competing for sunlight with a nearby building. Phototropism is a natural growth pattern whereby plants grow toward available light. A minor lean typically does not affect the stability of a tree. Trees adapt to minor leans through various mechanisms such as root growth adjustment or trunk thickening to maintain their stability.
