Application to Remove a Private Tree – 114 Marcos Boulevard

Date: April 16, 2024

From: Director, Urban Forestry, Parks, Forestry and Recreation

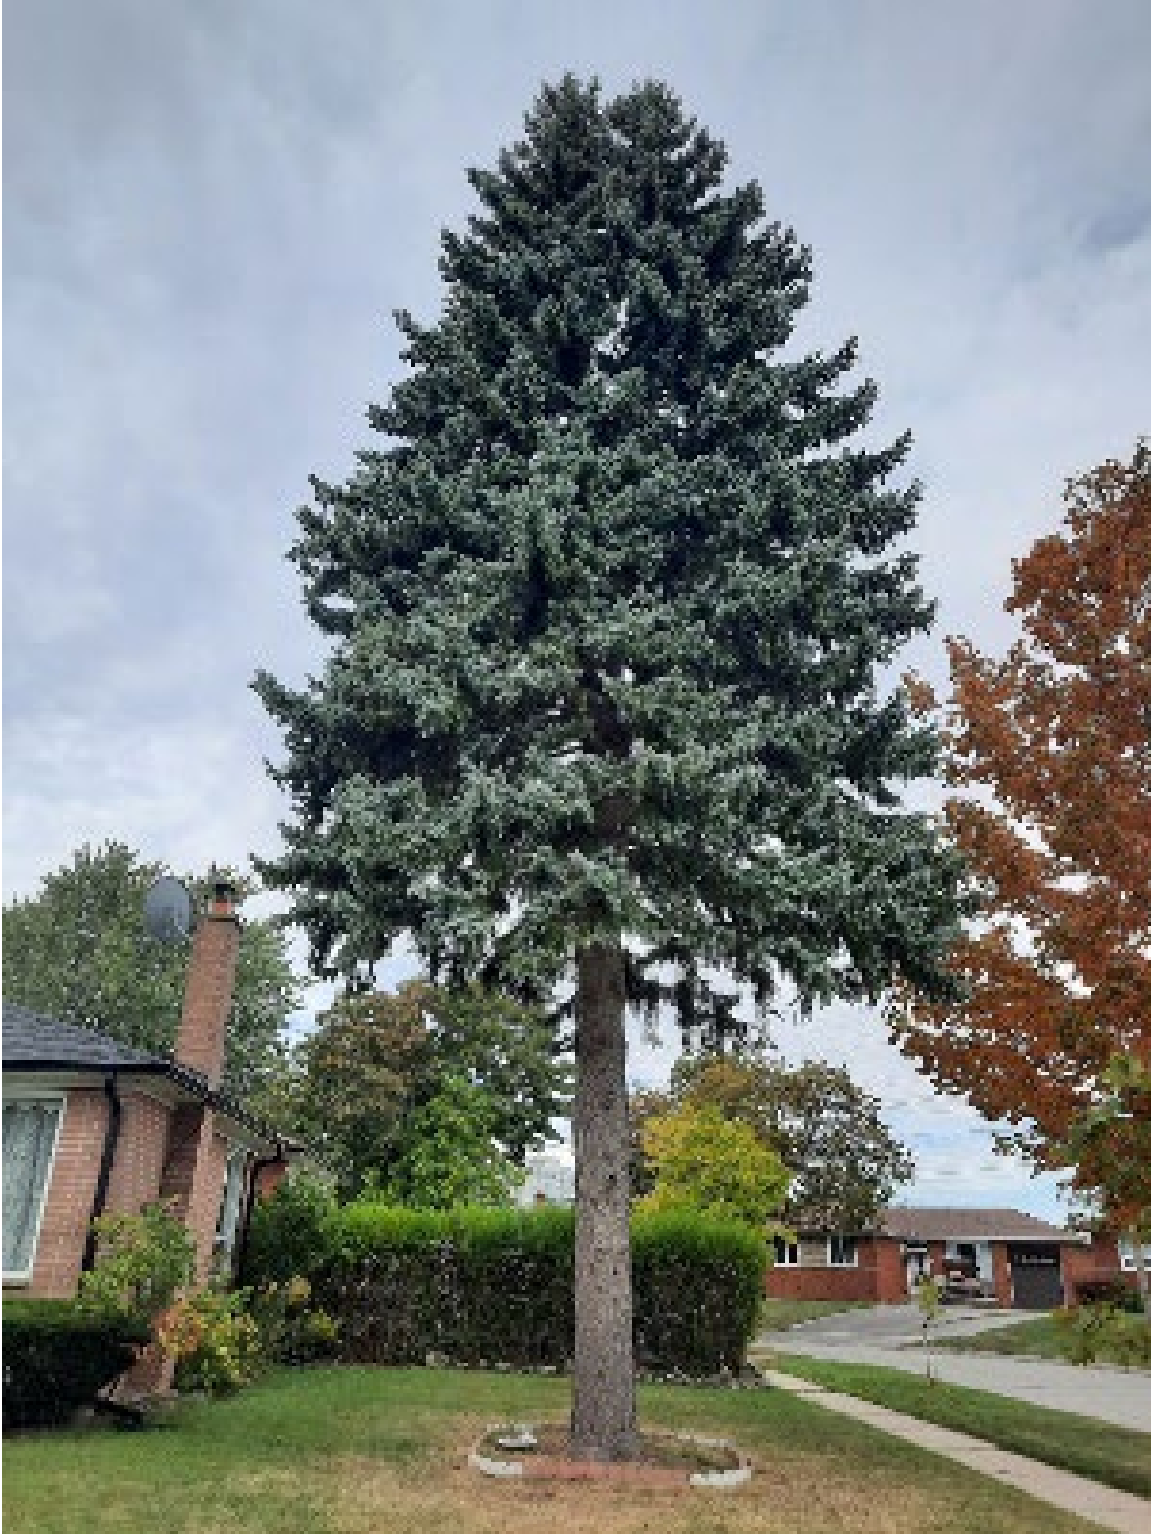
Attachment 1 – Figure 1: Staff photograph of the Colorado blue spruce tree at 114 Marcos Boulevard; September 28, 2023

City staff inspected the tree and at the time of inspection determined that the tree is healthy and maintainable. City staff did not assess an increased susceptibility to wind damage and therefore subsequent failure as a result of lower branches being removed in the past. The lean observed is not impacting the structural integrity of the tree. The root system appears healthy and has grown to support the slight lean. There is no evidence of heaving of structural roots or other root damage that would be indicative of potential tree failure.

Staff observed that the tree has a codominant leader and a canker on the trunk of the tree, but assessed that neither are critical to the structural and botanical viability of the tree. While water sprouts can be an indication of stress, no evidence of decay was observed in relation to this growth. Staff perform visual ground level inspections of trees and cannot confirm the presence of sprouts in the upper canopy.
