EXISTING SITE CONDITIONS

Existing Site Conditions : Trails

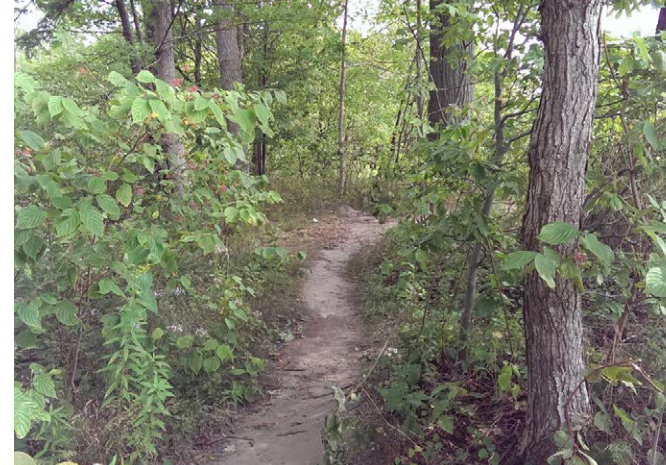
The conditions of the trails vary, but the unsanctioned trails exhibit the highest degree of degradation, in part due to ongoing erosion of the bluffs.

2 Informal natural surface trails along the top of bluffs

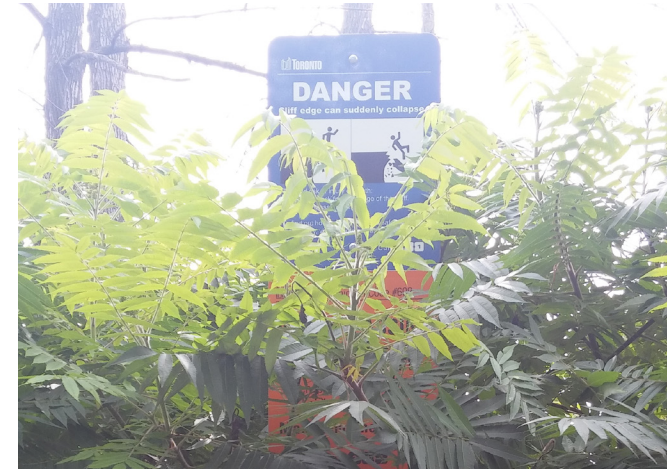
In some instances a lack of vegetation maintenance has lead to the obstruction of safety signage. The effectiveness of the current signage strategy is limited, especially regarding discouraging access to the bluff edge.

2 Bluff edge warning signage obscured by overgrown vegetation

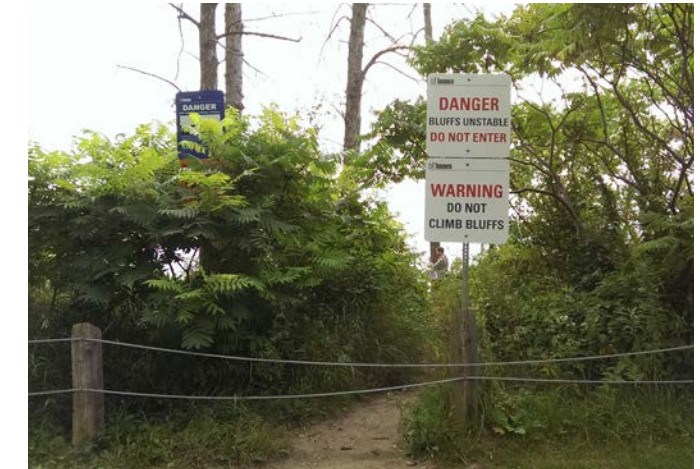
3 Warning signage ineffective at eliminating unsafe access to the bluff edge

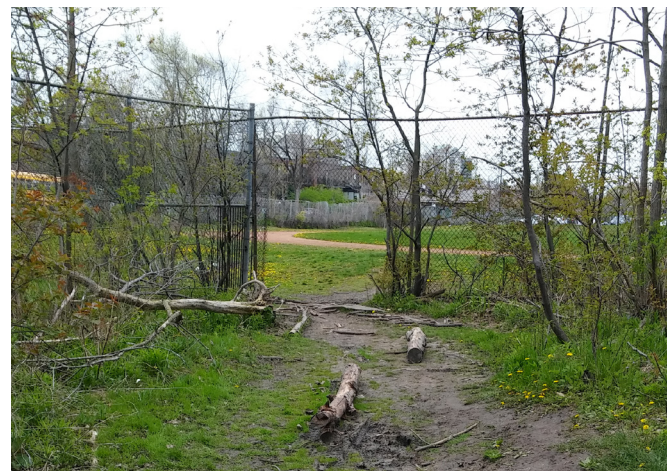
The site has one informal entrance point, a gap in the chain link fence along the southern property line of the neighbouring Sir Wilfrid Laurier Collegiate Institute.

1 Informal access point in fence of adjacent school

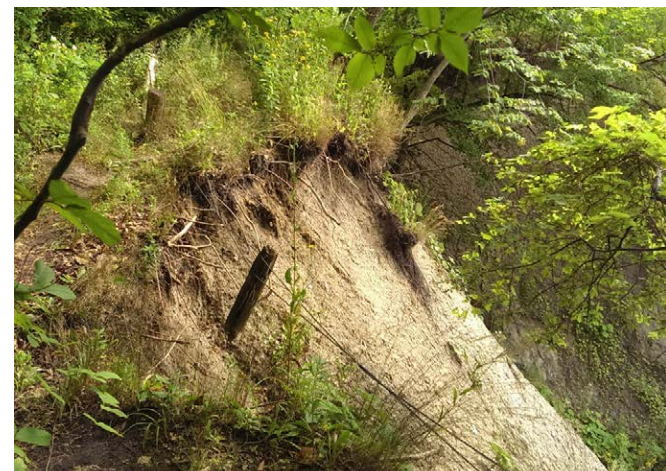
2 Undermined fence posts resulting from ongoing bluff erosion

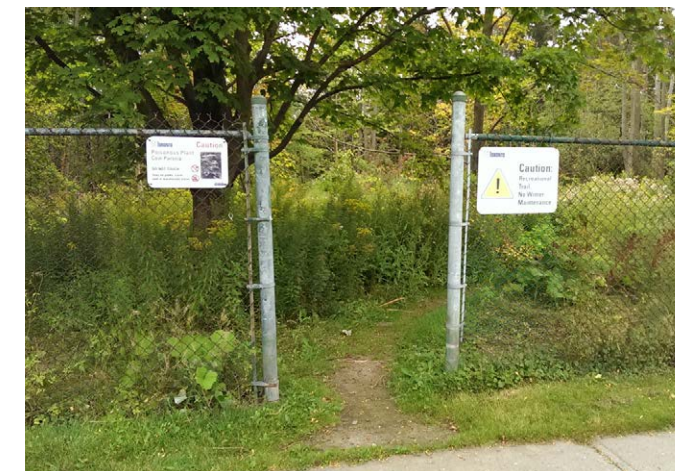
3 Uninspired entrance to wooded area trail

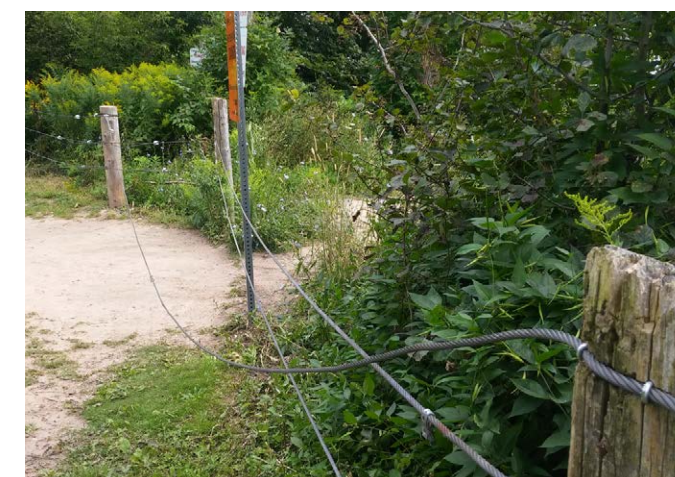
6 Damaged fencing along the top of bluffs

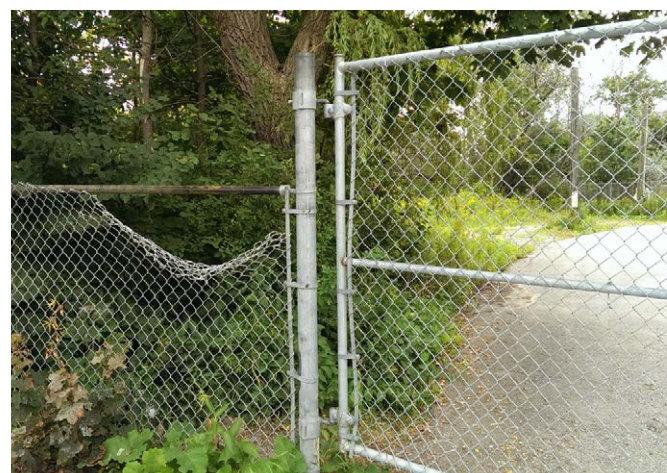
Entry onto the construction access route is controlled by a chain link gate. This gate is often closed and locked, restricting access to the road to the trail from the East Trail Area parking lot, and the switchback trail. Some visitors scale the fence to bypass the locked gate, which poses a safety risk.

7 Construction access route gate. Gate is typically locked but visitors have climbed the fence for access

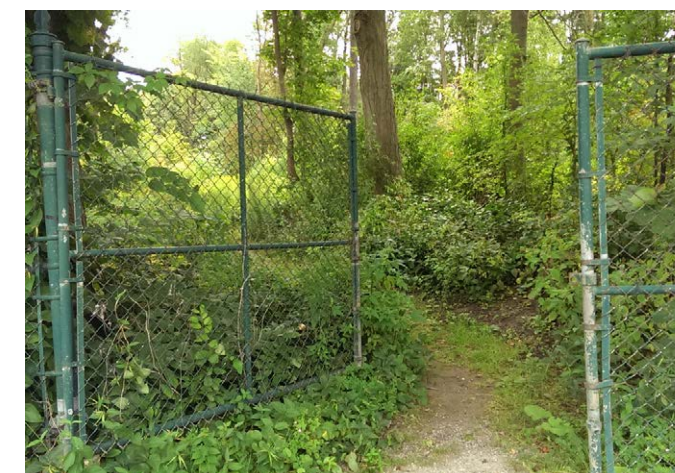
9 Unlocked gate to access East Trail Area from sidewalk

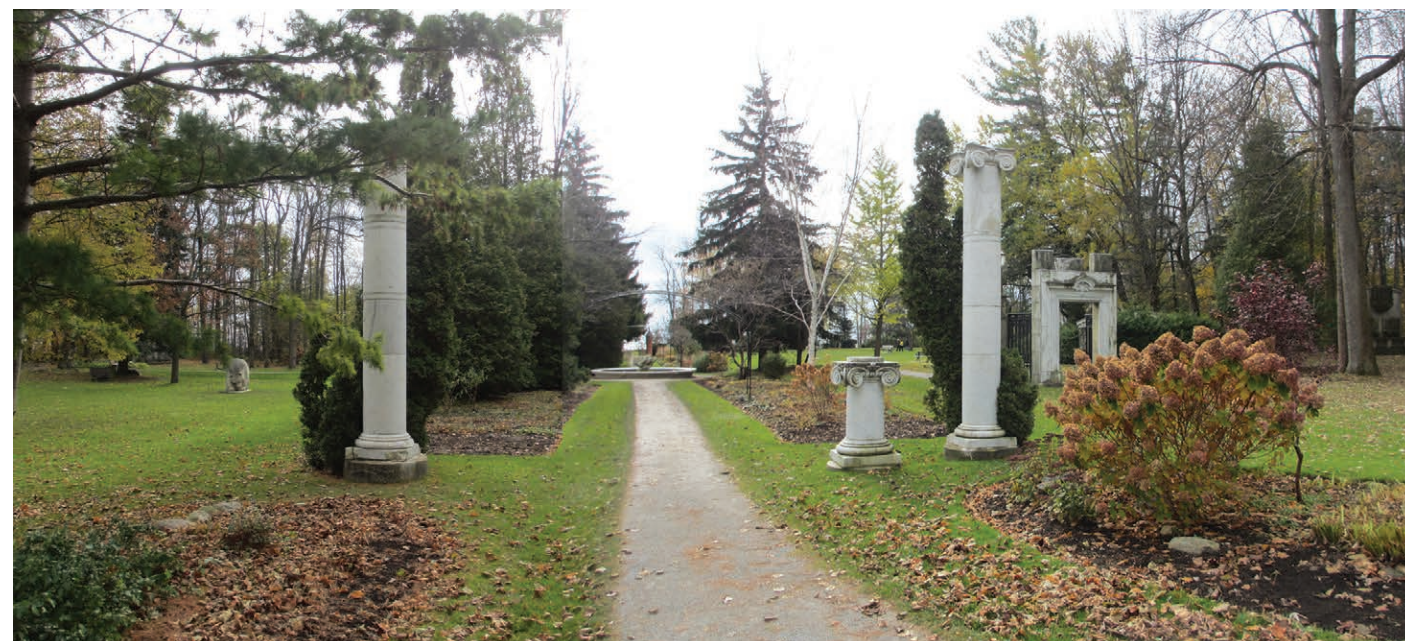
EXISTING - Primary view and path to lake - today. View to the lake is partially obstructed by plant material.

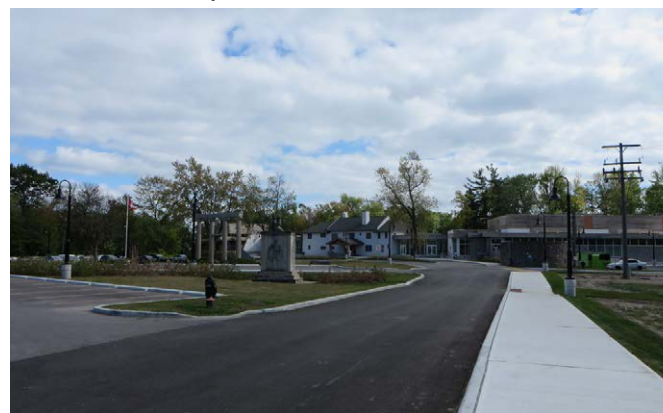
EXISTING - View from main entrance gate to Guild Inn building - today. Entry sequence of estate landscape structure has been compromised.

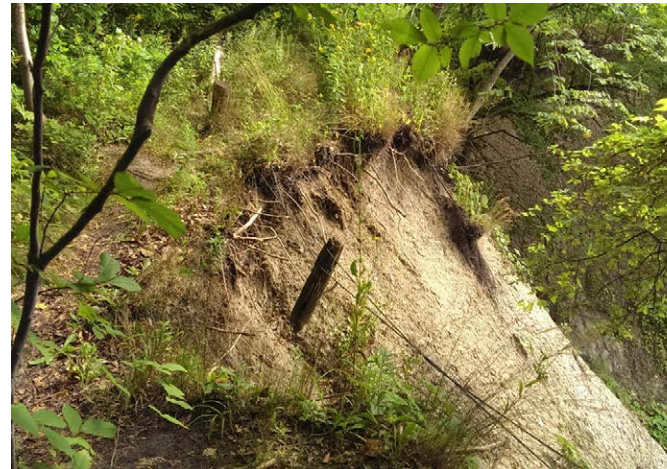
1 Unstable and eroding top of bluff edge

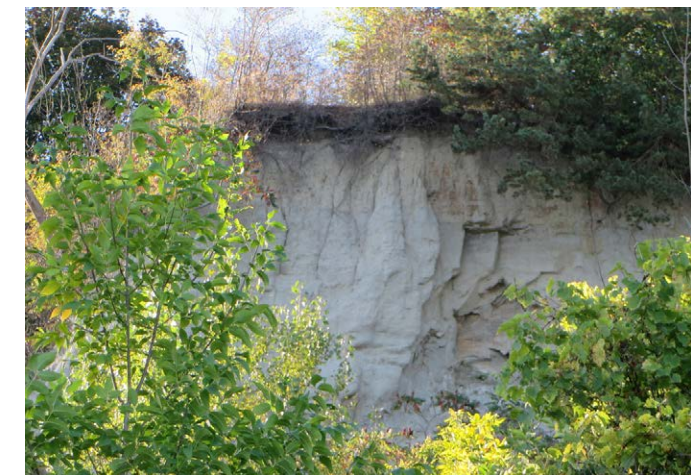
6 Steep and unstable bluff slopes

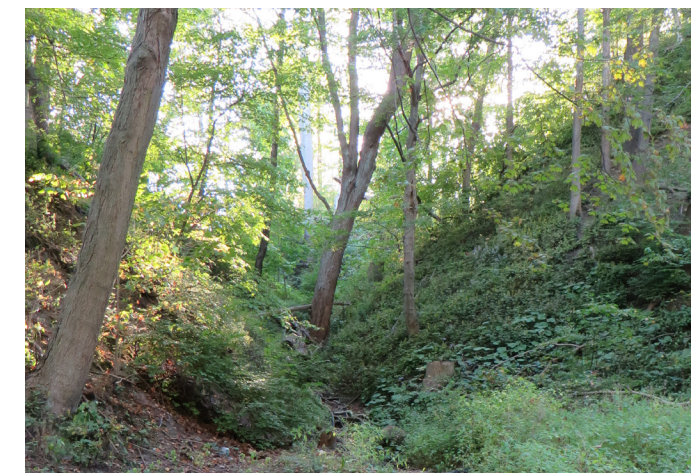
9 Steep slopes along the construction access route
