TREE INVENTORY AND ASSESSMENT REPORT

North York Centre South South Service Road Class Environmental Assessment Study

Schollen & Company Inc.

Date: October 30, 2013

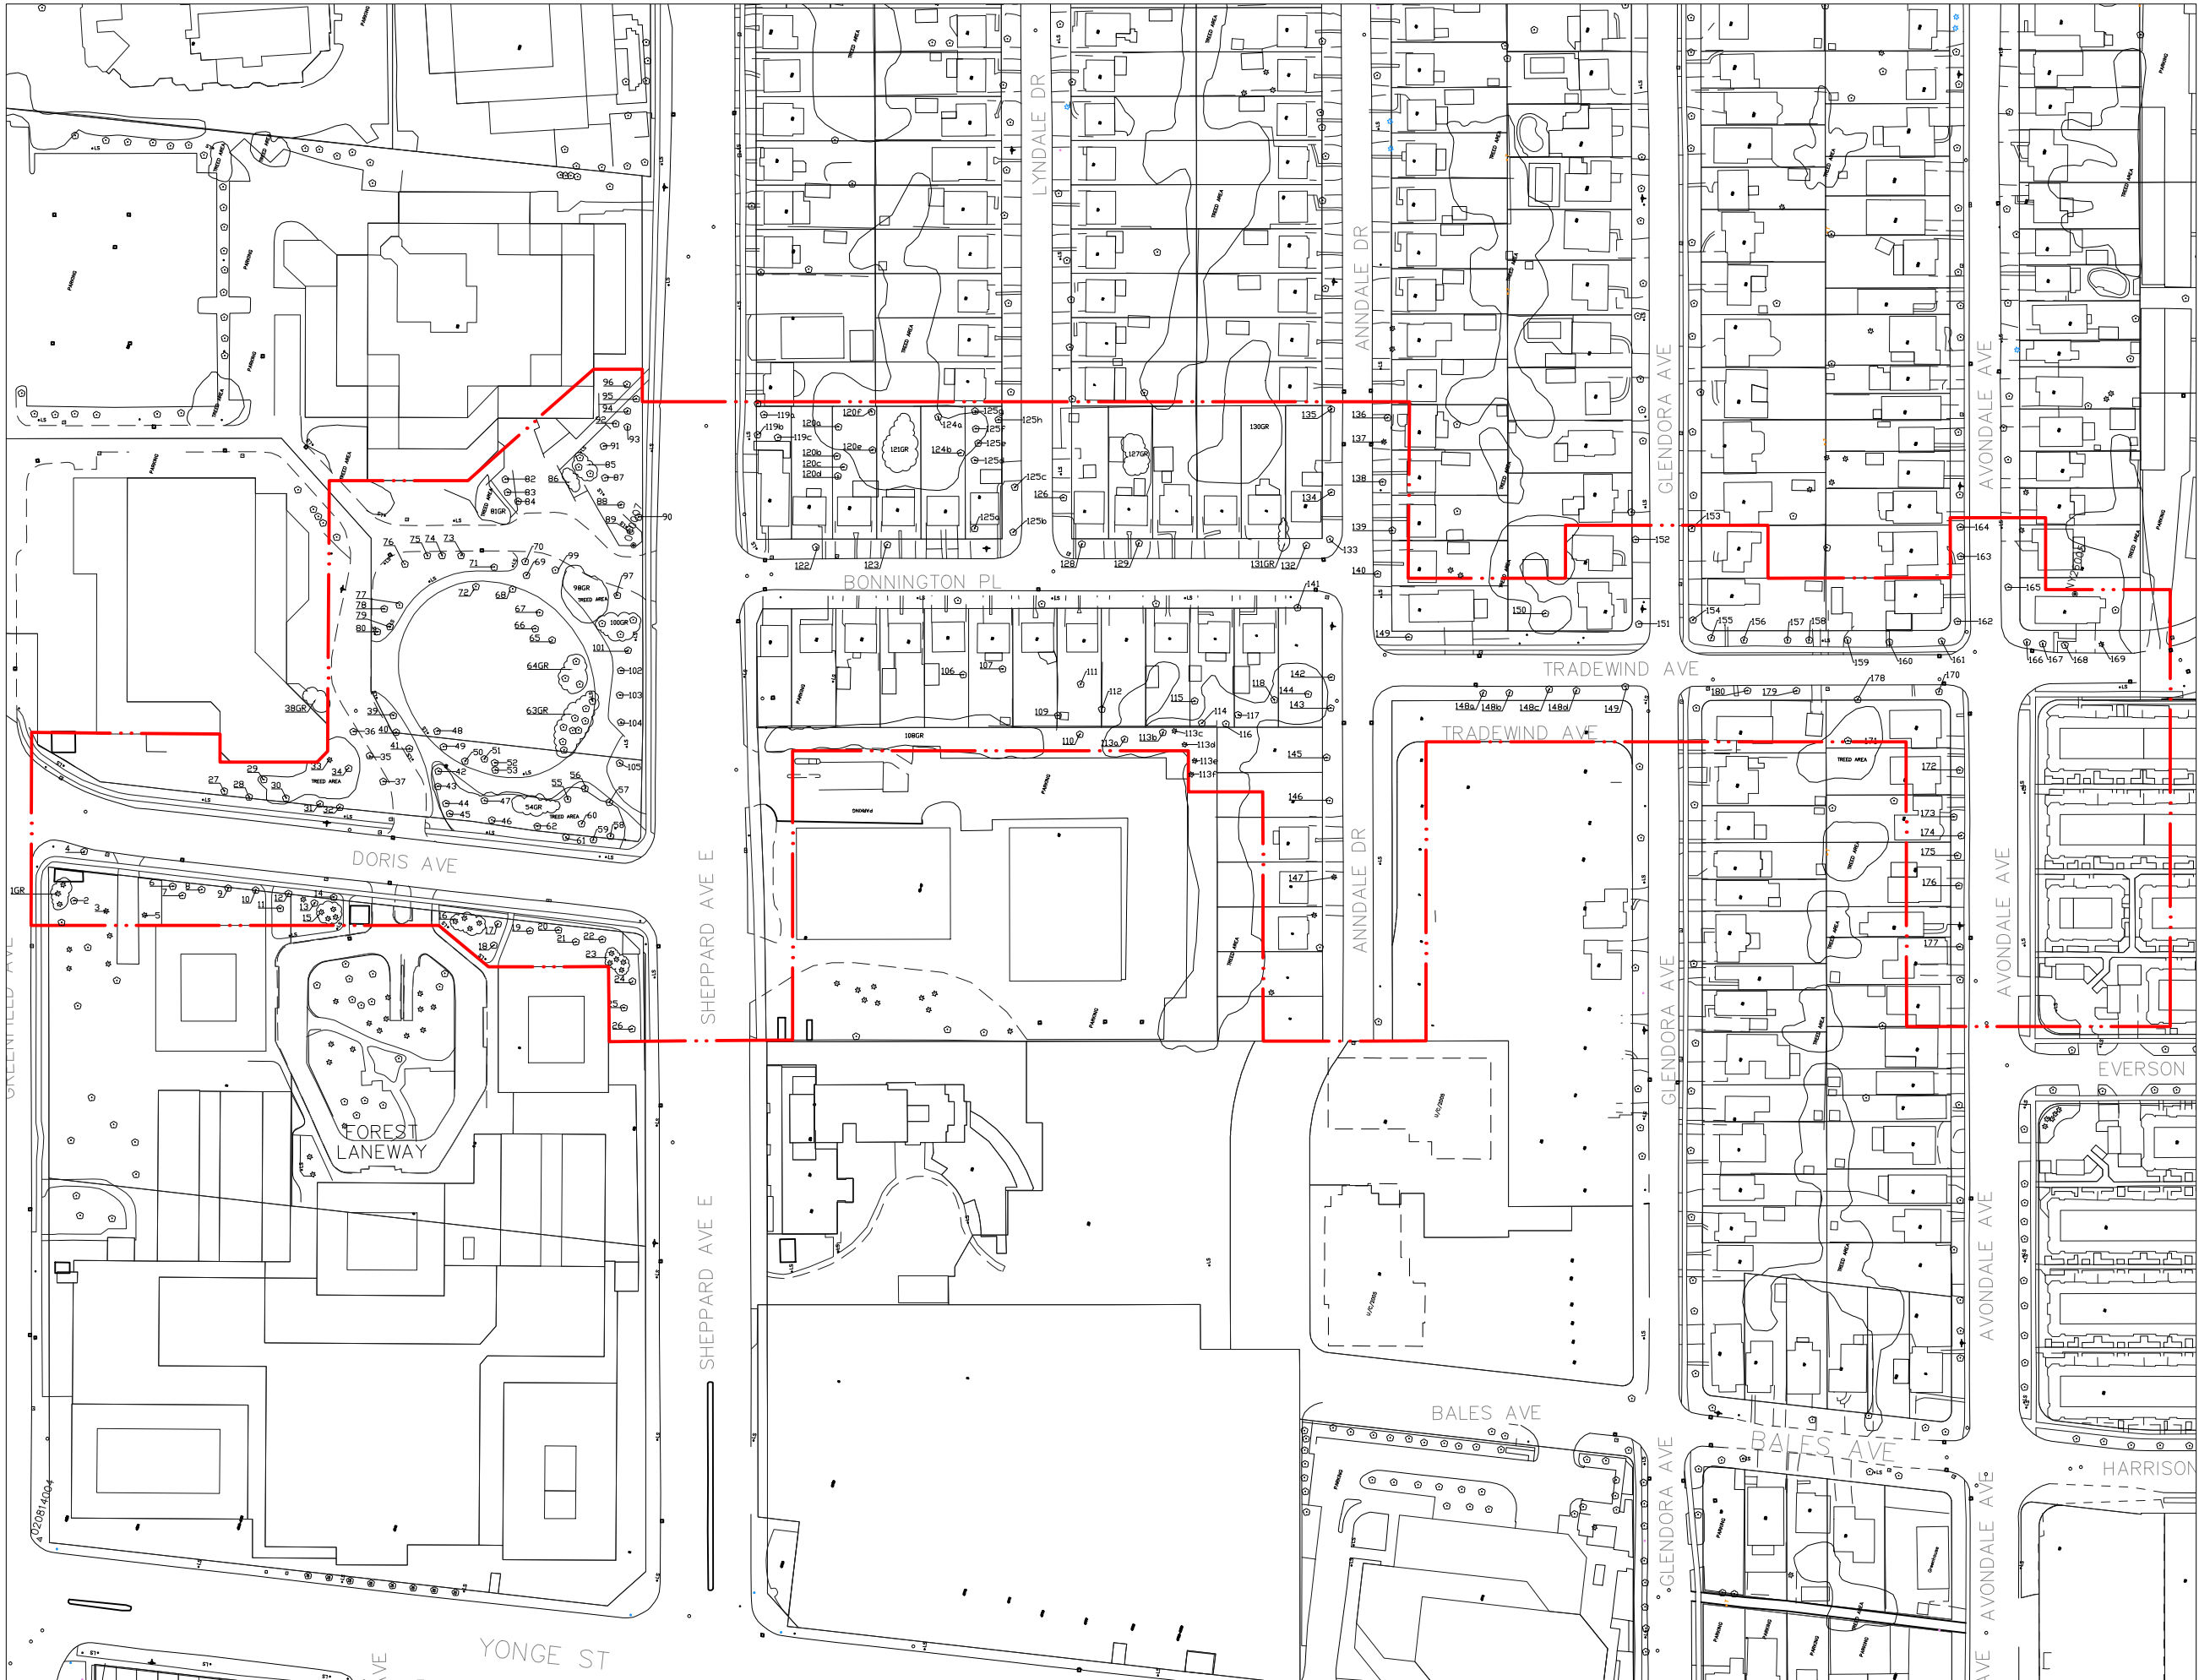
TOWN REVIEWED	D-1
Town No

Table 1 and Drawings D-1 and D-2 combined provide a detailed description of the location, species composition, size and condition of each tree and group of trees inventoried. The open space parkland, south of the School Board Building on the east side of Doris Avenue and the residences along the west side of Bonnington Place were a prime focus of the inventory due to the potential to be the most affected by the future service road.

Table 1 provides an itemized summary of the findings of the inventory exercise. Drawing D-1 illustrates the number and location of all trees inventoried. A 1:500 scale version of Drawing D-1 is included with this report.
