GERMAN MILLS CREEK GEOMORPHIC SYSTEMS MASTER PLAN MONITORING REPORT APPENDIX E

GERMAN MILLS CREEK GEOMORPHIC SYSTEMS MASTER PLAN SHORT-TERM EROSION MONITORING REPORT

GERMAN MILLS CREEK GEOMORPHIC SYSTEMS MASTER PLAN

SHORT TERM EROSION MONITORING REPORT

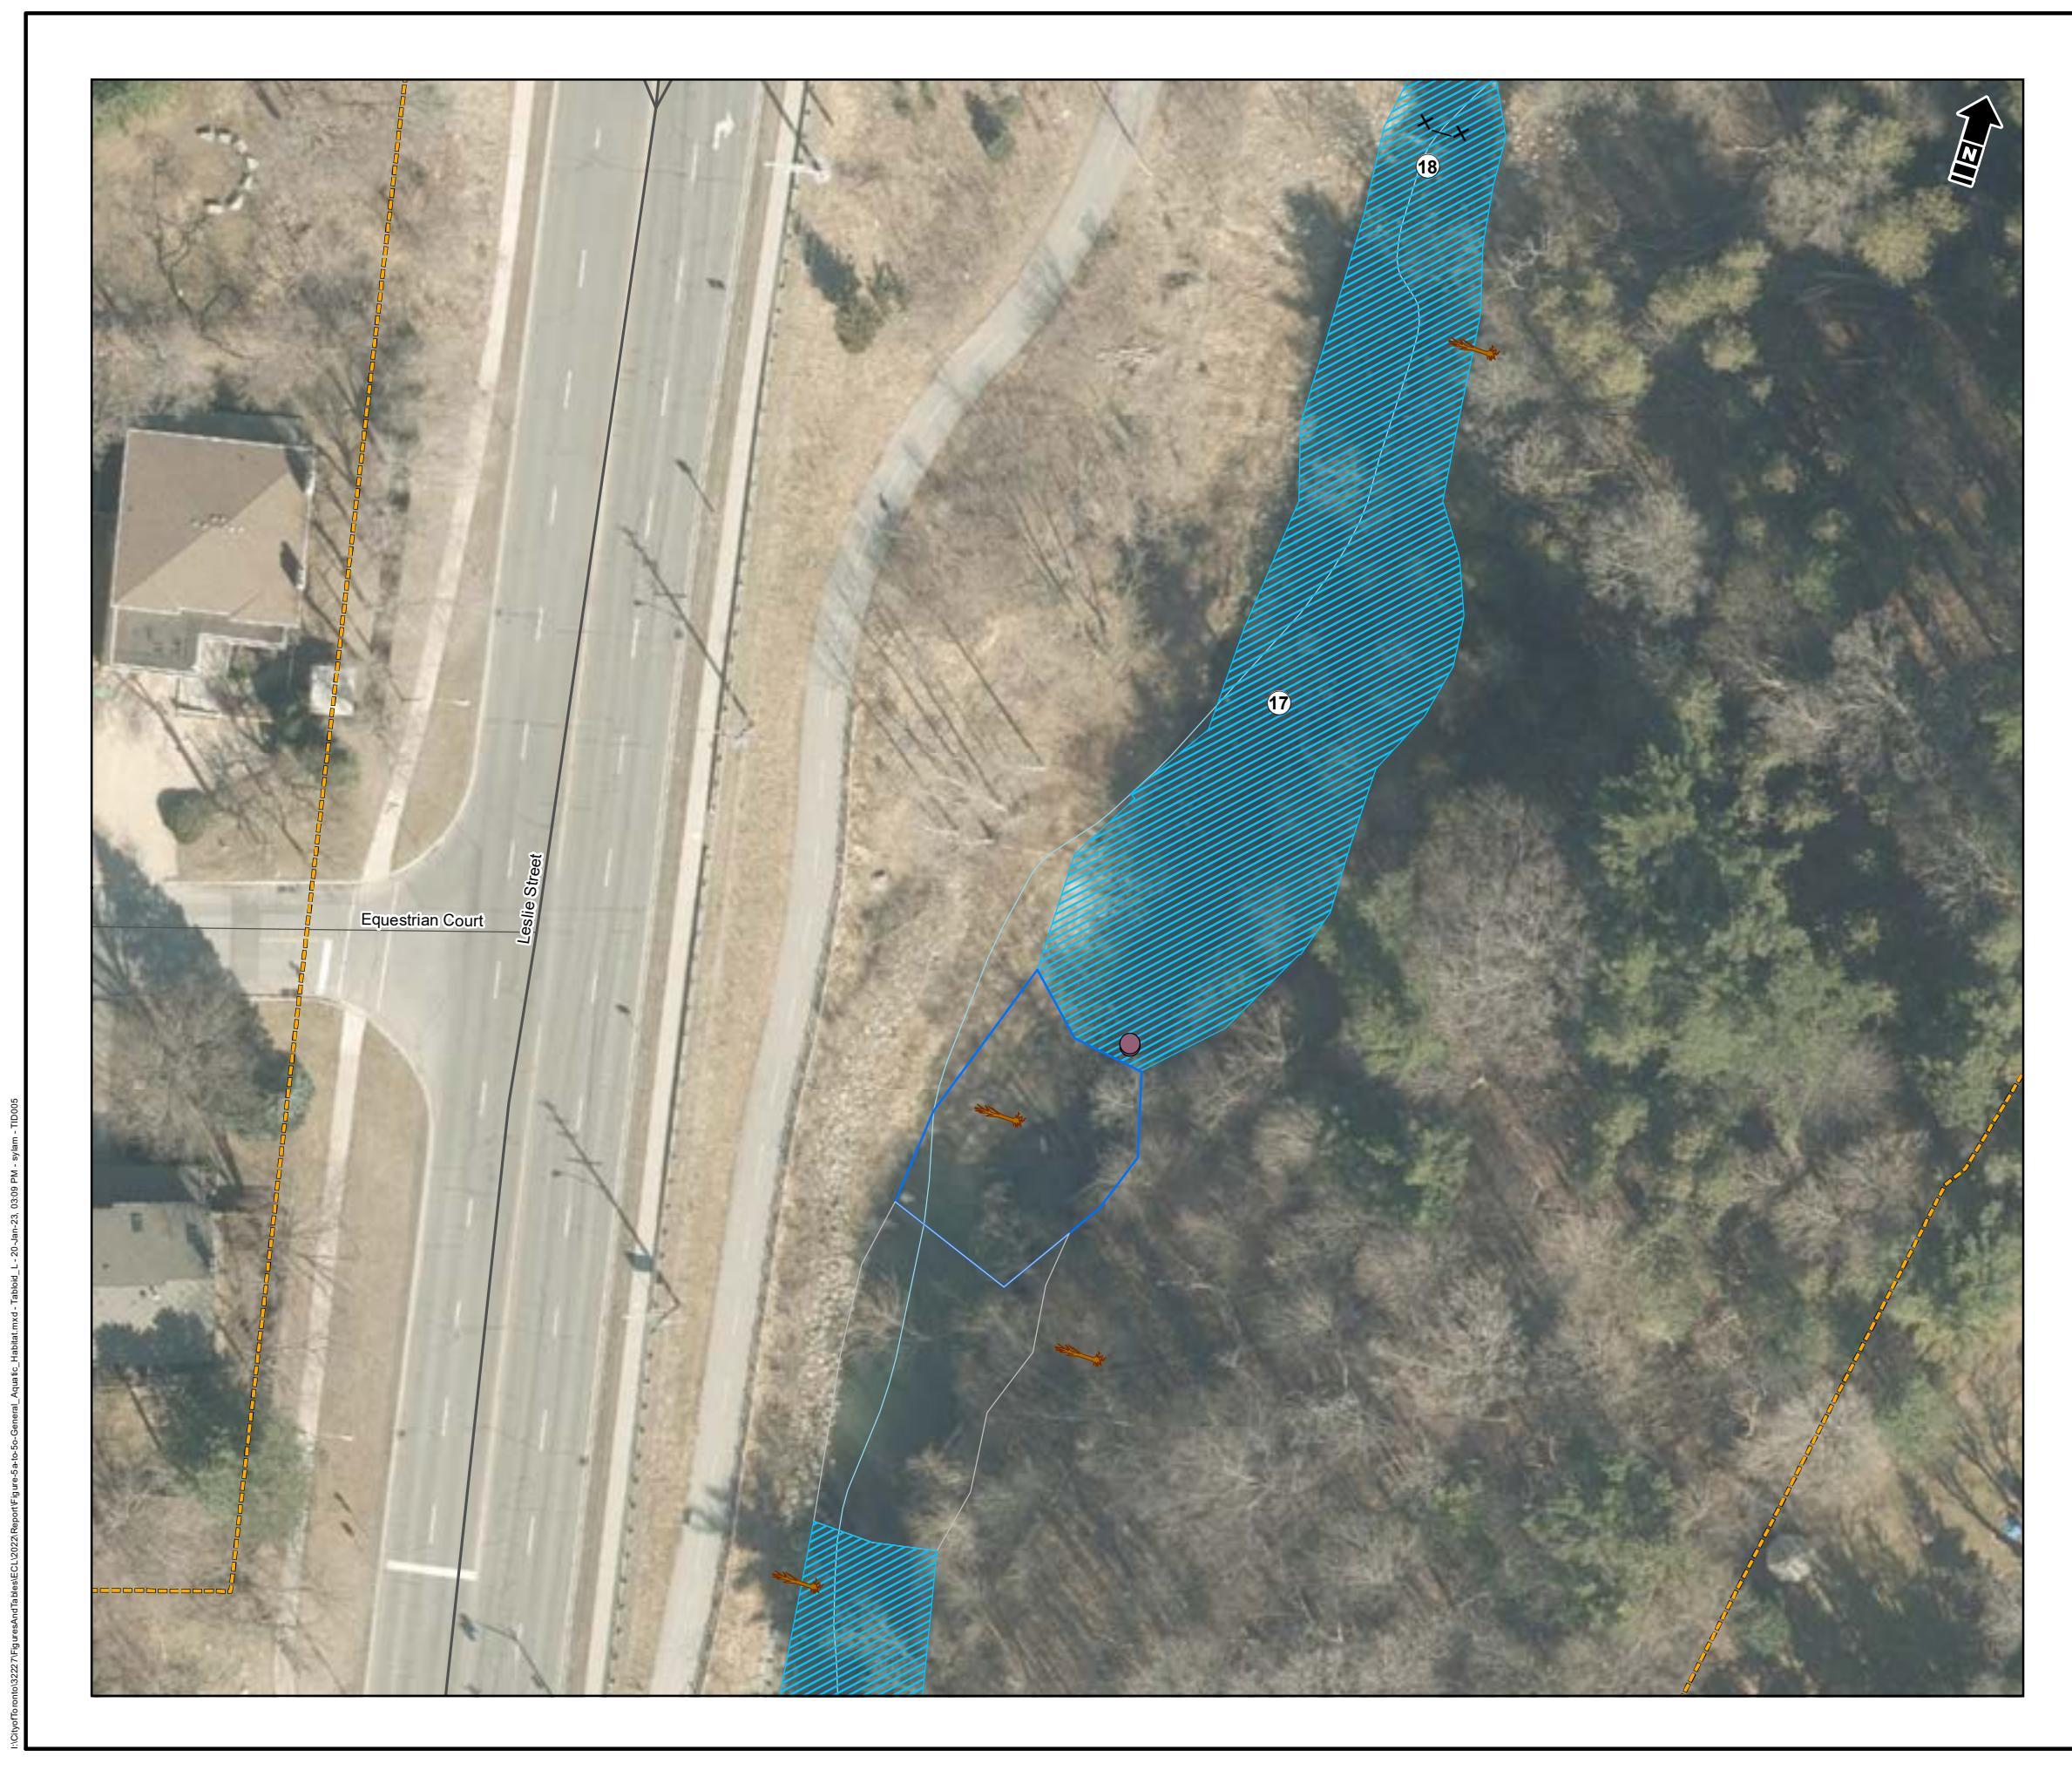
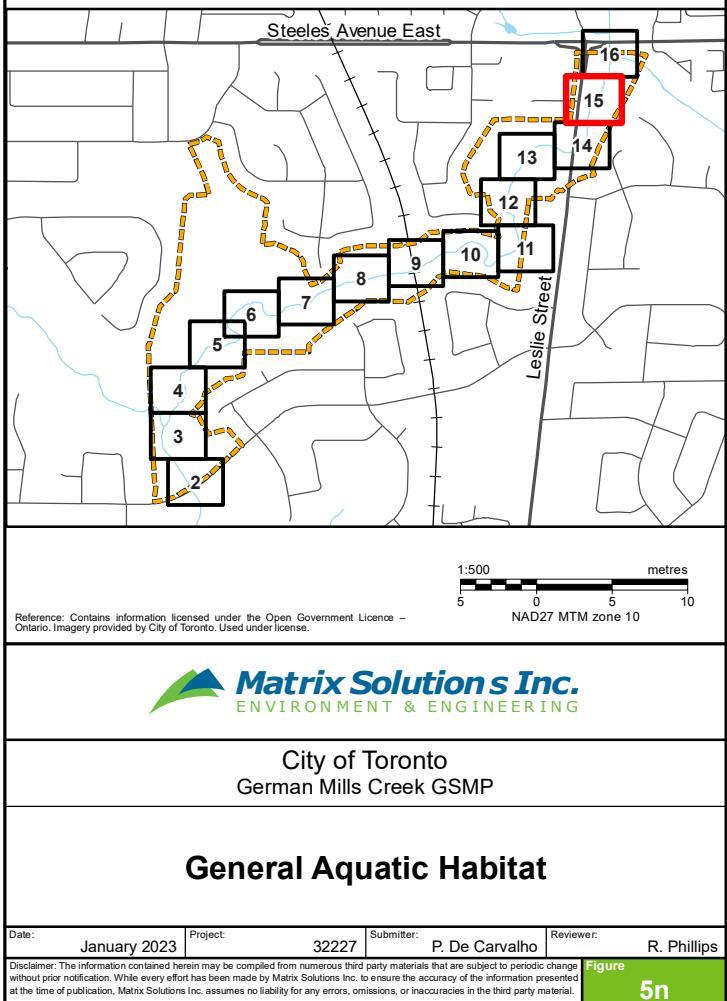
Notes: 17. Riffle series with a wetted width of 5.30 m and a wetted depth of 16cm. Cobble and small boulder substrate. 18. Embedded armourstone forming riffles and creating a potential fish barrier with a drop of 50 cm.

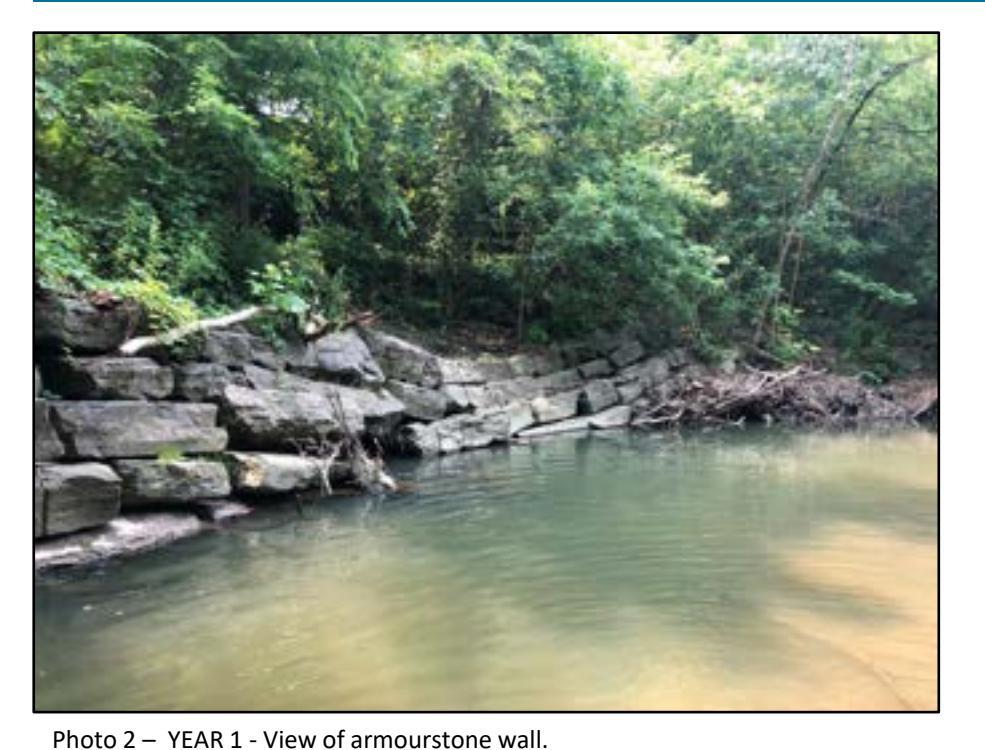
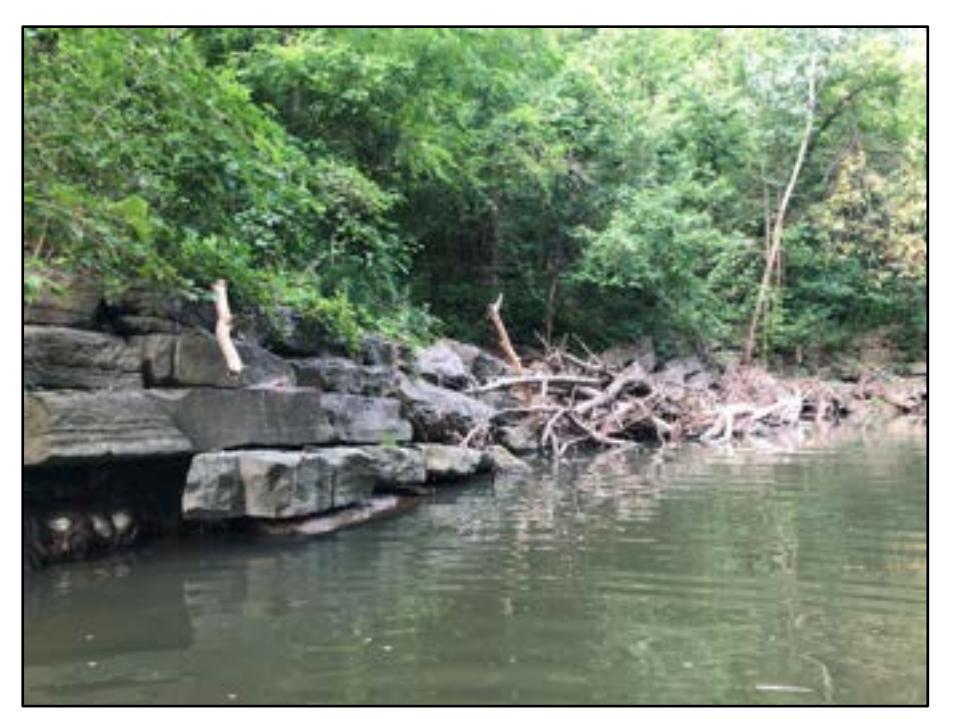
Photo 2 – YEAR 2 - View of armourstone wall. Additional debris has accumulated.

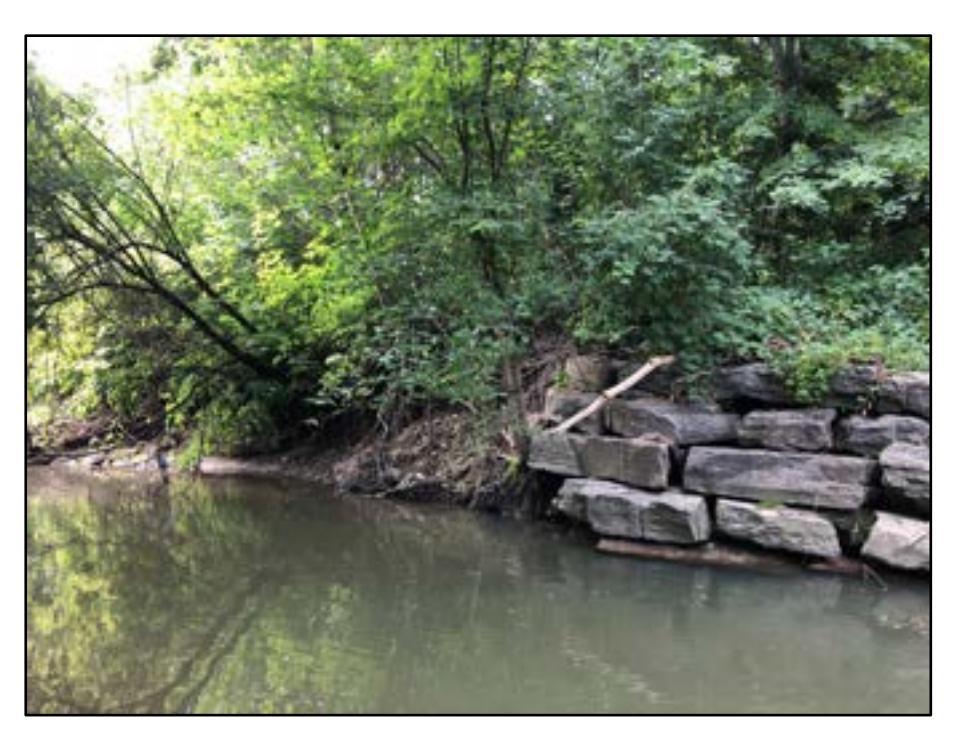
Photo 3 – YEAR 1 - South creek bank at downstream limit of armourstone wall.

Photo 3 – YEAR 2 - South creek bank at downstream limit of armourstone wall. Bank top tree leans further toward channel.

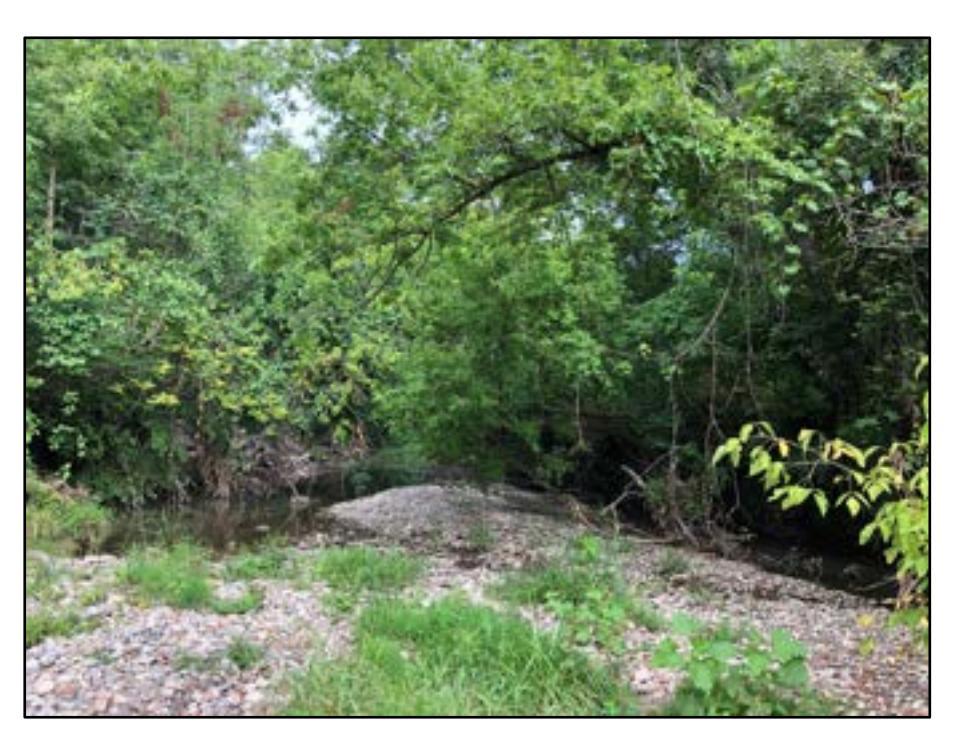
Photo 5 – YEAR 1 – View looking upstream near MON1-1.

Photo 5 – YEAR 2 – View looking upstream near MON1-1. Bar form has changed. Water levels were lower during Year 2 than Year 1 survey.

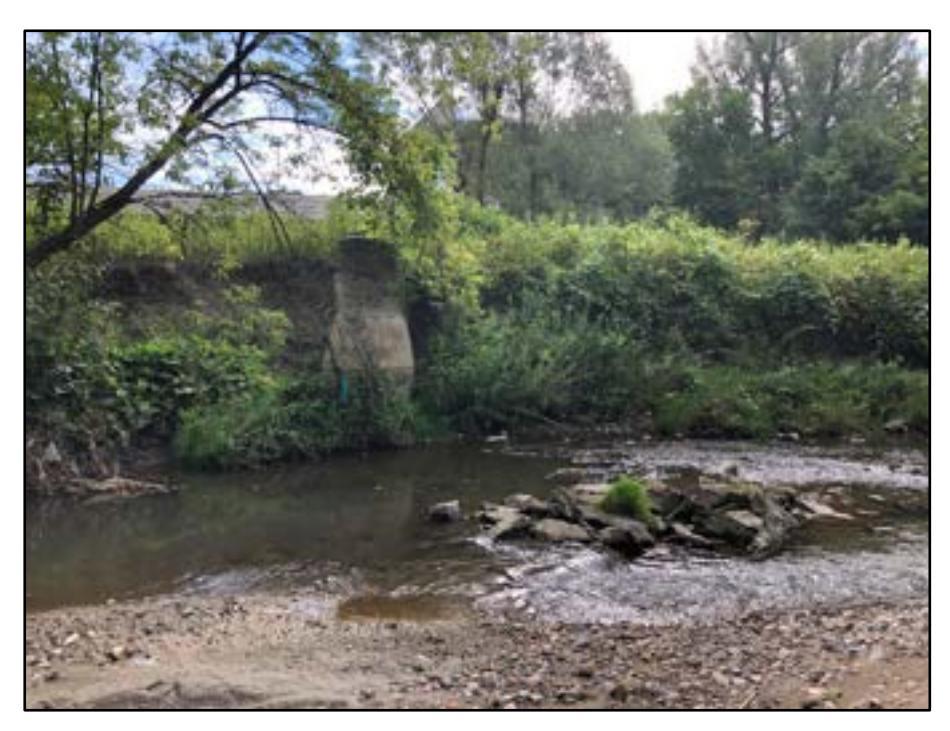
Photo 6 – YEAR 1 – Exposed manhole on north creek bank.

Photo 6 – YEAR 2 – Exposed manhole on north creek bank.

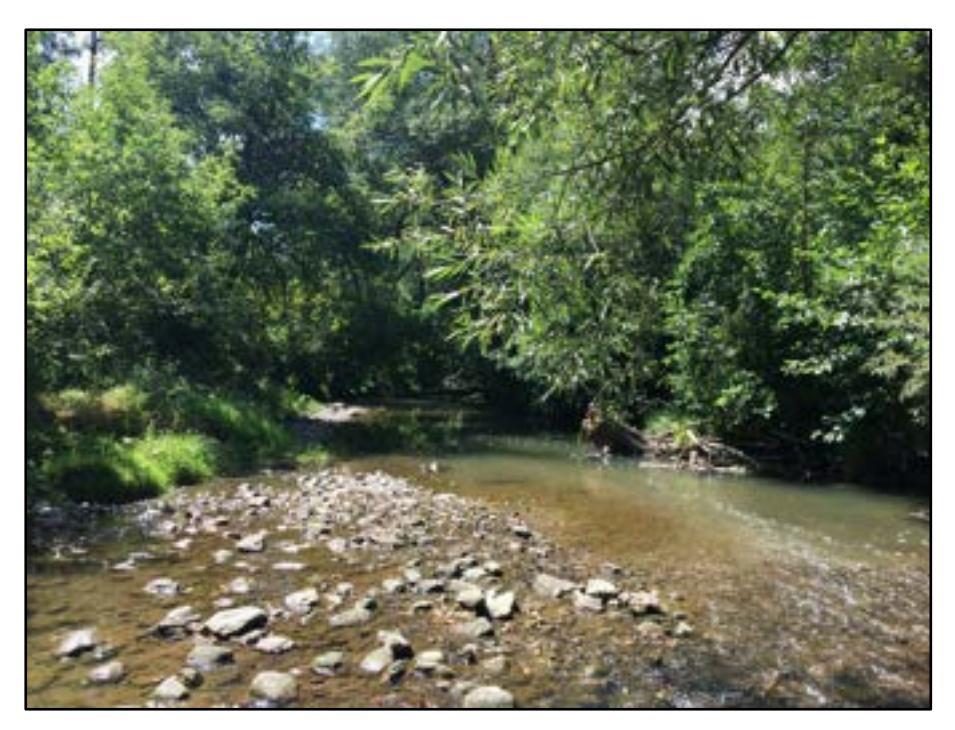
Photo 5 – YEAR 1 – Riffle looking downstream

Photo 5 - YEAR 2 - Riffle looking downstream; water levels were lower

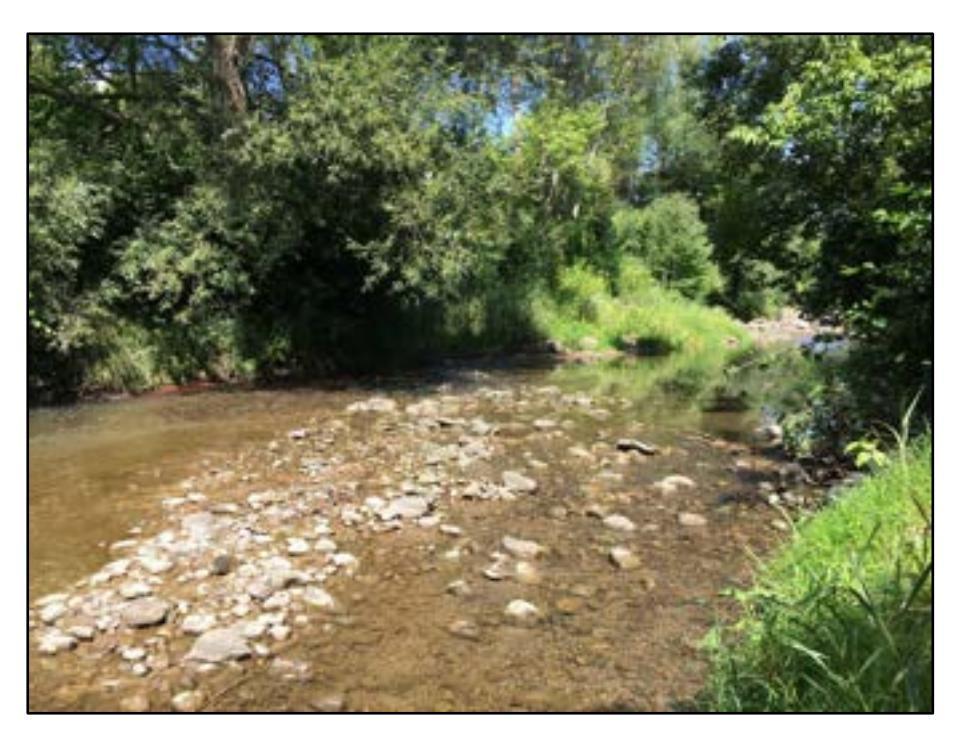
Photo 6 – YEAR 1 – Riffle looking upstream

Photo 6 – YEAR 2 - Riffle looking upstream; water levels were lower

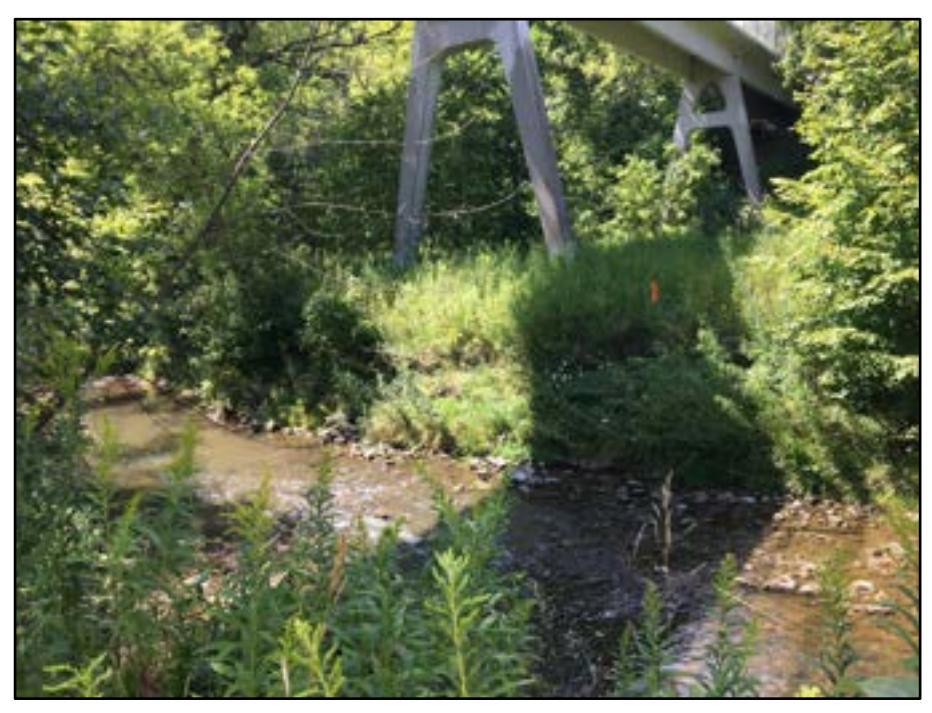
Photo 8 – YEAR 1 – View downstream below pedestrian bridge

Photo 8 – YEAR 2 – Bank conditions similar to previous year.

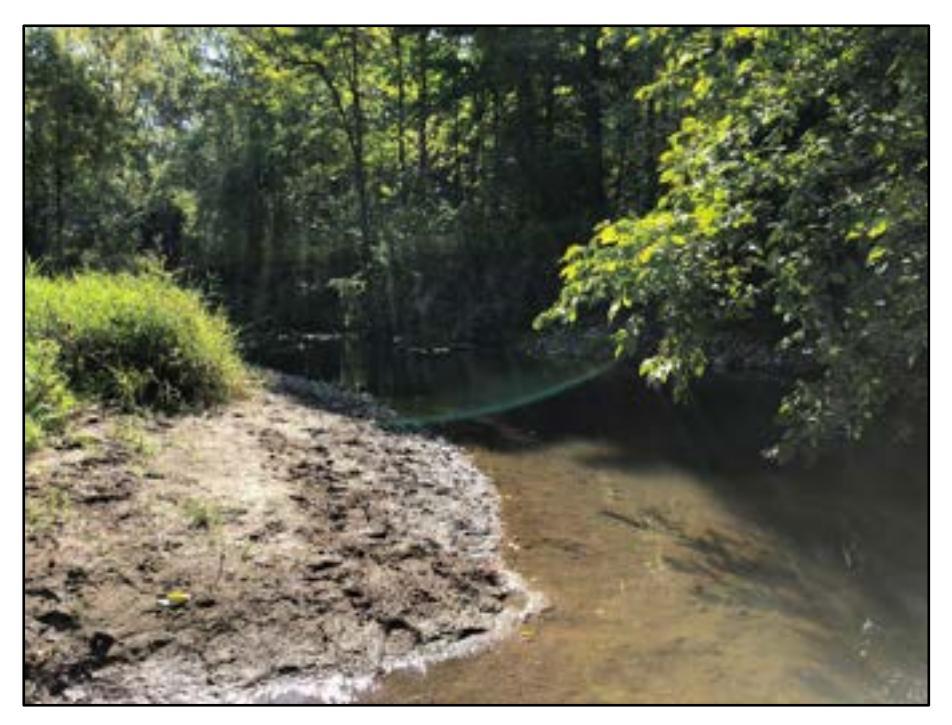
6. View downstream at MON3-5 from south bank

6. View downstream at MON3-5 from south bank. Vegetation has filled in on upper part of bank while the lower part of the bar remains unvegetated and covered in fresh deposits of fines.

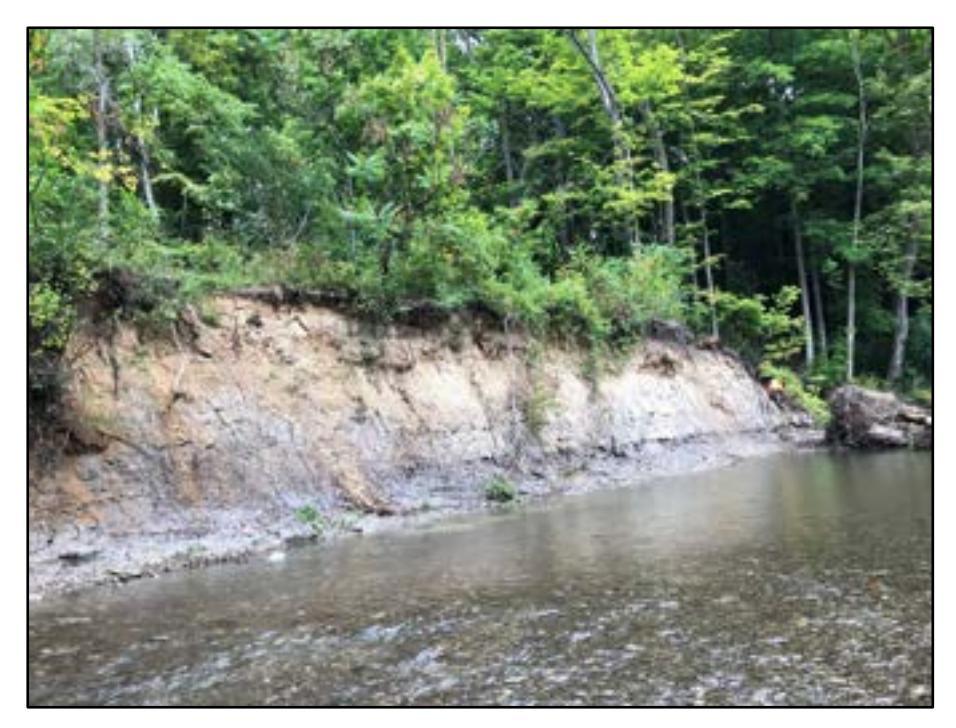
7. View upstream toward MON3-6 from south bank. Eroding bank at valley contact visible at MON3-6.

7. View upstream toward MON3-6 from south bank. Top of bank has receded slightly. Bar material has migrated downstream. Large woody debris has accumulated upstream of exposed bank at a meander.

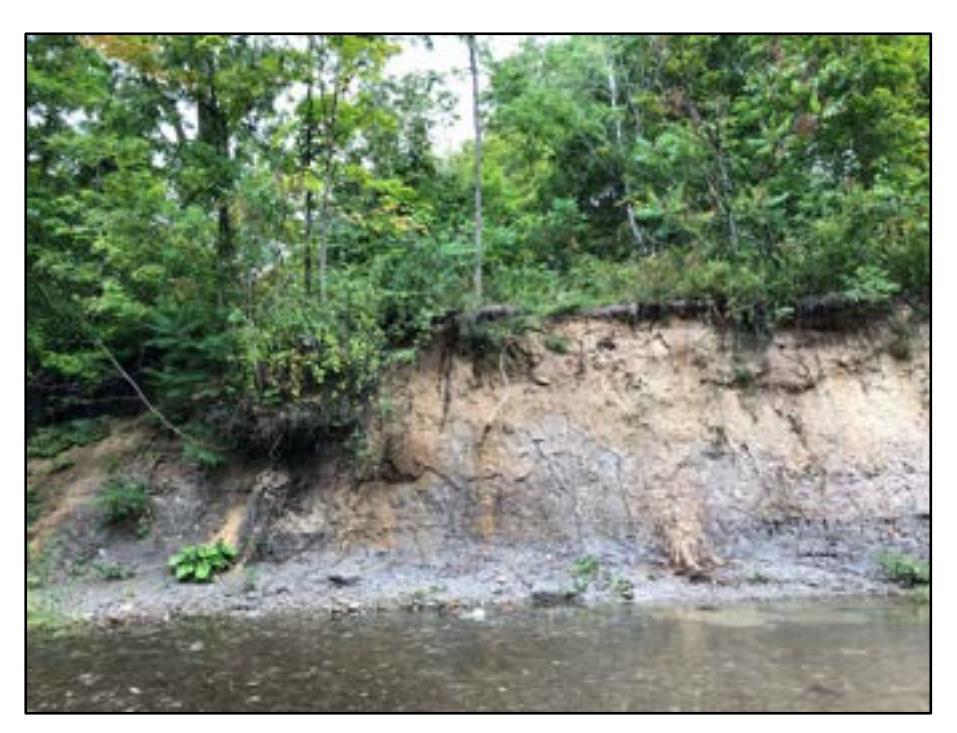
8. View of north bank at MON2-6 (eroding bank / valley contact)

8. View of north bank at MON2-6. Bank has receded slightly near top of bank.
