APPENDIX C Characterization and Development of Alternatives (Phase 2)

APPENDIX C5 Rapid Geomorphic Assessment and Rapid Stream Assessment Technique Methods

APPENDIX C5-1 Site Photographs

German Mills Geomorphic Systems Master Plan – Risk Assessment Methodology

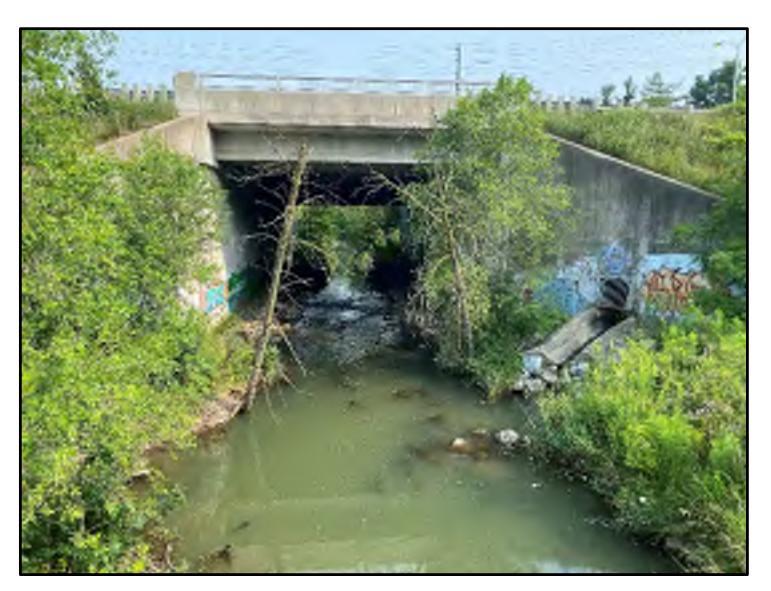
Reach GM-4 – German Mills Creek at Steeles Ave. bridge. Outfalls on left (risk site 27.2) and right (risk site 27.1) becoming undermined at toe of bank.

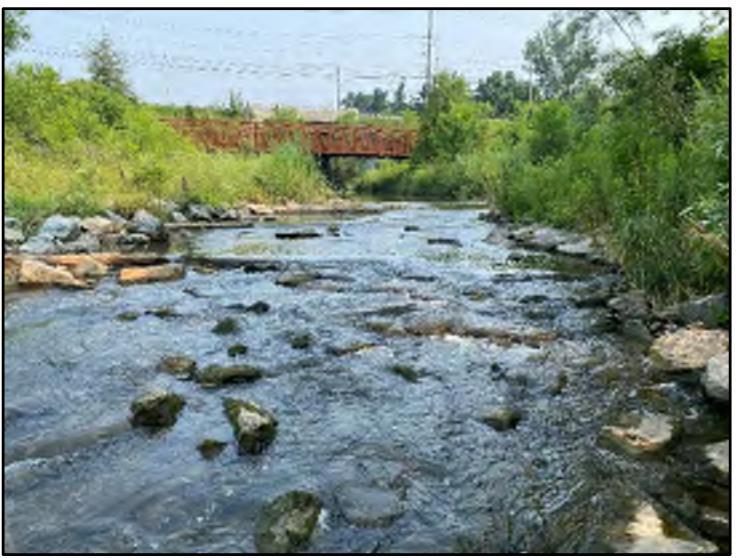
Reach GM-4 – Series of rocky ribs in German Mills Creek constructed concurrent to Duncan Creek realignment and restoration works.

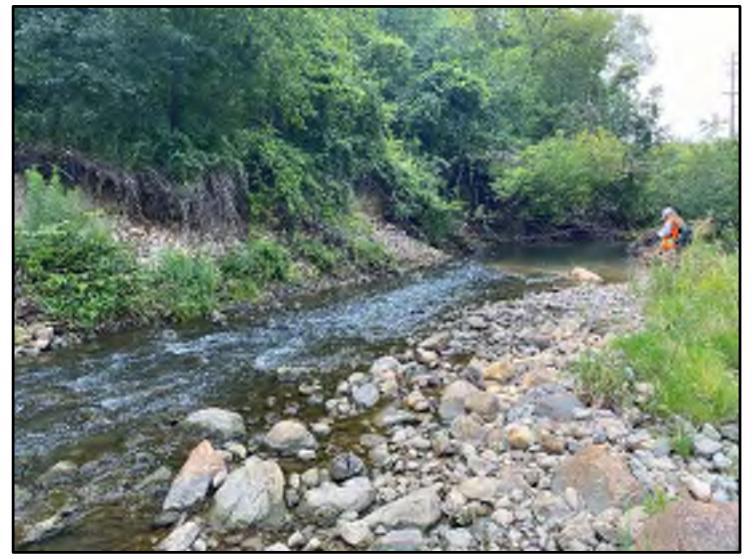
3. Reach GM-4 – View downstream; large cobble/boulder point bar towards right (in image), while watercourse is confined towards left with an overhanging, steep bank.

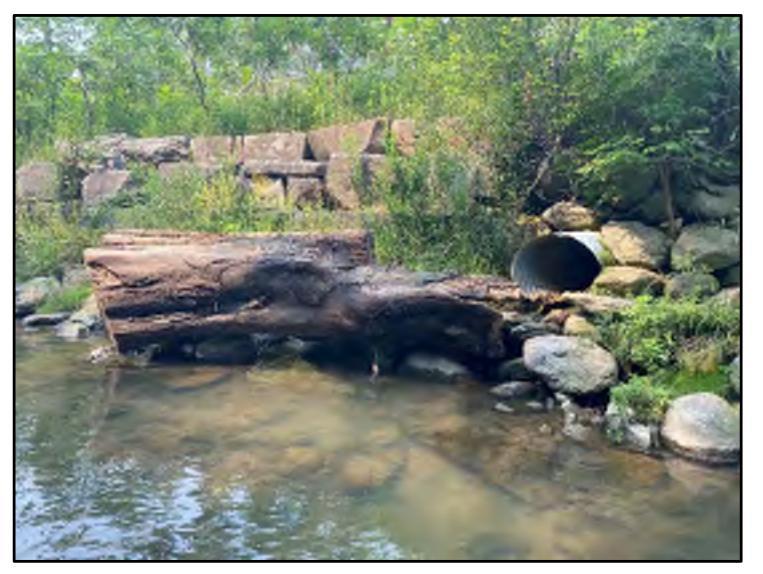
Reach GM-4 – Armourstone wall and outfall on left bank with large woody debris in channel. Sanitary sewer runs parallel to creek behind armourstone wall.

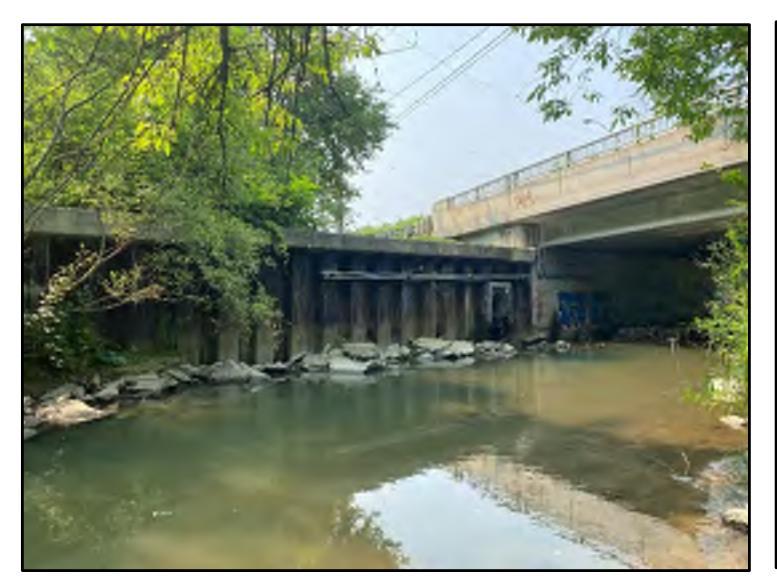
5. Reach GM-4 – Sheet pile wall with outfall along right bank upstream of Leslie St. bridge in good condition.

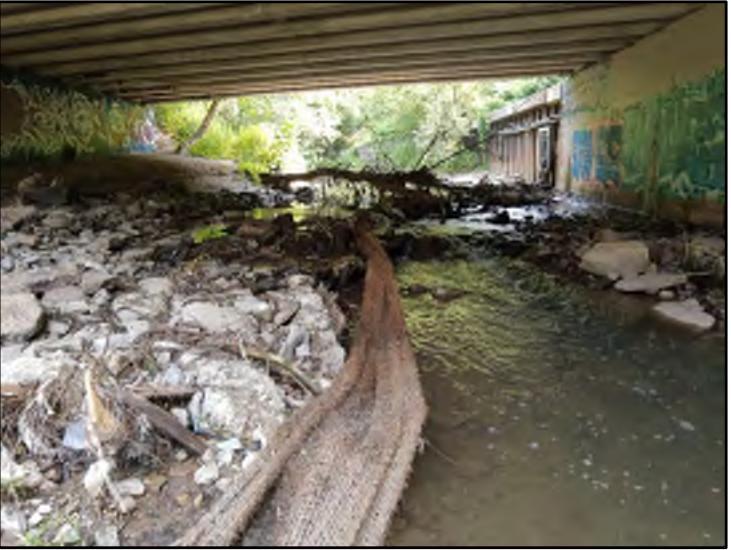
View upstream under Leslie St. bridge; well defined channel under bridge with large drop (~0.8 m) in profile.

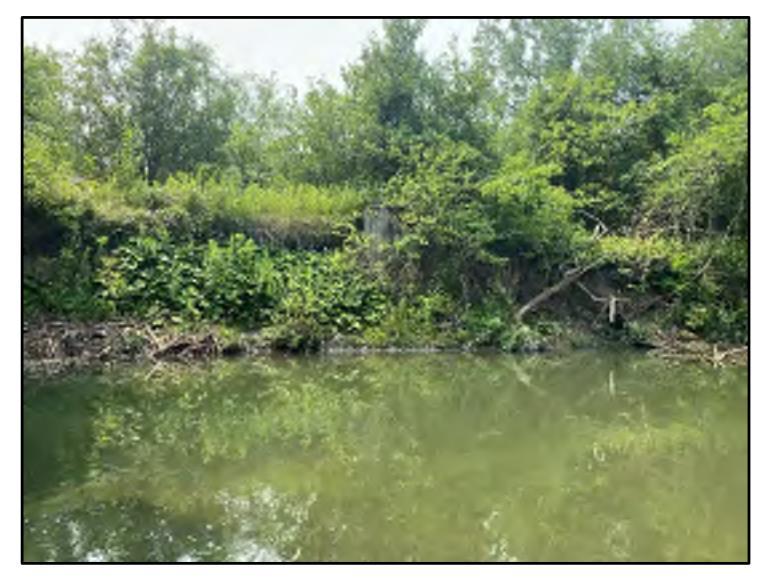
7. Reach GM-3 – View of fully exposed maintenance hole on right bank (looking upstream); banks are vertical in this area and actively slumping.

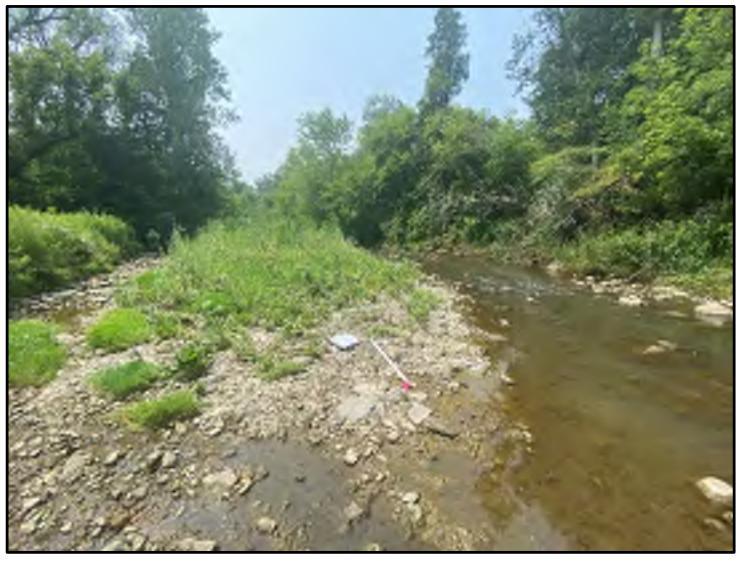
8. Reach GM-3 – View downstream of typical channel planform; reach contains numerous cobble/gravel point and medial bars, some of which are partially vegetated.

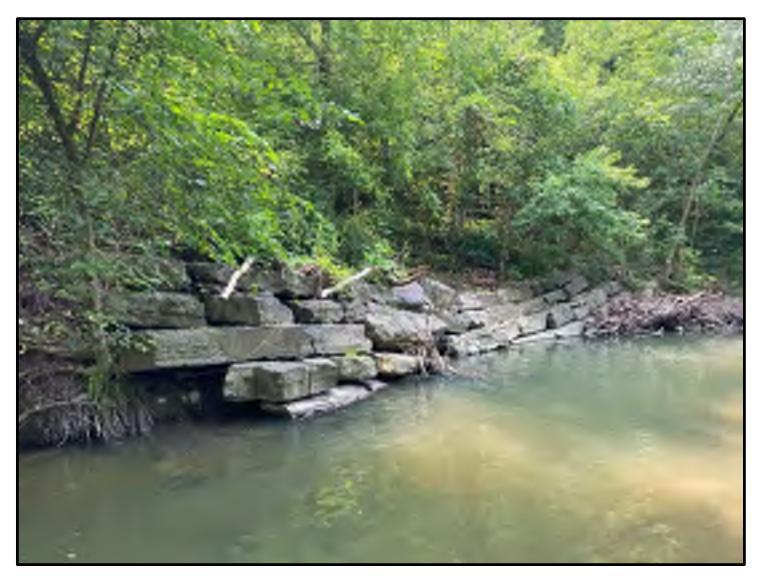
9. Reach GM-3 – View of left bank with armourstone wall at a deep pool that has become undermined and is failing. Pedestrian pathway directly behind wall at risk.

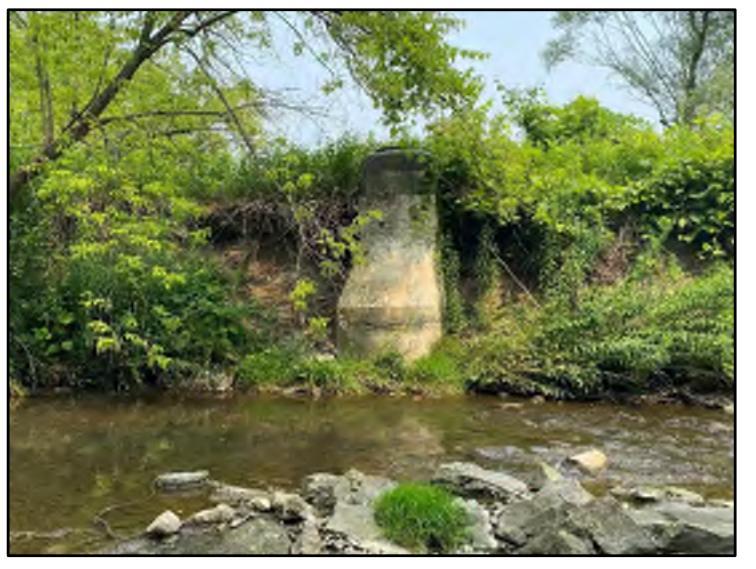
10. Reach GM -3 – Second exposed maintenance hole midreach on right bank; channel widening is prevalent throughout all of reach resulting in vertical, undercut, and overhanging banks.

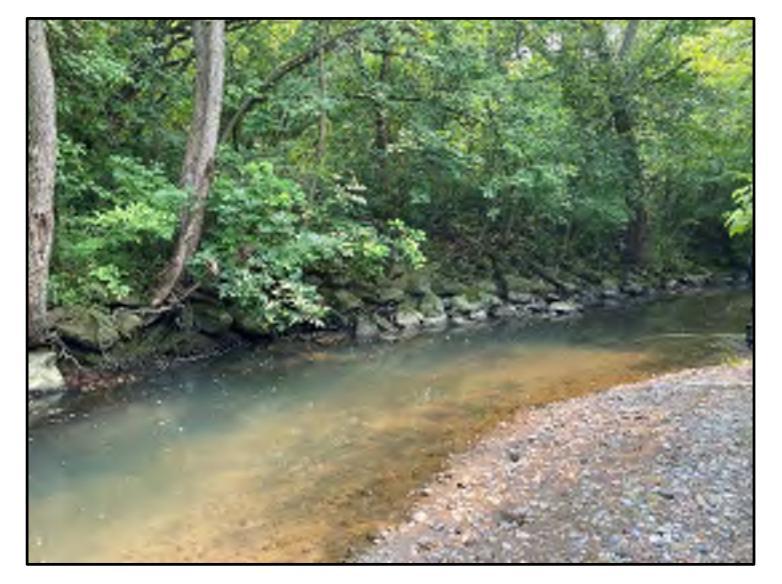
11. Reach GM-3 – View downstream of riprap placed along bank protecting property above; riprap in moderate condition, some minor toe erosion occurring.

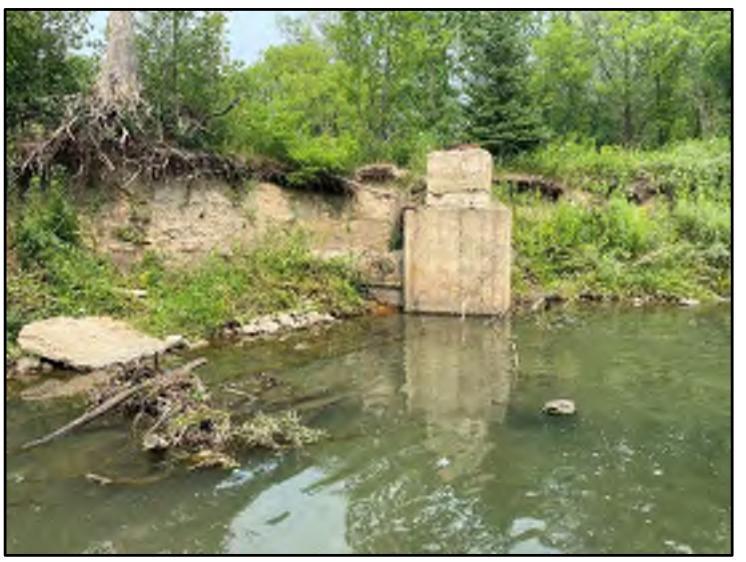
Reach GM -3 – Third exposed maintenance hole towards downstream reach break along left bank. Lateral pipe connected to MH also exposed and bank continues to erode.

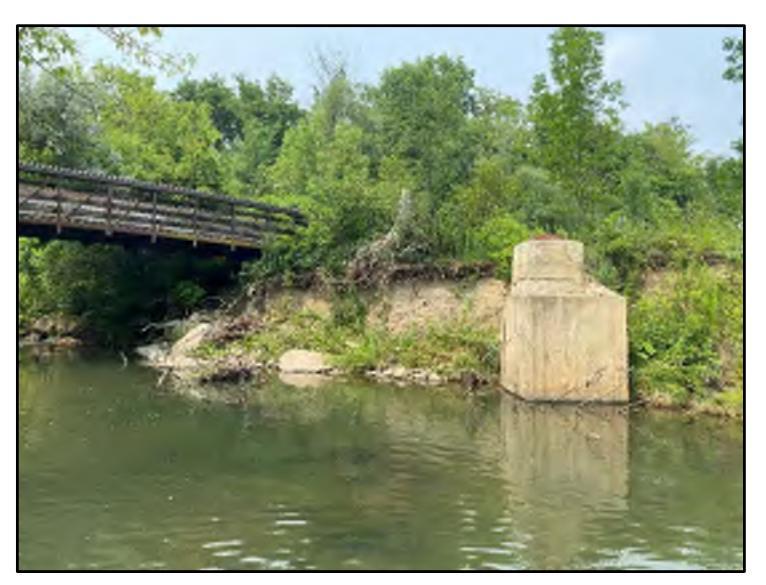
13. Reach GM-3 – Another view of third exposed maintenance hole looking downstream towards pedestrian bridge.

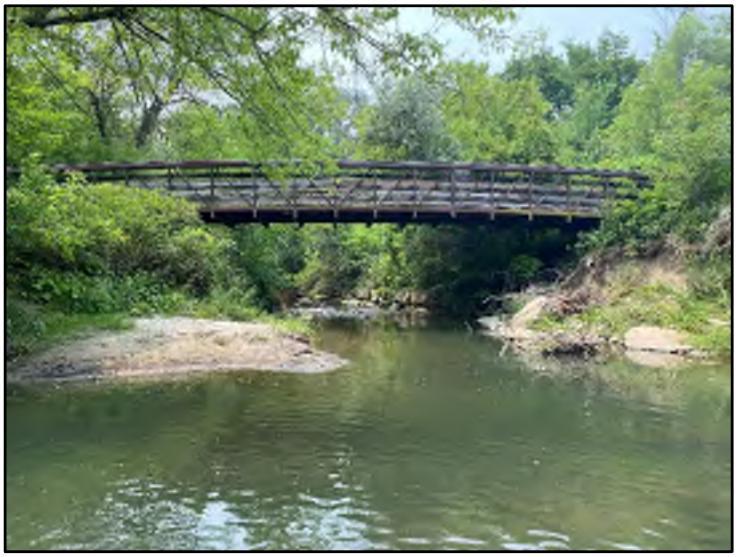
14. View downstream towards reach break between GM-3 and GM -2; active bank erosion occurring underneath pedestrian bridge requiring protection.

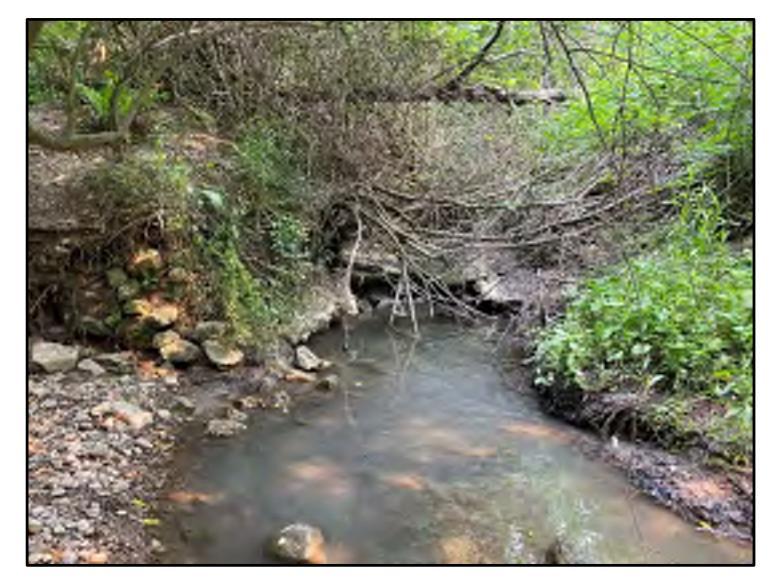
Reach GM – 2 – View of outfall channel on right bank; active erosion occurring around confluence with German Mills Creek.

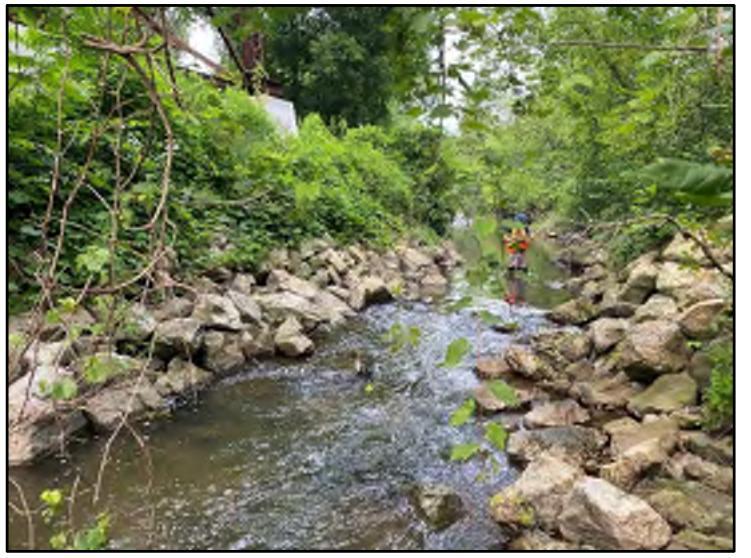
16. Reach GM – 2 – View downstream under CN Railway bridge; riprap placed on both banks under railway and is in good condition.

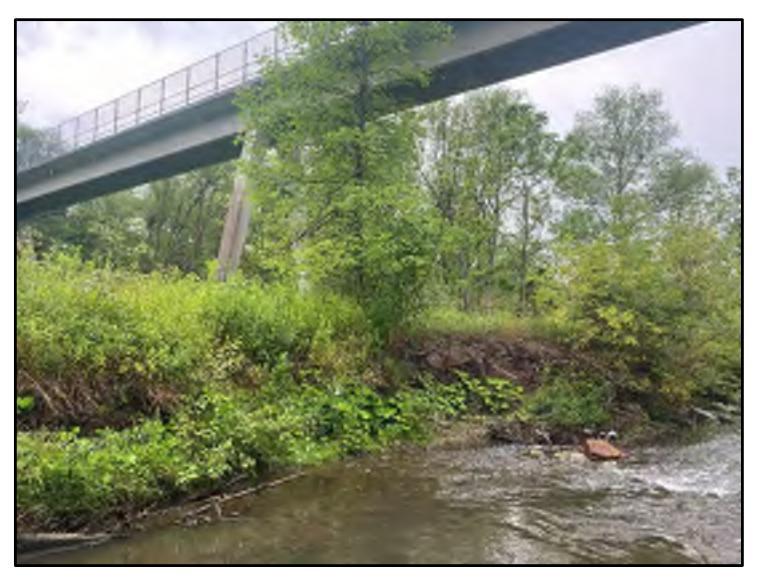
17. Reach GM – 2 – View towards right bridge pier under pedestrian bridge; pier is at risk of becoming exposed due to ongoing bank erosion and channel widening under bridge; no bank protection present.

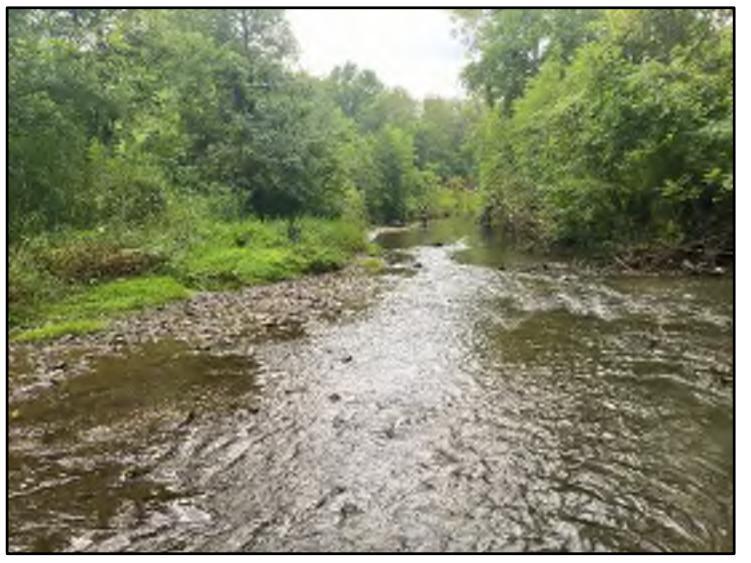
18. Reach GM – 2 – View downstream of typical channel planform; well vegetated riparian zone.

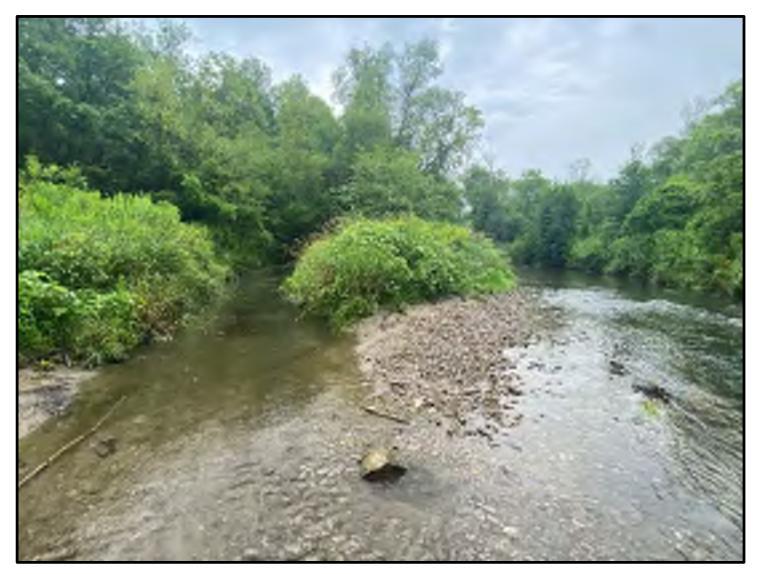
19. View upstream of confluence of Bestview Tributary (left) with German Mills Creek (right).

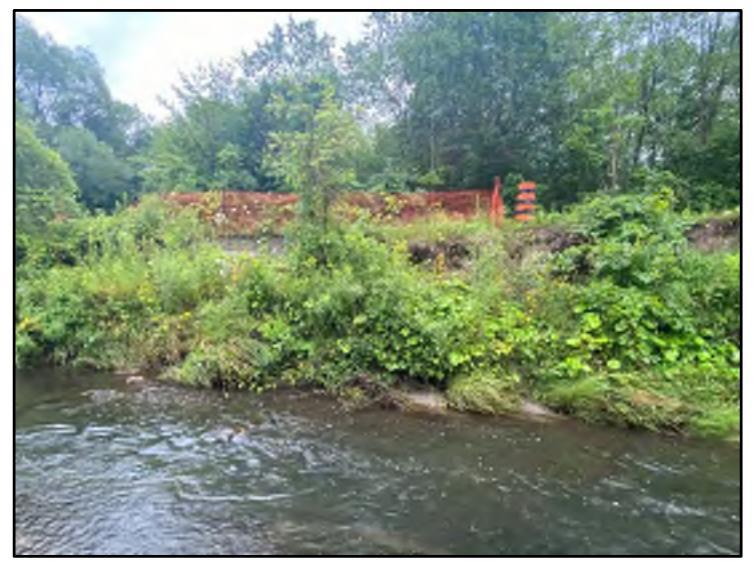
20. Reach GM – 2/GM – 1 reach break – View of right bank across from Bestview Tributary confluence; sewer is directly behind bank parallel to creek and bank has undergone extensive erosion placing sewer at risk.

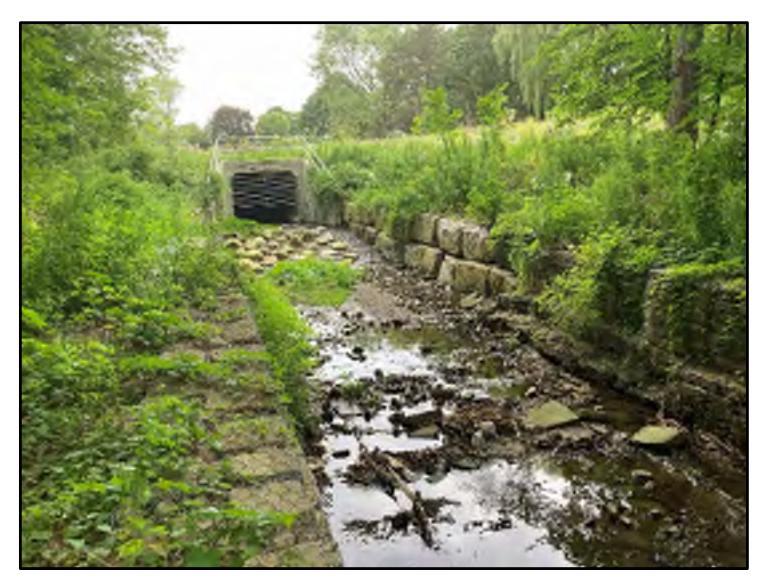
21. Reach GM-BV-2 – View looking upstream of outfall outletting to Bestview tributary; channel is lined with armourstone blocks and appears stable.

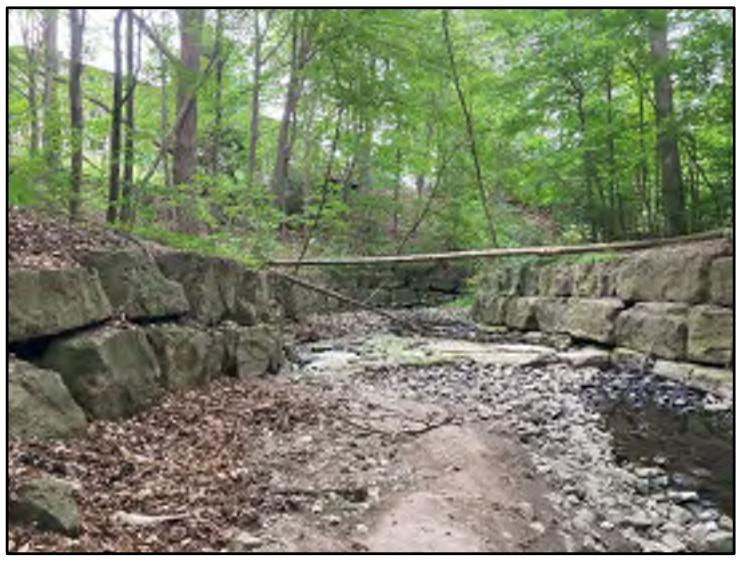
22. Reach GM-BV-2 – View downstream of armourstone Bestview tributary channel; property (left) within close proximity to channel.

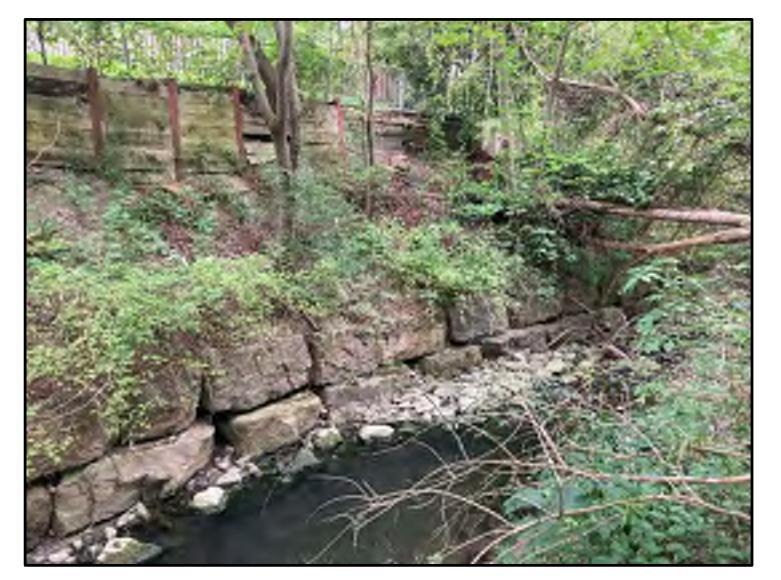
23. Reach GM-BV-2 – View of right bank in Bestview tributary of armourstone wall protecting adjacent property; armourstone in fair condition.

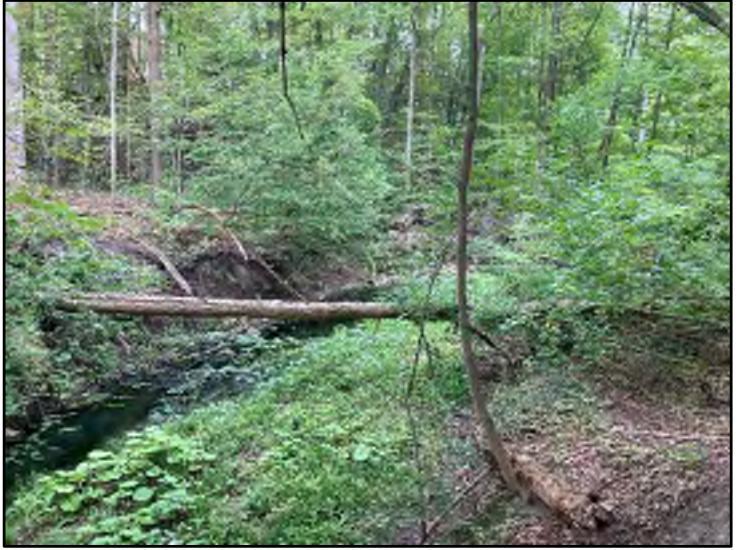
24. Reach GM-BV-1 – View of downstream reach of Bestview tributary; channel no longer contains/ bed/bank protection and is undergoing substantial erosion.

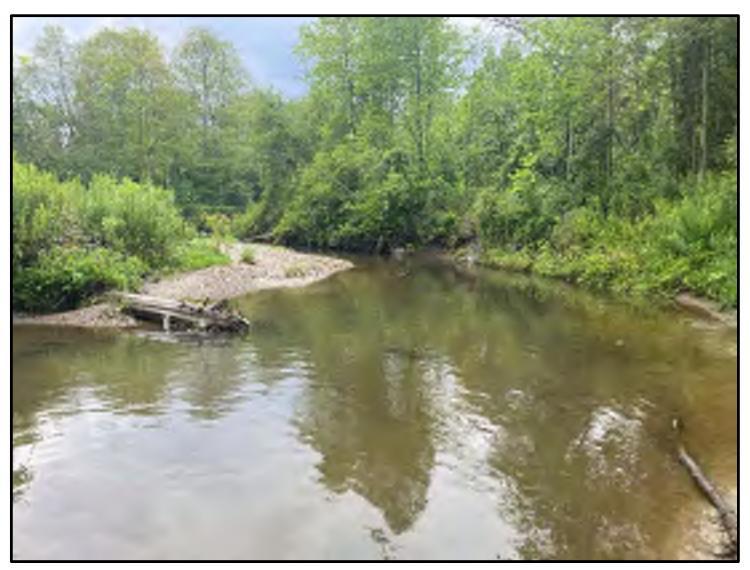
25. Reach GM – 1 – View downstream of large pool; channel is generally well connected to floodplain and contains a wide riparian zone.

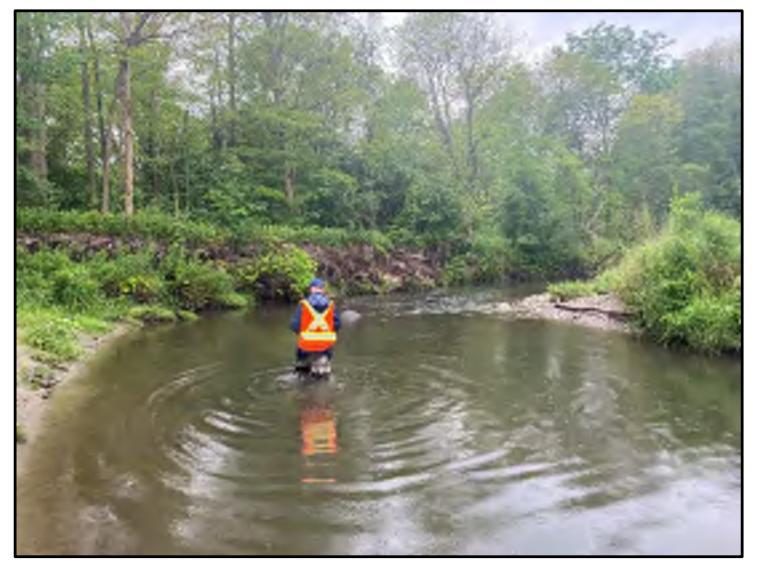
26. Reach GM – 1 – View downstream of another large pool that is actively migrating towards sewer; vertical channel banks within vicinity of sewer.

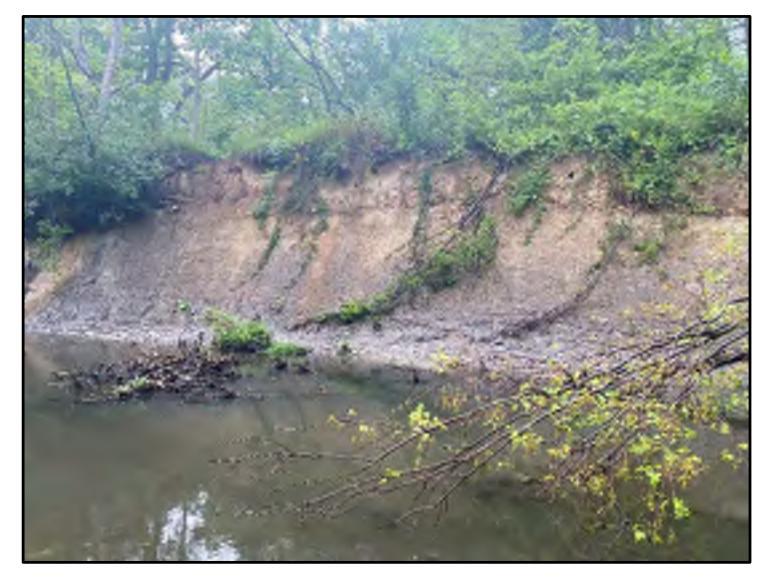
27. Reach GM – 1 – View of left bank which is highly eroded and vertical; channel has occasional valley-wall contacts within reach.

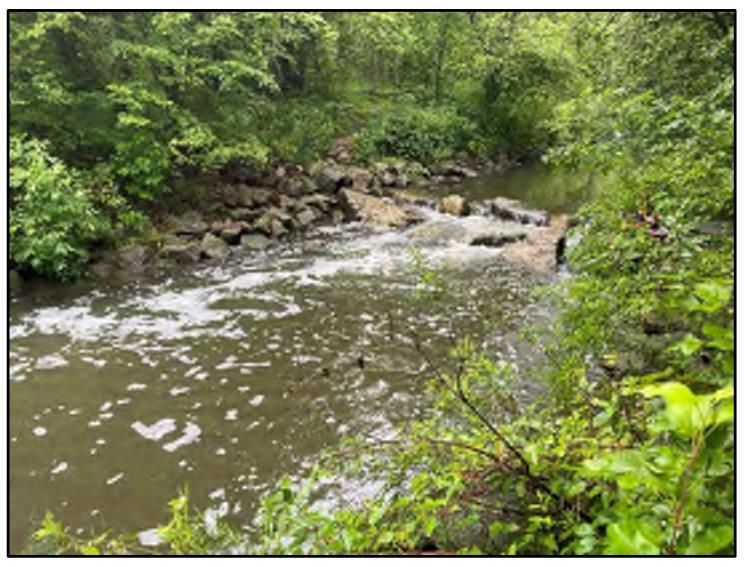
28. Reach GM – 1 – View looking upstream of riprap weir mid-reach acting as grade control.

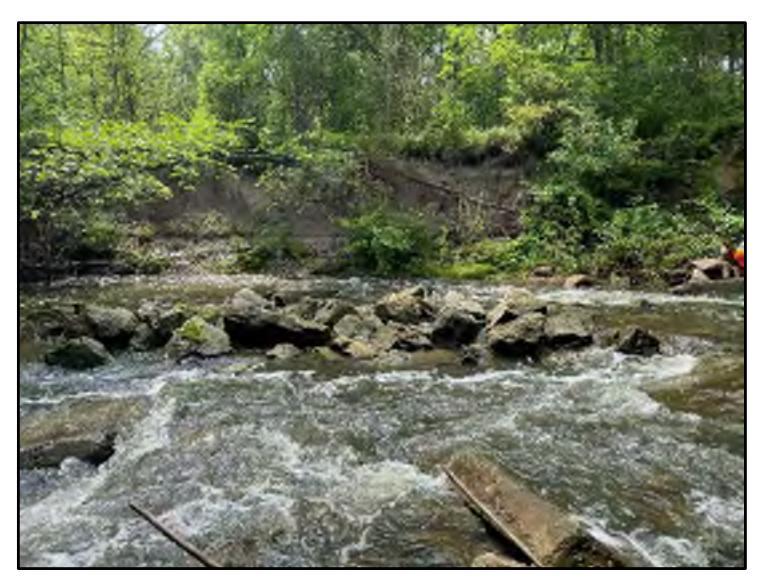
29. Reach GM – 1 – View of left bank; riprap has washed into middle of channel from previous bank protection/armouring of channel.

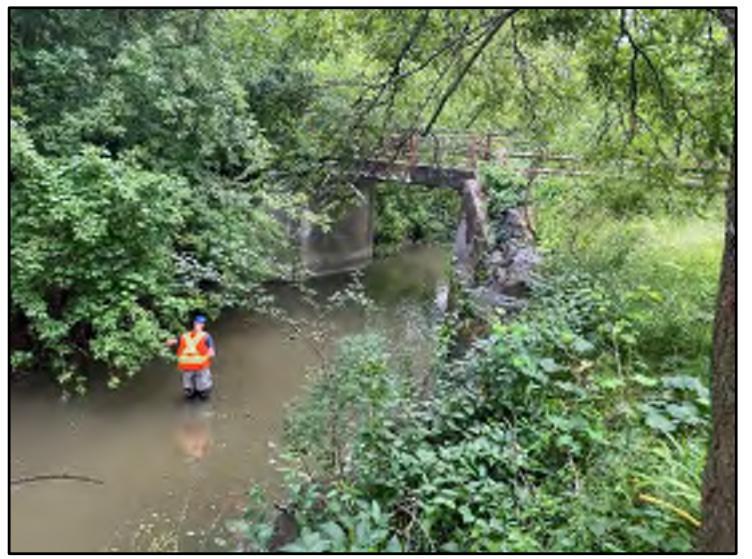
30. Reach GM – 1 – View looking downstream at pedestrian bridge near confluence with East Don River.

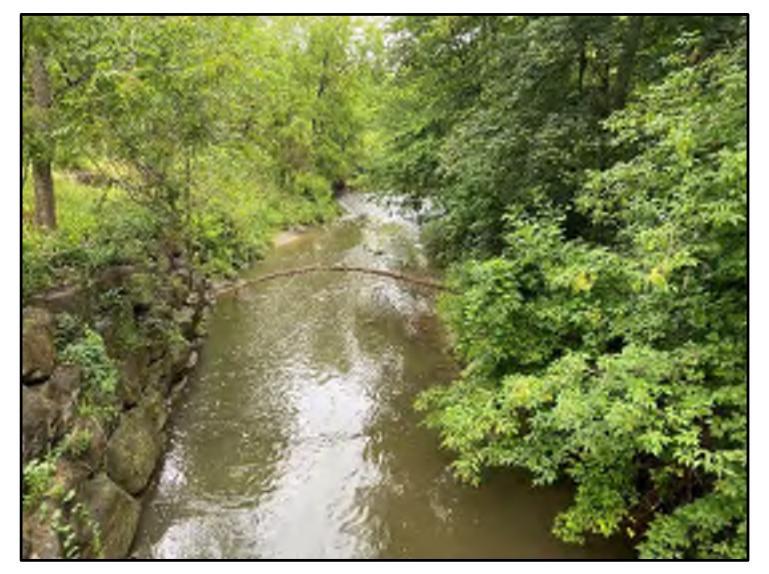
Reach GM – 1 – View looking upstream at German Mills Creek from pedestrian bridge near confluence; left bank and adjacent maintenance hole protected with armourstone blocks in good condition.

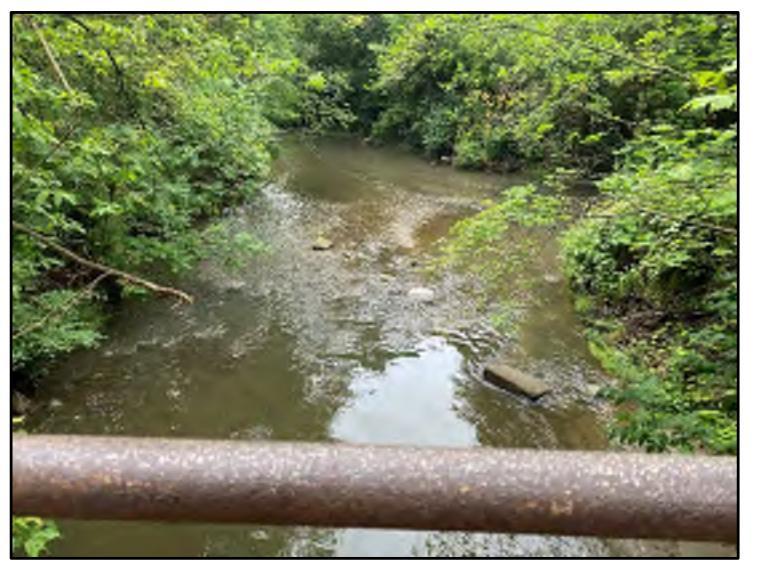
32. View downstream from pedestrian bridge looking at confluence with East Don River.
