# GERMAN MILLS CREEK GEOMORPHIC SYSTEMS MASTER PLAN PHASE 2 TECHNICAL MEMORANDUM DEVELOPMENT OF ALTERNATIVE SOLUTIONS

Prepared for: CITY OF TORONTO

Prepared by: MATRIX SOLUTIONS INC., A MONTROSE ENVIRONMENTAL COMPANY

Version 1.0 December 2024 Mississauga, Ontario

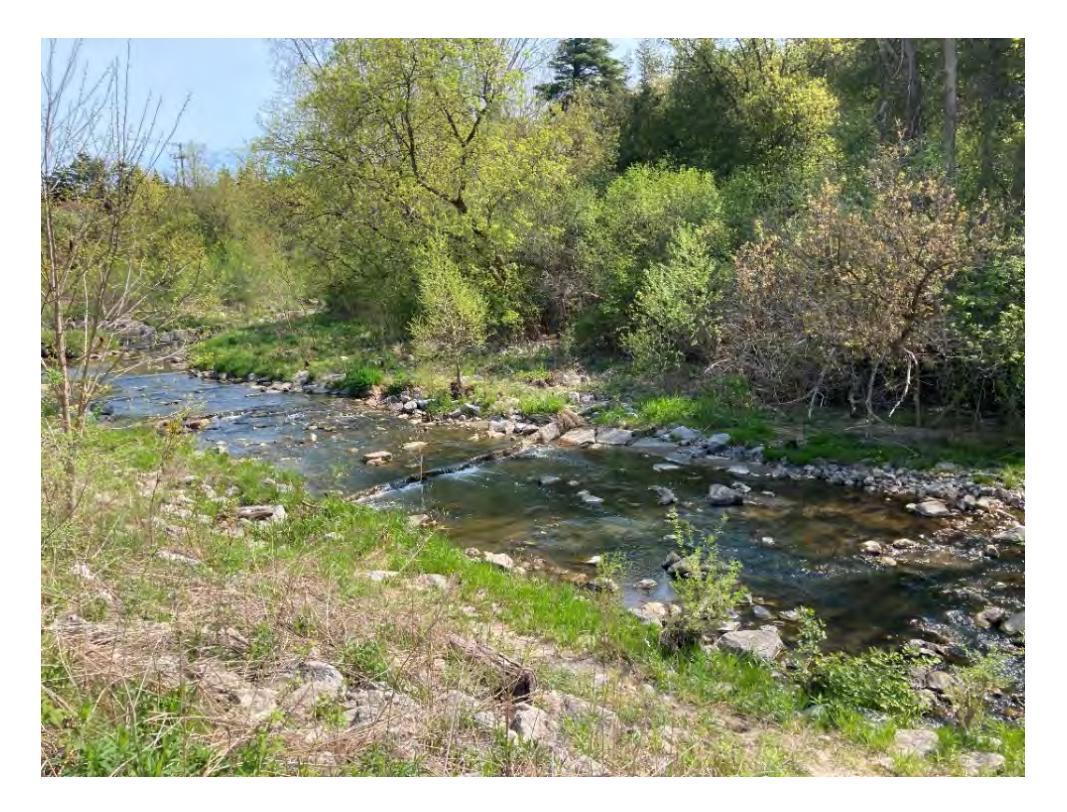
FIGURE 2-6 Armoured Riffle with Transverse Ribs, Reach GM-4

In 2013, efforts were made to stabilize significant erosion issues within Duncan Creek, including issues at the confluence with German Mills Creek. Works included a meandering riffle-pool design engineered and constructed with riprap and armourstone for channel stabilization. These works, which were extended into German Mills Creek (Reach GM-4), consisted of an armoured riffle feature with traverse armourstone ribs extending approximately 30 m downstream from the confluence (Figure 2-6). This approach for channel/bed stability has been fairly common among recent designs throughout the City over the last decade. Annual monitoring reports by Aquafor Beech (2021a, 2021b, 2021c) note that there has been ongoing localized scour of the bed and banks, with rates at 0.21 m/year and 0.13 to 0.35 m/year, respectively. However, Aquafor Beech (2021c) concluded that current conditions pose "no significant risks to the adjacent assets in the short-medium term, including City's sanitary sewer, trail systems and private properties." Further monitoring was recommended to evaluate long-term risks associated with the ongoing adjustment.

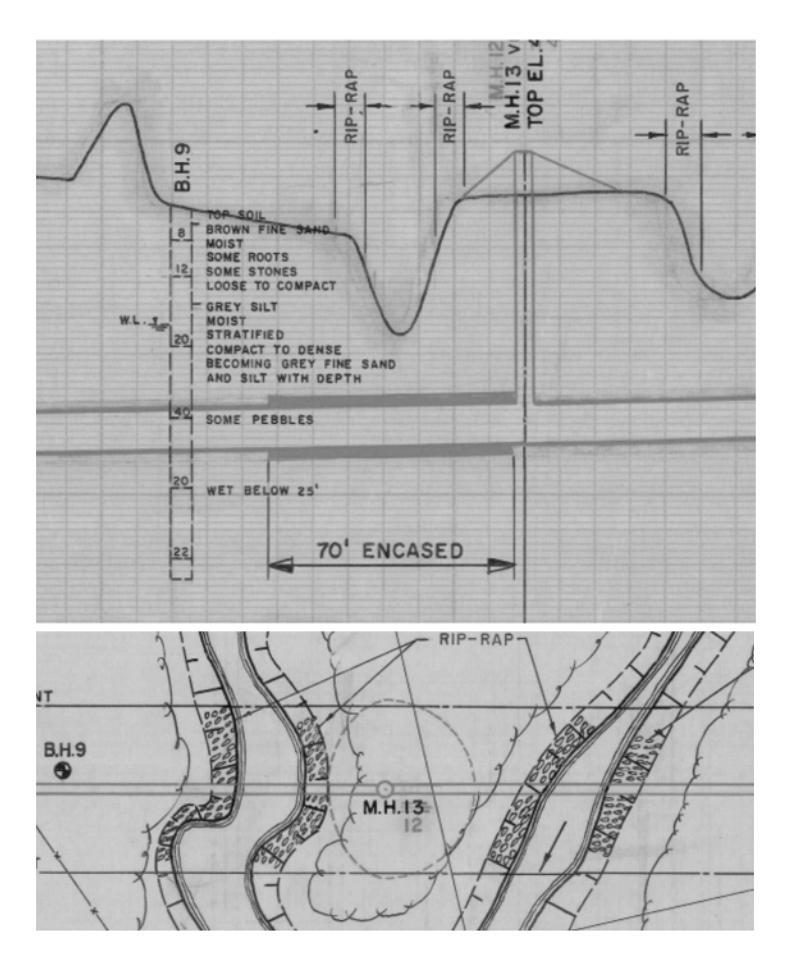
FIGURE 3-5 Excerpts from Sanitary Trunk Sewer Engineering Drawing 1268-D-6660

There is also no information on what flow diversion methods were used to construct the sewer through the creek crossing locations. Installation of riprap is noted in the vicinity of the crossings with the note "WIDTH OF RIP-RAP TO BE WIDTH OF TRENCH AT TOP RIVER BANK PLUS 5 FEET ON UNDISTURBED SOIL ON EACH SIDE."

It is also noted that only one of the creek crossings were encased at the time of construction, at the location of the lowest ground cover shown above (Figure 3-5, Drawing 1268-D-6660). No buoyancy control measures were indicated as well throughout; however, given the reinforced concrete pipe material, this is unlikely to cause challenges due to the significant rigidity and weight of the pipe.

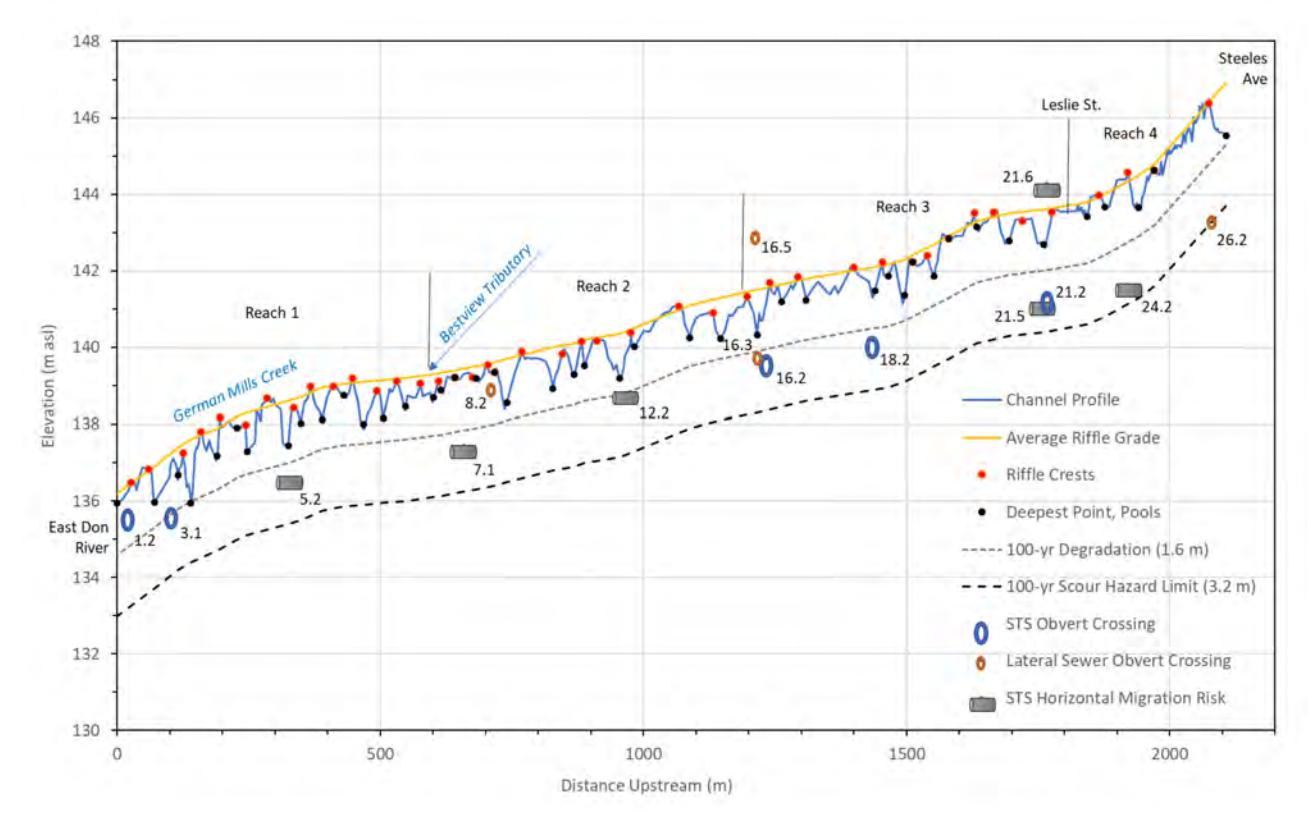
### FIGURE 4-6 Profile Analysis for Delineation of the Scour Hazard Limit with Respect to Sanitary Sewer Infrastructure (including Lateral Migration Risks as symbolized)

Figure 4-6 displays the location of Toronto Water infrastructure relative to the 100-year natural scour hazard (1.6 m below riffle grade) and the overall 100-year SHL (natural scour and general scour) of 3.2 m. As summarized in Table 4-7, one lateral sewer pipe is exposed (erosion site 16.5, behind exposed maintenance hole), three pipe crossings are within the 100-year degradation limit, and five pipe crossings are within the SHL. In addition, there are six sections of the STS and lateral sewer identified where future horizontal migration risks could generate new crossings where pipes would also be within the SHL (note: STS Horizontal Migration Risk points in Figure 4-6 are offset horizontally from the channel profile and thus are not currently crossings). Credit for existing erosion controls on the channel bed have not been accounted for in the delineated SHL but are included in the TTE calculations presented in Section 4.3 (e.g., Site ID 26.2 is located below armoured rocky ramp).
