Stage 2 Property Assessment

**Sheppard East Light Rail Vehicle Maintenance and
Storage Facility Environmental Assessment,
City of Toronto, Ontario**

November 2009
(Revised February 2010)

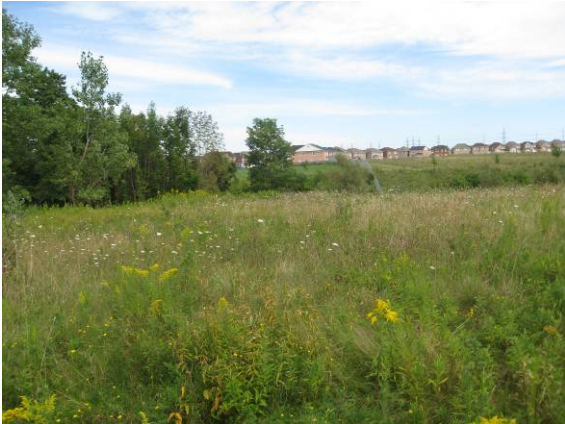
Area 1 is roughly 0.012 ac in size and is located approximately 150 m south of the northeast corner of the study area. The area was generally flat and covered in heavy vegetation, including long grasses and weeds (Plates 1-2). A gravel pathway bisects this area. Two test pits, consisting of top soil mixed with gravel and asphalt, were visibly disturbed east of the pathway (Plate 3). Two additional test pits were excavated west of the pathway, and these were also disturbed. All test pits were approximately 30 to 40 cm deep.

Plate 1: Looking east towards Area 1.

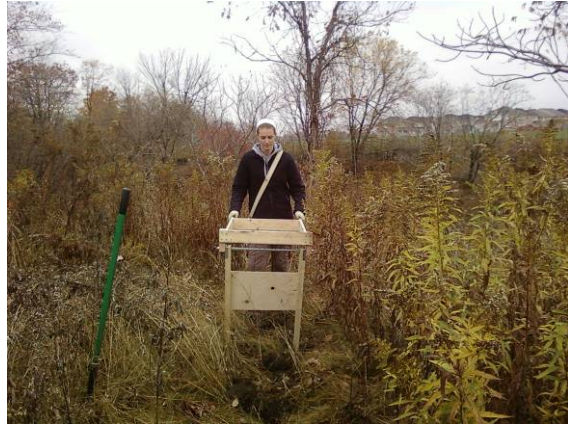
Plate 2: Looking northeast at test pit survey.

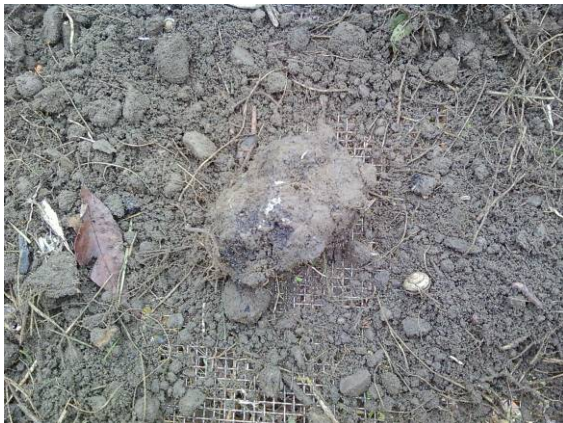
Plate 3: Example of fills from disturbed test pit.

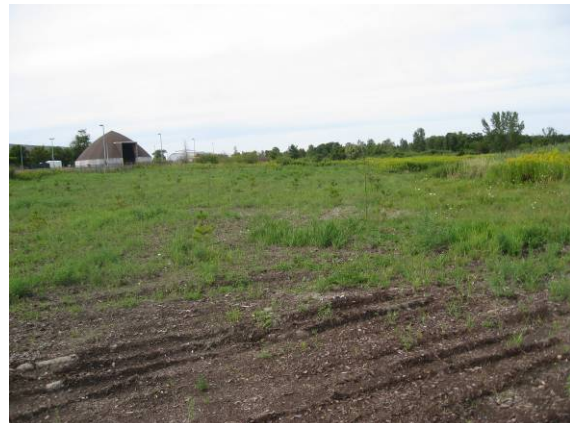
Area 2 is roughly 5 ac in size and covers the majority of the middle section of the study area. The area was generally flat and also covered in heavy vegetation (Plate 4). Four test pits at the north end of Area 2 were visibly disturbed, and consisted of top soil mixed with gravel. Judgmental testing continued to the south (Plate 5). A total of seven test pits were excavated over the area, and all showed disturbed soil contexts.

Plate 4: Looking north-northwest into Area 2.

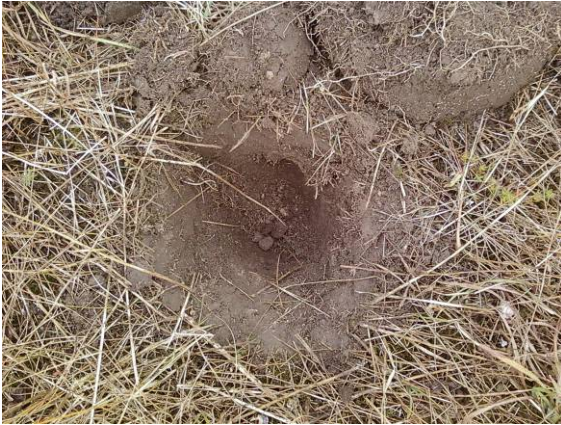
Plate 5: Example of excavated test pit (top soil mixed with gravel).

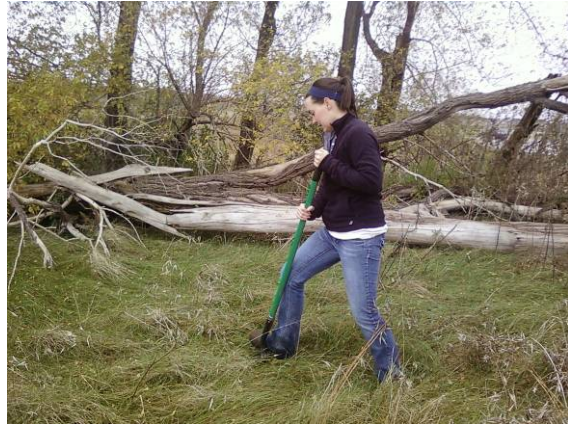
Area 3 is roughly 0.006 ac in size, and is located in the southeast corner of the study area around a cluster of elm trees that possibly relate to the structure illustrated in the southeast corner of the property in the 1878 *Illustrated Historical Atlas of the County of York* (Plate 6). Five test pits were excavated at this location. Two test pits were visibly disturbed and consisted of concrete and asphalt mixed with gravel. The remaining three test pits, consisting of brown-grey clay-loam top soil mixed with gravel fill, and were also considered to be disturbed (Plate 7).

Plate 6: Looking north at test pit survey in Area 3

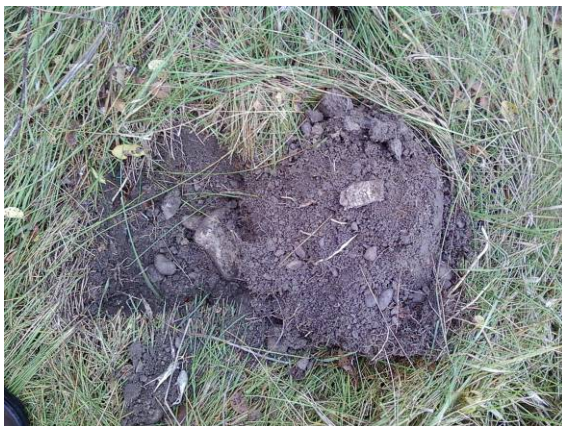
Plate 7: Example of disturbed test pit.
