11 Mooregate Avenue – City Owned Tree Removal

Date:	March 5, 2007
To:	Scarborough Community Council
From:	Brenda Librecz, General Manager, Parks, Forestry and Recreation
Wards:	Ward 37 – Scarborough Centre
Reference Number:

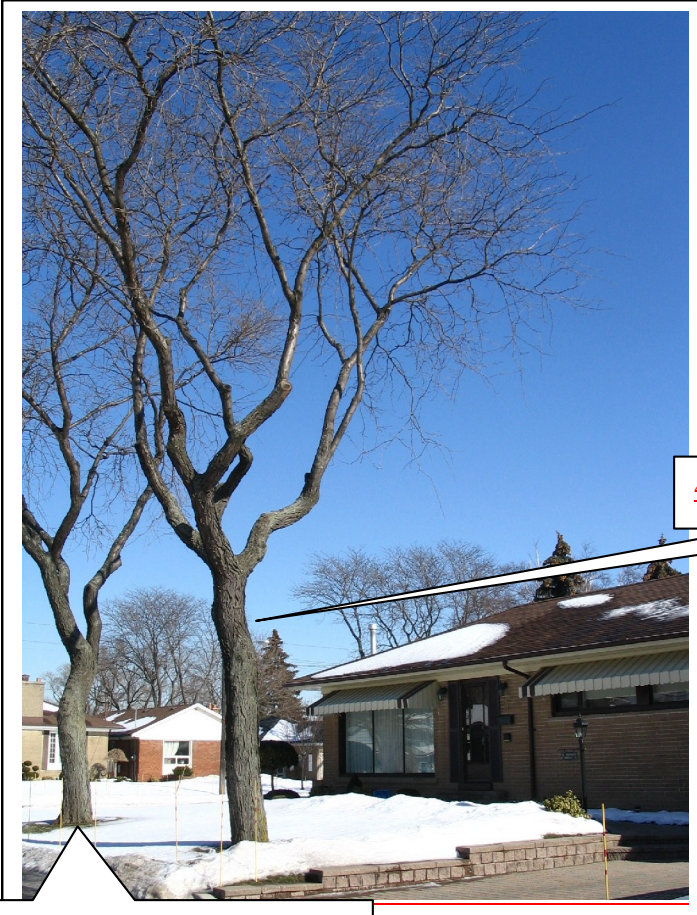
48cm diameter honey locust

51cm diameter honey locust

Inspection of the trees by staff revealed that the trees are in good condition. Both are located approximately six metres from the front of the house. Urban Forestry staff were unable to detect any damage to the foundation; however, the area had not been excavated. With respect to damage to foundations, poor or deteriorating foundations allow water to penetrate and the freezing and thawing of this water causes cracks. The presence of any roots in cracks is circumstantial. With proper care and maintenance, the trees should continue to provide benefits to the community for years to come. Therefore, Urban Forestry cannot support removal of these trees.

The trees in question are located approximately six metres from the front of the house. Tree roots have extended up to the foundation wall, which is evident from the suckers that have sprouted in the front garden. Urban Forestry staff were unable to locate any damage to the exterior of the house; however, the area next to the house had not been excavated. It is our view that these trees have not and will not cause any damage to the foundation.

These trees are significant and are a valuable part of the forest community that exists within this area. With proper care and maintenance, the subject trees should continue to provide benefits to the owner and to the community for many years to come. Urban Forestry cannot support removal of these trees.

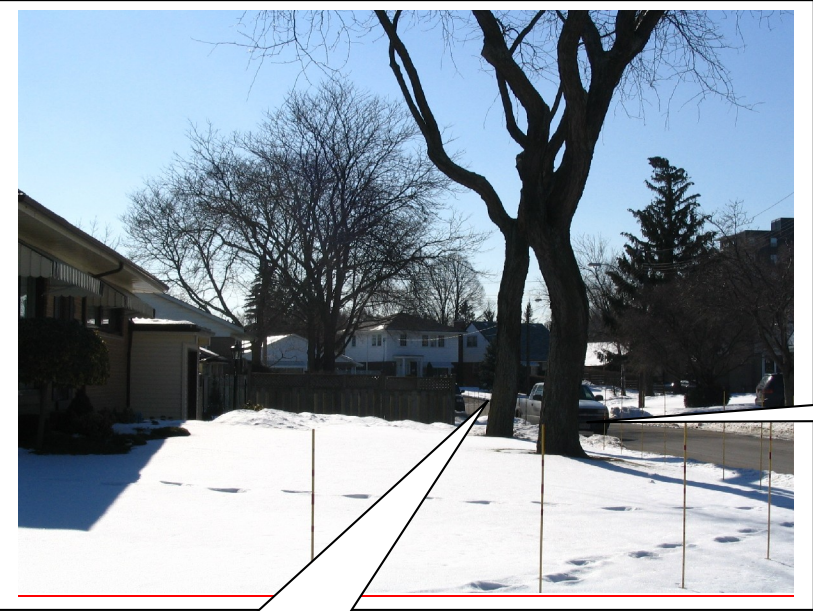
51cm diameter honey locust

48cm diameter honey locust
