3.2 EXISTING STREET CHARACTER

3.3 EXISTING PARKS AND OPEN SPACE

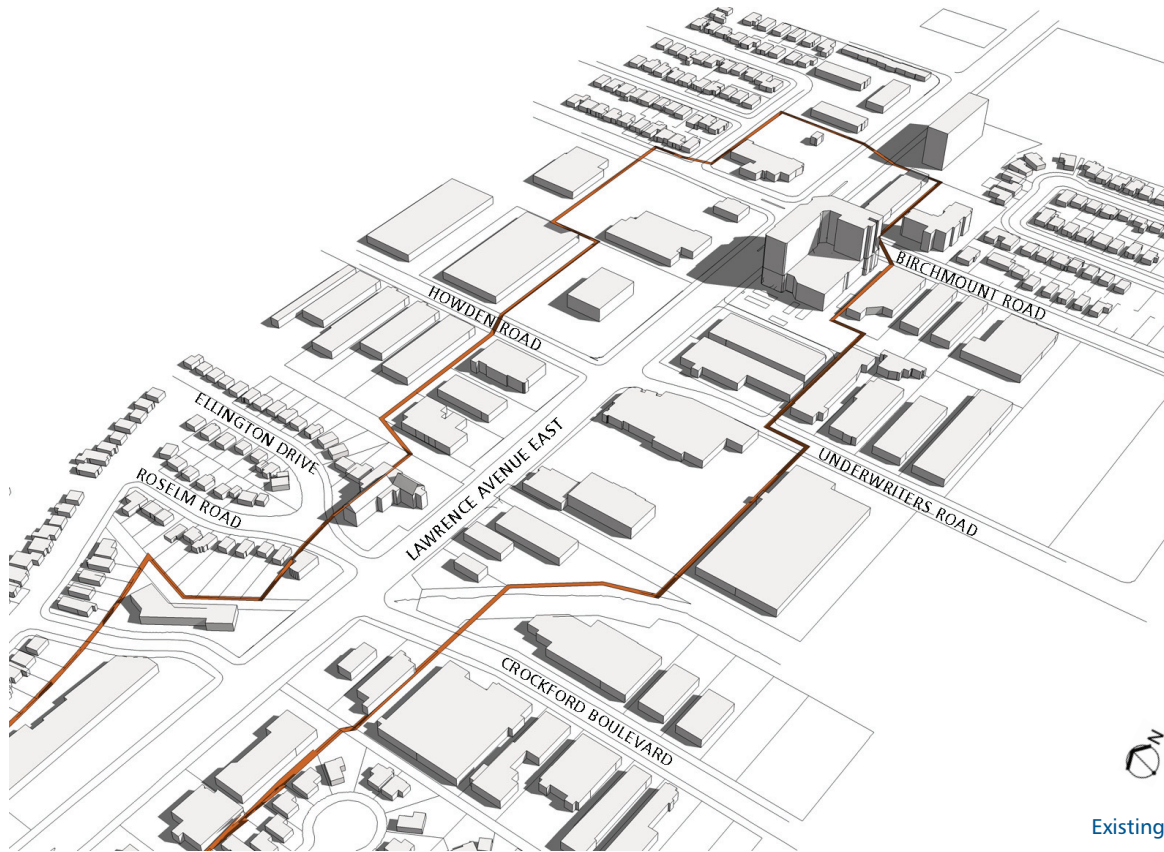
Figure 3.5: Characteristics of Sub Area 3, N.T.S.

Lawrence Avenue East: North Elevation

Existing Condition Bird's Eye View from Southwest

Lawrence Avenue East: South Elevation

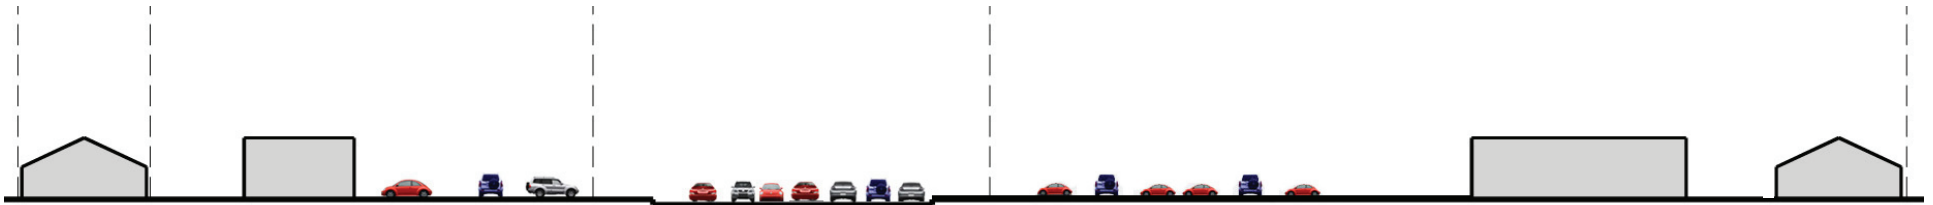
Figure 3.7: Lawrence Street Section at Pharmacy Avenue looking East (N.T.S.)

The current pavement width of Lawrence Avenue is about 26 metres, accommodating 6 travel lanes (three each way) and a seventh, centre-turn lane. Each of these lanes is at least 3.5 metres wide, with the curb lanes a bit wider. There are six signalized intersections along the length of Lawrence Avenue East between Victoria Park Avenue and Birchmount Road, providing limited pedestrian crossing opportunities, particularly along the 1 kilometre commercial/retail stretch between Pharmacy Avenue and Warden Avenue.

The lane widths, along with the few signalized pedestrian crossings, the lack of buildings along the street edge, the lack of street tree planting and high speed traffic contribute to an inhospitable environment for pedestrians (see Figures 3.7 and 3.8).

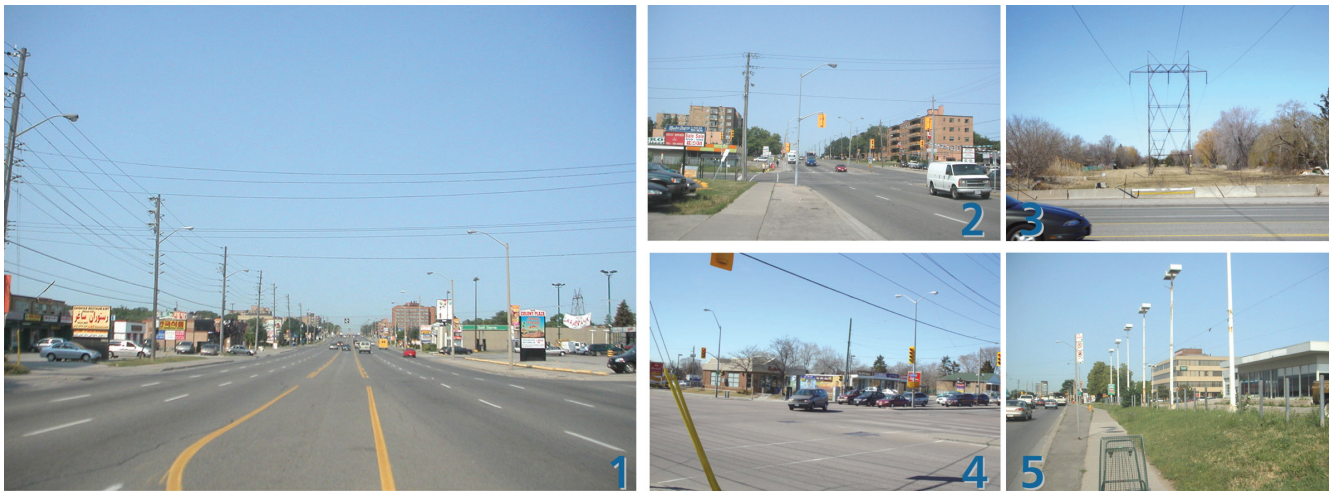
Figure 3.8: Street Character

There is little or no consistent street tree planting or street furniture within the right-of-way to create pedestrian amenity or visual containment for the street. Overhead high voltage hydro wires and auto oriented street lighting contribute to creating a generally auto-focused character on the street.

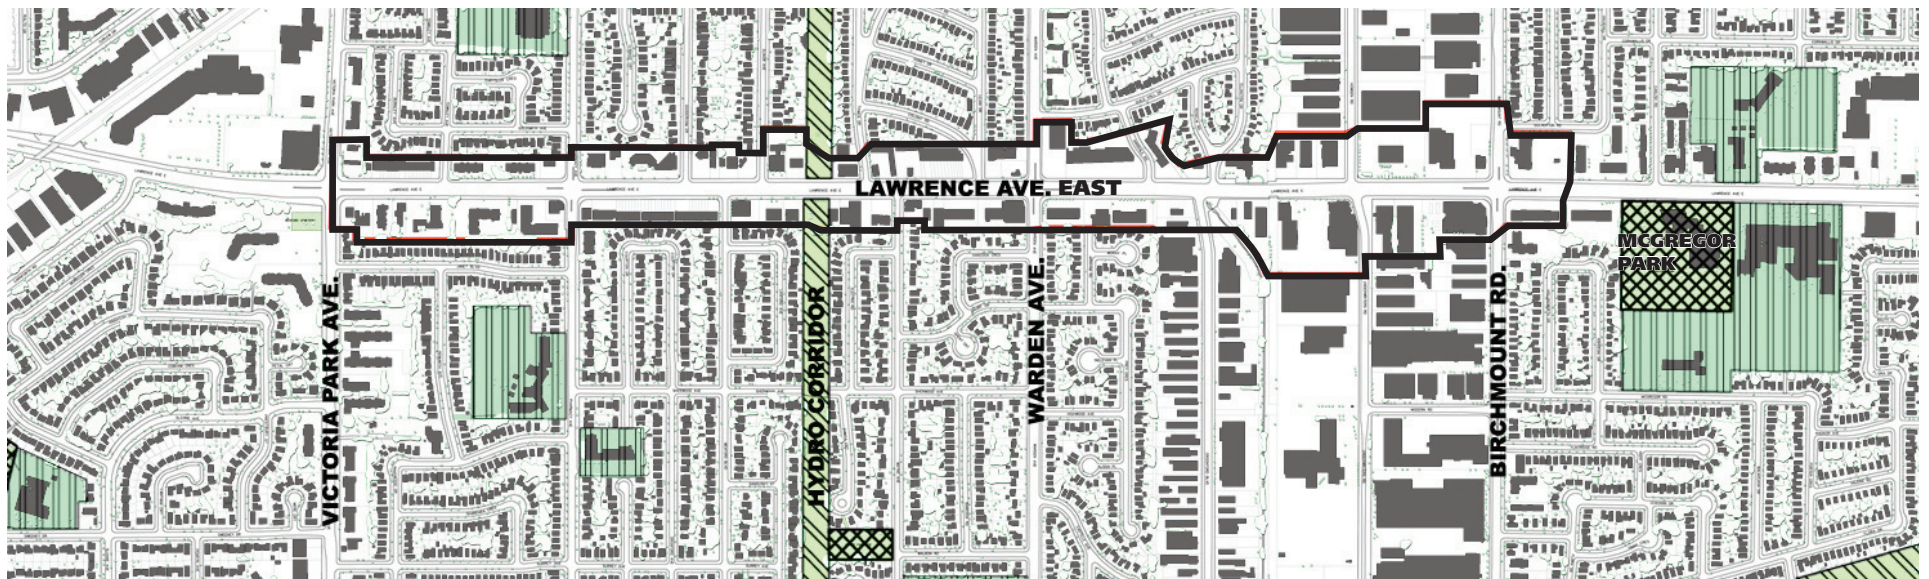
Figure 3.9: Existing Parks, Open Space and Tree Coverage, N.T.S.

McGregor Park, located east of the Study Area, is the closest major park facility containing a community centre and library within the Study Area (Figure 3.9).

Otherwise, parks and open spaces are scarce along Lawrence Avenue East and located far from the Study Area. There are no pedestrian linkages from Lawrence Avenue East to the larger trail system or greenways in the wider community. As already mentioned, all of the area north of Lawrence Avenue East and the area south of Lawrence Avenue East, between Warden Avenue and Birchmount Road, is defined as a park-deficient area in the City's Official Plan.

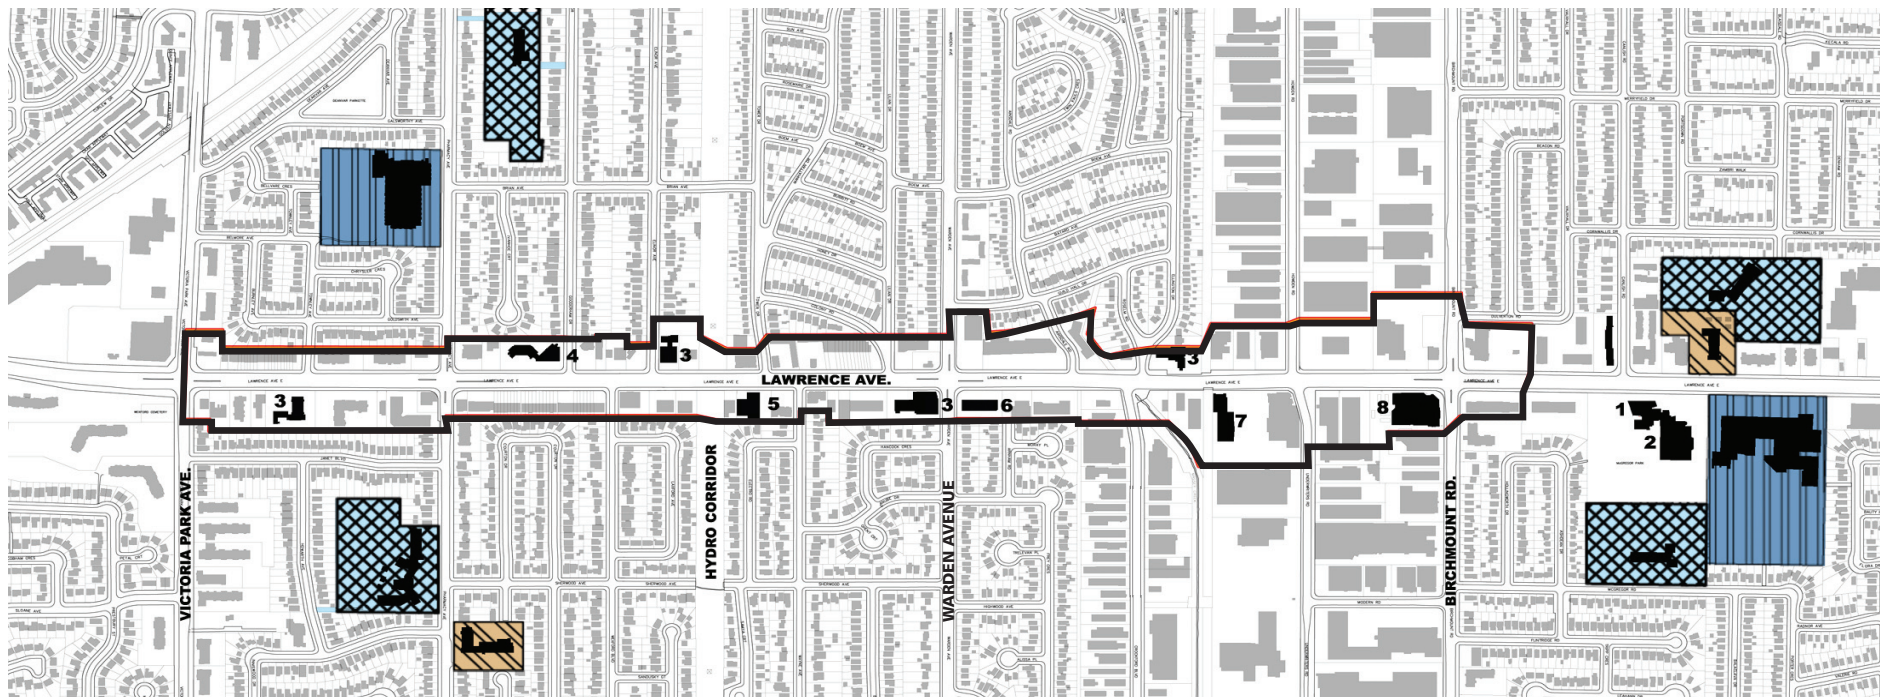
Figure 3.10: Existing Community Services and Facilities, N.T.S.

Existing community services and facilities are shown in Figure 3.10. The City completed a Community Services and Facilities Review in August 2007 for the Study Area. A summary of the findings include:
