Princes' Gates: Restoration of the Central Arch and North/ South Pylons

Presentation to the Toronto Preservation
Board by James Bailey Architect

*2010/ 11 Princes' Gates
Restoration*

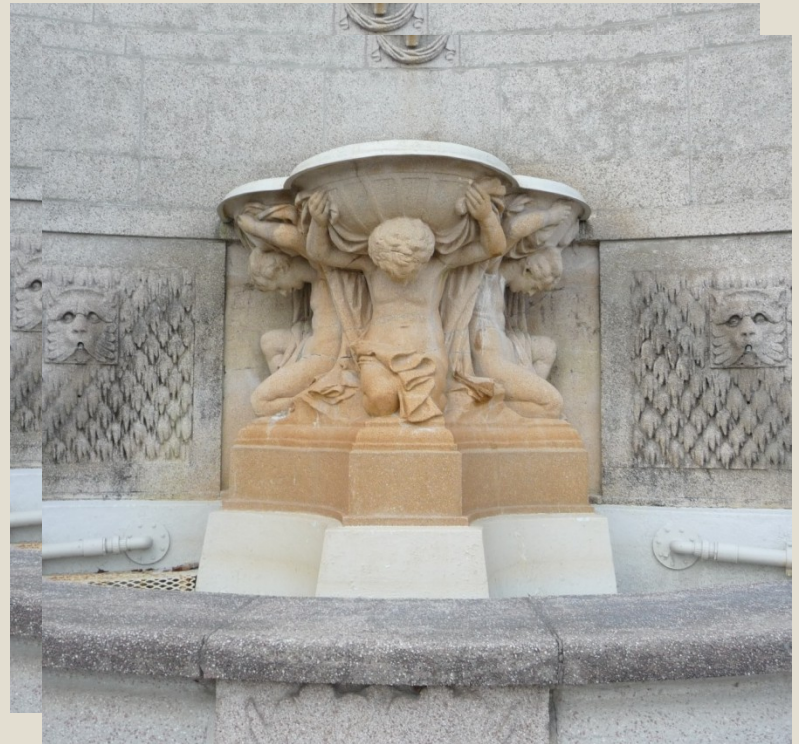
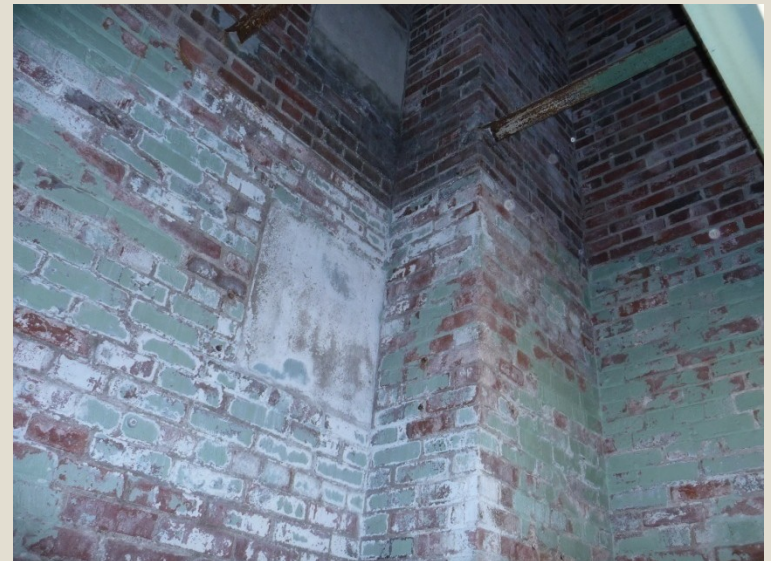
A detailed audit of existing conditions was undertaken from grade level, beginning December 1, 2009. At that time we also began to audit the internal brickwork and existing mechanical ventilation.

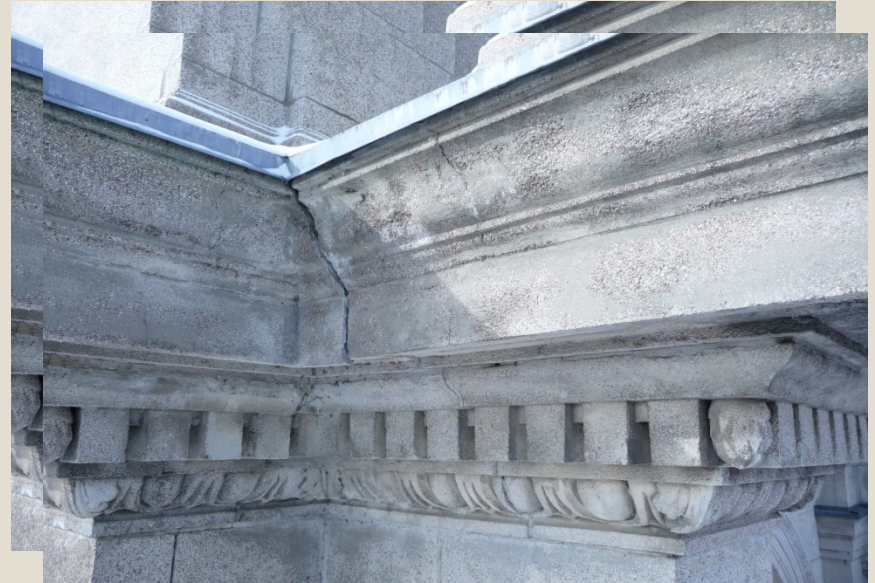
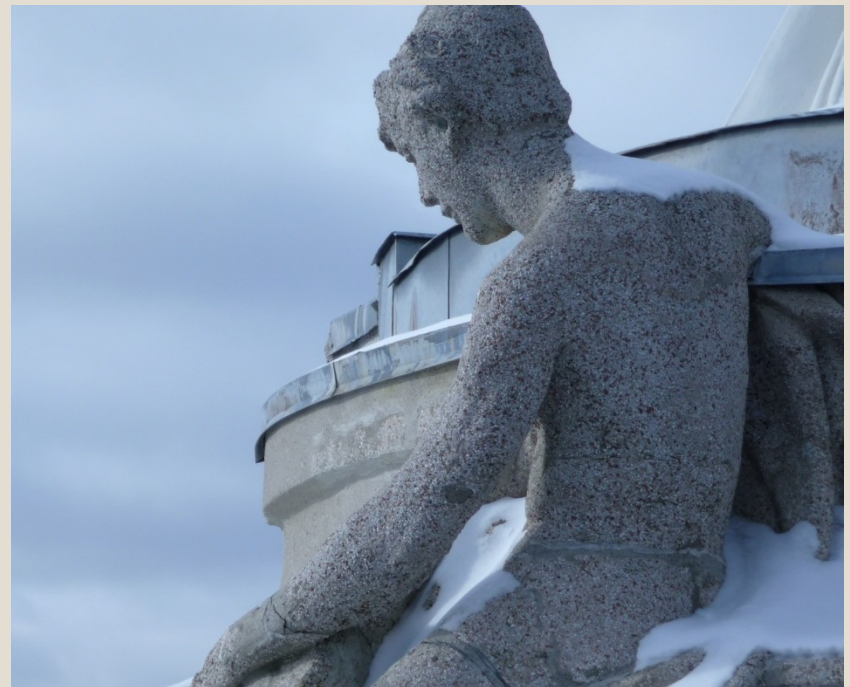
The first week of January we carried out two days of examination working from a boom-lift which provided close access to the upper wall areas and the statuary.

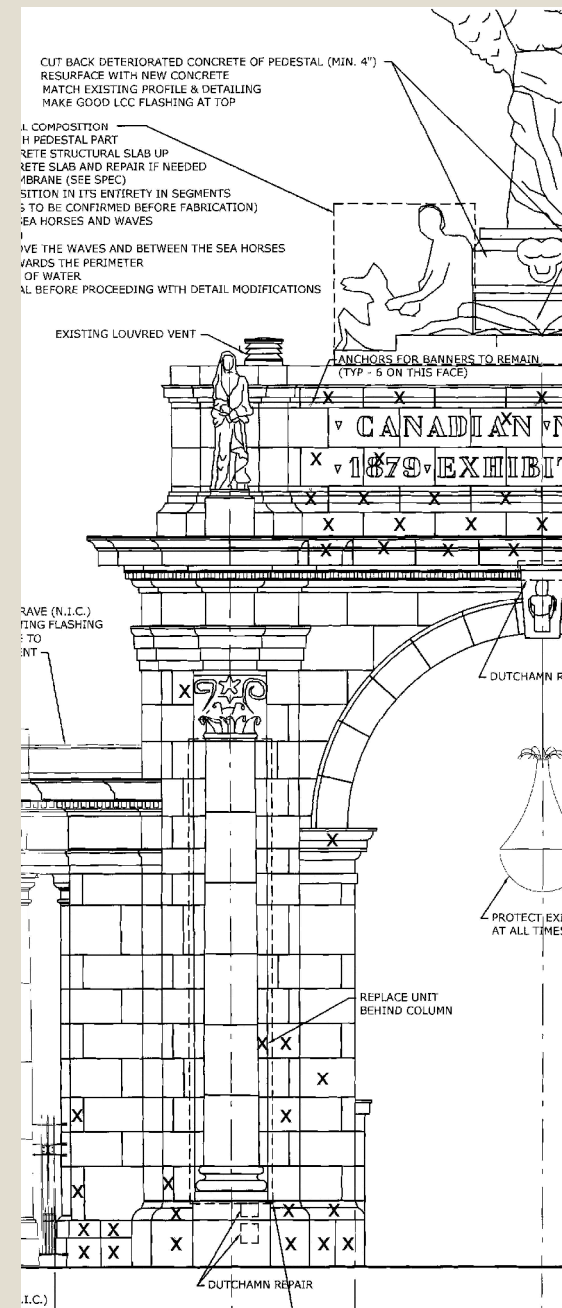
As no drawings were accurate, we prepared as-built drawings of the specific elements of the Gate within our scope.

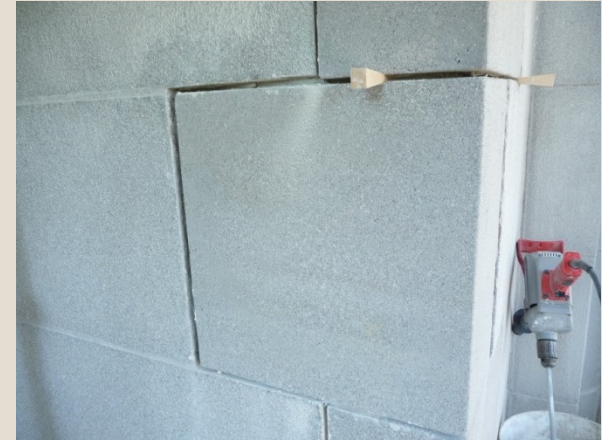
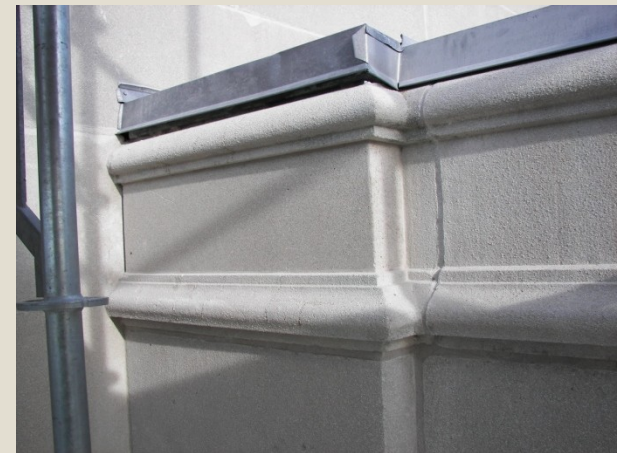
Failing cast stone:

- where the stone is showing signs of disintegration due to water infiltration or delamination of face from backing: REPLACEMENT WITH LIKE.
- where stone is chipped or broken: DUTCHMAN REPAIRS are sometimes used.

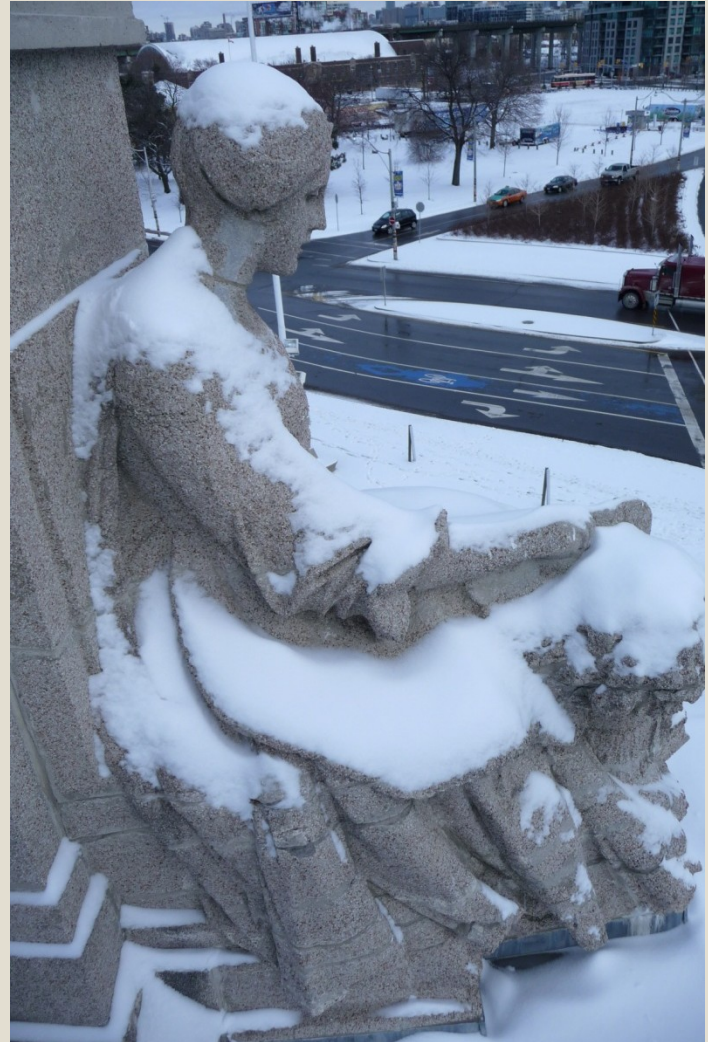
Statuary other than five pieces replaced in past restorations

- these are all due for rebuilding
- Record these using three-dimensional digital technology
- remove these to access the structural ("roof") slabs below
- install waterproofing membrane
- Fabricate replacement statues in materials identical to original

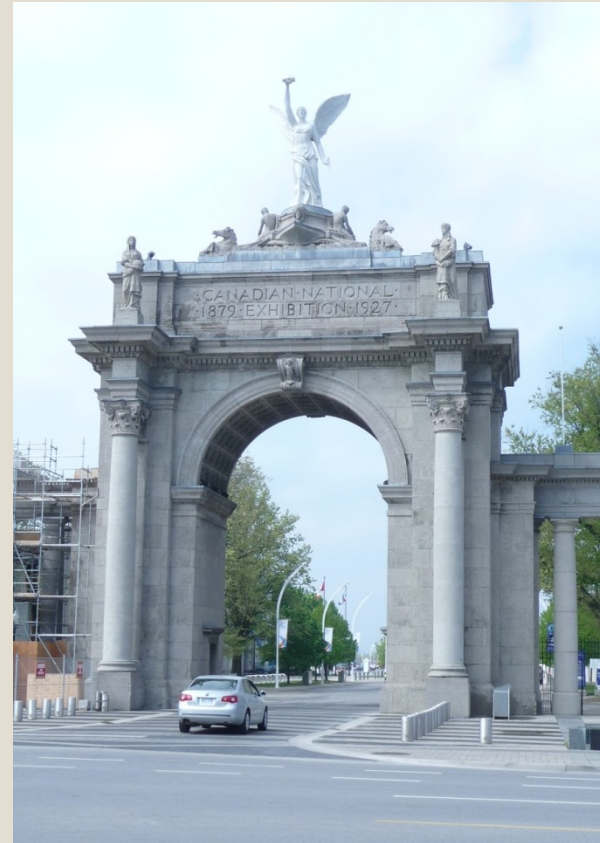
Rebuild the four prominent columns

- Confirmed by core-testing that these are failing in the same way as the two colonnades have failed.
- These are to be rebuilt in their entirety.

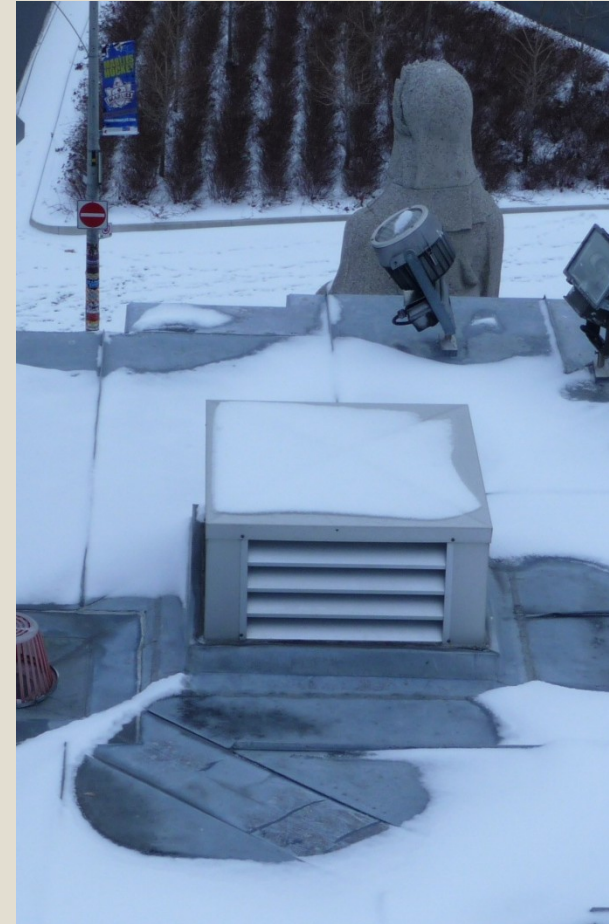
Removal of unsightly fan-units

- In the mid-1990's an attempt was made to control humidity build-ups in the pylons by installing motorized fan units. These are very visible and during this project the humidity will be exhausted through existing louvre openings through the walls of the pylons.

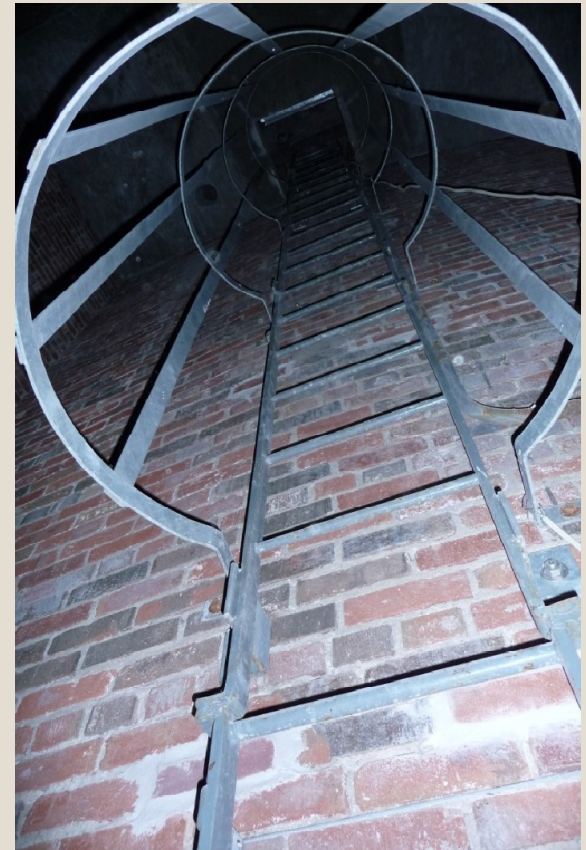
Improving Internal Access for Service

- Ladders and cat-walk access to internal mechanical equipment is being improved.
- Internal service lighting is being added to facilitate maintenance.

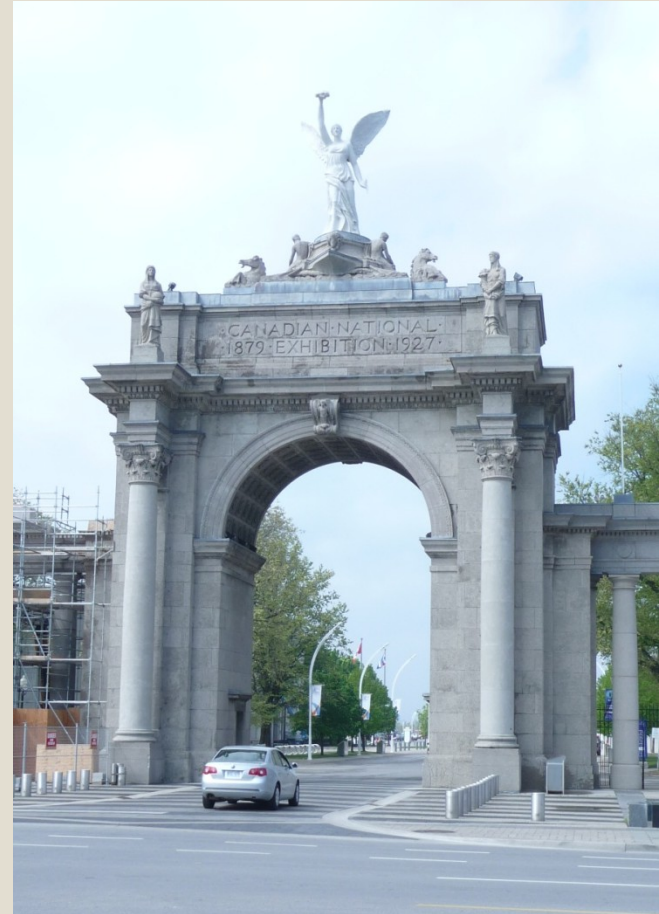
Full re-pointing and cleaning of all the masonry; Restoration of flashings:

- The gates are soiled, especially where sheltered from the rain.
- all the masonry will be washed with a detergent wash to remove any dirt or organic soiling.
- All masonry joints will be cut out and be re-pointed in an appropriate mortar to match the stone and original look of the Gates.

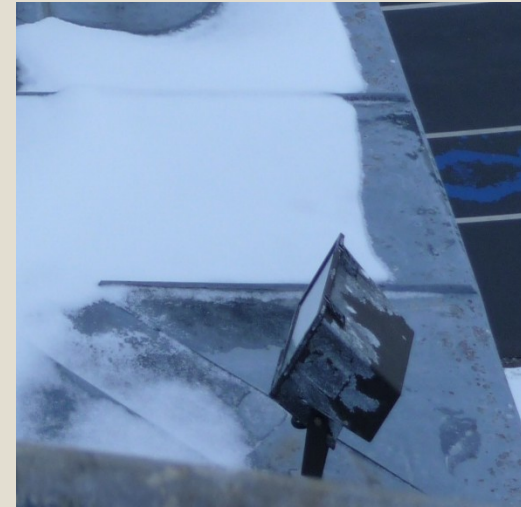
Addressing the Lighting of the Gates:

- The existing lighting dates from the 1990's.
- A Lighting Consultant is being retained to propose a lighting system which accentuates the architectural detail of the Gates, rather than blasting it with light.
